## MINERALS PROGRAM INSPECTION REPORT

<b>MINE NAME:</b> AFS - Bennett Pit	<b>MINE/PROSPECTING ID#:</b> M-2001-038	<b>MINERAL:</b> Sand and borrow material construction	<b>COUNTY:</b> Adams
<b>INSPECTION TYPE:</b> Preoperation Inspection	<b>INSPECTOR(S):</b> Jared L. Ebert	<b>INSP. DATE:</b> April 9, 2019	<b>INSP. TIME:</b> 09:00
<b>OPERATOR:</b> Albert Frei & Sons Inc.	<b>OPERATOR REPRESENTATIVE:</b> Ben Frei	<b>TYPE OF OPERATION:</b> 112c - Construction Regular Operation

<b>REASON FOR INSPECTION:</b> Pre-operation Inspection	<b>BOND CALCULATION TYPE:</b> None	<b>BOND AMOUNT:</b> \$110,860.00
<b>DATE OF COMPLAINT:</b> NA	<b>POST INSP. CONTACTS:</b> None	<b>JOINT INSP. AGENCY:</b> None
<b>WEATHER:</b> Cloudy	<b>INSPECTOR'S SIGNATURE:</b>

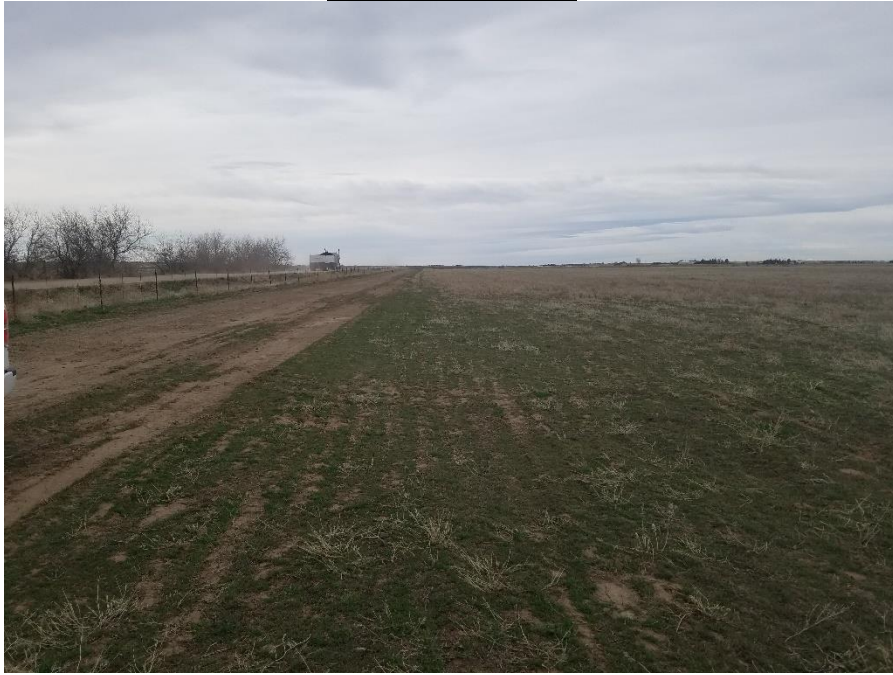
Figure 1. From the northeast corner of the expansion area looking south.

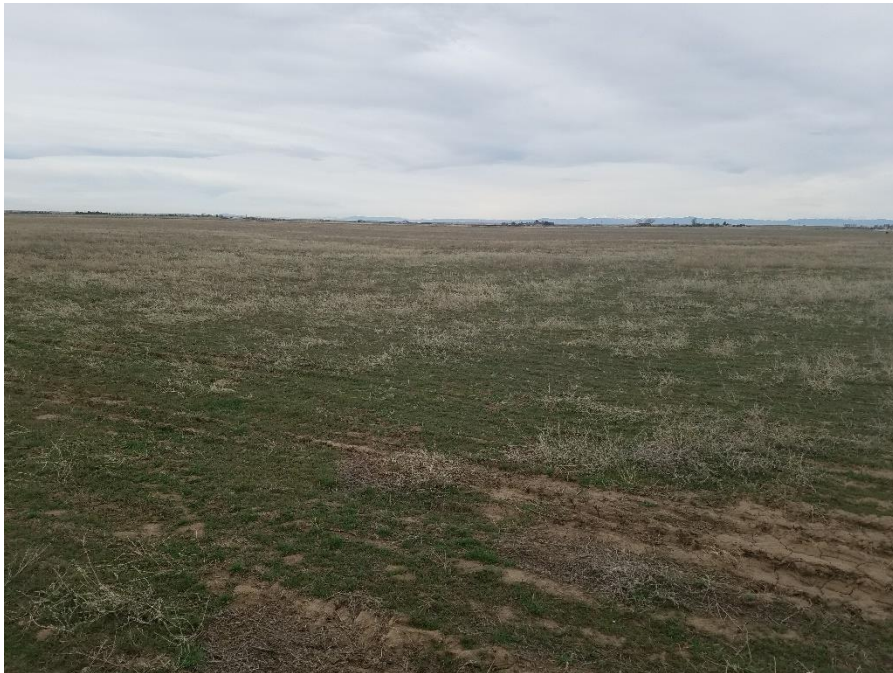
Figure 2. From the northeast corner of the expansion area looking southwest.

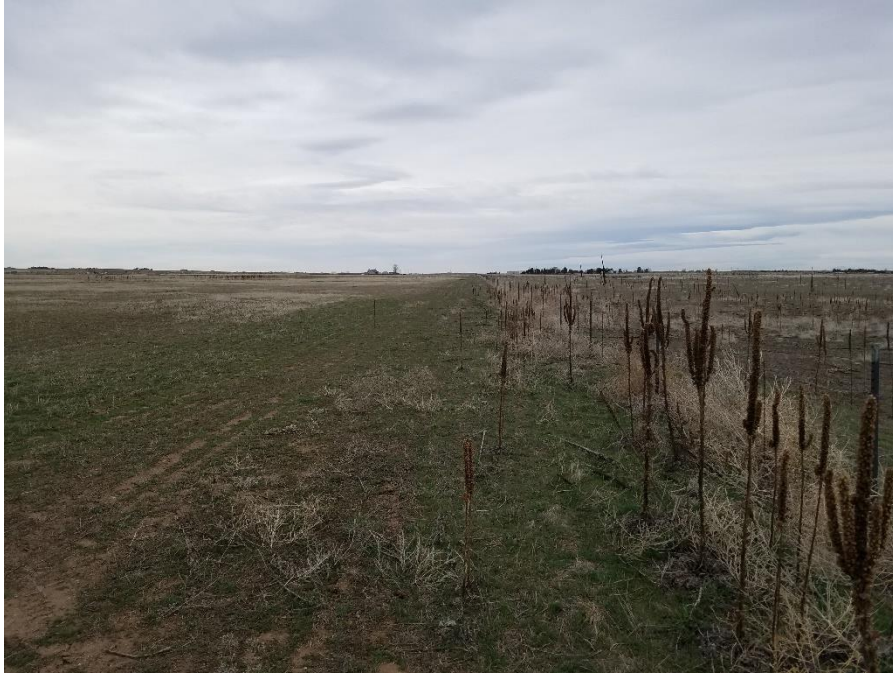
Figure 3. From the west side of the north area looking south.

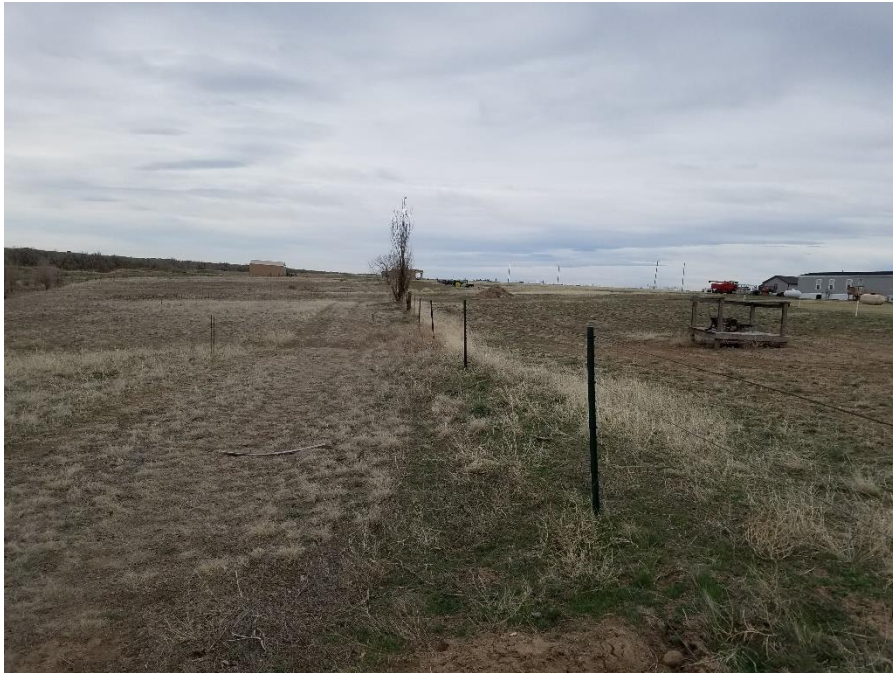
Figure 4. From the northwest corner of the southeast portion of the expansion area looking south.

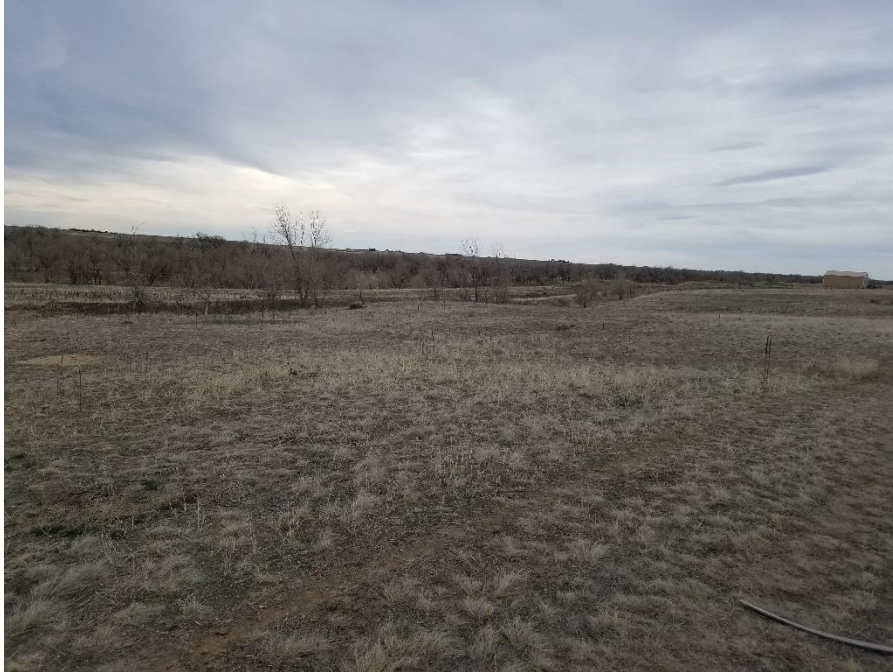
Figure 5. From the northwest corner of the proposed south expansion are looking southeast.

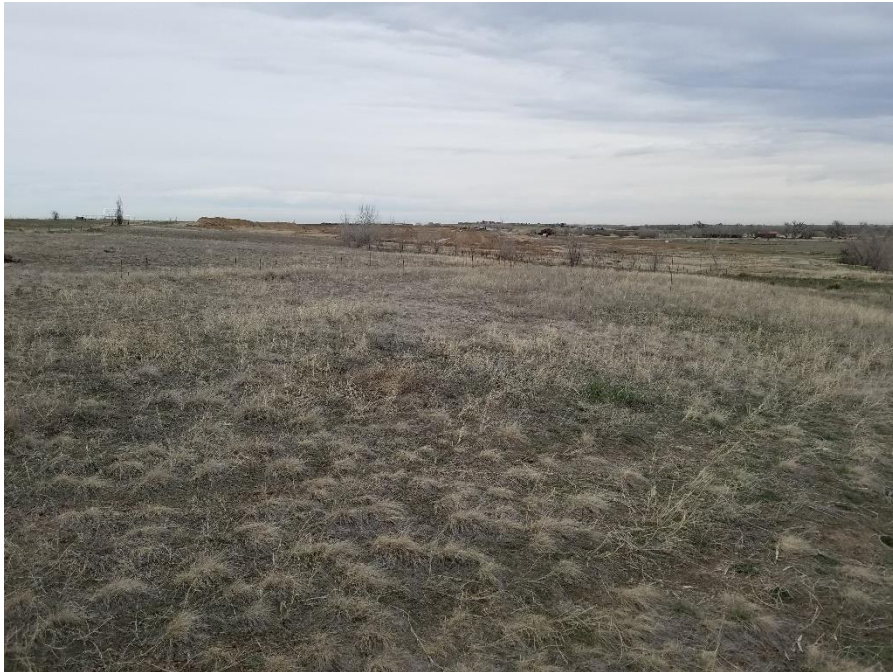
Figure 6. From the south end of the south expansion area looking north.

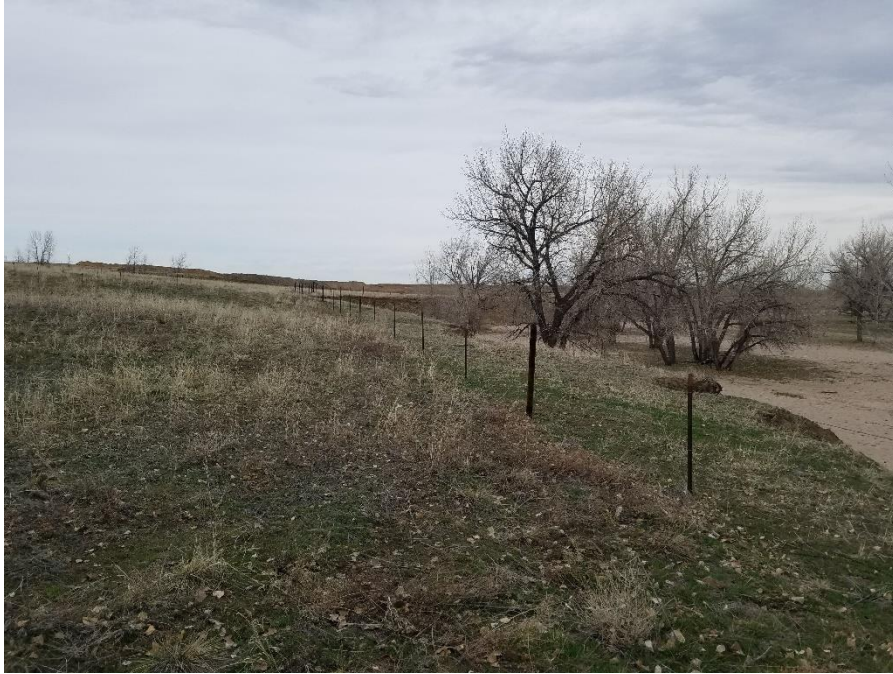
Figure 7. From the southeast corner of the south expansion area looking north. Kiowa Creek to the east.

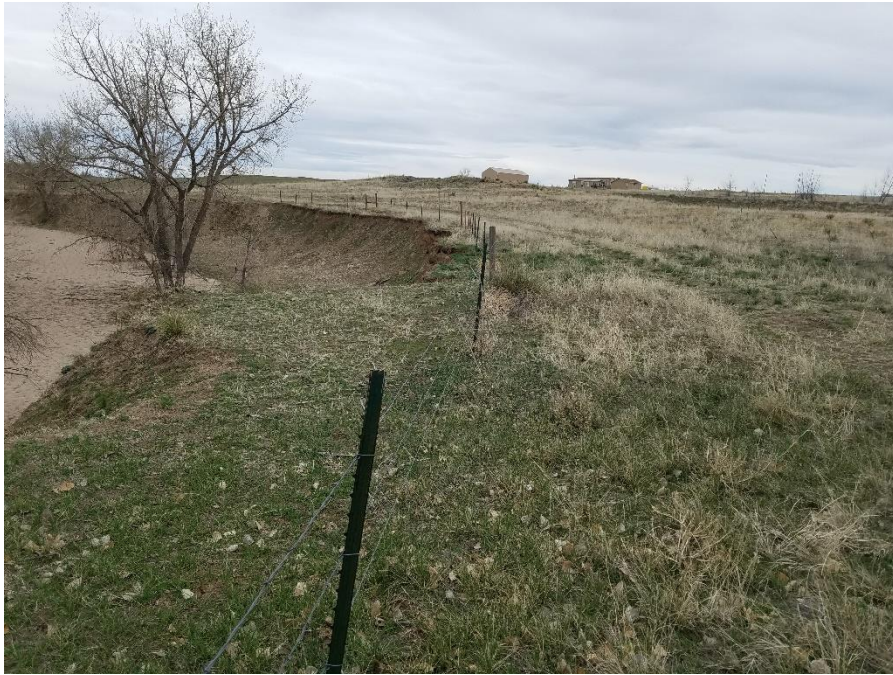
Figure 8. From the northeast corner of the south expansion area looking south.

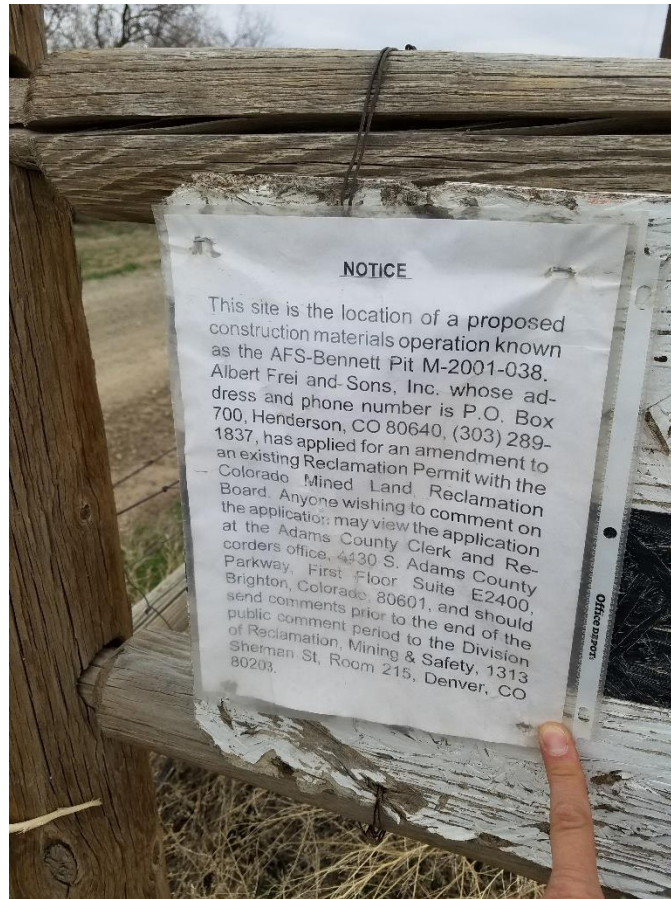
The mine identification sign was in place and the required notification sign for the AM01 application was observed at the site entrance.

Figure 9. AM01 Notice Sign
