**MINERALS PROGRAM INSPECTION REPORT**  
**PHONE: (303) 866-3567**

| <b>MINE NAME:</b><br>Pit 29 | <b>MINE/PROSPECTING ID#:</b><br>M-1980-183 | <b>MINERAL:</b><br>Sand and gravel | <b>COUNTY:</b><br>Adams |
| <b>INSPECTION TYPE:</b><br>Monitoring | <b>INSPECTOR(S):</b><br>Jared L. Ebert | <b>INSP. DATE:</b><br>April 19, 2019 | <b>INSP. TIME:</b><br>13:00 |
| <b>OPERATOR:</b><br>Brannan Sand and Gravel Company, L.L.C. | <b>OPERATOR REPRESENTATIVE:</b><br>Joshua Oliver | <b>TYPE OF OPERATION:</b><br>112c - Construction Regular Operation | |

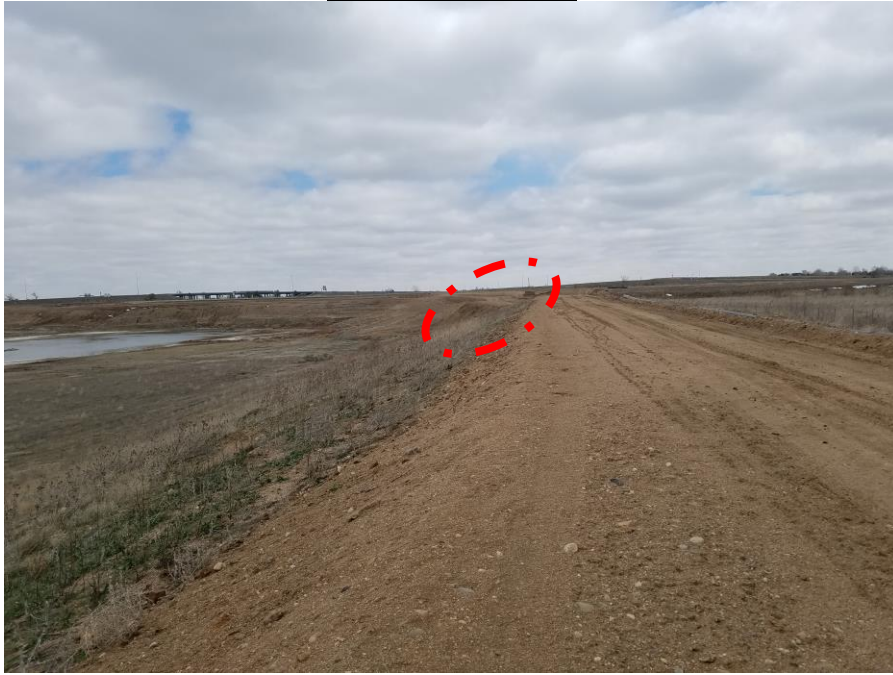
Mining Area II at the center of the site is being reclaimed as a water storage reservoir. During the previous DRMS inspection, Brannon indicated the slurry wall around this cell was leaking. The reservoir operator has repaired the slurry wall and according to Mr. Hagen the slurry wall has passed the Office of the State Engineer's (SEO) leak test requirement. DRMS requests Brannan provide documentation that the SEO has certified both the Mining Area I and Mining Area II slurry walls. The majority of the slopes of the reservoir have been graded to a 3H:1V ratio or less. The slopes around the pump house located on the west side of the reservoir are steep, likely graded to a 1.5H:1V ratio. Near the southeast corner of this reservoir on the eastern reservoir slope, an area estimated to be 150 to 200 feet in length has not been graded to the required 3H:1V slope. The slope is steep to near vertical at the base at this location. Also on the southern end of the Mining Area II cell, where the slurry wall repair was completed, the slopes have been re-affected and are steeper than the required 3H:1V ratio. The reclamation plan requires all of the graded pit slopes to be at least a 3H:1V ratio. Brannan indicated they would work with the reservoir operator to complete the required earthwork.

**Figure 1. Southern pit slopes of Mining Area II, from the southwest corner looking east.  
Slurry Wall repair area outlined in red.**

As discussed above, DRMS will need documentation to confirm the slurry walls at the site have passed the SEO standards.

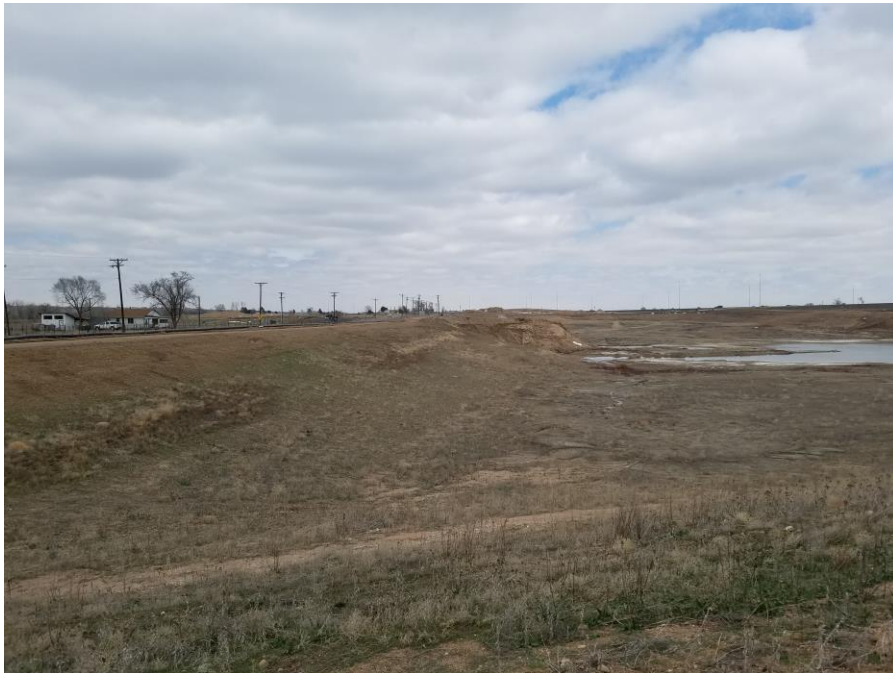
Final grading of portions of the Mining Area II pit remains to be completed. The vegetation around the Mining Areas I and II primarily consists of annual weeds with sparse desired vegetation established. The slopes around Mining Area I are vegetated primarily with cheatgrass and patches of thistle were observed. The slopes around Mining Area II have sparse vegetation established around the southern and eastern pit slopes. Brannan will need to conduct appropriate weed control and possibly utilize soil amendments to help facilitate the desired vegetation establishment. Brannan will need to revegetate the site with the approved seed mixture defined in the permit.

**Figure 2. From southwest corner of Mining Area II looking north.**

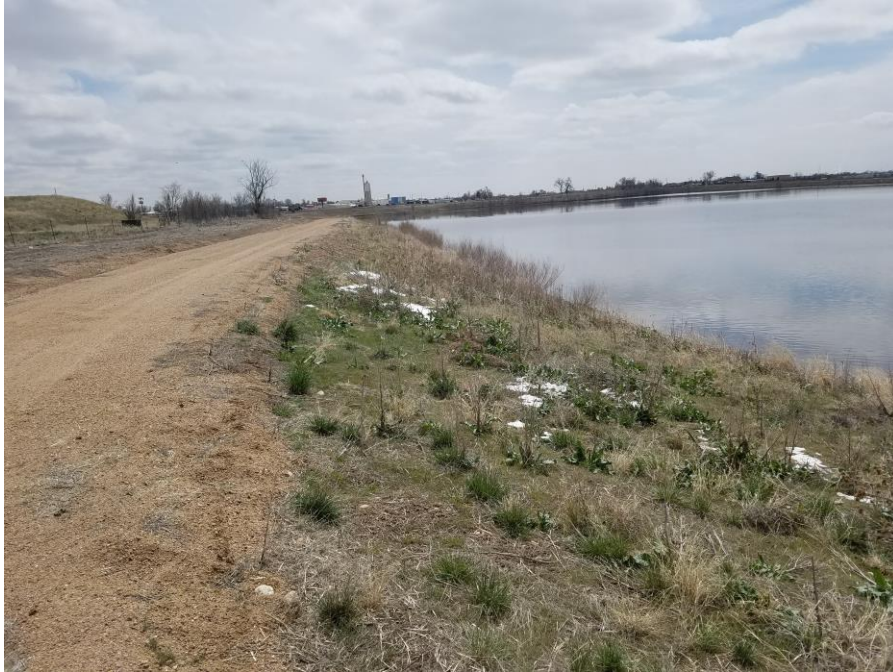
Figure 3. From the northeast corner of Mining Area I, looking south.

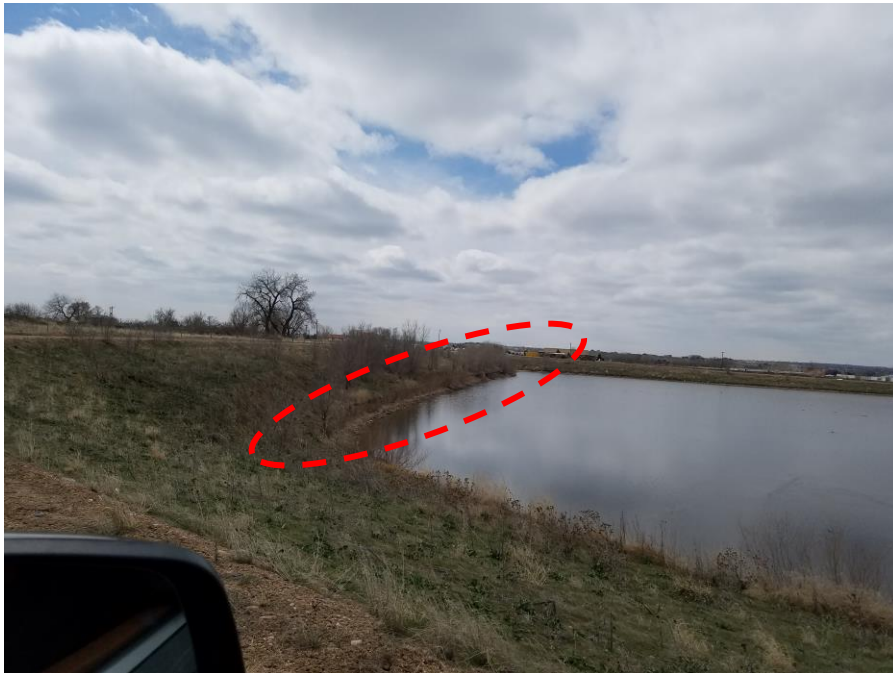
Mining Area I at the southern end of the site has been reclaimed as a water storage reservoir. The reservoir was holding water and the slopes above the waterline appeared stable with the exception of some bank cutting at the southern end of the lake. The bank cutting is most pronounced along the southern end of this reservoir. The slopes in this area appears to have cut due to wave action. The shore cutting is two to three feet in height in most places, however trees and shrubs has established on the cut area and dense vegetation has developed on this slope. Rip-rap has not been placed on the reclaimed slopes. It was discussed that Brannan could submit a Technical Revision to remove the requirement to rip-rap the shoreline as this is currently a requirement of the reclamation plan. Brannan will need to provide a demonstration that rip-rap will no longer be necessary for the long-term stability of the pit slopes.

Figure 4. From the southeast corner of Mining Area I looking west. Slope cutting outlined in red.

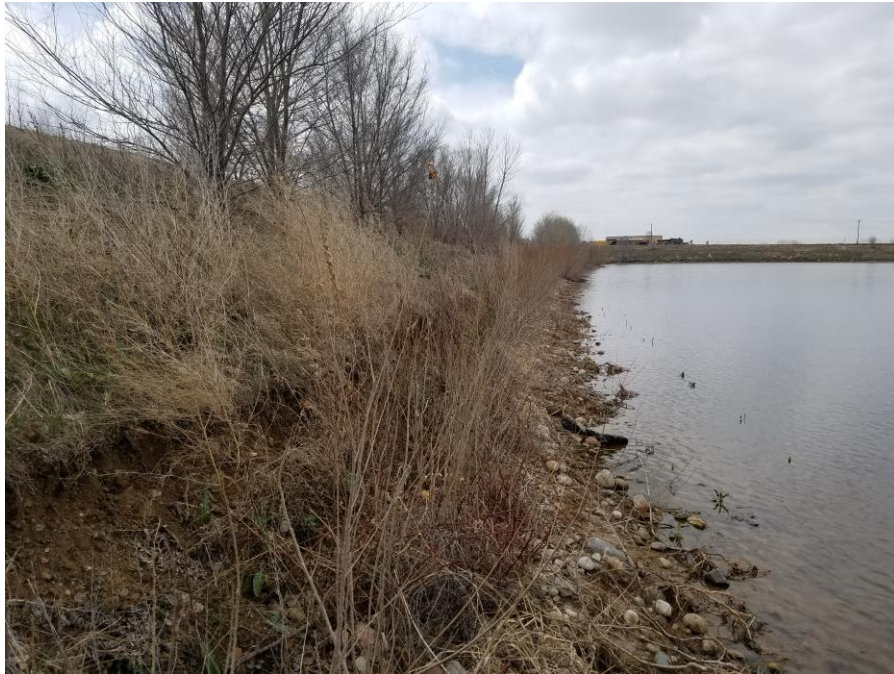
**Figure 5. Shore cutting on the southern pit slope of Mining Area I.**
