MINERALS PROGRAM INSPECTION REPORT
PHONE: (303) 866-3567

MINE NAME: Ard Property Borrow	MINE/PROSPECTING ID#: M-2017-002	MINERAL: Borrow material	COUNTY: Weld
INSPECTION TYPE: Monitoring	INSPECTOR(S): Peter S. Hays	INSP. DATE: April 9, 2019	INSP. TIME: 09:30
OPERATOR: Ames Construction, Inc.	OPERATOR REPRESENTATIVE: None	TYPE OF OPERATION: 111 - Construction by Government Agency	
REASON FOR INSPECTION: Normal I&E Program	BOND CALCULATION TYPE: None	BOND AMOUNT: \$25,820.00	
DATE OF COMPLAINT: NA	POST INSP. CONTACTS: None	JOINT INSP. AGENCY: None	
WEATHER: Clear	INSPECTOR'S SIGNATURE:

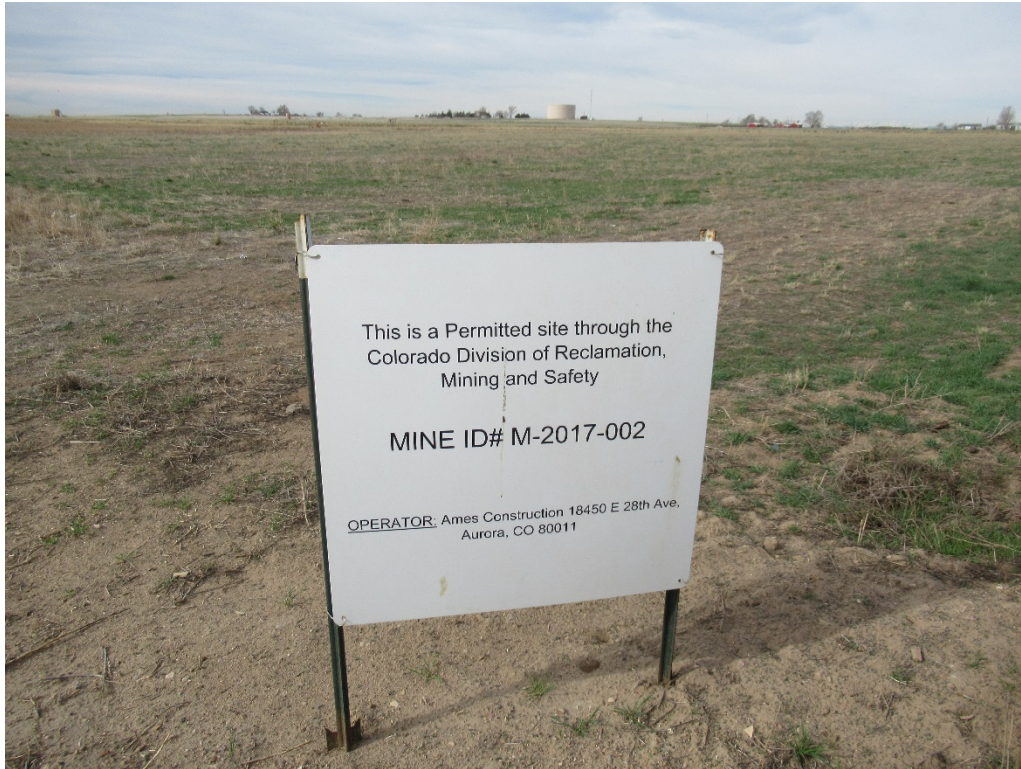
As cited as a problem following the last inspection, the mine sign and boundary markers were not observed during the inspection as required by Rule 3.1.12. The Operator submitted proof of a posted mine sign on November 1, 2018 and stated the boundary markers were installed, however the Operator failed to provide proof of the boundary markers. The Division observed wood stakes with "borrow limits" indicating the permit boundary during this inspection. The problem cited for the lack of a mine sign and boundary markers is considered resolved by the Division.

Ard Property Borrow mine sign

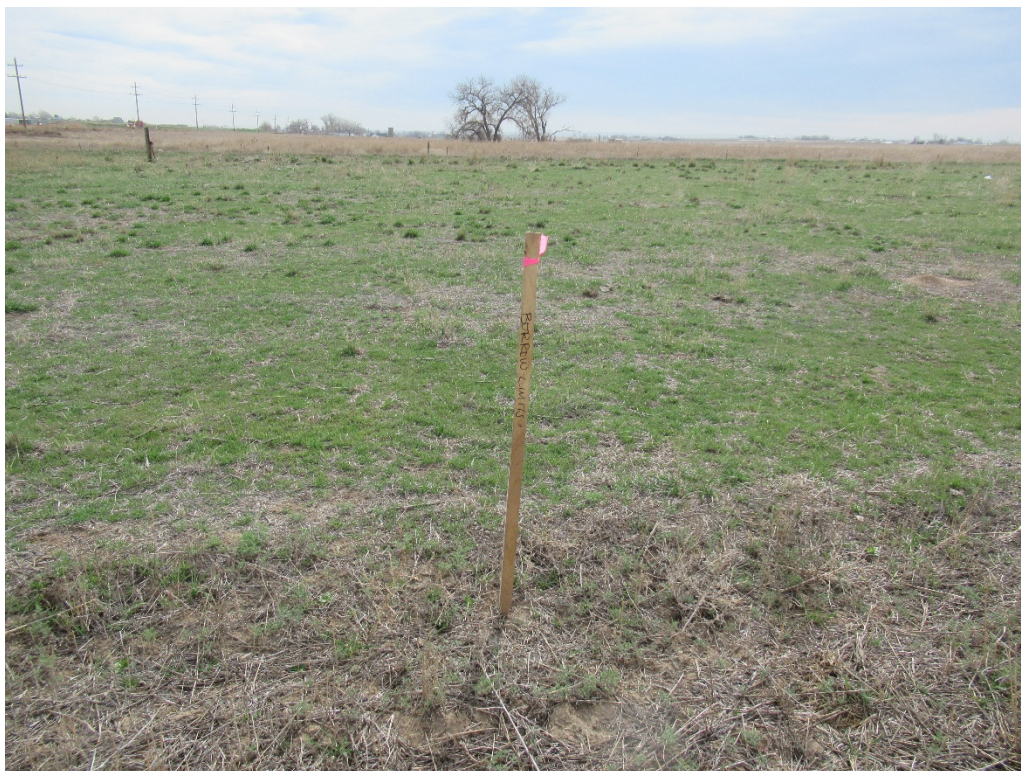
Typical boundary marker

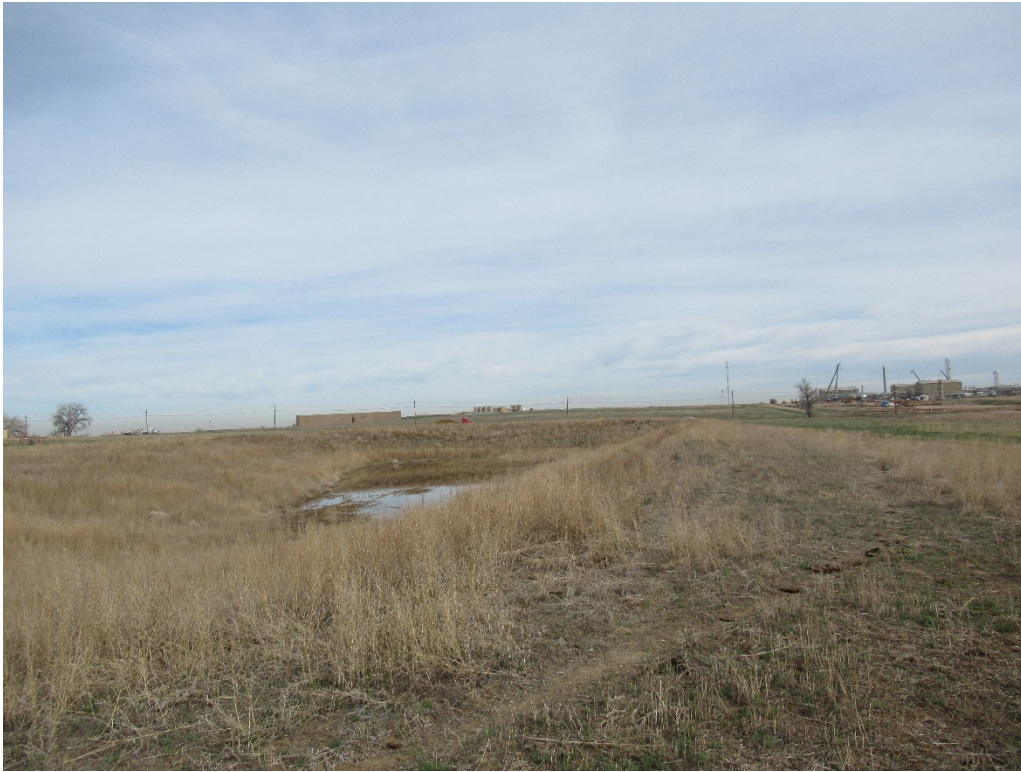
The Operator previously stated the site was revegetated in March/April of 2018. As observed during the last inspection, the site vegetation consists of kochia and Halogeton with patches of a grass species not included in the approved dryland pasture mix for the site. Halogeton is a List C noxious weed by the Colorado Weed Management Association. The Operator is required to control the spread of noxious weeds at the site. The vegetation was similar to the previously observed vegetation. No evidence of weed control or revegetation efforts were observed during the inspection.

View of pit from the southeast corner looking northwest

The Division recommends the Operator control the kochia and Halogeton and reseeds the site with the approved seed mixture to establish reclamation vegetation. Noxious and annual weed control measures must continue until the reclamation vegetation is well-established and the permit is released by the Division.

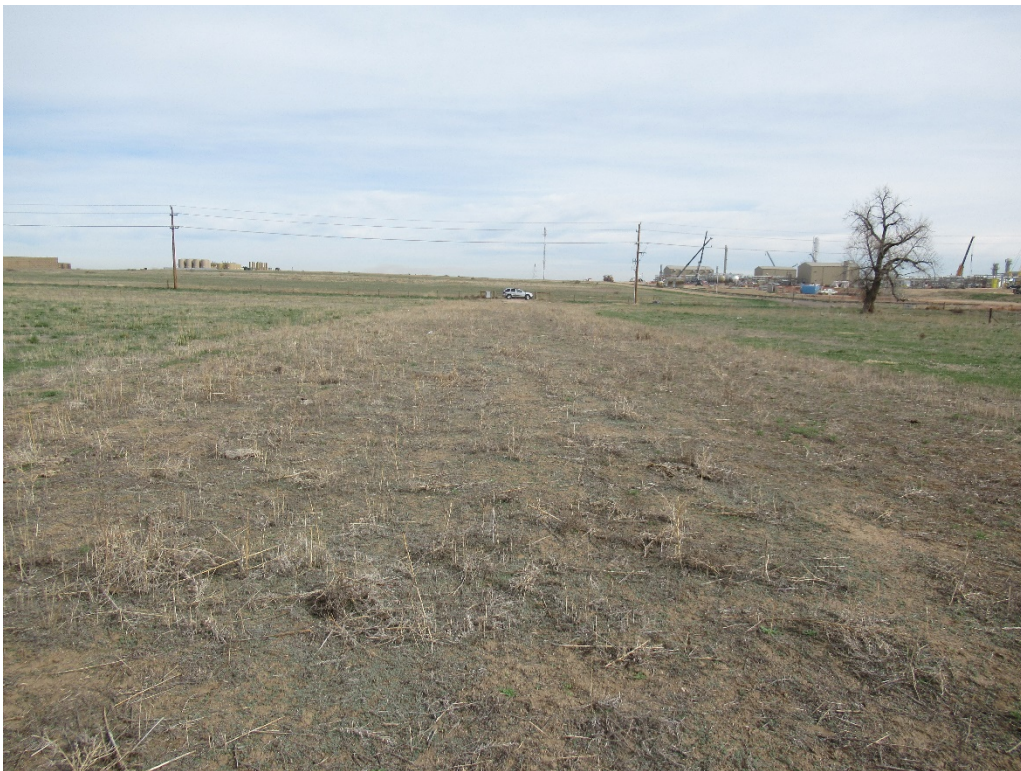
View of access road from the south end looking north
