**COLORADO**Division of Reclamation,
Mining and Safety

MINERALS PROGRAM INSPECTION REPORT**PHONE: (303) 866-3567**

MINE NAME: Bent County Pit # 2	MINE/PROSPECTING ID#: M-2001-019	MINERAL: Gravel	COUNTY: Bent
INSPECTION TYPE: Monitoring	INSPECTOR(S): Amy Eschberger	INSP. DATE: March 7, 2019	INSP. TIME: 13:45
OPERATOR: Bent County	OPERATOR REPRESENTATIVE: Robert Darnell	TYPE OF OPERATION: 112c - Construction Regular Operation	
REASON FOR INSPECTION: Normal I&E Program	BOND CALCULATION TYPE: None	BOND AMOUNT: \$0.00	
DATE OF COMPLAINT: NA	POST INSP. CONTACTS: None	JOINT INSP. AGENCY: None	
WEATHER: Clear	INSPECTOR'S SIGNATURE:

M-2001-019 / Bent County Pit # 2 / Bent County

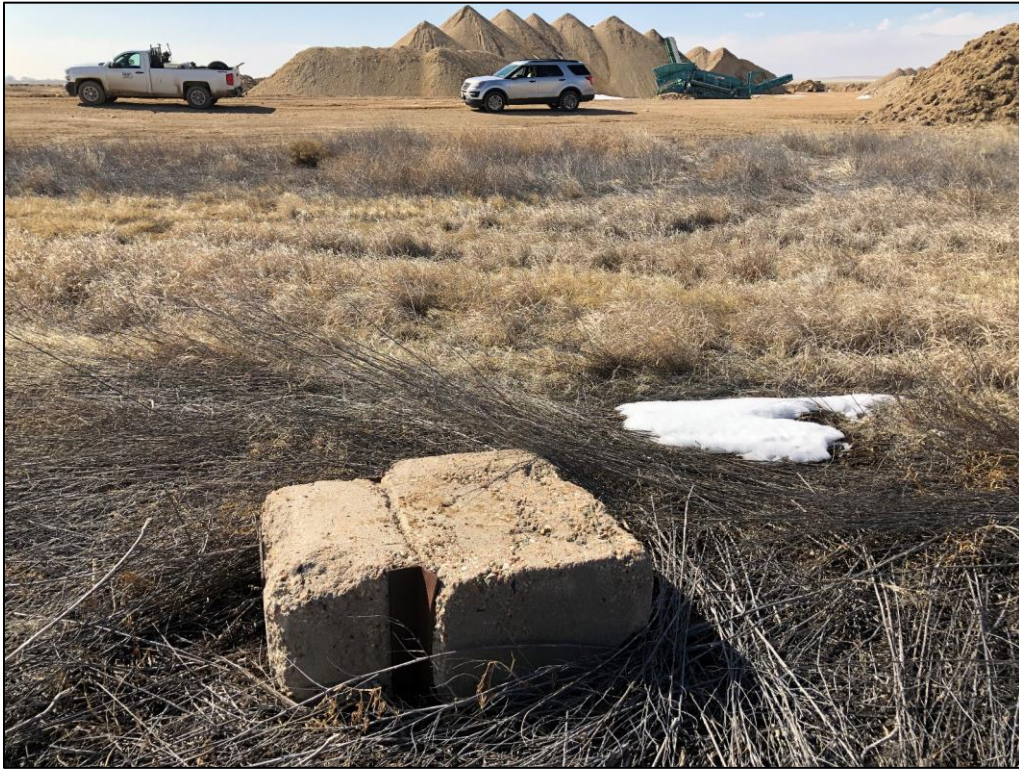
Photo 1. View looking northwest from southern corner of permit boundary, marked by a large concrete block.

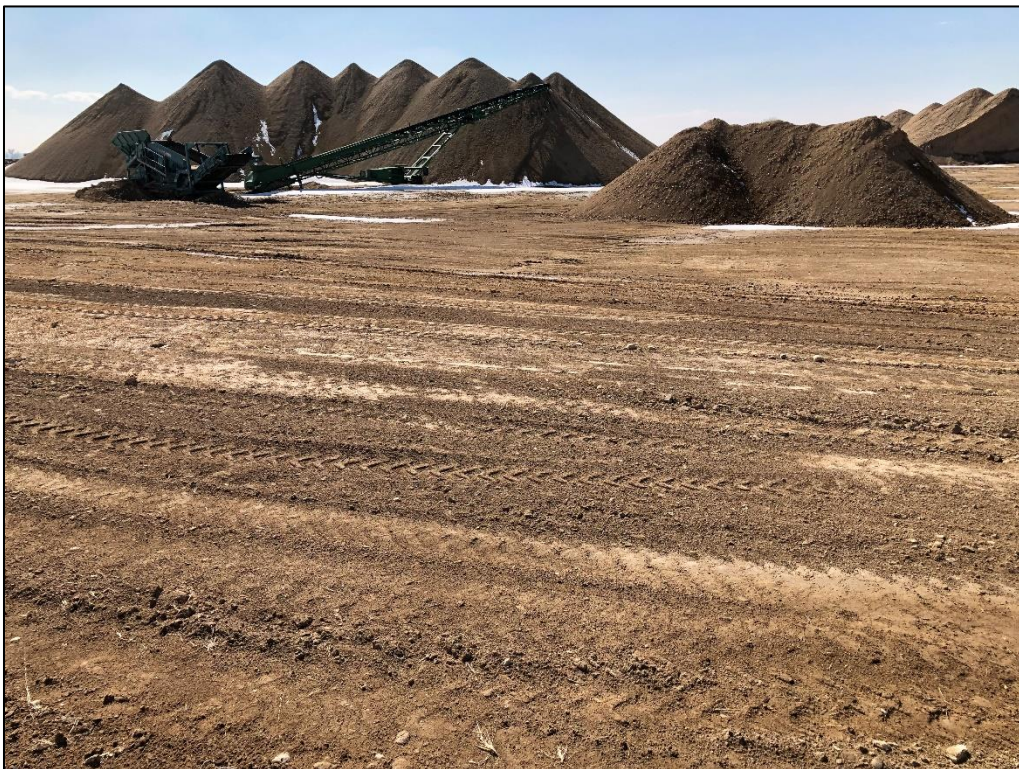
Photo 2. View looking southwest from eastern edge of pit disturbance, showing material stockpiles and mobile processing equipment stored on pit floor.

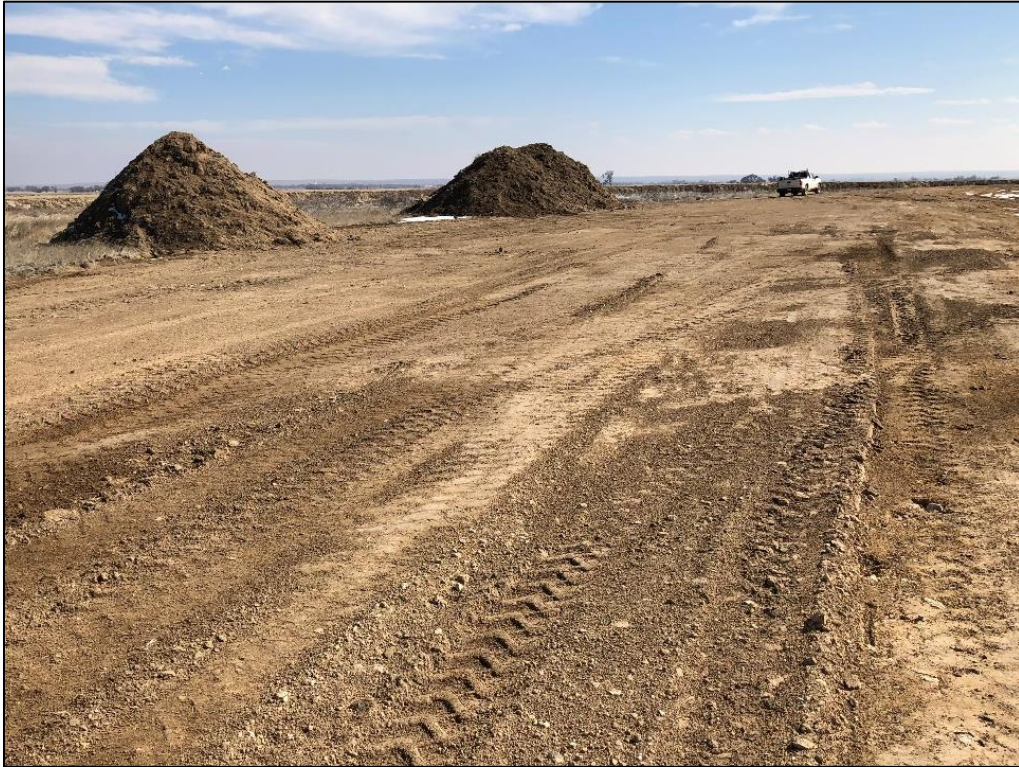
Photo 3. View looking south, showing topsoil stored at southern edge of pit disturbance

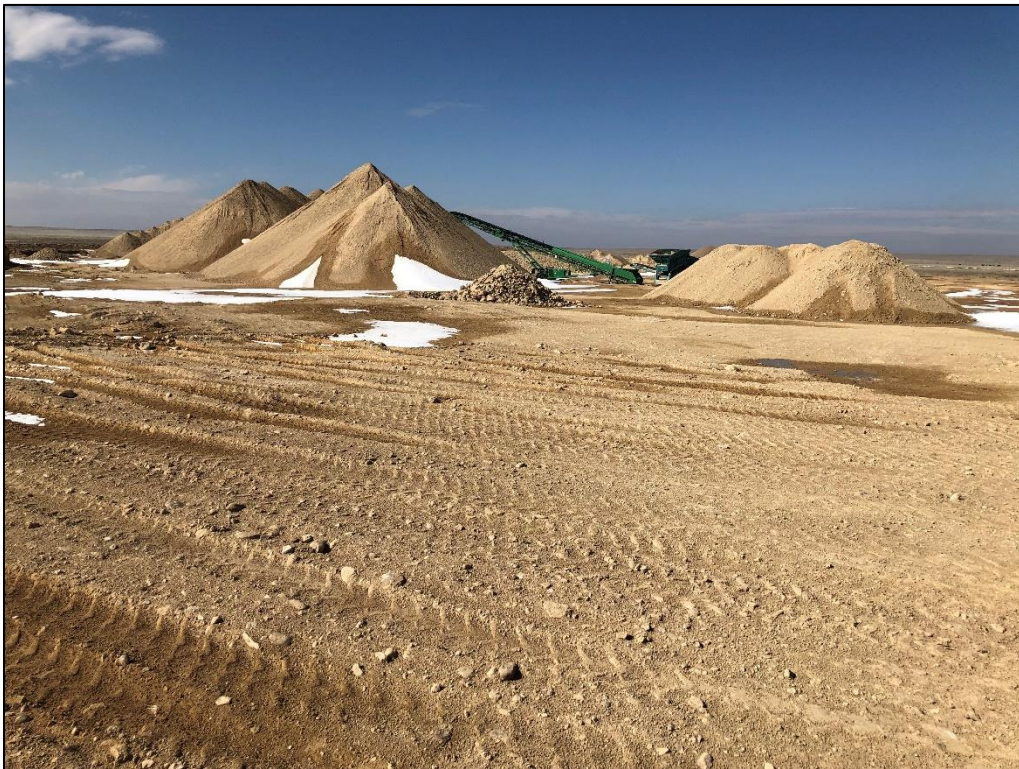
Photo 4. View looking southeast from western edge of pit disturbance, showing material stockpiles stored on pit floor.

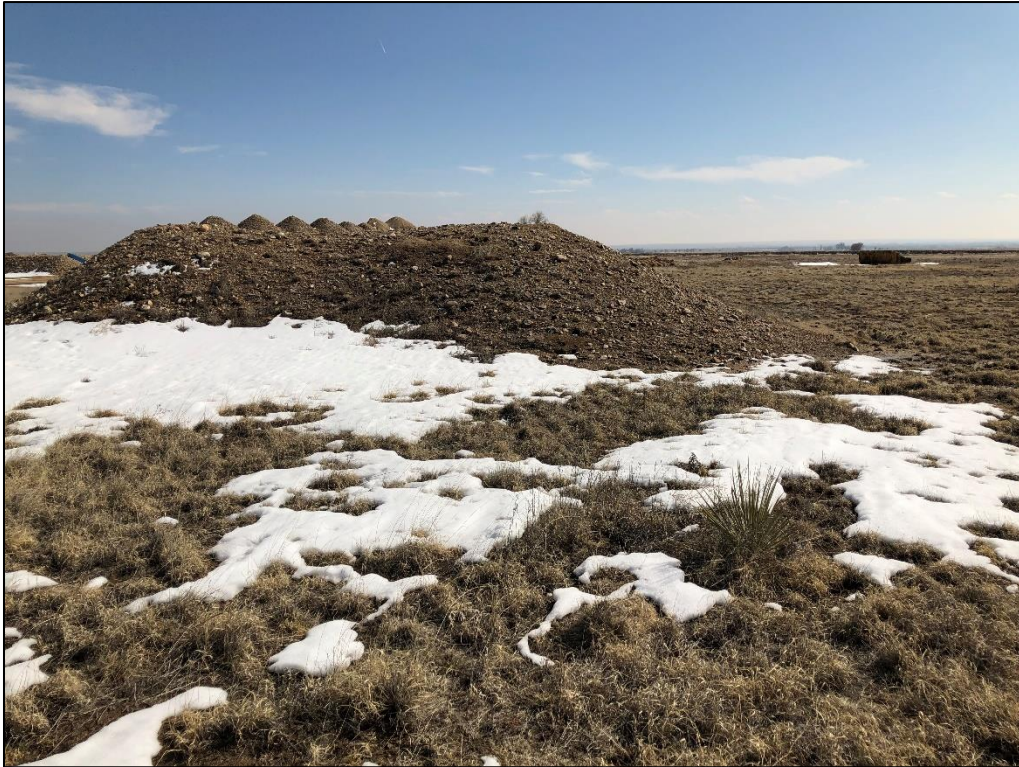
Photo 5. View looking west, showing one of two topsoil stockpiles stored at northern edge of pit disturbance.

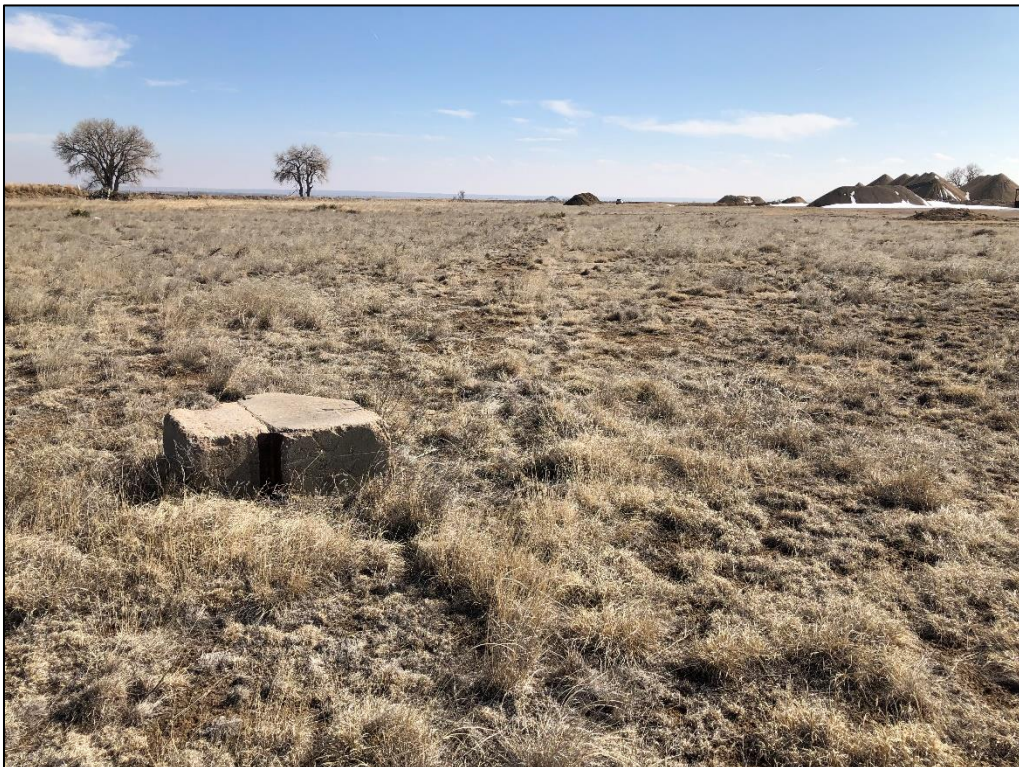
Photo 6. View looking southeast from northeastern corner of permit boundary, marked by a large concrete block.

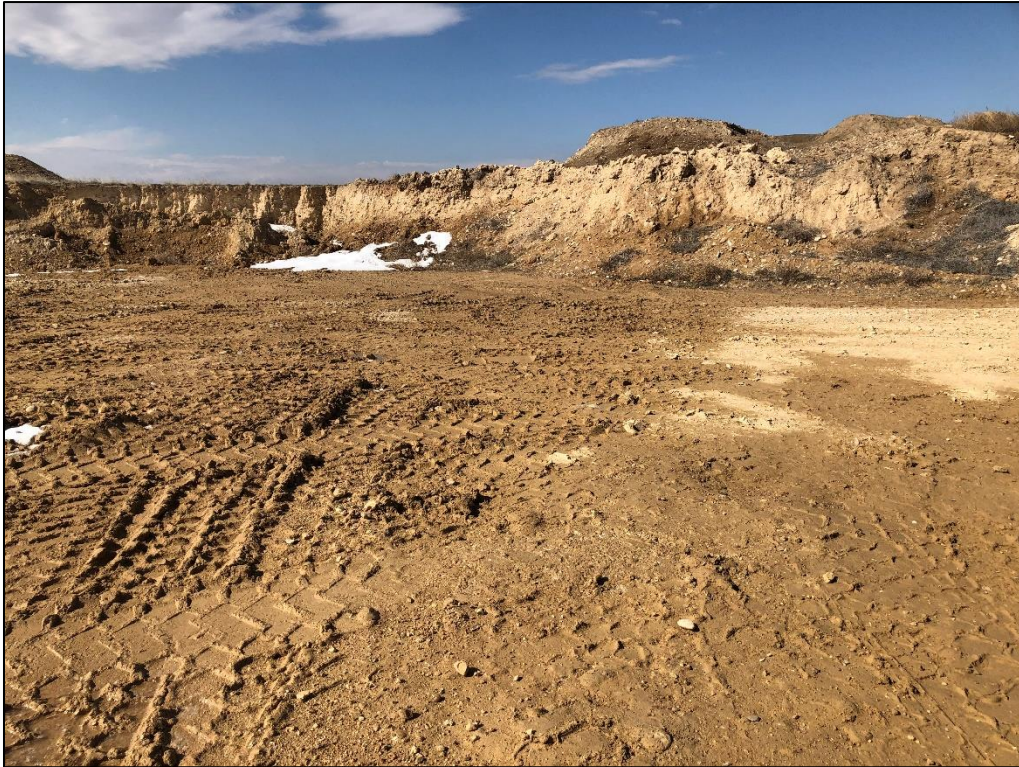
Photo 7. View looking northwest from pit floor, showing northwestern portion of pit wall, approximately 5-8 feet in height with near vertical slopes.

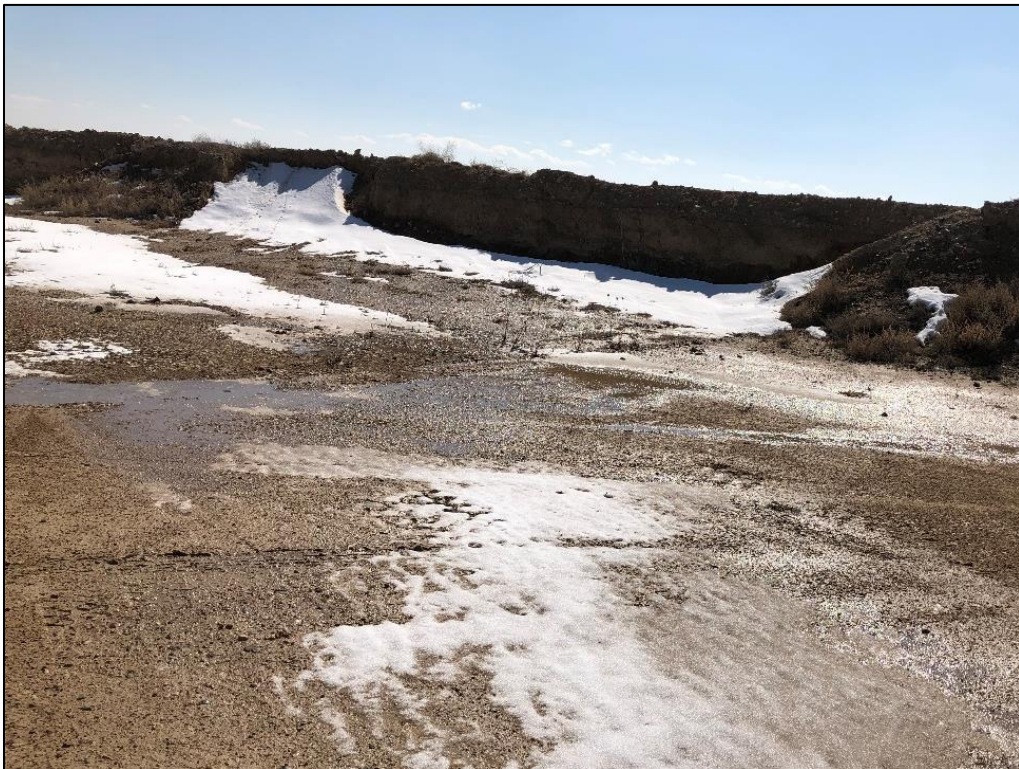
Photo 8. View looking west from pit floor, showing western portion of pit wall, approximately 5-8 feet in height with near vertical slopes.

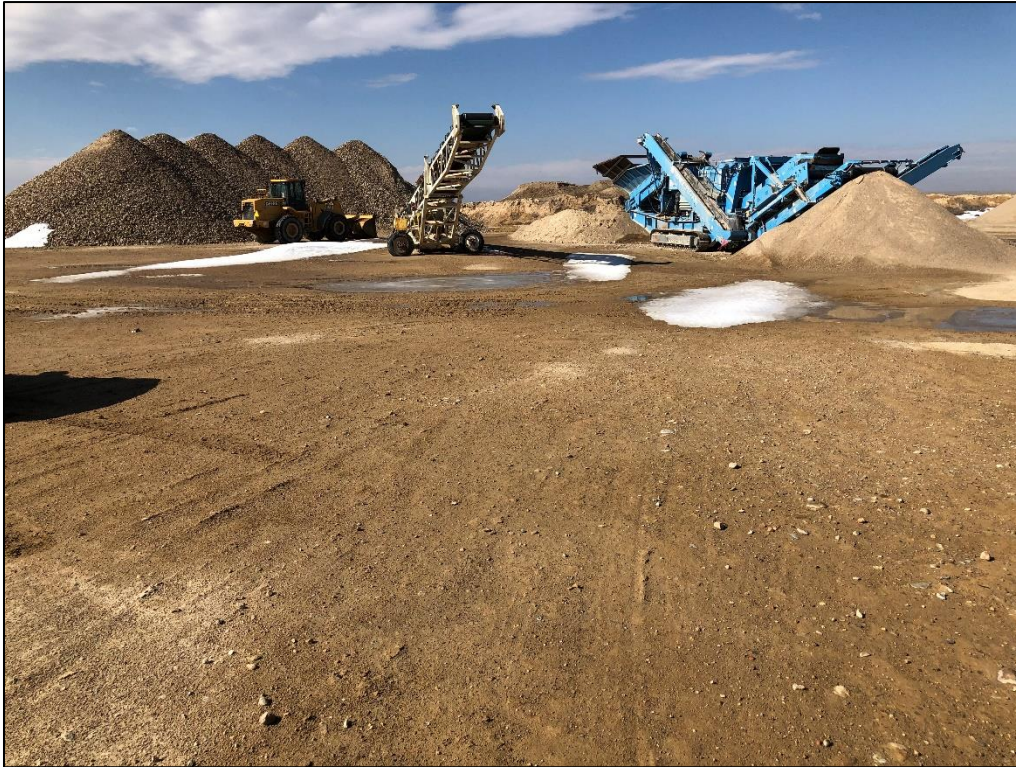
Photo 9. View looking north from pit floor, showing material stockpiles and mobile processing equipment stored on pit floor.

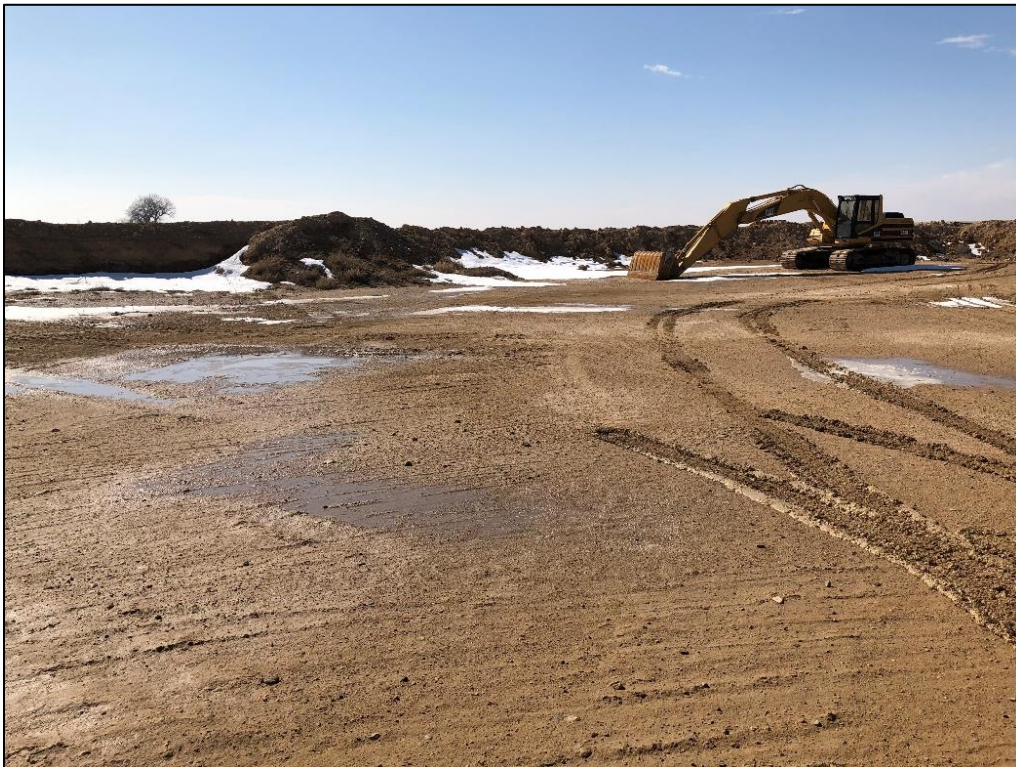
Photo 10. View looking west from pit floor, showing portion of western pit wall, approximately 5 feet in height with near vertical slopes.
