MINERALS PROGRAM INSPECTION REPORT**PHONE: (303) 866-3567**

MINE NAME: Reyher Trusts Pit	MINE/PROSPECTING ID#: M-2004-057	MINERAL: Sand and gravel	COUNTY: Bent
INSPECTION TYPE: Monitoring	INSPECTOR(S): Amy Eschberger	INSP. DATE: March 7, 2019	INSP. TIME: 14:45
OPERATOR: Bent County	OPERATOR REPRESENTATIVE: Curtis Sniff, Kevin Vanegmond	TYPE OF OPERATION: 112c - Construction Regular Operation	
REASON FOR INSPECTION: Normal I&E Program	BOND CALCULATION TYPE: None	BOND AMOUNT: \$0.00	
DATE OF COMPLAINT: NA	POST INSP. CONTACTS: None	JOINT INSP. AGENCY: None	
WEATHER: Clear	INSPECTOR'S SIGNATURE:

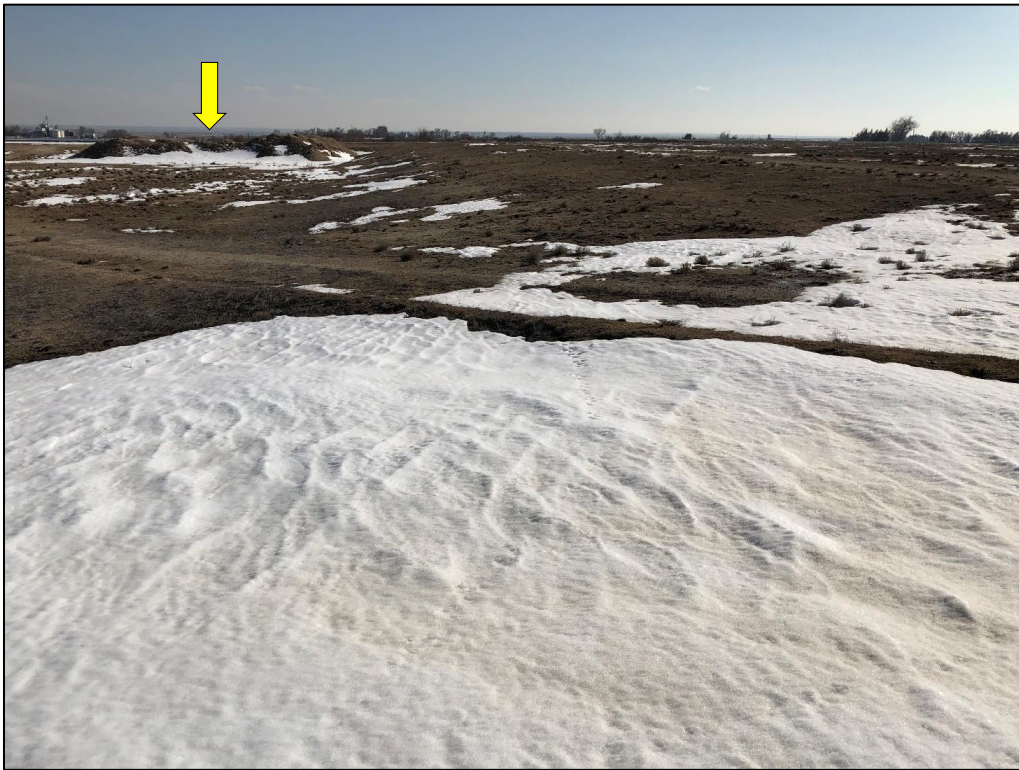
Photo 1. View looking southwest across western pit slope, graded flatter than 3H:1V. Note material stockpile stored on pit floor (indicated with arrow in background).

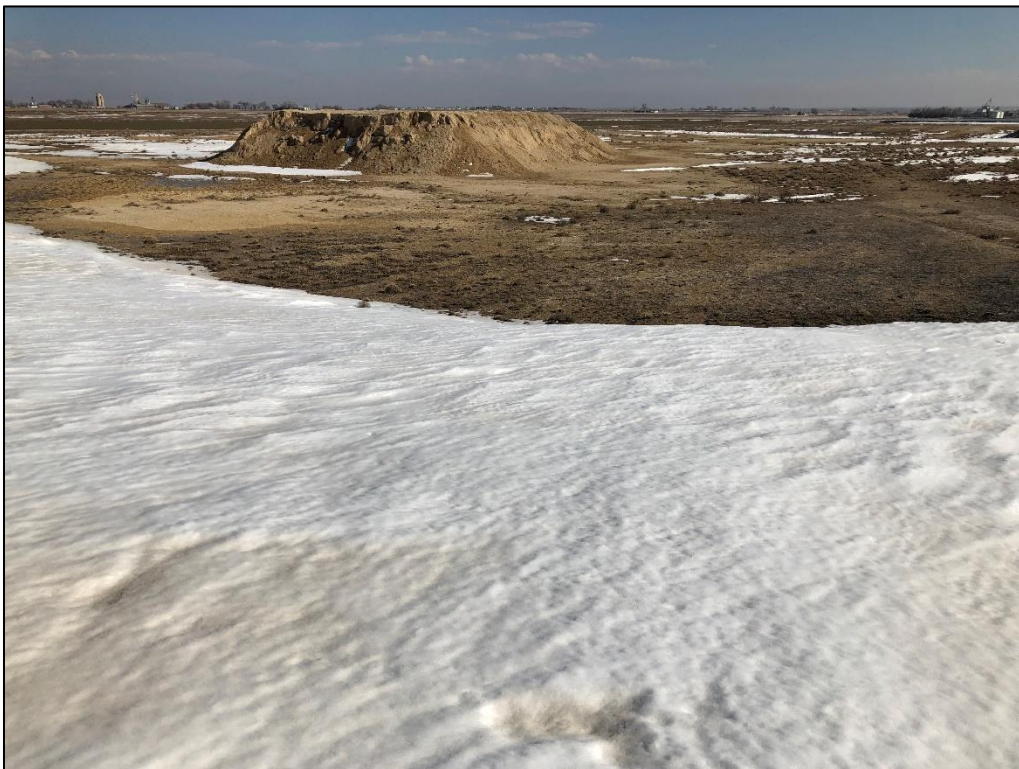
Photo 2. View looking south across pit from its northern edge, showing large sand stockpile stored on pit floor.

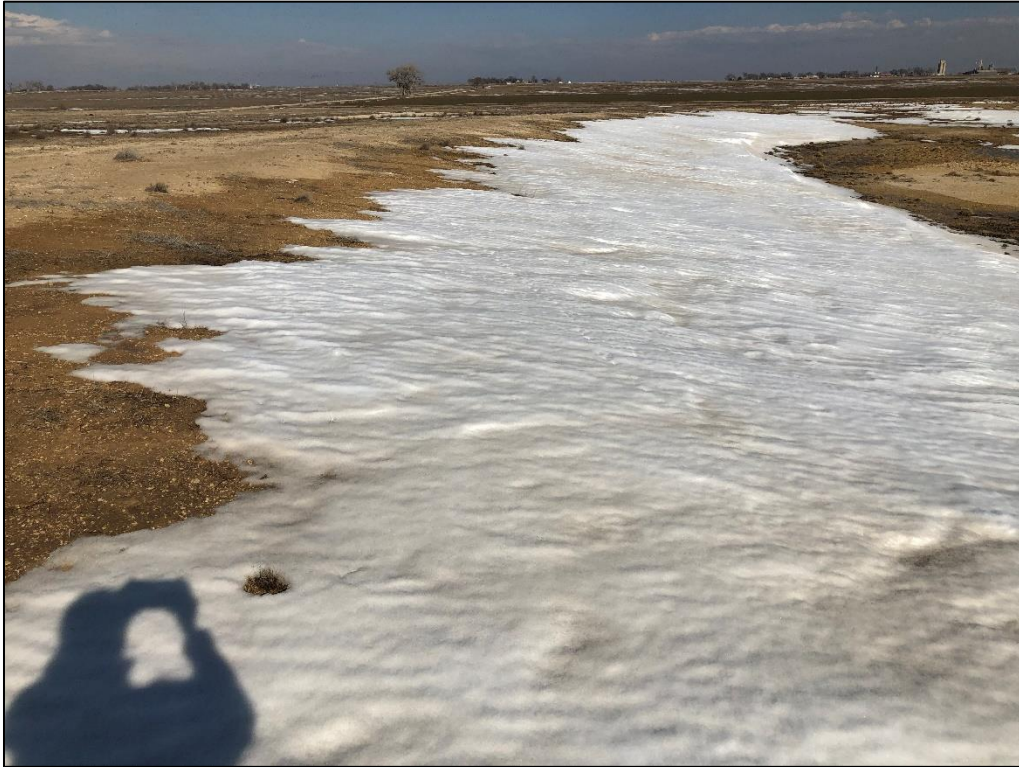
Photo 3. View looking east across northern pit slope, graded flatter than 3H:1V.

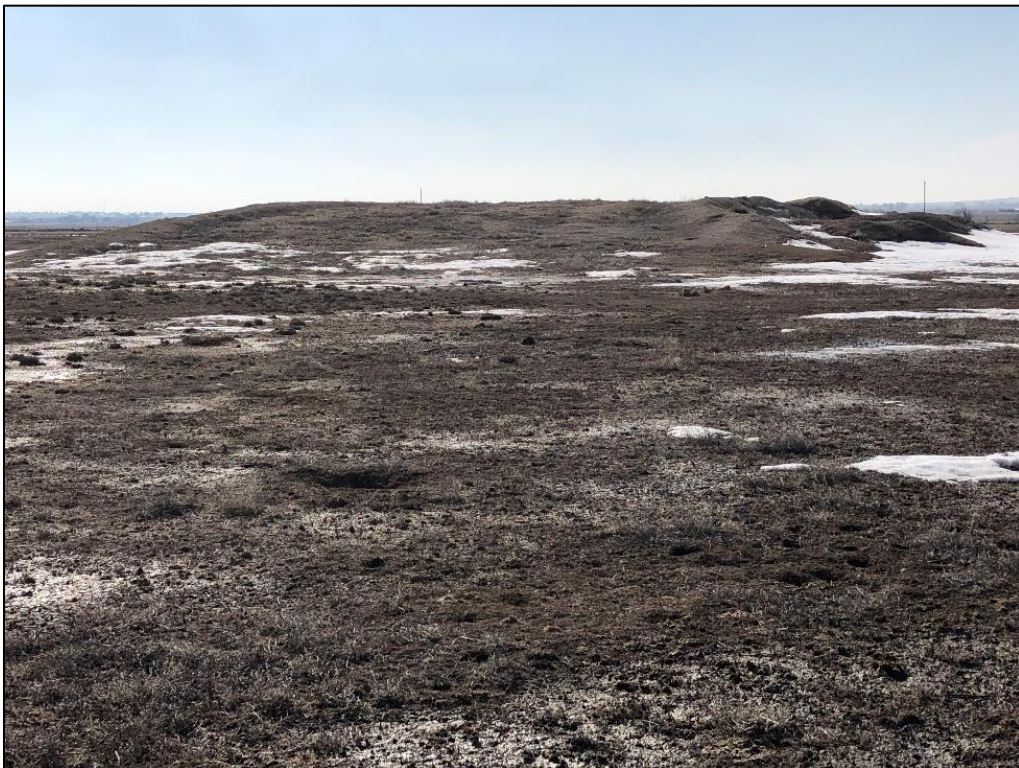
Salvaged topsoil was stored at the southwestern edge of the permit area, west of the haul road. This large topsoil stockpile was stable with grass cover. Due to the proximity of the topsoil stockpile to the southwestern permit boundaries (~50 feet from the southern boundary and ~75 feet from the western boundary), the operator should be careful when accessing/loading this stockpile so as not to disturb land outside the approved permit boundary.

Photo 4. View looking west at large topsoil stockpile stored at southwestern edge of permit area, west of haul road.

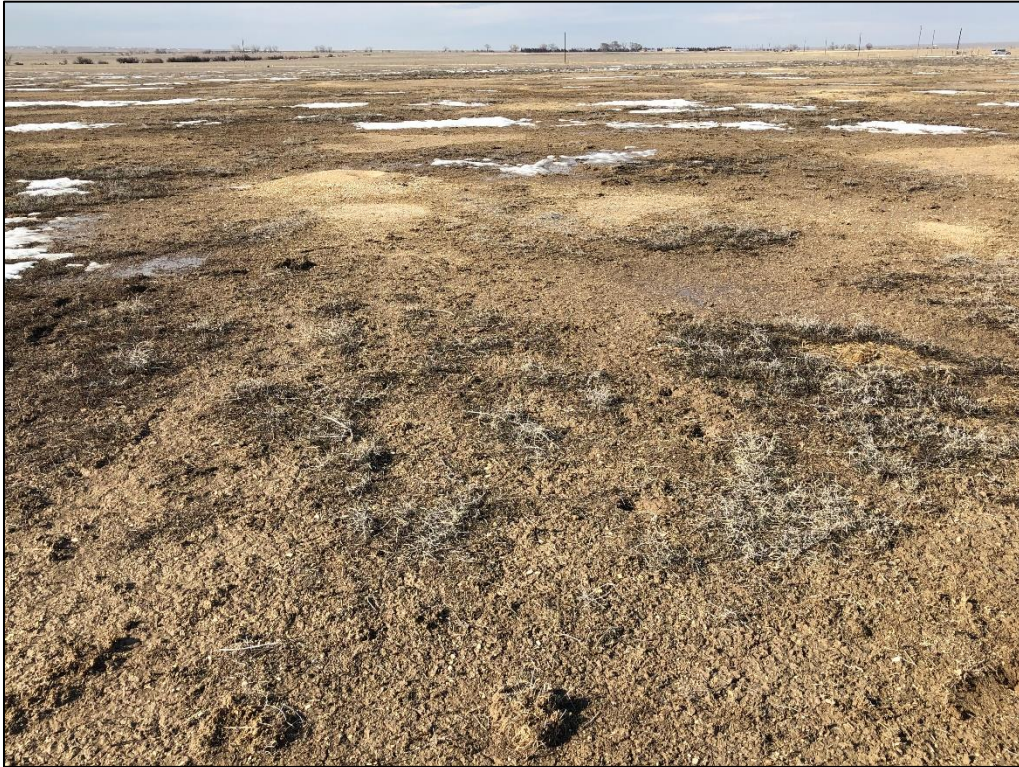
Photo 5. View looking north across undisturbed western half of permit area, west of haul road.

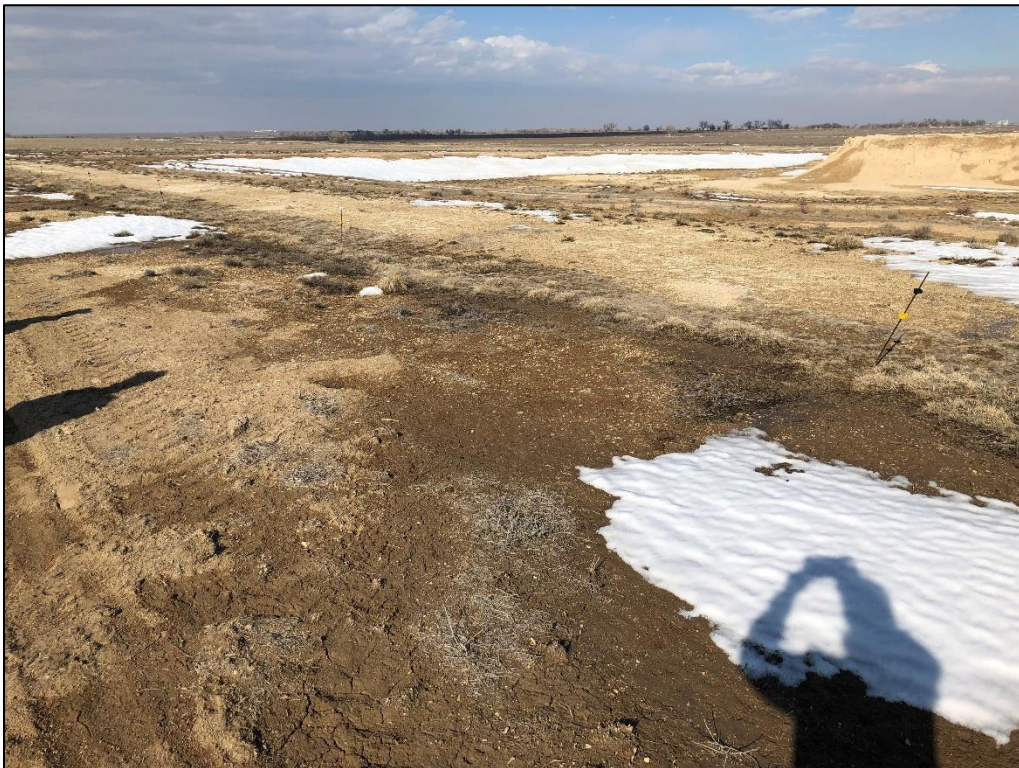
Photo 6. View looking northeast, showing haul road that runs north-south through permit area which will be mined through then reconstructed on pit floor for reclamation. Large sand stockpile on pit floor visible at far right edge of photo.
