**COLORADO**Division of Reclamation,
Mining and Safety

MINERALS PROGRAM INSPECTION REPORT**PHONE: (303) 866-3567**

MINE NAME: Mitchell Pit #2	MINE/PROSPECTING ID#: M-1990-131	MINERAL: Gravel	COUNTY: Adams
INSPECTION TYPE: Monitoring	INSPECTOR(S): Jared L. Ebert	INSP. DATE: April 18, 2019	INSP. TIME: 09:30
OPERATOR: Ricky W. Mitchell	OPERATOR REPRESENTATIVE: Rick Mitchell	TYPE OF OPERATION: 110c - Construction Limited Impact

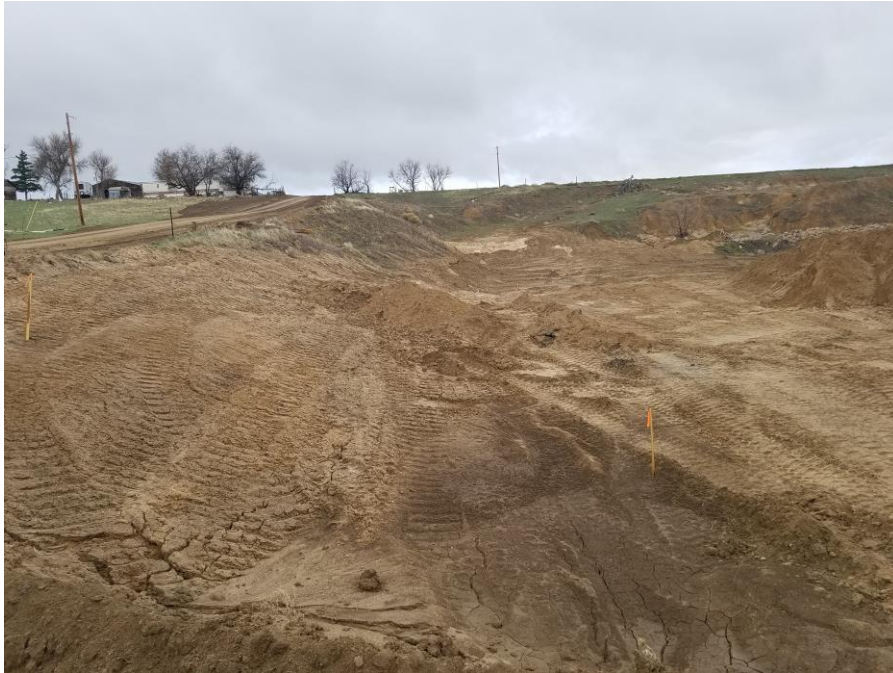
The mine excavation daylights to the east and to the north. The pit slopes vary from 3H:1V in places to angle of repose in others. According to Mr. Mitchell an adjacent residential development is occurring and the Town of Bennett would like to install a storm drain from the adjacent development through a portion of the permit area. The alignment for the drain was flagged as shown on the photographs below. The alignment of the drain will run from west to east along the south side of the permit boundary. According to Mr. Mitchell, the drain will be installed and the slope of the south side of the site will be graded to a 3H:1V ratio, topsoiled and revegetated. This overall plan appears to be in agreement with the approved reclamation plan. However, it appears likely that the installation of the storm drain will result in land outside of the approved permit boundary to be disturbed. As this disturbance would not be the result of the mining operation; as long as material is not sold or otherwise hauled off-site from the excavation of the drain, an amendment to the permit area would not be required. The Division requests that Mr. Mitchell provide a map that depicts the proposed location of the storm drain.

Figure 1. From the southeast corner of the site looking west at the proposed storm drain alignment.

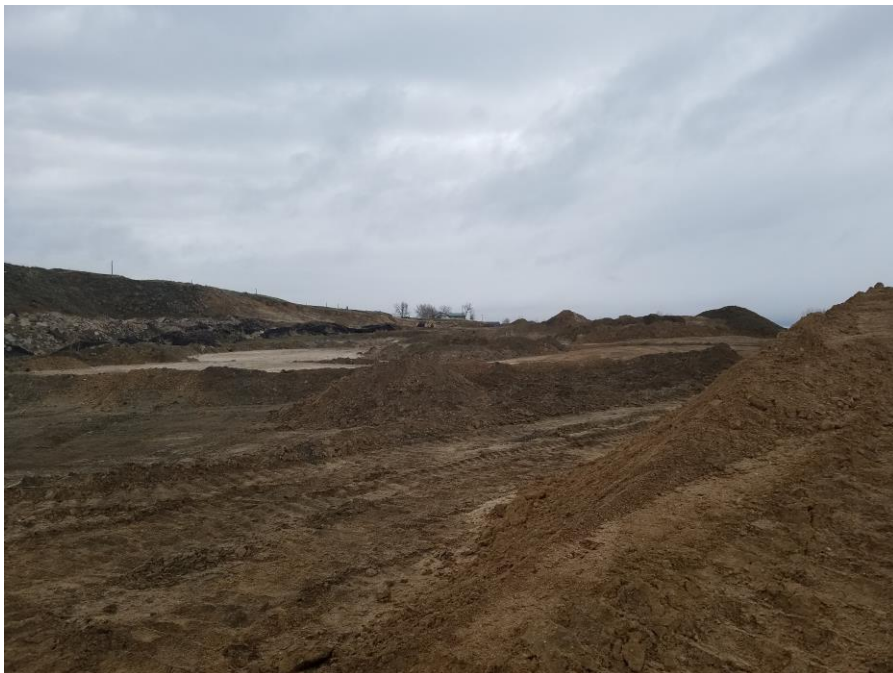
Figure 2. From southeast corner looking northwest.

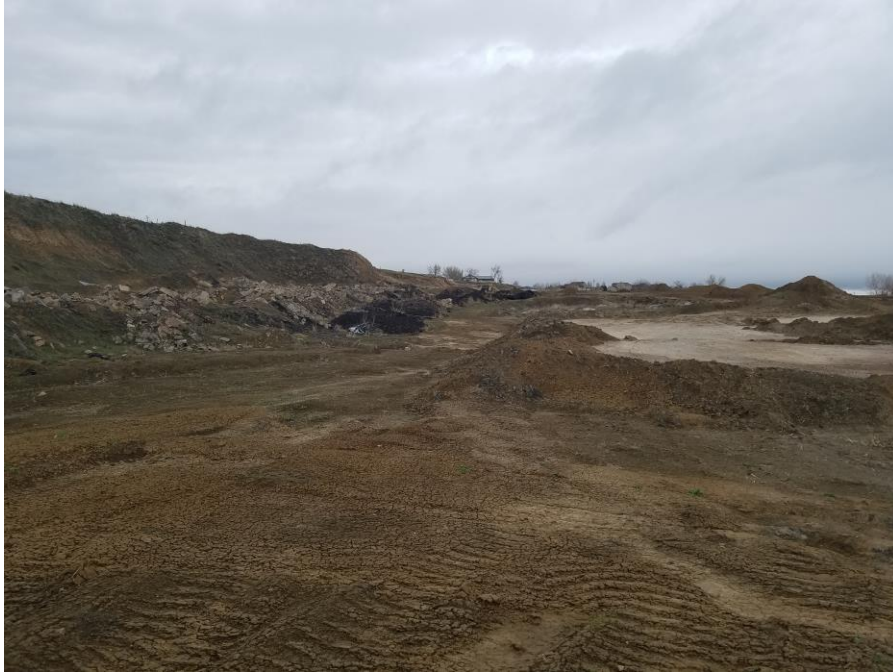
Figure 3. From the south end of the site looking north.

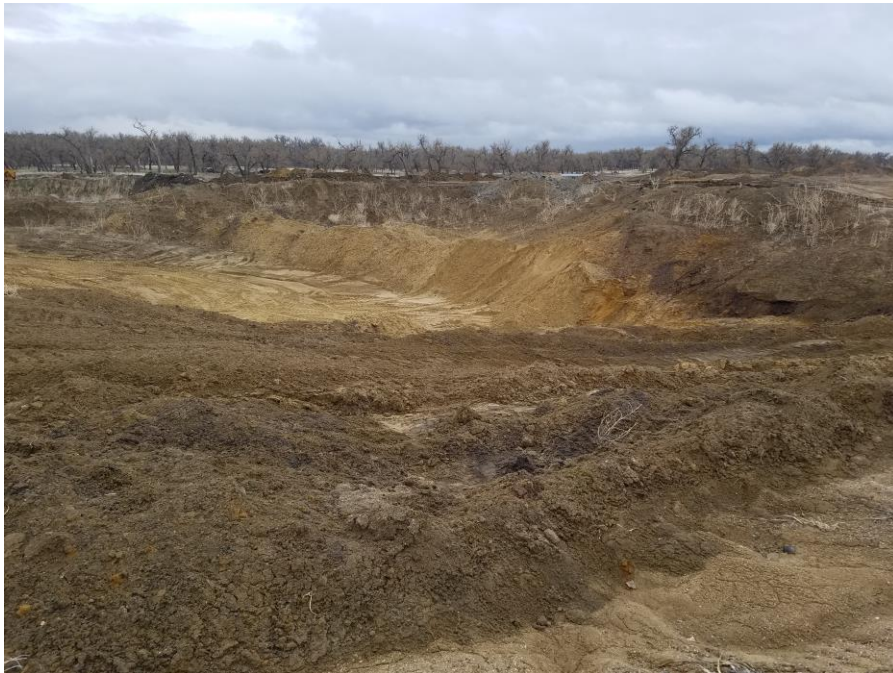
A small active pit excavation is located on the southeast side of the site. This is a shallow pit with a pile of excavated material located adjacent to the pit.

Figure 4. Excavation at the southeast end of the site.
