MINERALS PROGRAM INSPECTION REPORT**PHONE: (303) 866-3567**

MINE NAME: Mitchell Pit	MINE/PROSPECTING ID#: M-1987-023	MINERAL: Sand and gravel	COUNTY: Adams
INSPECTION TYPE: Monitoring	INSPECTOR(S): Jared L. Ebert	INSP. DATE: April 18, 2019	INSP. TIME: 10:00
OPERATOR: Ricky W. Mitchell	OPERATOR REPRESENTATIVE: Rick Mitchell	TYPE OF OPERATION: 110c - Construction Limited Impact

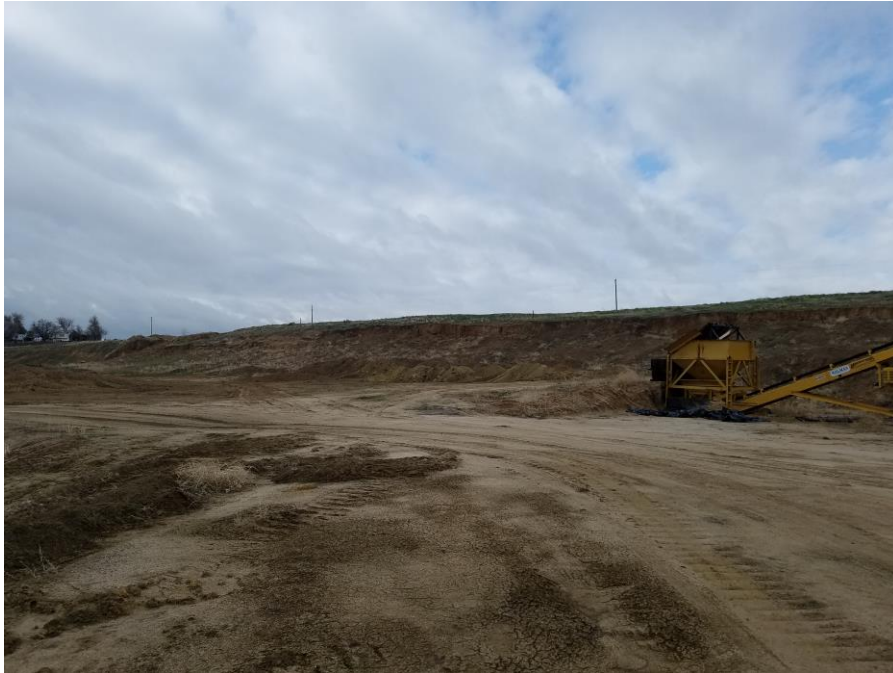
Figure 1. From the center of the site looking southwest.

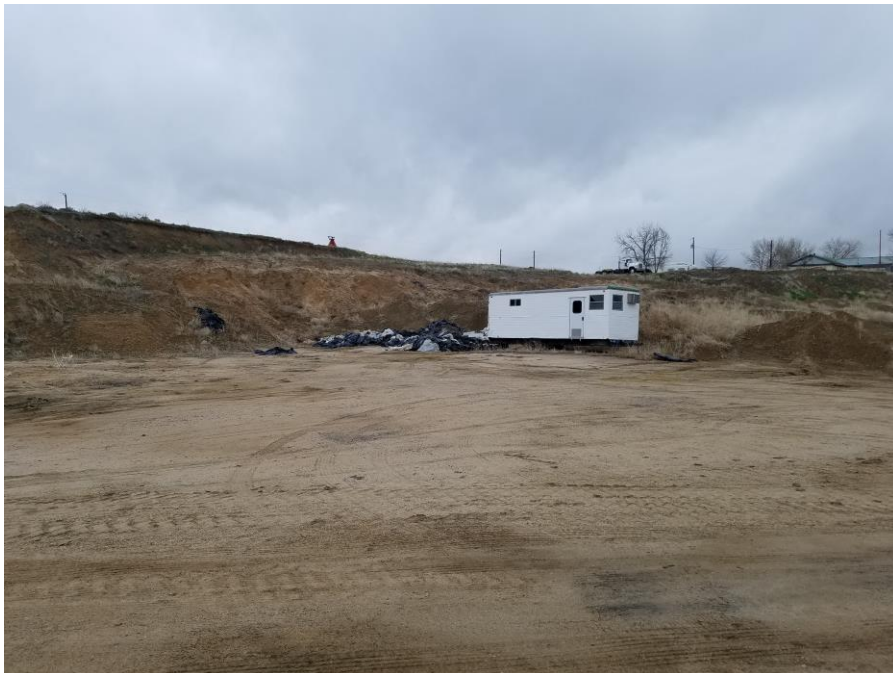
Figure 2. From the center of the site looking northwest.

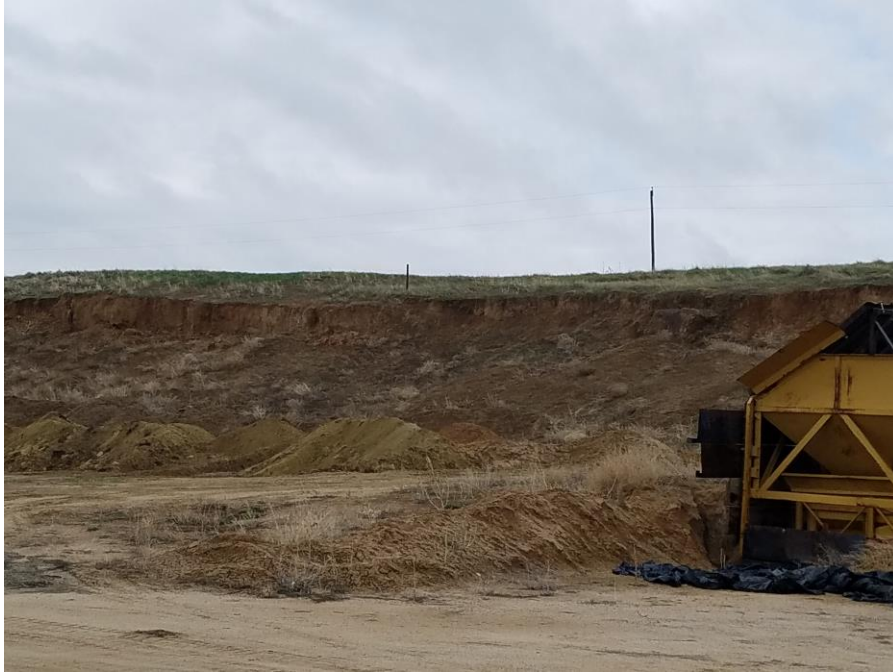
The main pit excavation daylights to the southeast. The pit slopes have been partially graded, however it appears the toe of the graded area has slumped leaving a vertical cut mid-slope. Several small pit excavations are located throughout the site where the operator backfills with inert material.

Figure 3. Slump observed in the pit slope.

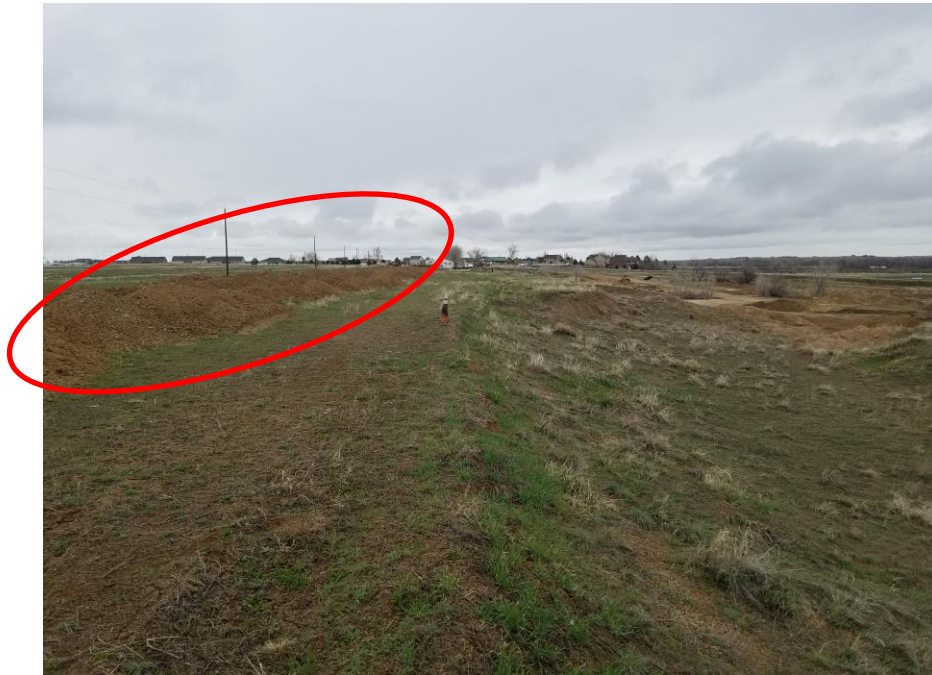
Mr. Mitchell has stockpiled soil and dirt material he claims was not excavated from this permit area west of the site above the primary pit slope outside of the permit boundary. This stockpile does not appear to be part of the current mining or reclamation plan.

Figure 4. Off-site material (not mined from this permit) stockpiled outside of the west permit boundary.
