PERMIT INFORMATION

Permit Number: C-1981-012 Mine Name: New Elk Mine Operator: New Elk Coal Company, LLC Operator Address: Mr. Louis Head 12250 Highway 12 Weston, CO 81091	County: Las Animas Operation Type: Underground Permit Status: Active Ownership: Private
	Operator Representative Present: V. Massarotti, N. Mason
Operator Representative Signature: (Field Issuance Only)

INSPECTION INFORMATION

Inspection Start Date: April 23, 2019 Inspection Start Time: 11:45 Inspection End Date: April 24, 2019 Inspection End Time: 08:30		Inspection Type: Coal Partial Inspection Inspection Reason: Normal I&E Program Weather: Raining	
Joint Inspection Agency: None		Joint Inspection Contacts: 	
Post Inspection Agency: None		Post Inspection Contacts: 	
Inspector(s): Robert D. Zuber, P.E.	Inspector's Signature:

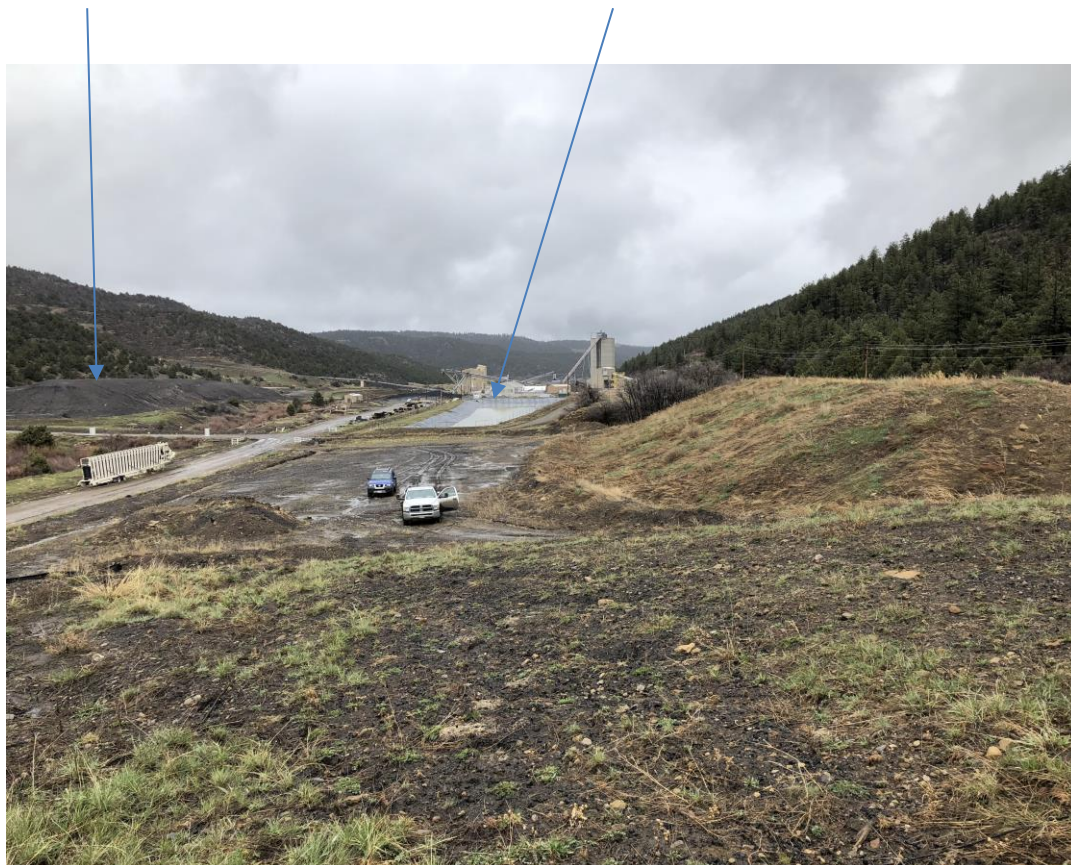
Pond 001A

Ponds 001A, 004A, 006A, 007A, and 08 were inspected. None of them were discharging, but all held at least a small amount of water. The impounded water in Pond 08 was more than 13 feet below the primary spillway, and the water in Pond 007A was well below the spillway. No significant issues were seen with the embankments or spillways of any ponds.

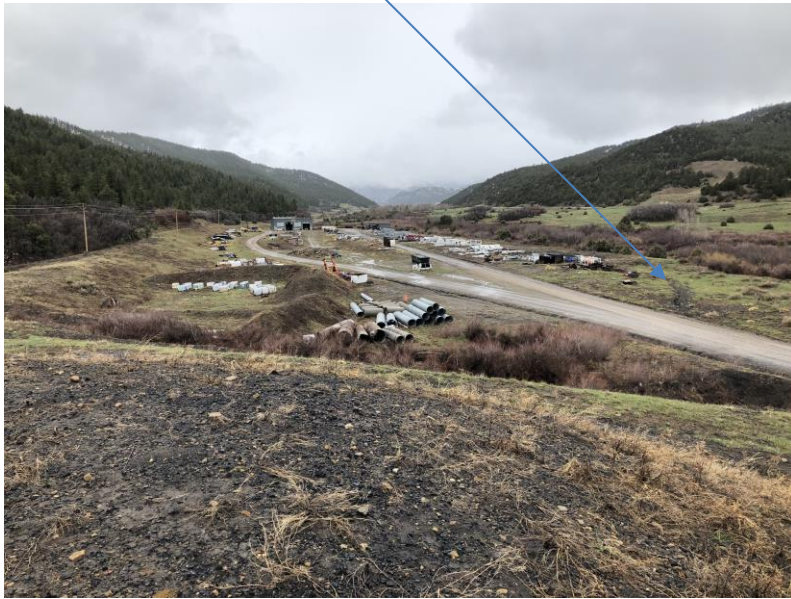
Improved drainage ditch (tributary to D5)

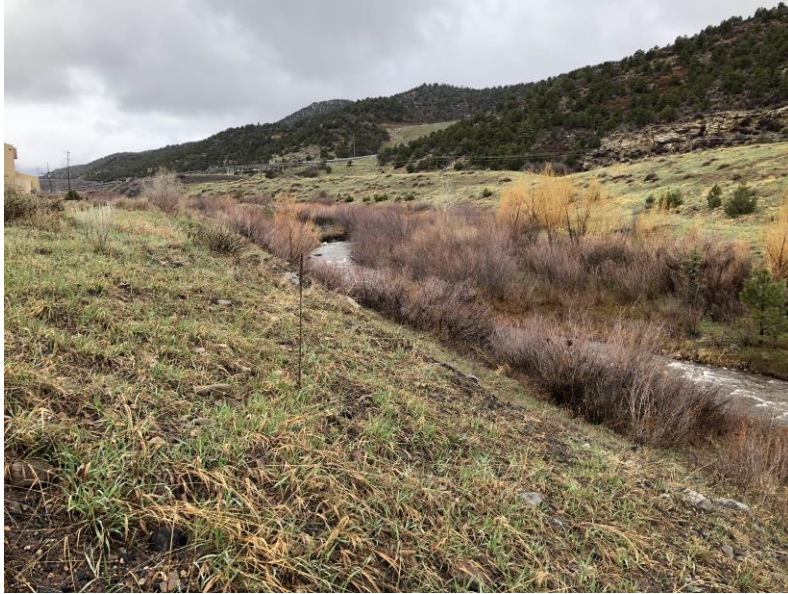
Pond 007A

Within the SAE by Pond 007A, BMPs appear to be functioning, and there was no discharge from this outfall.

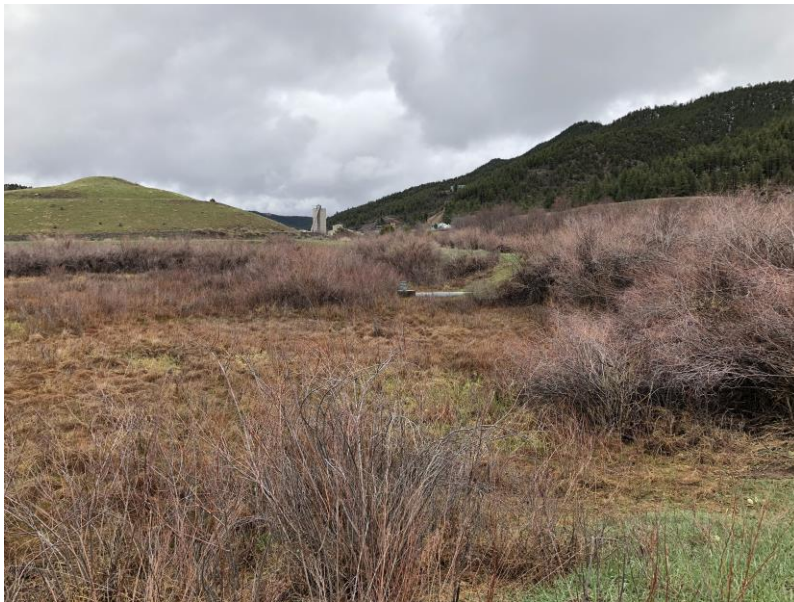
The Middle Fork of the Purgatoire River was inspected, and no eroding banks or signs of pollutant loading from the New Elk Mine were seen. Particular reaches that were inspected include below Pond 004A, near the entrance road, and beside Ponds 006A and 007A.

River, with Pond 007A embankment to left

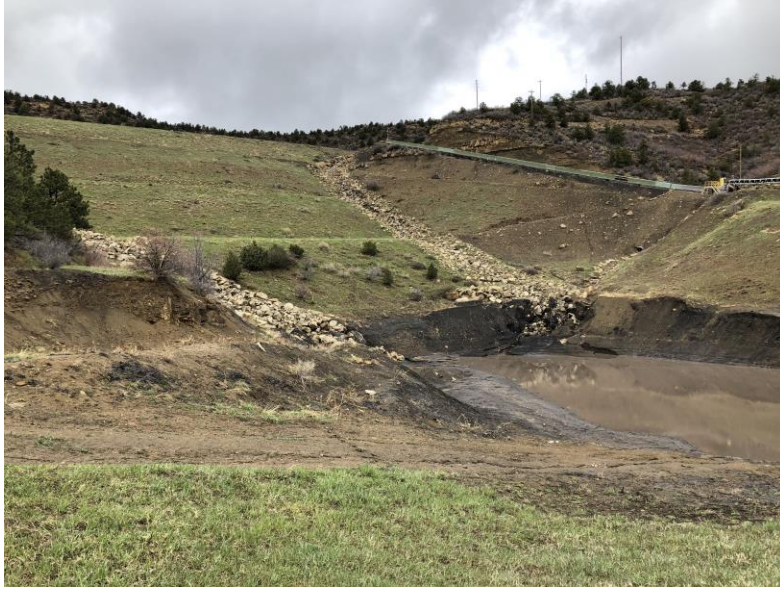
Pond 004A with Development Waste Pile in back

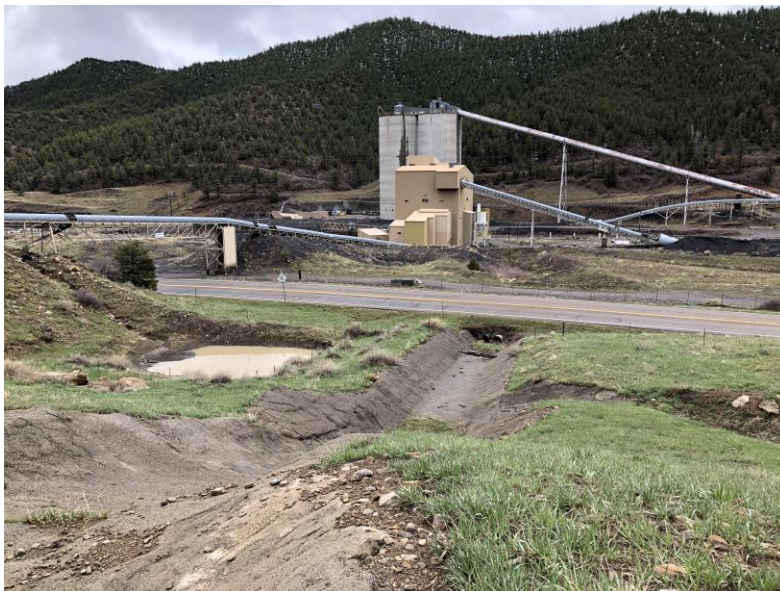
No erosion was seen on the reclaimed portion of the RDA, as viewed from the pond below.

RDA and Pond 08
