Subject: Corrective Actions Documentation for Stocks Clay Mine  
Mine/Prospecting ID#: M-1977-324

## MINERALS PROGRAM INSPECTION REPORT

<b>MINE NAME:</b> Stocks Clay Mine	<b>MINE/PROSPECTING ID#:</b> M-1977-324	<b>MINERAL:</b> Clay (general)	<b>COUNTY:</b> Fremont
<b>INSPECTION TYPE:</b> Monitoring	<b>INSPECTOR(S):</b> Timothy A. Cazier	<b>INSP. DATE:</b> August 1, 2018	<b>INSP. TIME:</b> 14:00
<b>OPERATOR:</b> Summit Brick & Tile Co.	<b>OPERATOR REPRESENTATIVE:</b> Mike Leidich & Mark Jesik	<b>TYPE OF OPERATION:</b> 112c - Construction Regular Operation

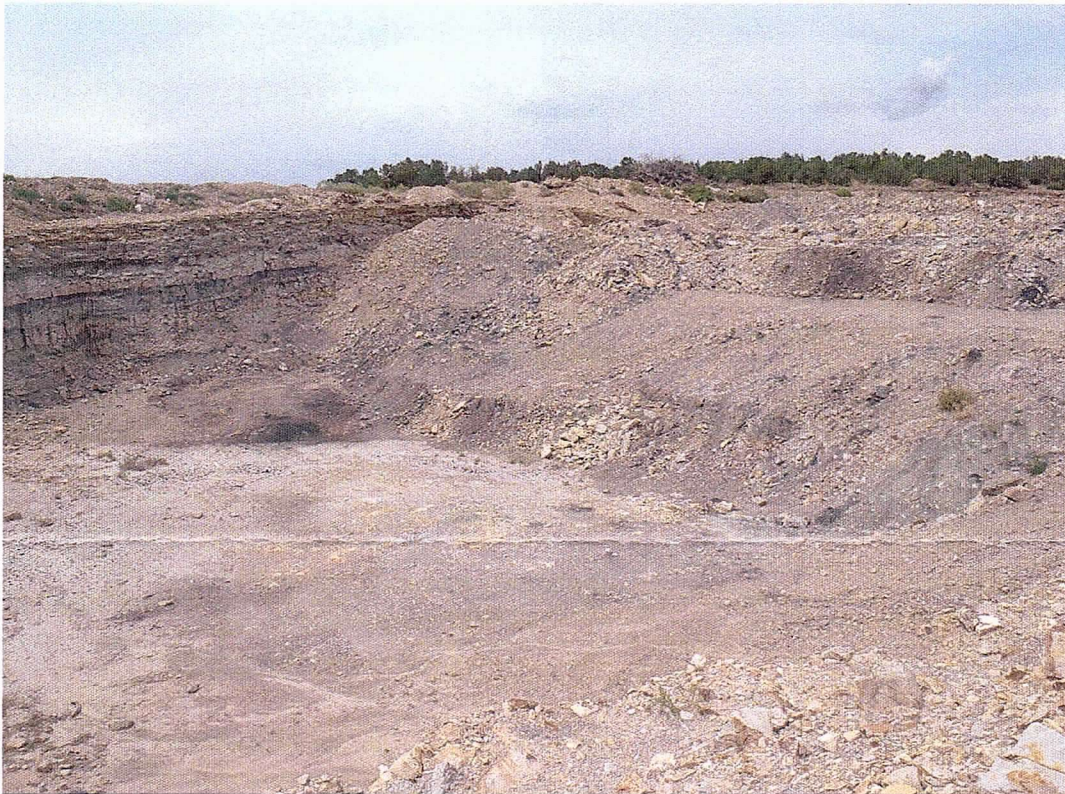
Backfilling and Grading: The southeast area of the site has been graded. Some backfill material appeared to be available for the active pit area (see **Photo 1**).

Photo 1. Backfill material available for the active pit area (looking west).

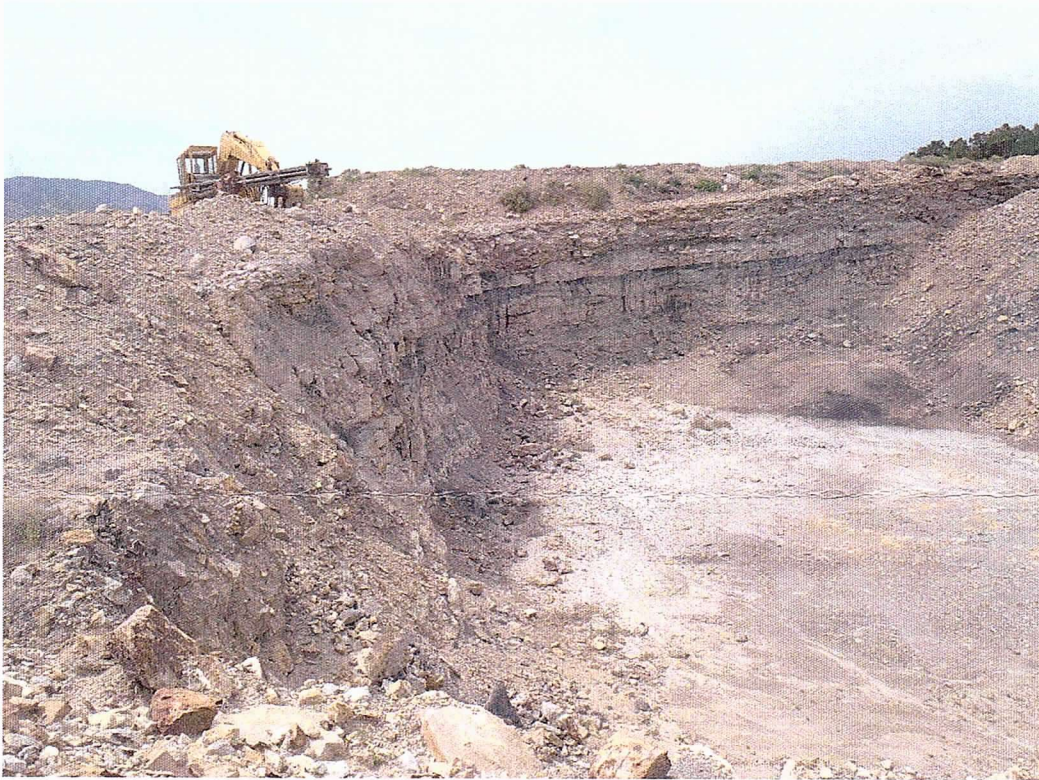
Gen. Compliance with Mine Plan: The operation appeared to be in compliance with the approved mine plan. Google Earth (2016 imagery) and data collected during the inspection using a handheld GPS unit (Juno 3B) was used to measure the disturbed area, which was estimated to be approximately 13 acres (see enclosed **Stocks Clay Mine 2018 Post Inspection Map**). This is well below the maximum allowed disturbance of 18.1 acres. It should be noted approximately 3.3 of those 13 acres are in active reclamation (southeast corner). Mine representatives indicated they are near to completing mining operations. Highwalls were estimated to vary between 15 and 20 feet in height (see **Photo 2**).

Photo 2. 15 to 20 highwall in active pit (looking west).

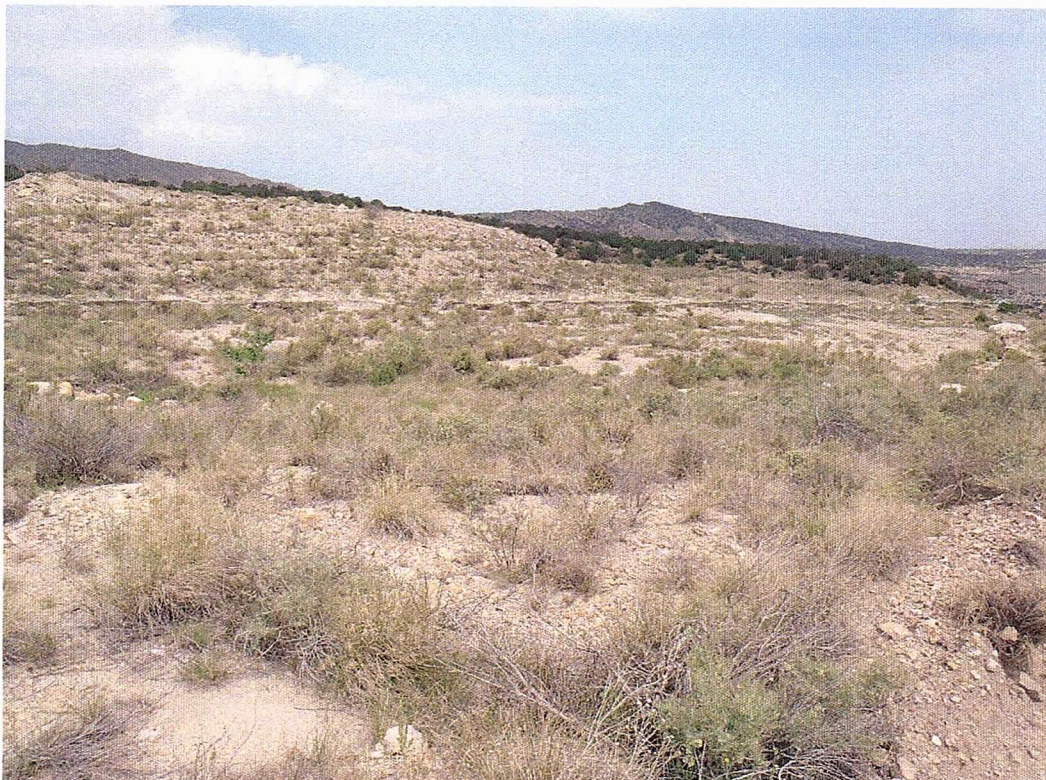
Reclamation Success: As discussed above under "Gen. Compliance with Mine Plan" the southeast portion of the site is in active reclamation (see **Photo 3**).

Photo 3. Southeast portion of the site in active reclamation (from access road, looking east).

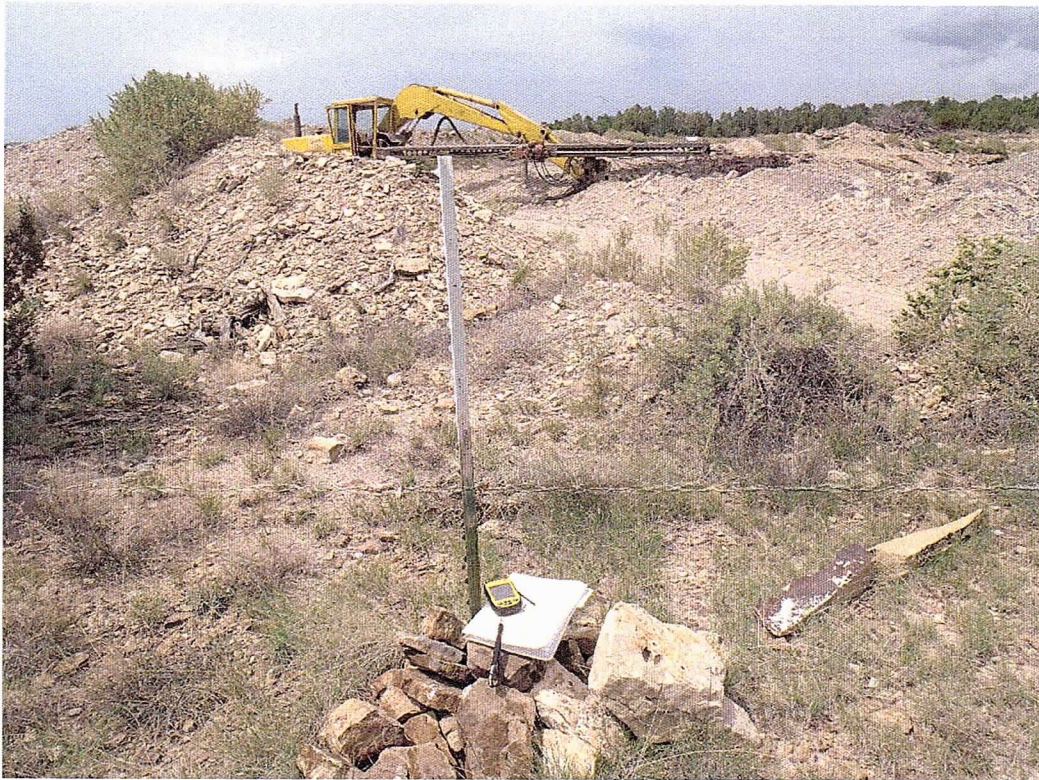
Support Facilities On-site: A drill rig (see **Photo 4**) and generator were observed on site.

Photo 4. Drill rig & typical boundary marker (south side, looking NW).

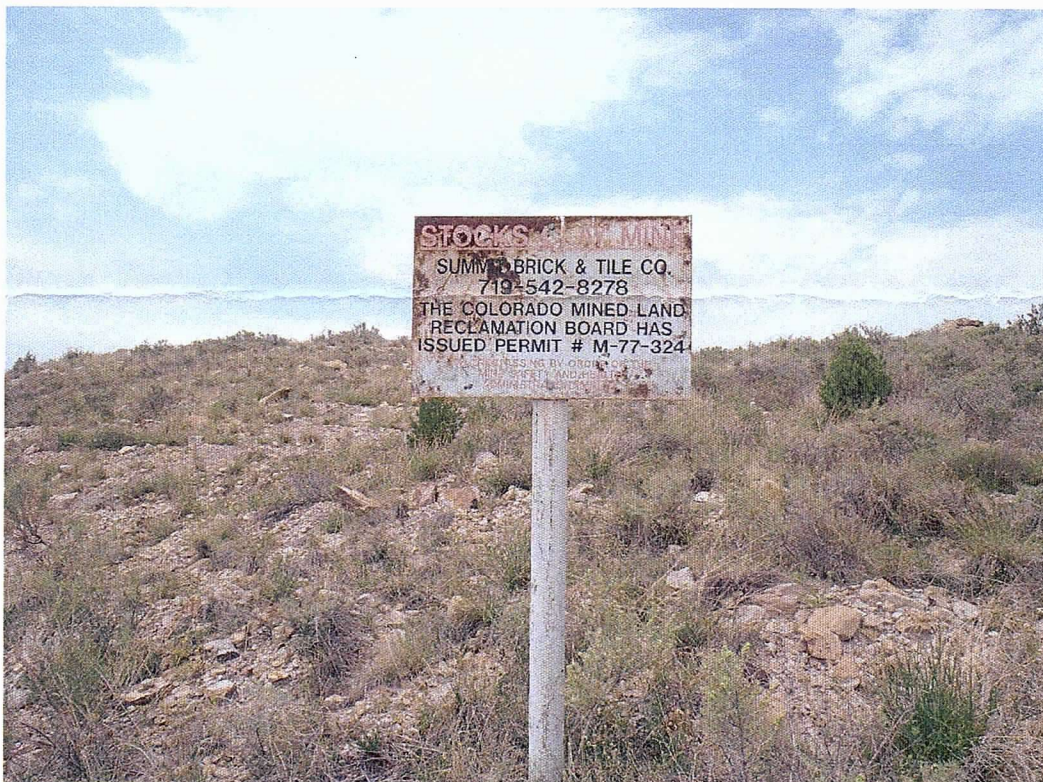
Signs and Markers: The permit sign was properly posted (see **Photo 5**) and boundary markers were observed to delineate the affected area boundary on the east end (see **Photo 6** and **7**). **The missing boundary markers for the active west portion of the pit is cited as a problem on page 1 of this report.**

Photo 5. Permit sign (at affected area boundary).

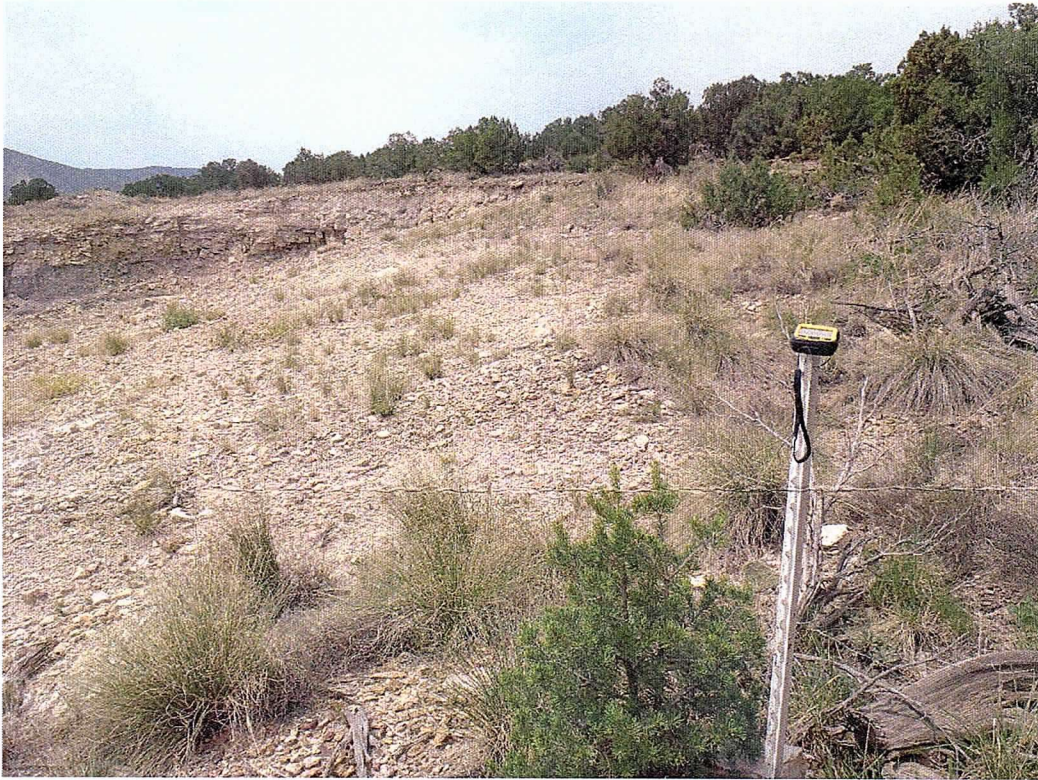
Photo 6. Typical boundary marker (north side, looking NW).

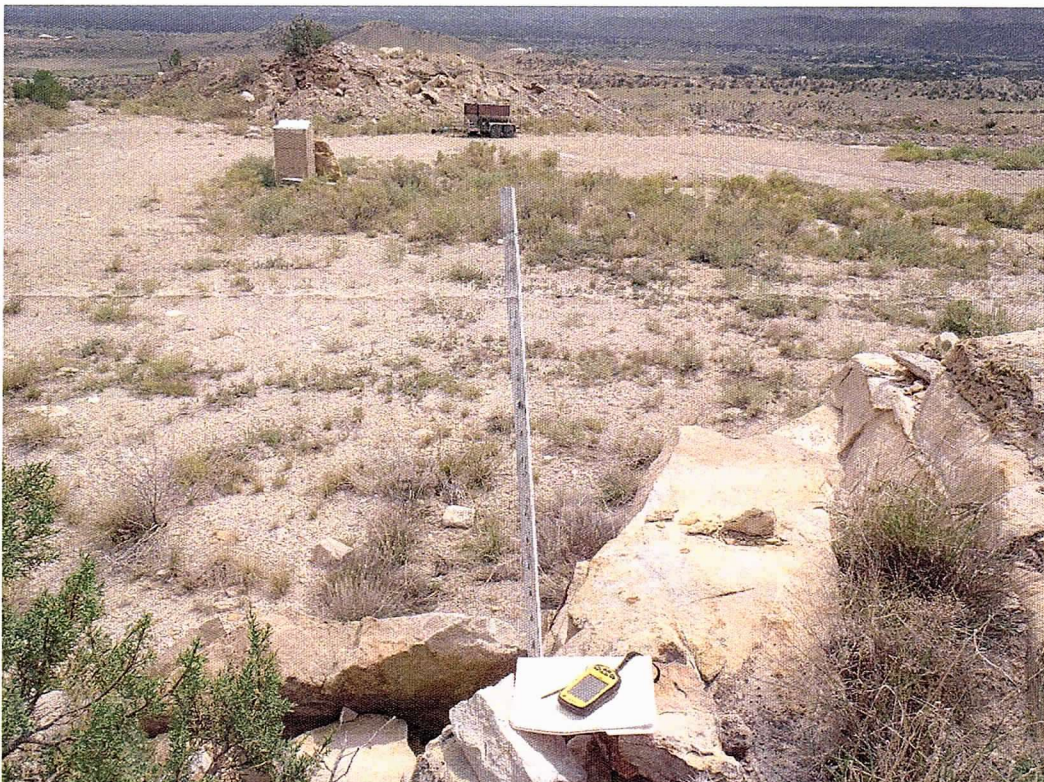
Photo 7. Typical boundary marker (north side, looking south).

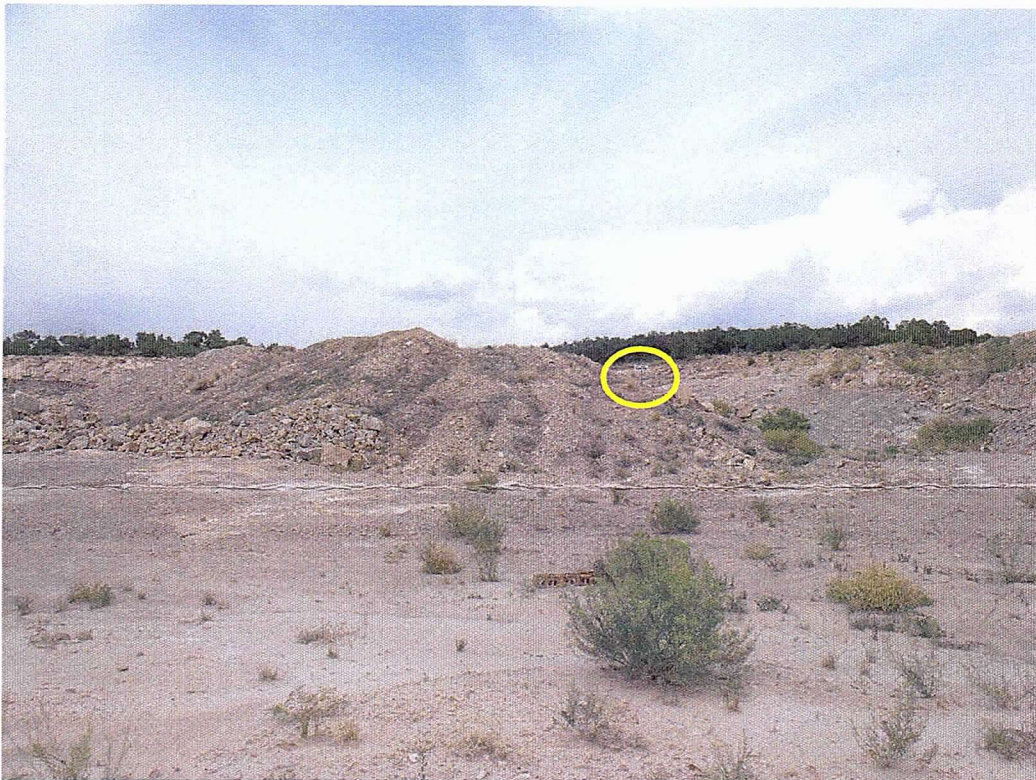
Topsoil: A topsoil stockpile was observed and labeled as such in between the east and west sides of the site (see **Photo 8**).

Photo 8. Topsoil stockpile with sign (circled), looking NE.

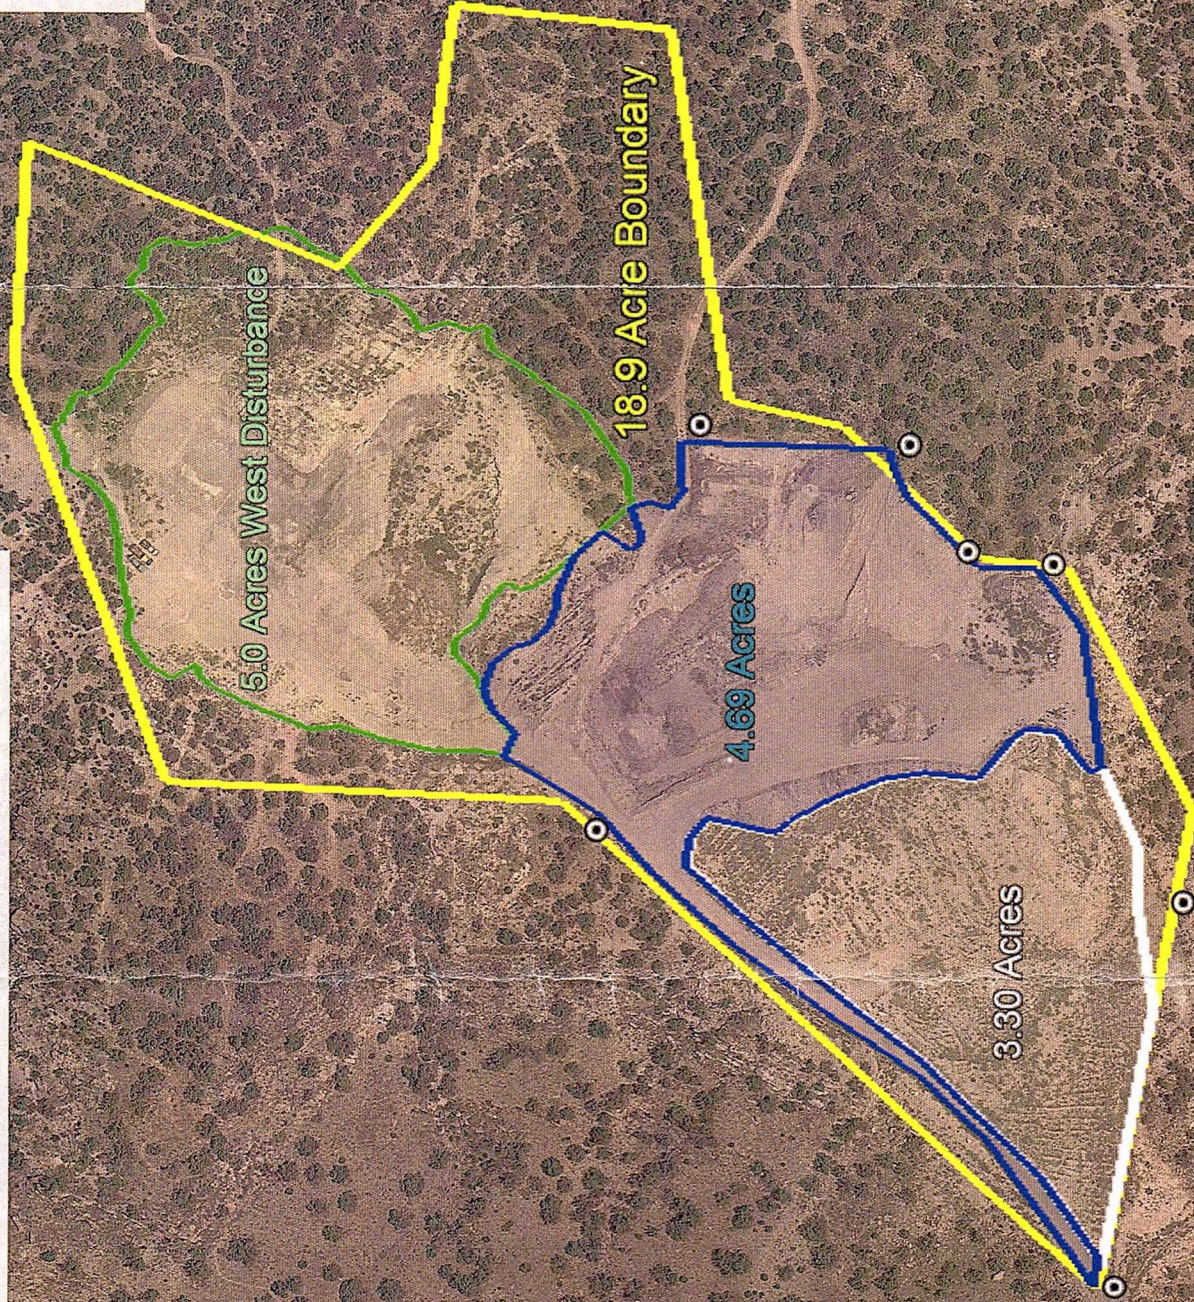
# Stocks Clay Mine 2018 Post-Inspection Map

**PROBLEM/POSSIBLE VIOLATION:** Problem: The west side affected area boundary markers are missing or incorrectly placed. This is a problem for failure to maintain boundary markers around the affected area as required by Section 3.1.12(2) of the rule.

Off-site Damage: The east portion of the operation appeared to be confined to the permit boundary, based on observed boundary markers and Google Earth review. It is not certain if the west portion is entirely within the permit boundary as no boundary markers could be located (see Signs and markers discussion below).

**CORRECTIVE ACTIONS:** The operator shall conduct a survey and replace the west side boundary markers in the correct location(s). The operator shall provide proof to the Division that this has been done by the corrective action date.
