Reg: McKenna Limestone Quarry M-2000-039

MINERALS PROGRAM INSPECTION REPORT**PHONE: (303) 866-3567**

MINE NAME: McKenna Limestone Quarry	MINE/PROSPECTING ID#: M-2000-039	MINERAL: Limestone (general)	COUNTY: Huerfano
INSPECTION TYPE: Monitoring	INSPECTOR(S): Patrick Lennberg	INSP. DATE: February 20, 2019	INSP. TIME: 12:30
OPERATOR: Delhur Industries, Inc.	OPERATOR REPRESENTATIVE: Rick Hurworth	TYPE OF OPERATION: 110c - Construction Limited Impact

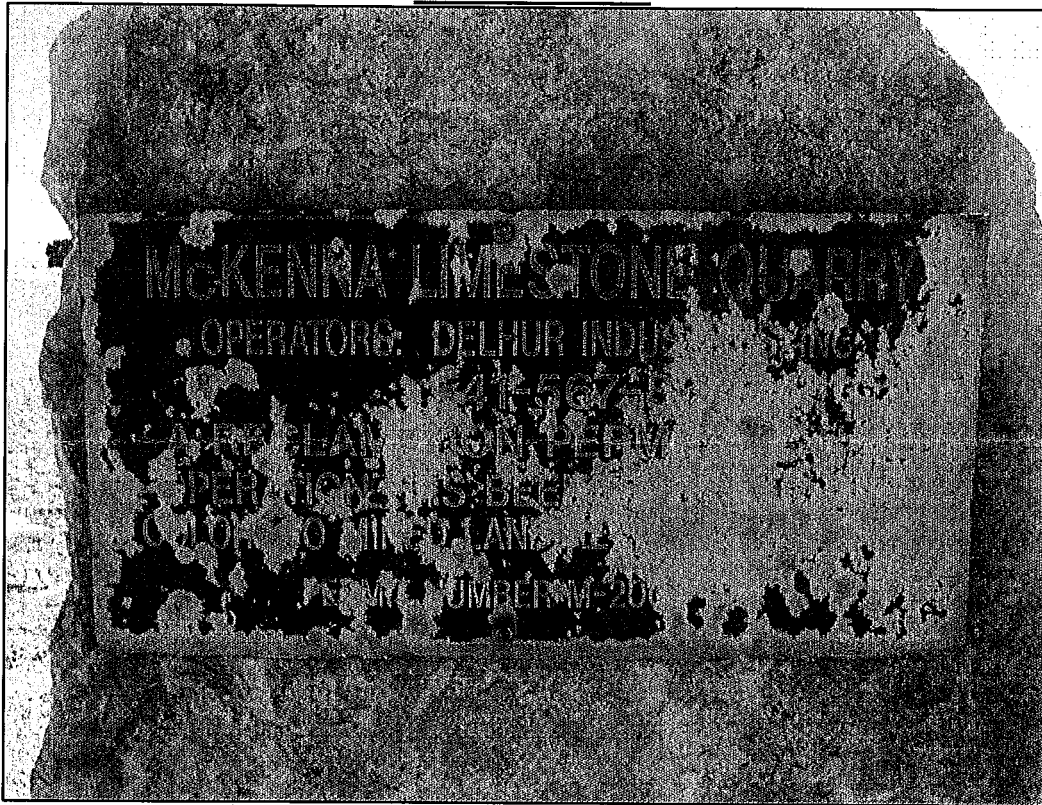
PROBLEM/POSSIBLE VIOLATION: Problem: The mine identification sign is very faded and the mine permit number is no longer legible. This is a problem for failure to maintain a mine identification sign as required by Section 3.1.12(1) of the rule.

The quarry is located approximately 3.5 miles southeast of the intersection of Colorado Highway 10 and County Road (CR) 210, which is about 8 miles northeast of Walsenburg, Colorado. The mine entrance road is approximately 1.5 miles southeast of the intersection of CR 210 and CR 211. The quarry is a 110c mining operation. The approved post-mining land use is rangeland. A mine sign was observed as required by Rule 3.1.12, although the sign is very faded and peeling away. It should be replaced.

Photo 1: Mine sign at junction of haul road and CR 211

CORRECTIVE ACTIONS: The operator shall, at the entrance of the mine site, repost a sign which shall be clearly visible from the access road with the following: the name of the operator, a statement that a reclamation permit for the operation has been issued by the Colorado Mined Land Reclamation Board; and the permit number. The operator shall submit photo documentation that a proper sign has been posted by the corrective action date.

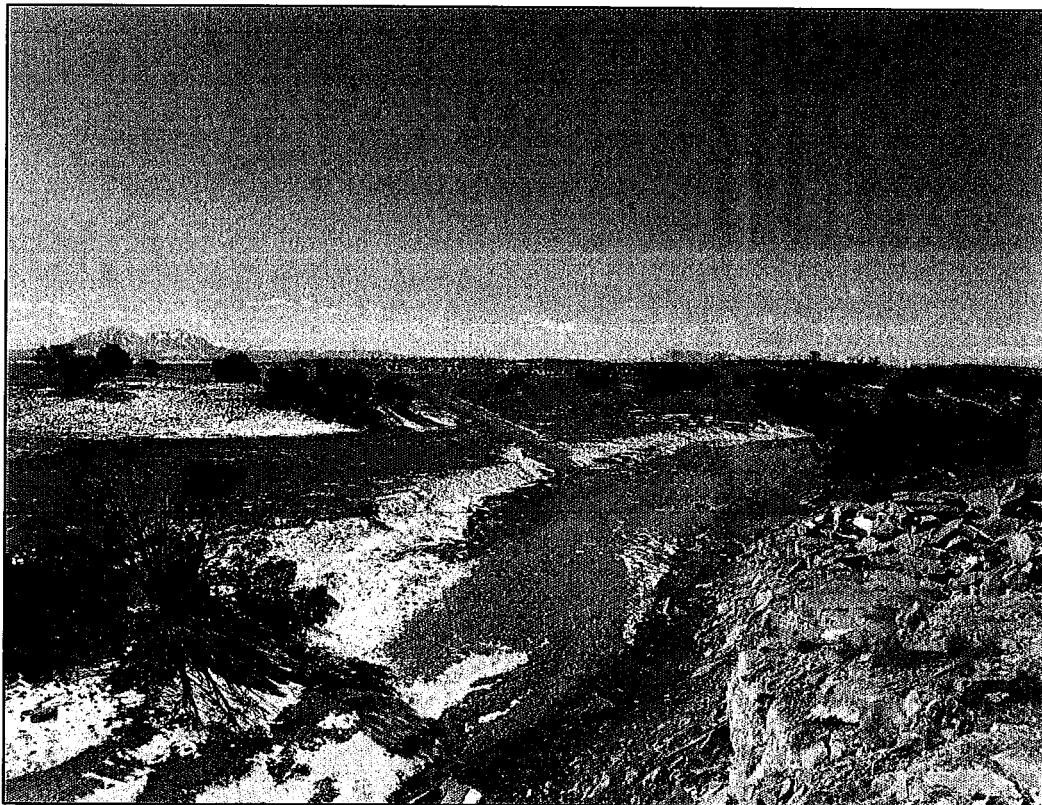
The pit and surrounding disturbed area is sloped to drain to the adjacent arroyo. There was some minor rilling observed. The haul road is in a 30 foot easement and is approximately 0.3 miles long from CR 211 that is allowed to remain in place after mining is complete.

Photo 2: Haul road as it comes to the site crossing the arroyo

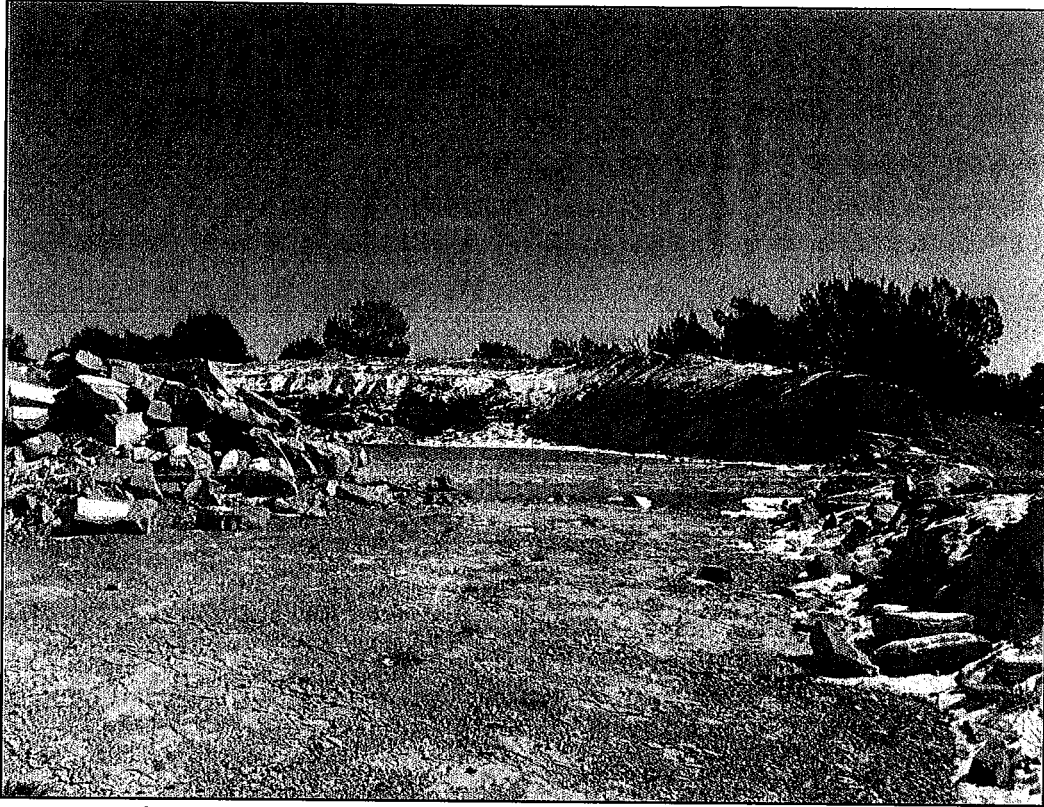
Photo 3: Highwall area with a small stockpile of dimensional stone to the left

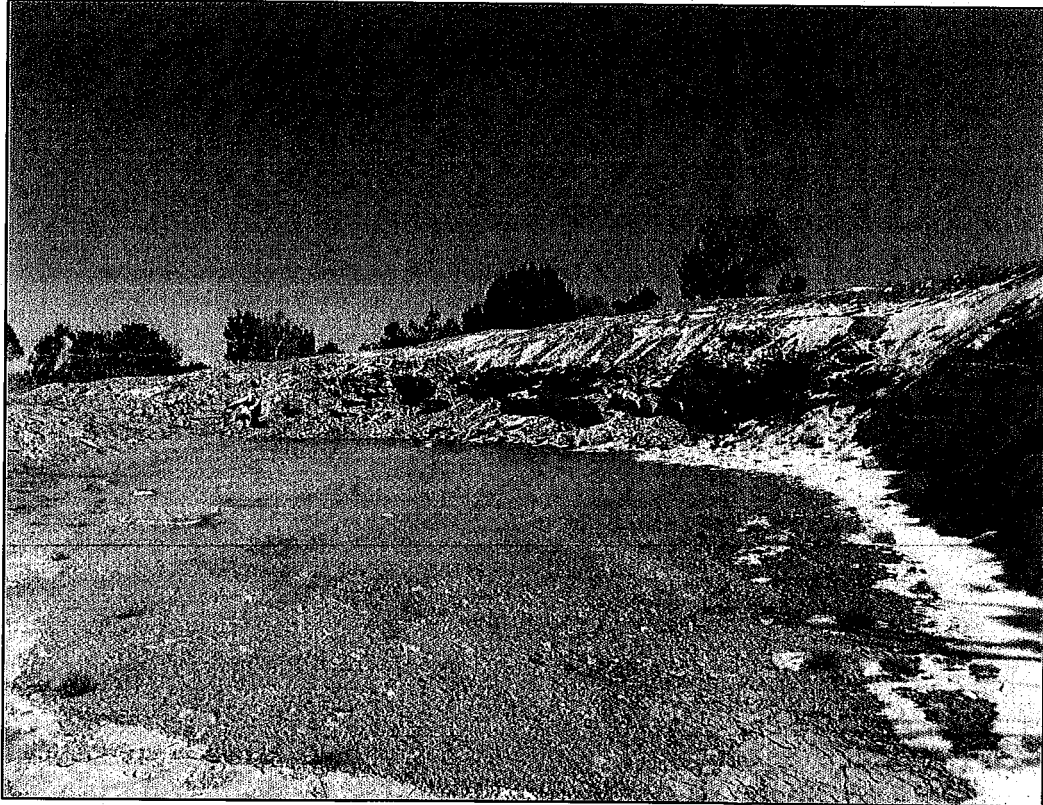
Photo 4: Highwall area looking east

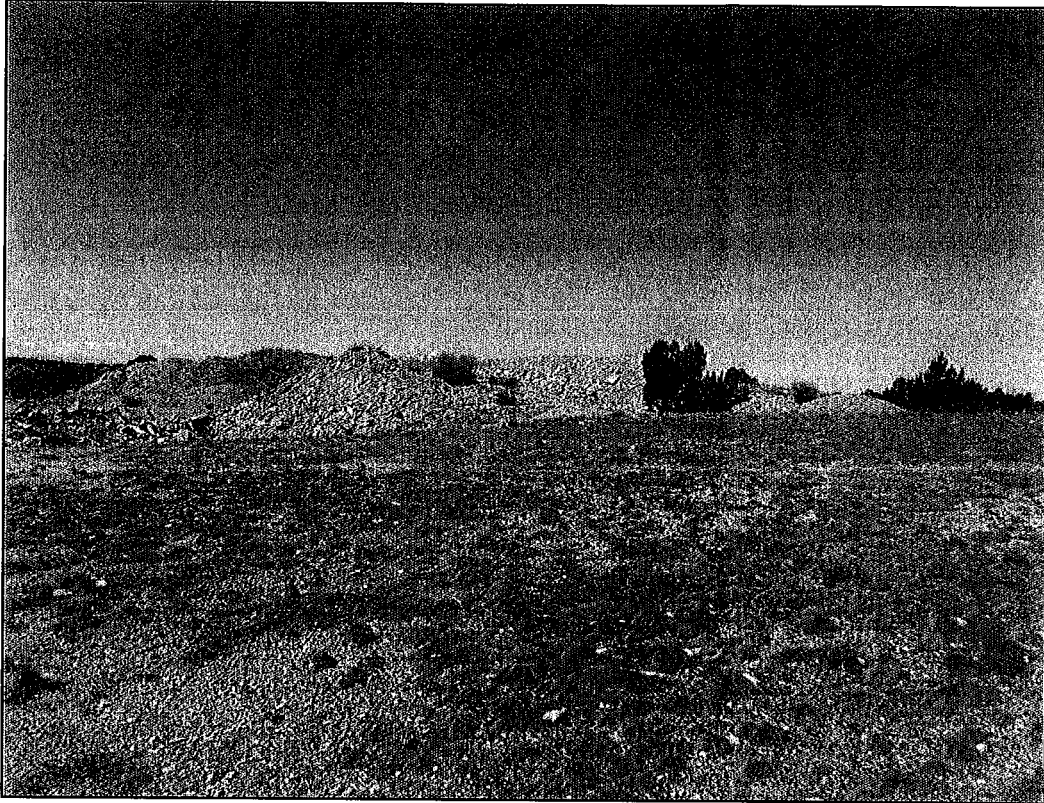
Photo 5: Looking north towards topsoil stockpile background with undisturbed land in the foreground

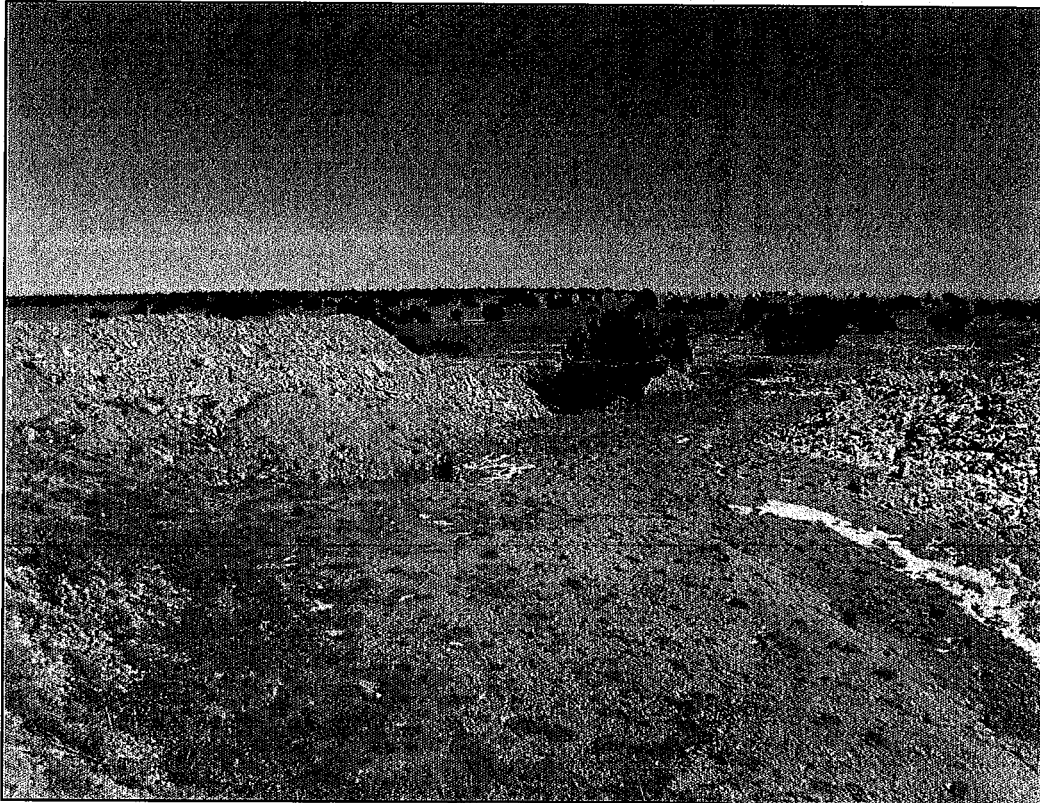
Photo 6: Looking southeast from the top of the topsoil stockpile, larger material stockpile to the right of photo

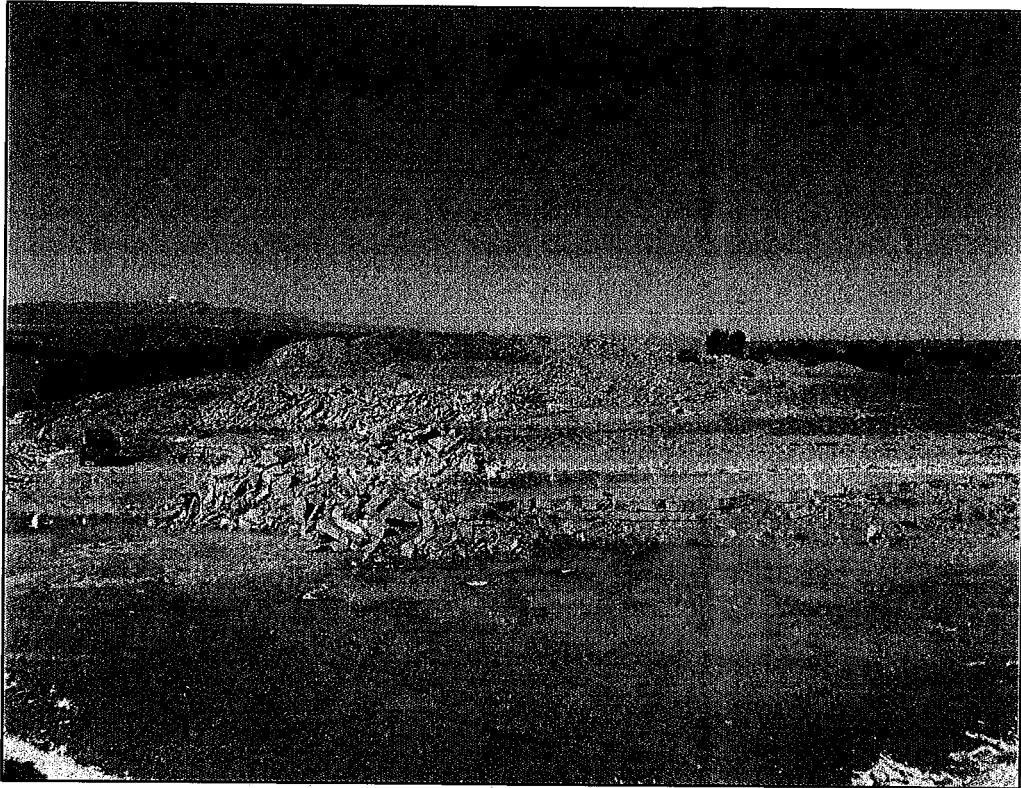
Photo 7: Looking north across the site
