**COLORADO**Division of Reclamation,
Mining and Safety

MINERALS PROGRAM INSPECTION REPORT**PHONE: (303) 866-3567**

MINE NAME: Van 4 Shaft	MINE/PROSPECTING ID#: M-1997-032	MINERAL: Uranium and vanadium	COUNTY: Montrose
INSPECTION TYPE: Monitoring	INSPECTOR(S): Dustin M. Czapla	INSP. DATE: April 17, 2019	INSP. TIME: 14:00
OPERATOR: Pinon Ridge Mining LLC	OPERATOR REPRESENTATIVE: None	TYPE OF OPERATION: 110d - Designated Limited Impact

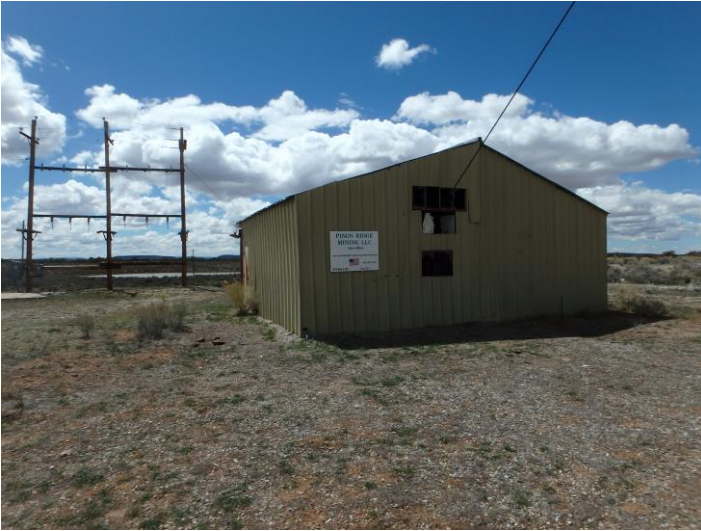
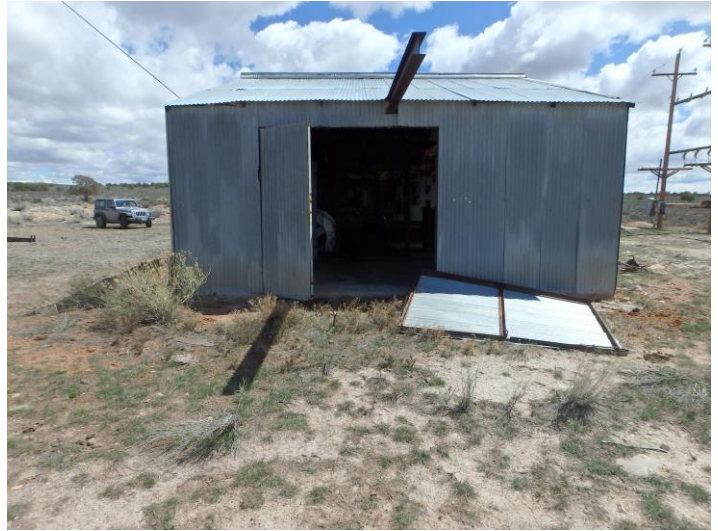
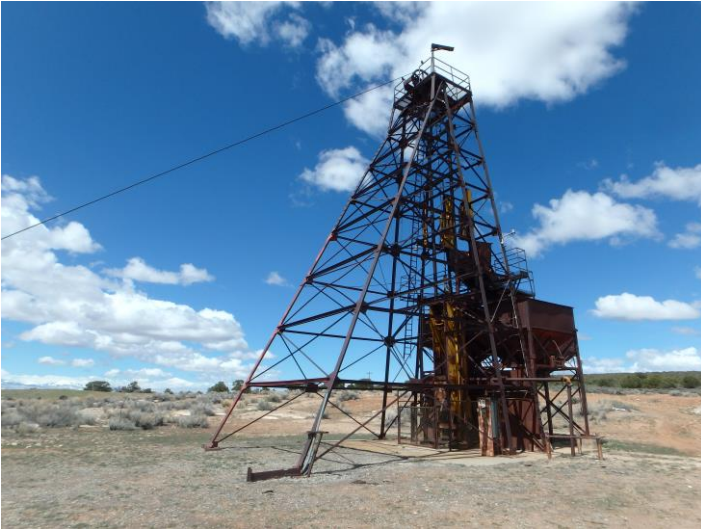
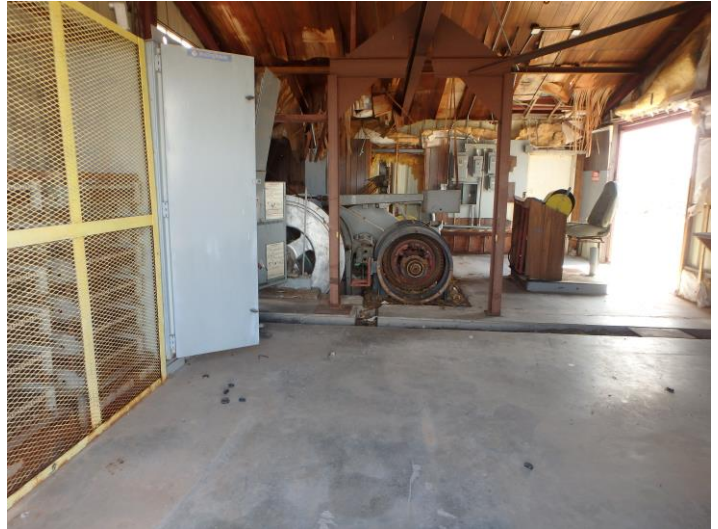
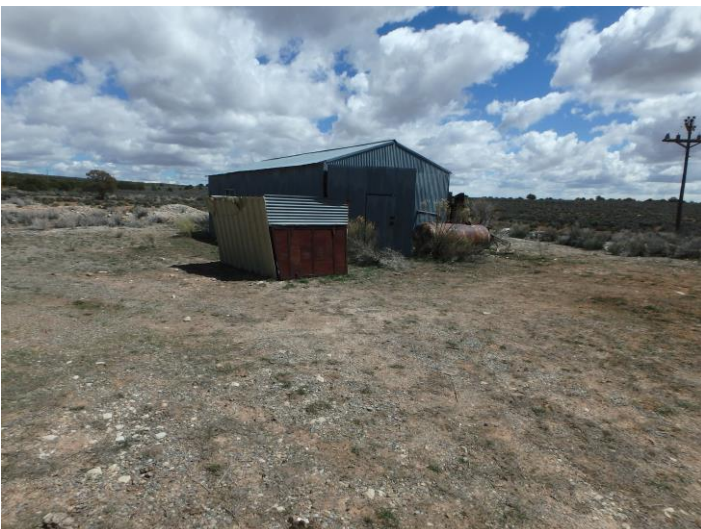
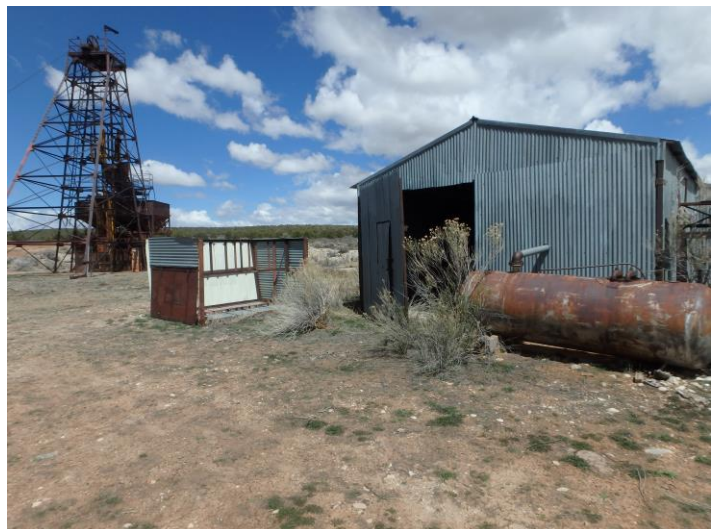
Two metal buildings remain on site, the hoist house and shop. The west wall of the hoist house is falling apart and the building is in disrepair. The west wall of the shop building is falling apart and the building is in disrepair. There is a metal shed behind the shop building that has been knocked over and is falling apart. These issues have been noted as a problem at the beginning of this report. The buildings shall be removed from the site, or repaired in order to control unsightliness and deleterious effects of such refuse.

The shaft is secured with grating welded to the collar, and a welded gate at the base of the headframe. The headframe appears stable.
