**MINERALS PROGRAM INSPECTION REPORT**  
**PHONE: (303) 866-3567**

<b>MINE NAME:</b> Rocky Ford East Pit	<b>MINE/PROSPECTING ID#:</b> M-1977-560	<b>MINERAL:</b> Sand and gravel	<b>COUNTY:</b> Otero
<b>INSPECTION TYPE:</b> Surety Release Inspection	<b>INSPECTOR(S):</b> Amy Eschberger	<b>INSP. DATE:</b> April 25, 2019	<b>INSP. TIME:</b> 11:00
<b>OPERATOR:</b> VALCO, Inc.	<b>OPERATOR REPRESENTATIVE:</b> Tom Brubaker	<b>TYPE OF OPERATION:</b> 112c - Construction Regular Operation

<b>REASON FOR INSPECTION:</b> Surety Release Requested	<b>BOND CALCULATION TYPE:</b> None	<b>BOND AMOUNT:</b> \$193,678.00
<b>DATE OF COMPLAINT:</b> NA	<b>POST INSP. CONTACTS:</b> None	<b>JOINT INSP. AGENCY:</b> None
<b>WEATHER:</b> Clear	<b>INSPECTOR'S SIGNATURE:</b>

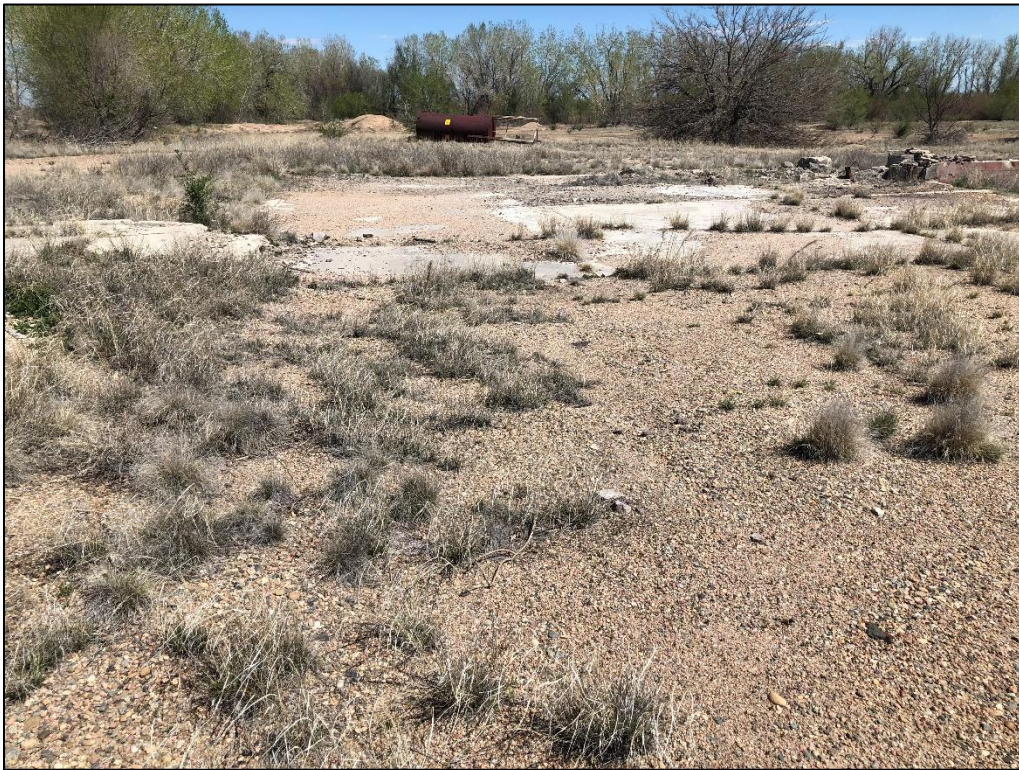
**Photo 1.** View looking north across old batch plant area in western portion of western parcel (proposed for release in AR-2).

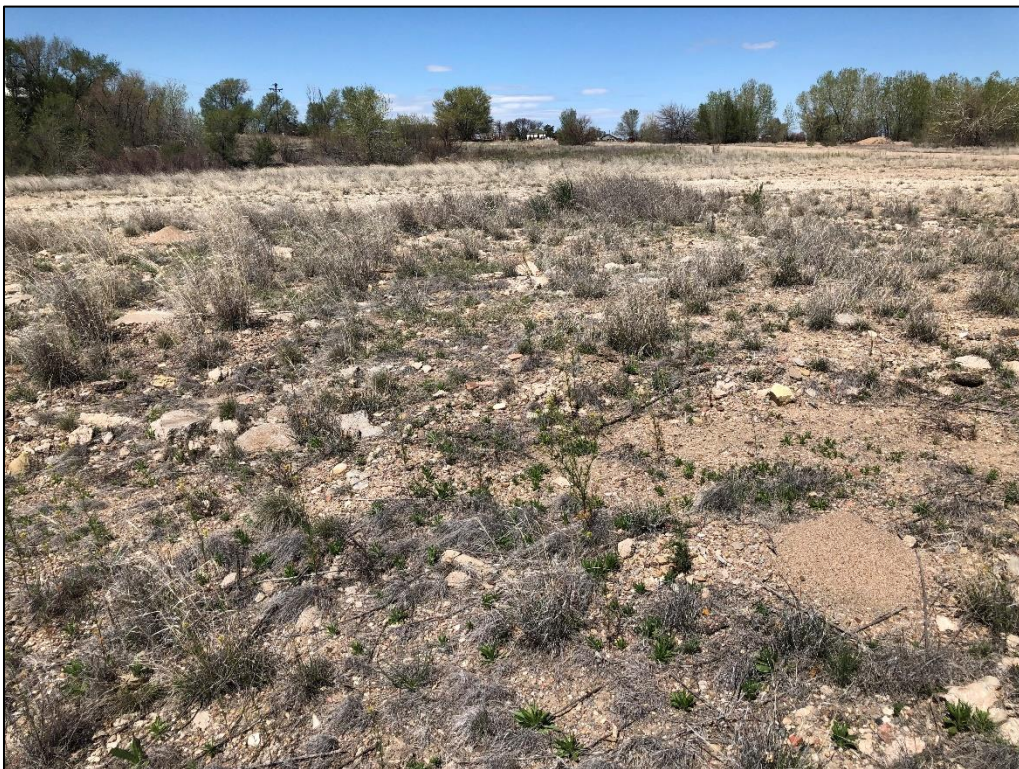
**Photo 2.** View looking west across central portion of western parcel (proposed for release in AR-2).

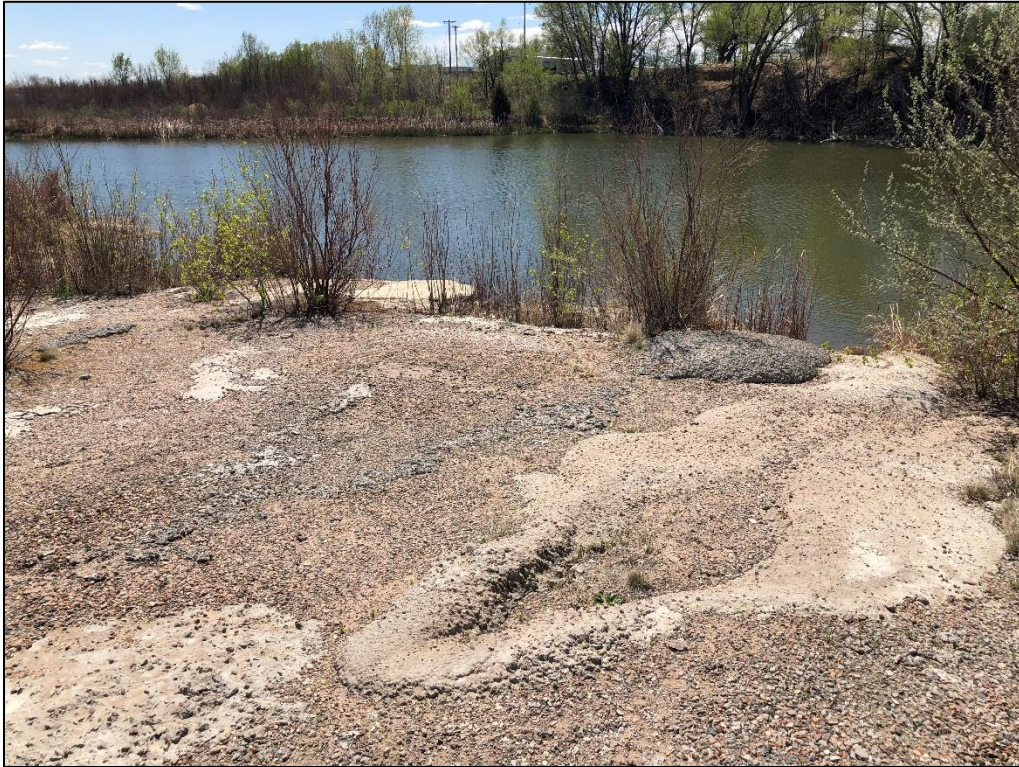
**Photo 3.** View looking southeast across small slurry pond in western parcel (proposed for release in AR-2). The new operator for this area, Deep Cut LLC, will need to implement the weed control plan for this site, particularly for Tamarisk.

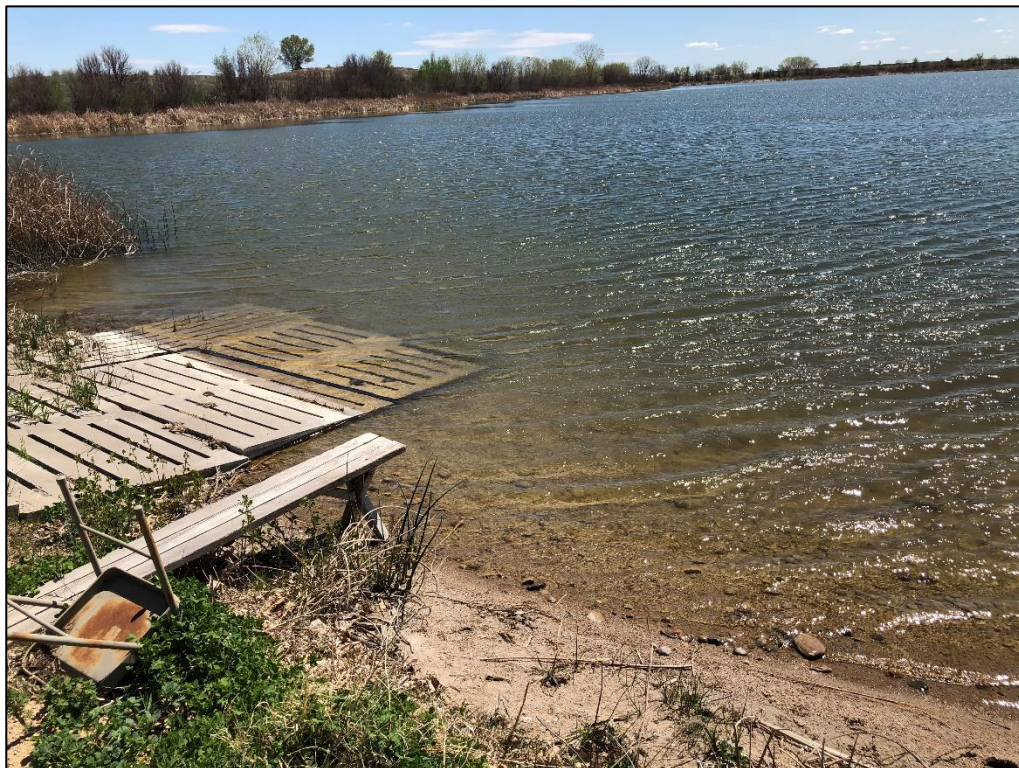
**Photo 4.** View looking northeast across larger pond in western parcel (proposed for release in AR-2).

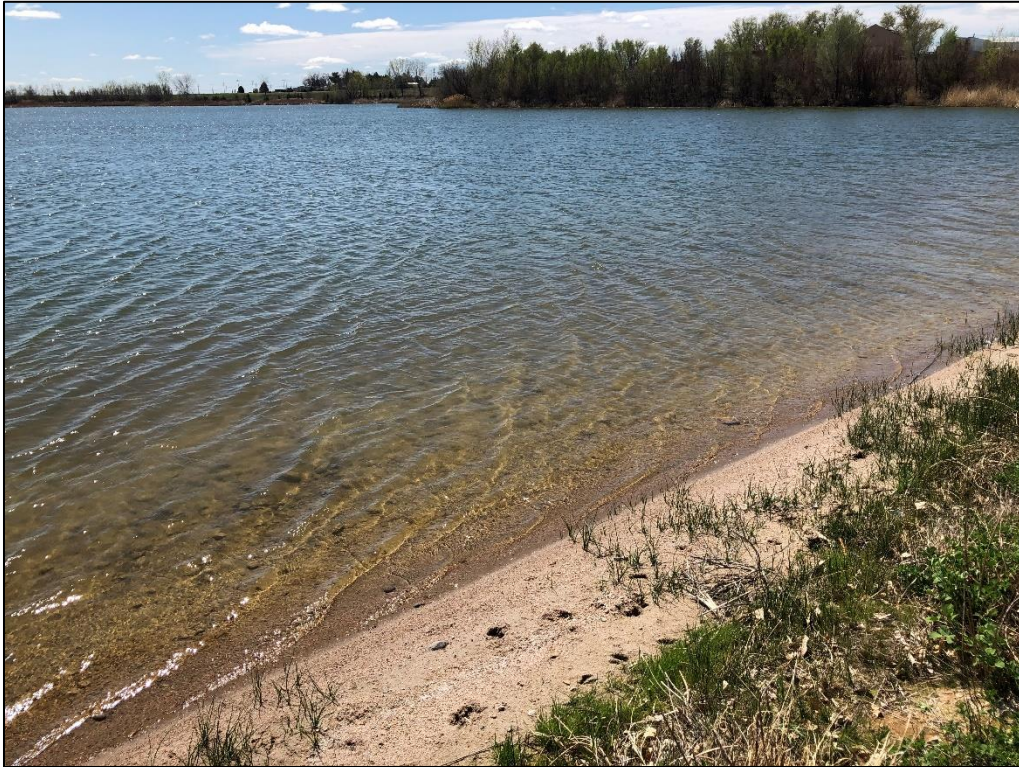
**Photo 5.** View looking southeast across larger pond in western parcel (proposed for release in AR-2).

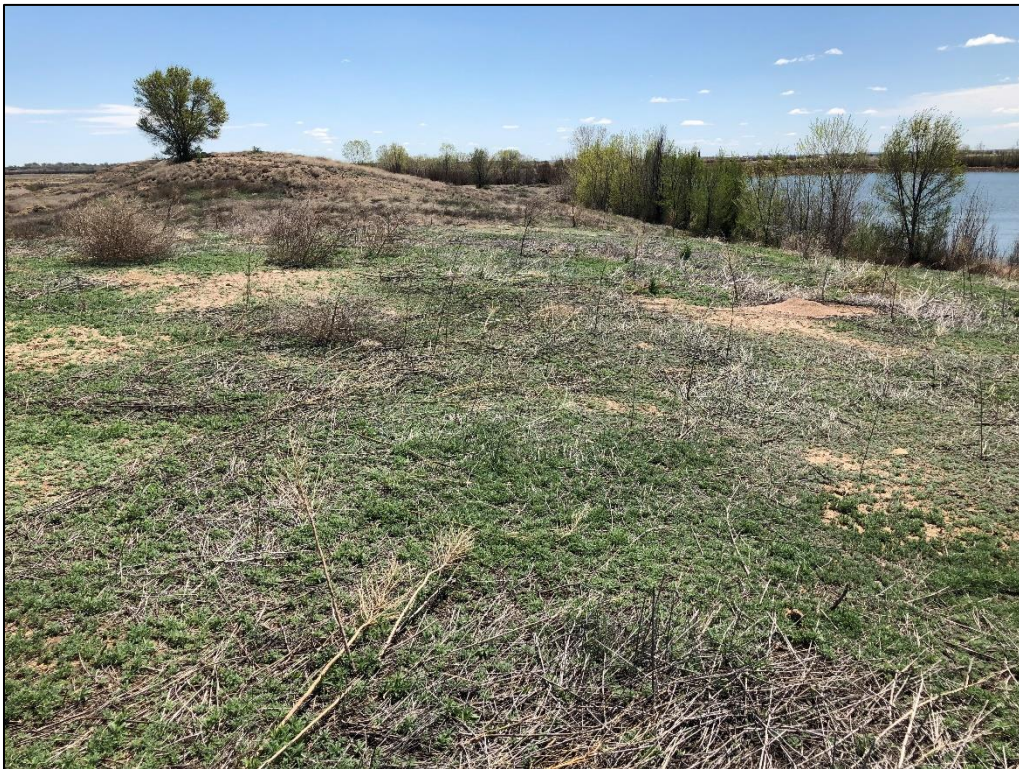
**Photo 6.** View looking east across land north of larger pond where topsoil and overburden is stored in western parcel (proposed for release in AR-2).

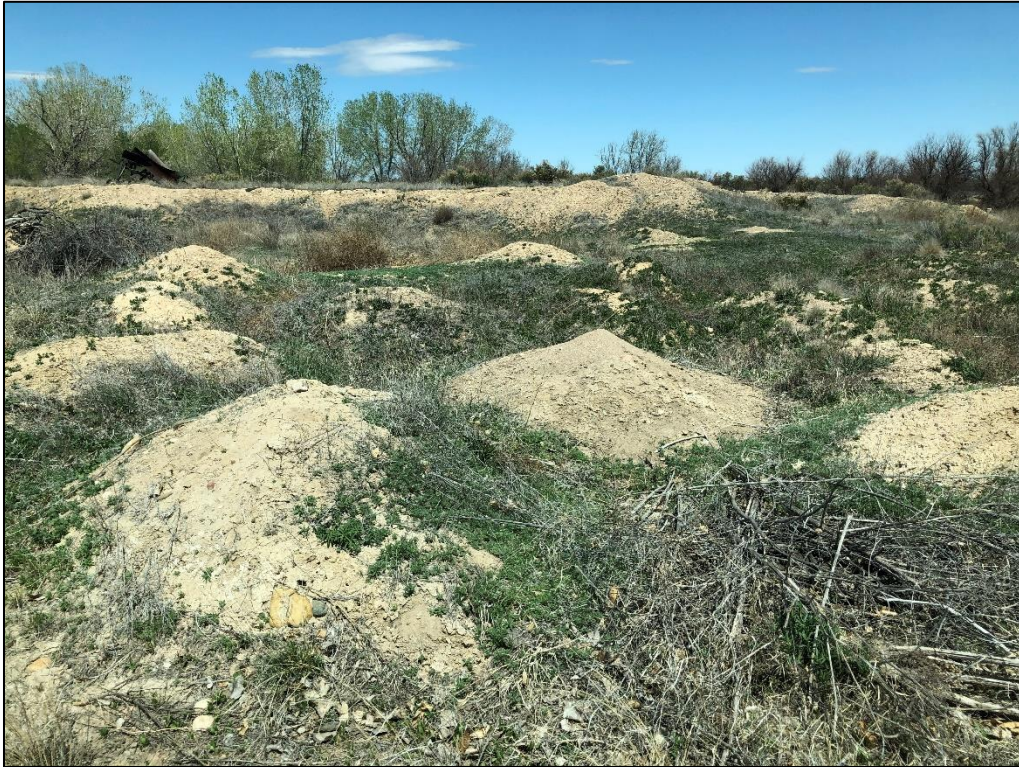
**Photo 7.** View looking west across small waste rock piles left near northwestern edge of western parcel (proposed for release in AR-2).

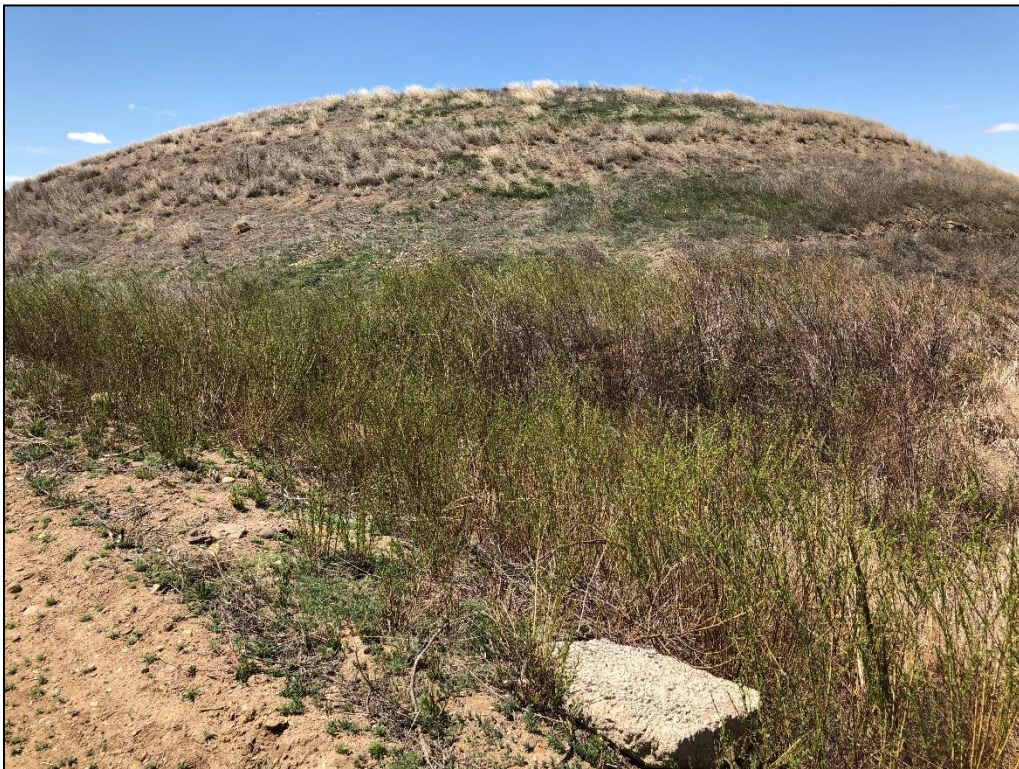
**Photo 8.** View looking southwest from northeastern boundary corner of western parcel showing large overburden stockpile stored north of larger pond (proposed for release in AR-2).

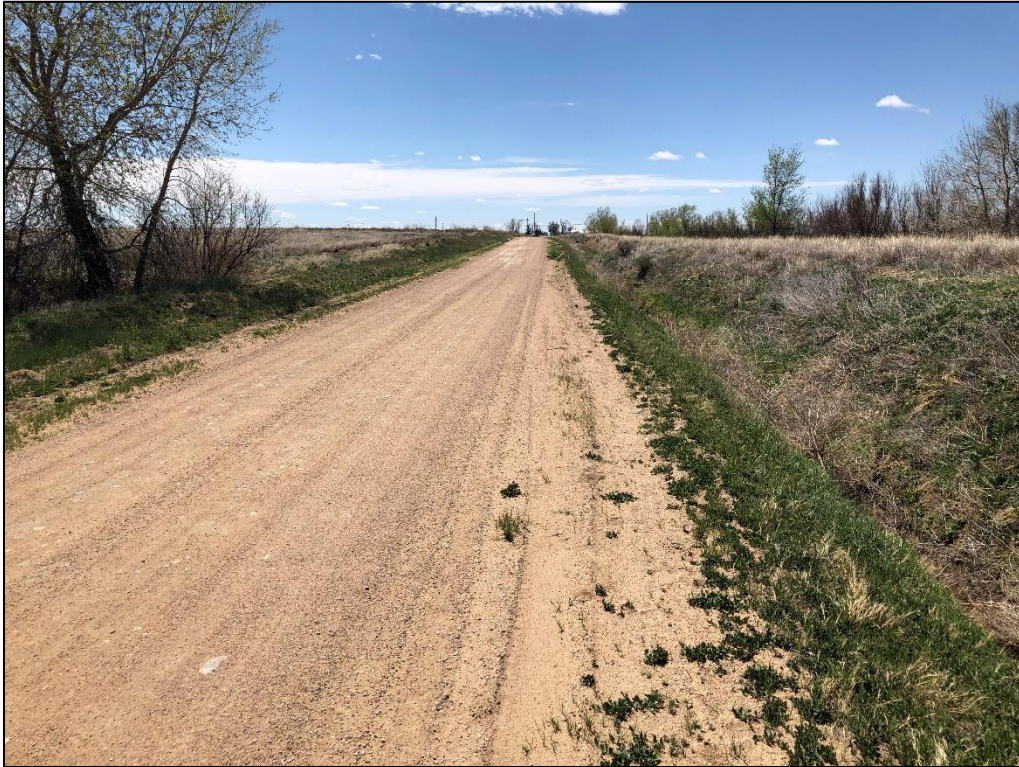
**Photo 9.** View looking south along Co Rd 22 which separates the western parcel (at right) from the eastern parcel (at left).

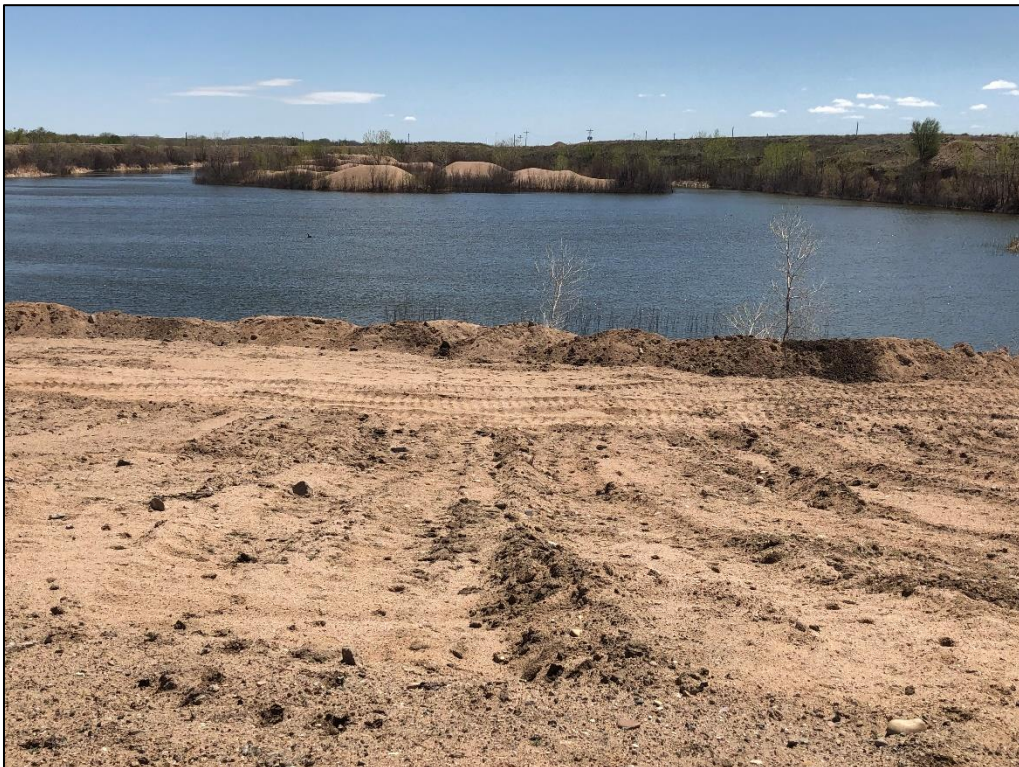
During the current inspection, the Division observed the eastern parcel to look the same as it did during the last inspection of this parcel (January 13, 2016), except that the concrete rubble which had been stockpiled adjacent to the two ponds had been pushed into the ponds. Mr. Brubaker indicated this was done in late 2018/early 2019. A small concrete rubble pile still exists northwest of the smaller pond. Large overburden stockpiles line the perimeters of the two ponds. The ponds in this parcel consist of 15.3 acres of post-1981 exposed groundwater according to the SWSP approved for this parcel for the period of August 1, 2018 through July 31, 2020.

**Photo 10.** View looking east across western edge of larger pond in eastern parcel where stockpiled concrete rubble was recently pushed into pond.

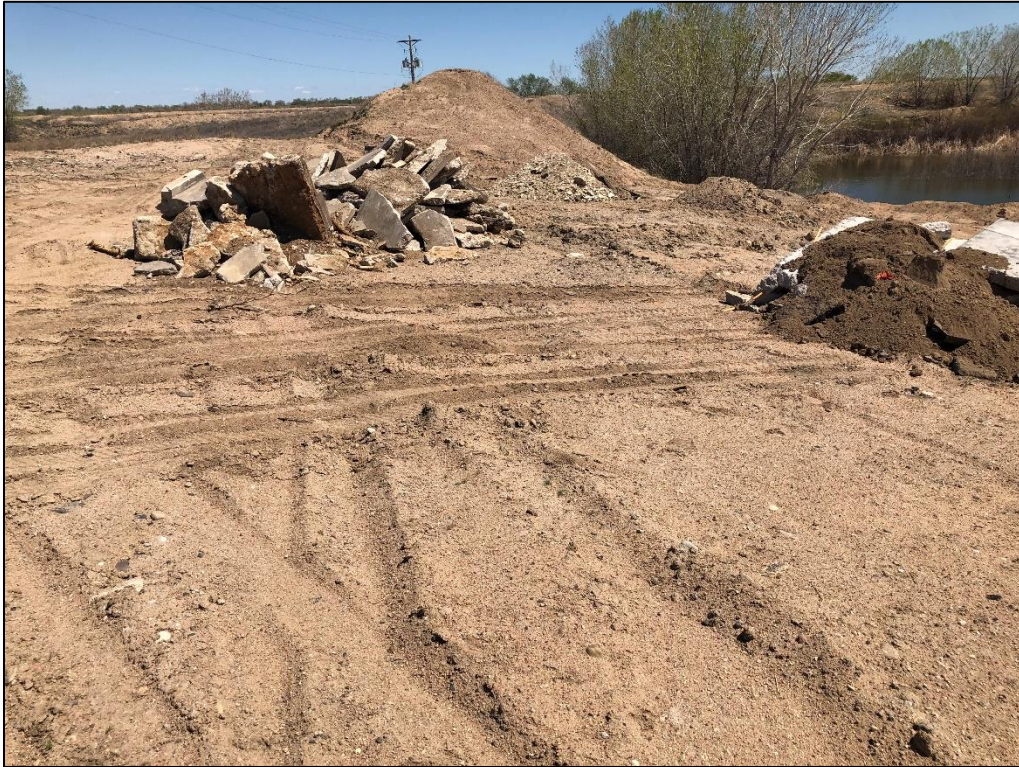
**Photo 11.** View looking north across western edge of larger pond in eastern parcel, showing small amount of concrete rubble pile remaining.

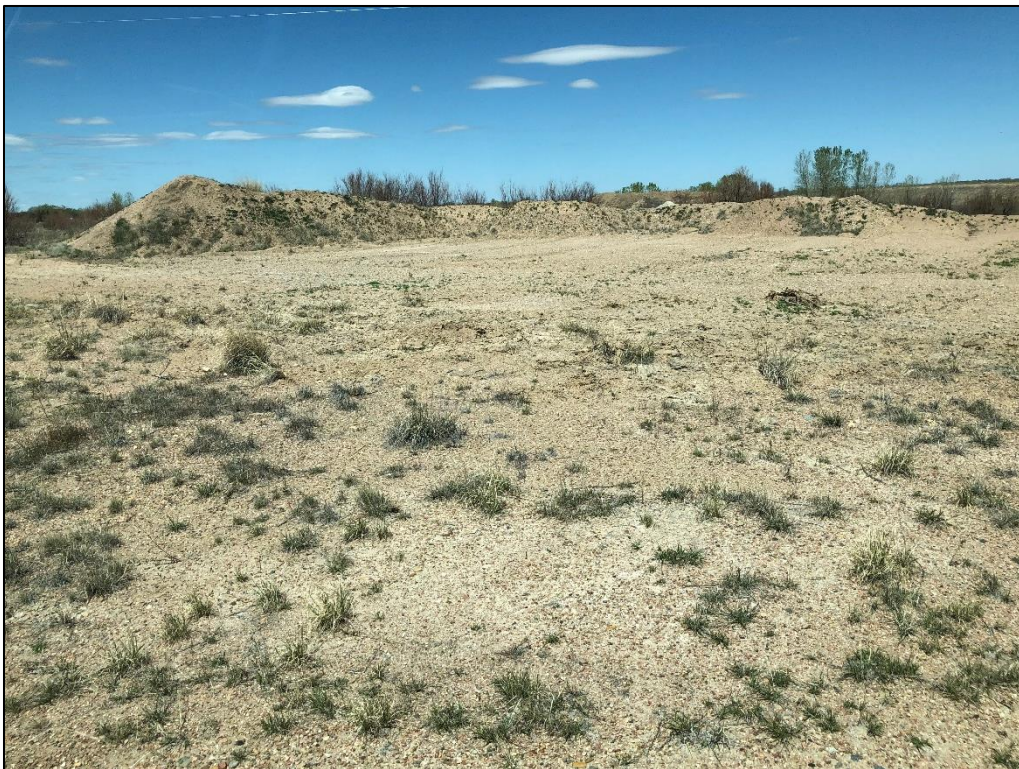
**Photo 12.** View looking north across eastern parcel showing overburden stockpile stored south of smaller pond which can be used as pond backfill for reclamation.

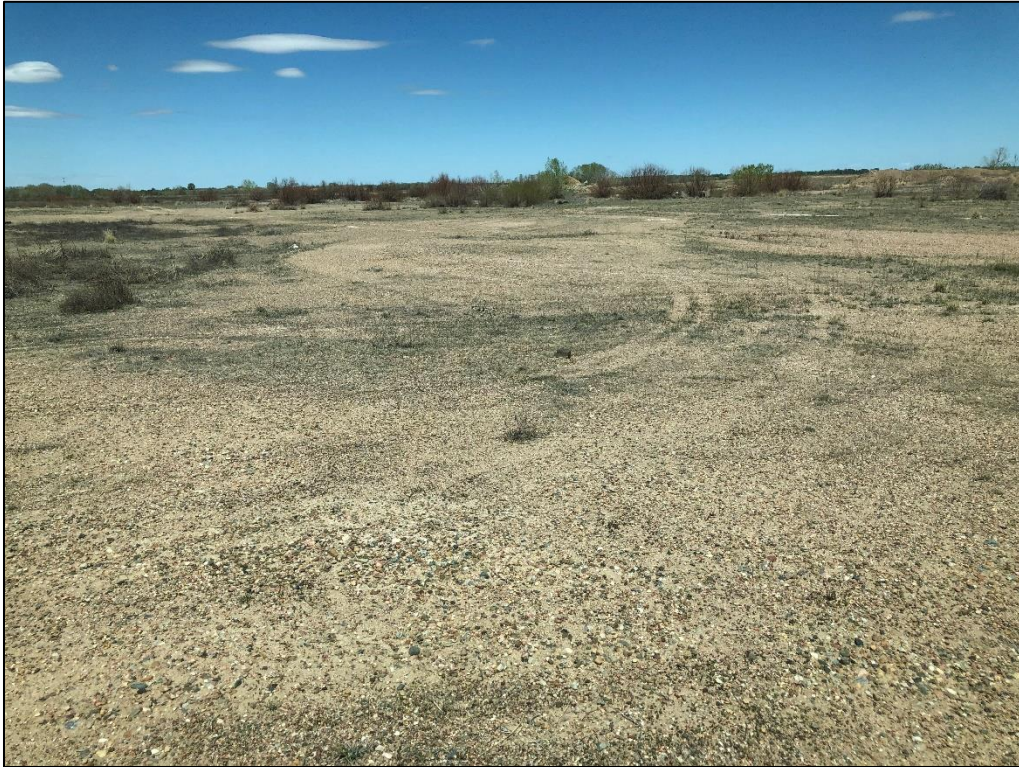
**Photo 13.** View looking northwest across central portion of eastern parcel which was used as a stockpiling/processing area during operations.

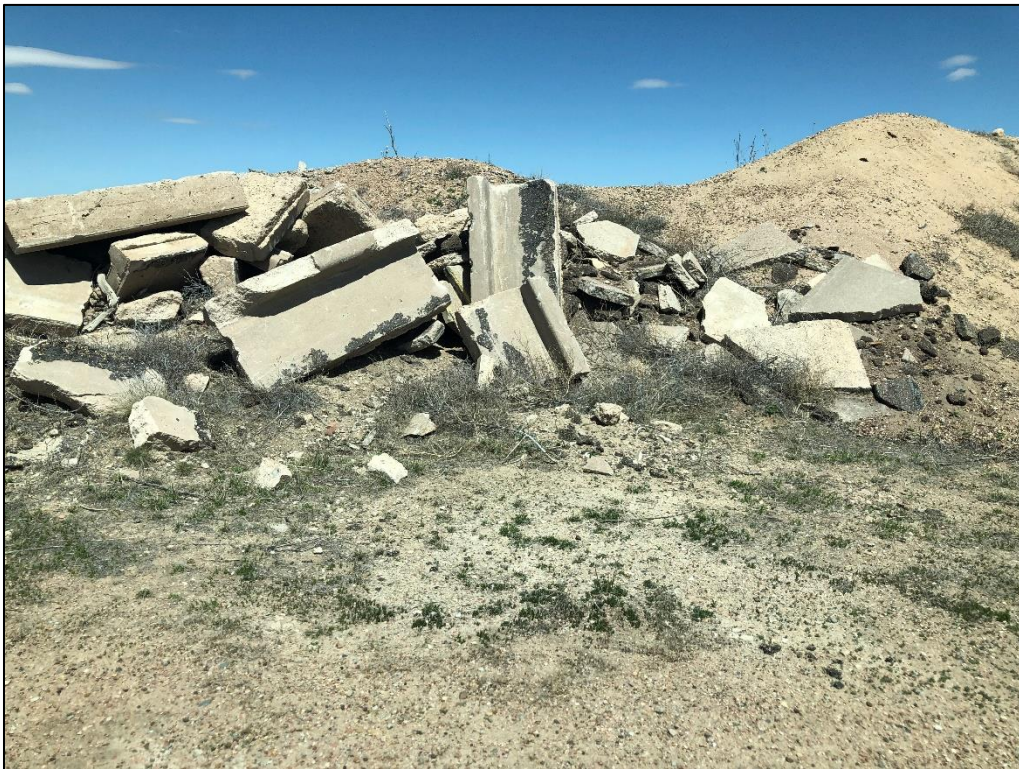
**Photo 14.** View looking north across eastern parcel showing waste rock and concrete rubble piles stored southwest of ponds which can be used as pond backfill for reclamation.

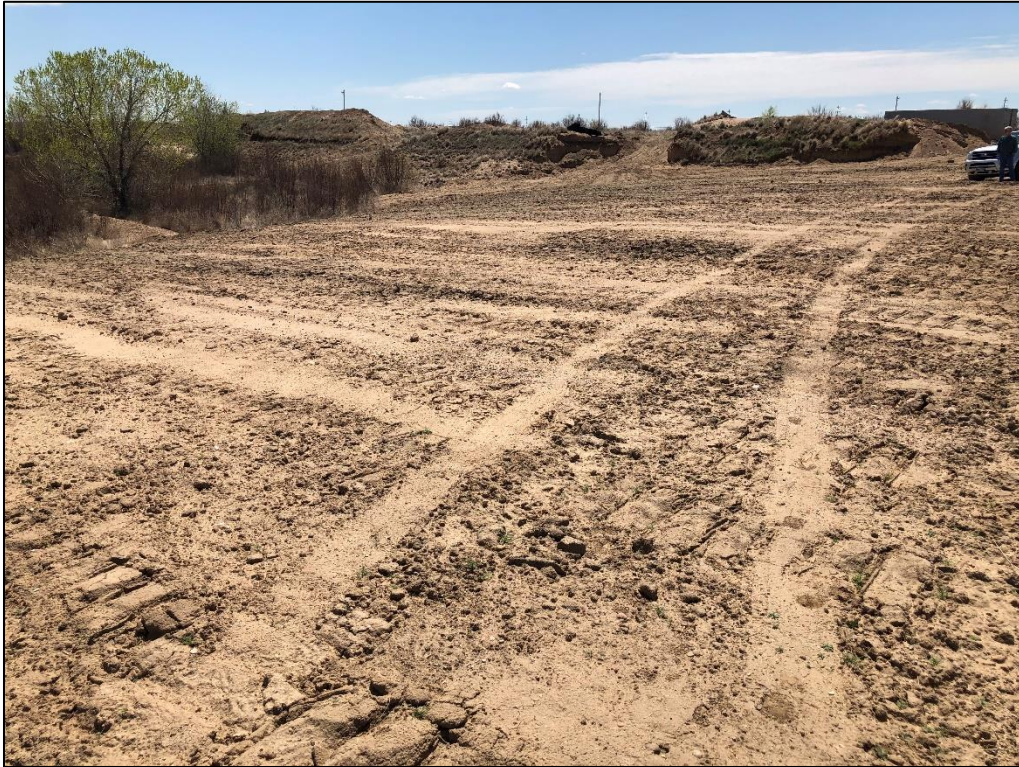
**Photo 15.** View looking southeast across southwestern edge of smaller pond in eastern parcel where stockpiled concrete rubble was recently pushed into pond.

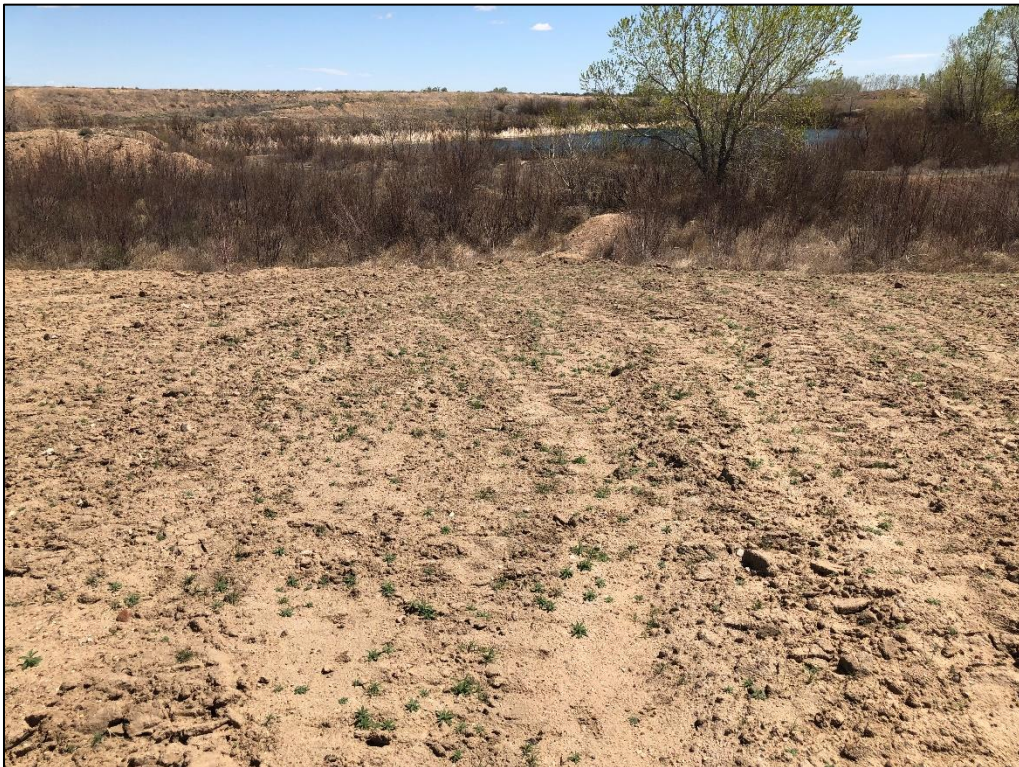
**PROBLEM:** There are state-listed noxious weeds present on site (primarily Tamarisk). This is a problem for failure to employ weed control methods for state listed noxious weed species within the permitted area, and to reduce the spread of weeds to nearby areas as required by Rule 3.1.10(6).

During the inspection, the Division observed widespread Tamarisk (salt cedar) growth throughout much of the eastern parcel, especially around the ponds. Tamarisk is considered a state-listed noxious weed species. Therefore, the Division is citing a problem in this report (see page 2) for failure to employ weed control methods for state-listed noxious weeds within the permitted area, and to reduce the spread of weeds to nearby areas as required by Rule 3.1.10(6). The operator will need to either implement the approved weed control plan for the site and provide proof to the Division this has been done, or develop a weed control plan in consultation with the county extension agency or weed control district office, and submit this plan to the Division in the form of a Technical Revision.

**Photo 16.** View looking east across southwestern edge of smaller pond in eastern parcel where stockpiled concrete rubble was recently pushed into pond. Note several Tamarisk trees growing along pond shoreline.

**CORRECTIVE ACTIONS:** By the corrective action due date, the operator shall implement the approved weed control plan and provide proof to the Division that this has been done. If a weed control plan is not already in place, the operator shall develop a weed control and management plan in consultation with the county extension agency or weed control district office, including specific control measures to be applied, a schedule for when control measures will be applied, and a post-treatment monitoring plan. This weed control plan shall be submitted to the Division as a Technical Revision, with the required \$216 revision fee, by the corrective action due date.

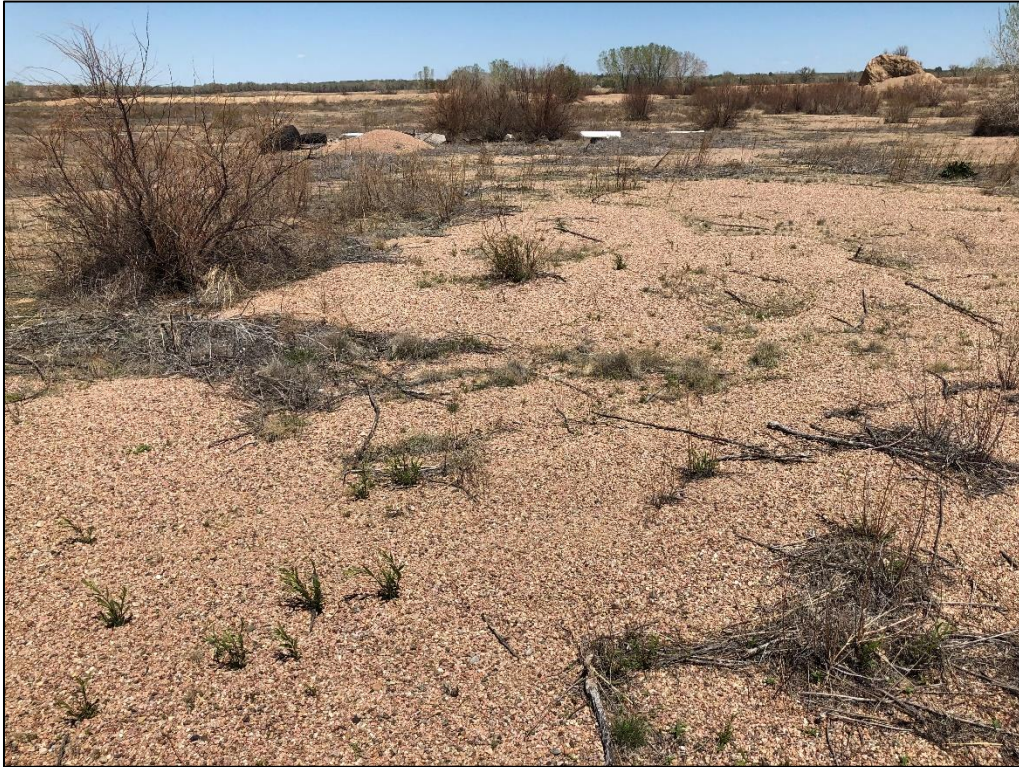
**Photo 17.** View looking north across eastern parcel west of smaller pond which was used as a stockpiling/processing area during operations. Note several Tamarisk trees growing in this area.

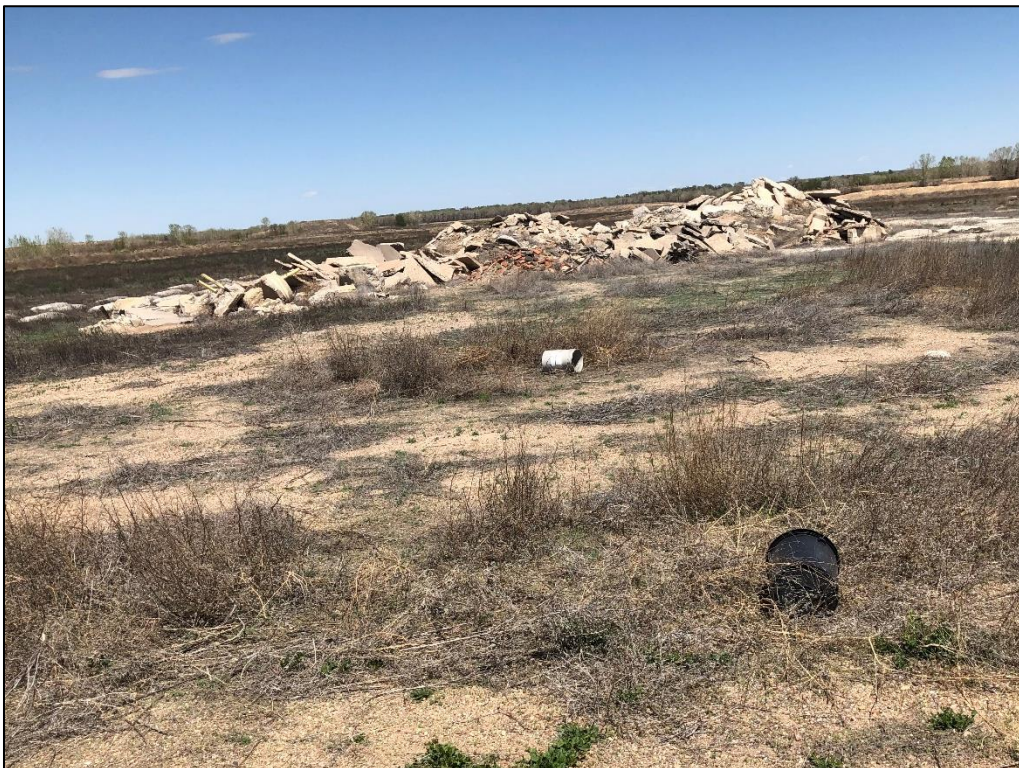
**Photo 18.** View looking north at small concrete rubble pile stored northwest of smaller pond in eastern parcel which can be used as pond backfill for reclamation.
