MINERALS PROGRAM INSPECTION REPORT
PHONE: (303) 866-3567

MINE NAME: Andersen Farms	MINE/PROSPECTING ID#: M-2006-050	MINERAL: Sand and gravel	COUNTY: Lincoln
INSPECTION TYPE: Monitoring	INSPECTOR(S): Patrick Lennberg	INSP. DATE: April 26, 2019	INSP. TIME: 09:10
OPERATOR: Lincoln County	OPERATOR REPRESENTATIVE: Fred Lundy	TYPE OF OPERATION: 110c - Construction Limited Impact	
REASON FOR INSPECTION: Normal I&E Program	BOND CALCULATION TYPE: None	BOND AMOUNT: \$0.00	
DATE OF COMPLAINT: NA	POST INSP. CONTACTS: None	JOINT INSP. AGENCY: None	
WEATHER: Clear	INSPECTOR'S SIGNATURE:

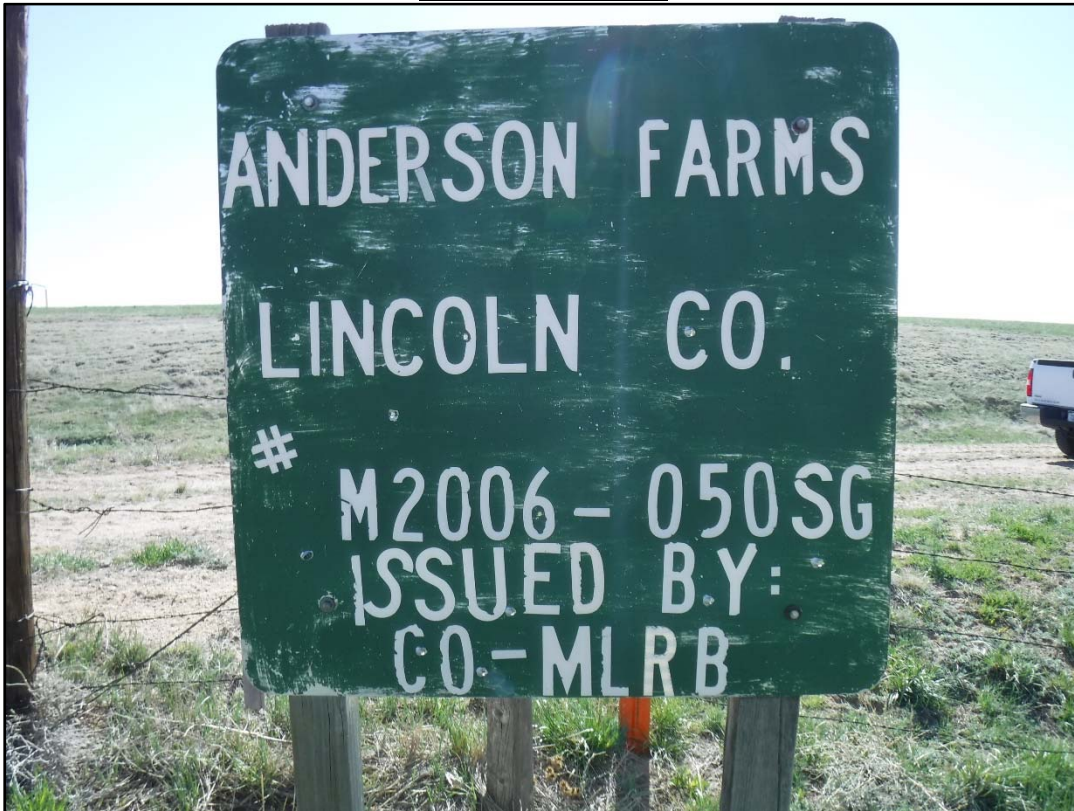
The Andersen Farms Pit is located 14 miles northeast of Genoa, Colorado. Access to the site is off of Co Rd 35. The pit is situated on Dugout Creek, which only flows during heavy storm events. When carrying water, the creek flows eastward. The pit is a 110c operation permitted for 7.6 acres for the removal of sand and gravel for county road maintenance and repair. The site is surrounded by rangeland and the post-mining land use is rangeland. A mine sign was observed as required by Rule 3.1.12

Photo 1: Mine sign at entrance off of County Road 35

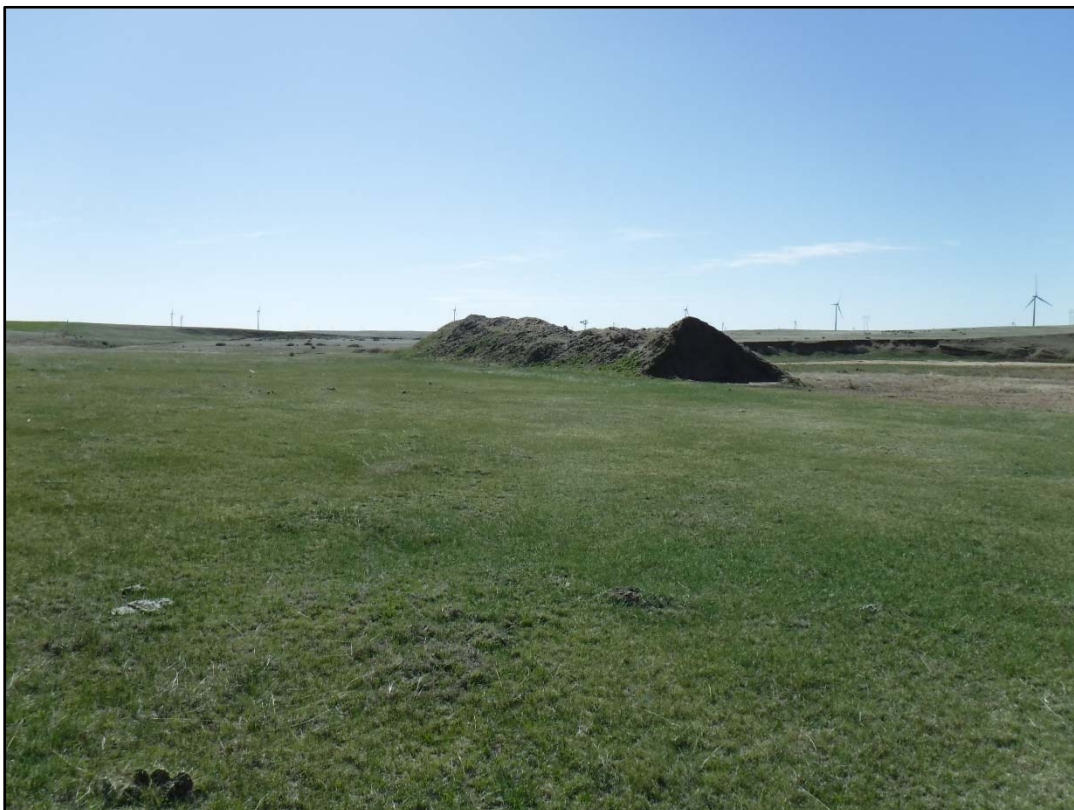
The site was not active at the time of the inspection but is active periodically throughout the year. A topsoil stockpile is located near the northwest corner of the permit boundary and trends to the east. The stockpile is stable with some vegetation covering it with no evidence of erosion. All mining activities appeared to be restricted to the north side of the creek. The creek bed itself appeared to have not been mined in some time. The horseshoe-shaped pit opens up to the south, with the mined slopes at 3H:1V or flatter. The pit was approximately 5-10 feet deep. The northern mined slopes exhibited some erosional damage which the operator should continue to monitor and repair as needed. The Division currently holds no financial warranty because it is a county operation.

Photo 2: Topsoil stockpile near the northwestern portion of permit area

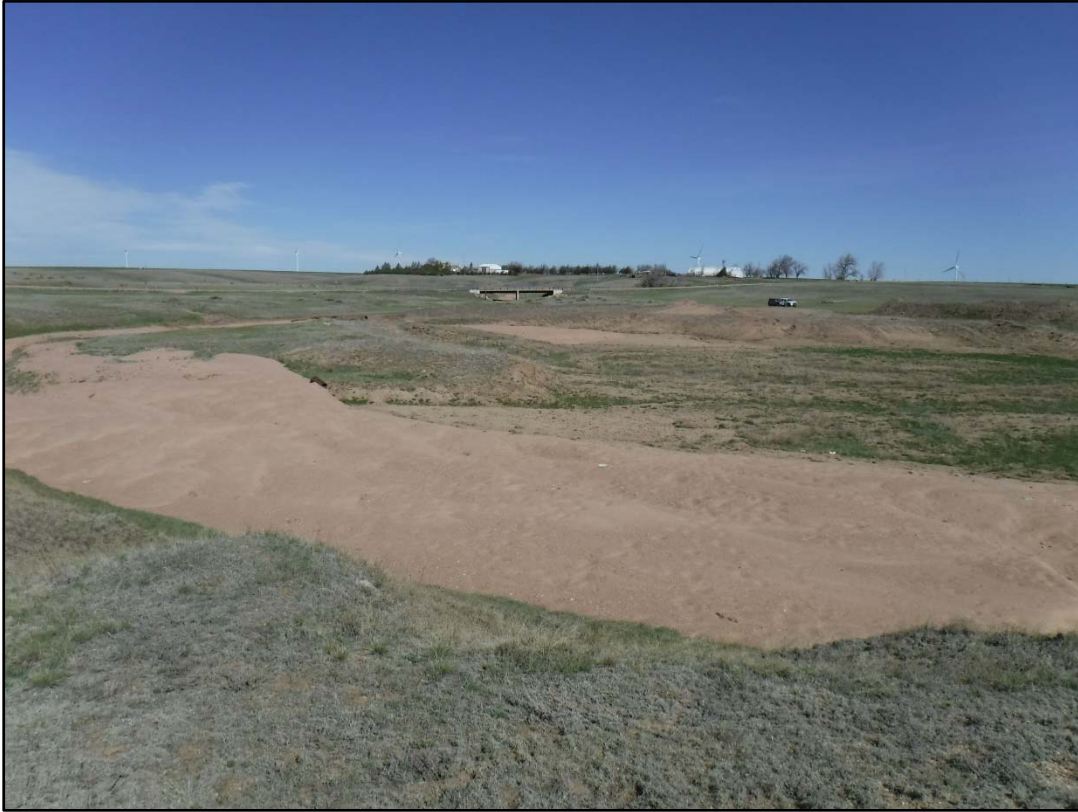
Photo 3: A view from the southern high bank looking towards the northwestern corner of permit at trucks

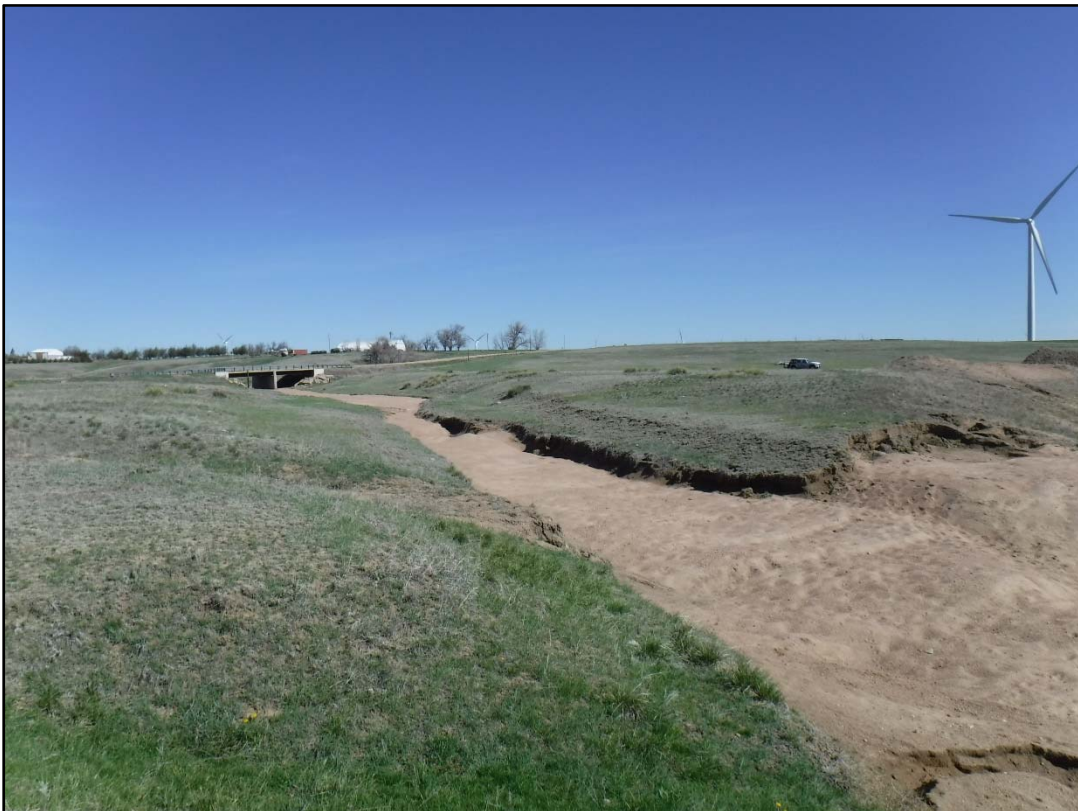
Photo 4: Dugout Creek as it enters the permit area

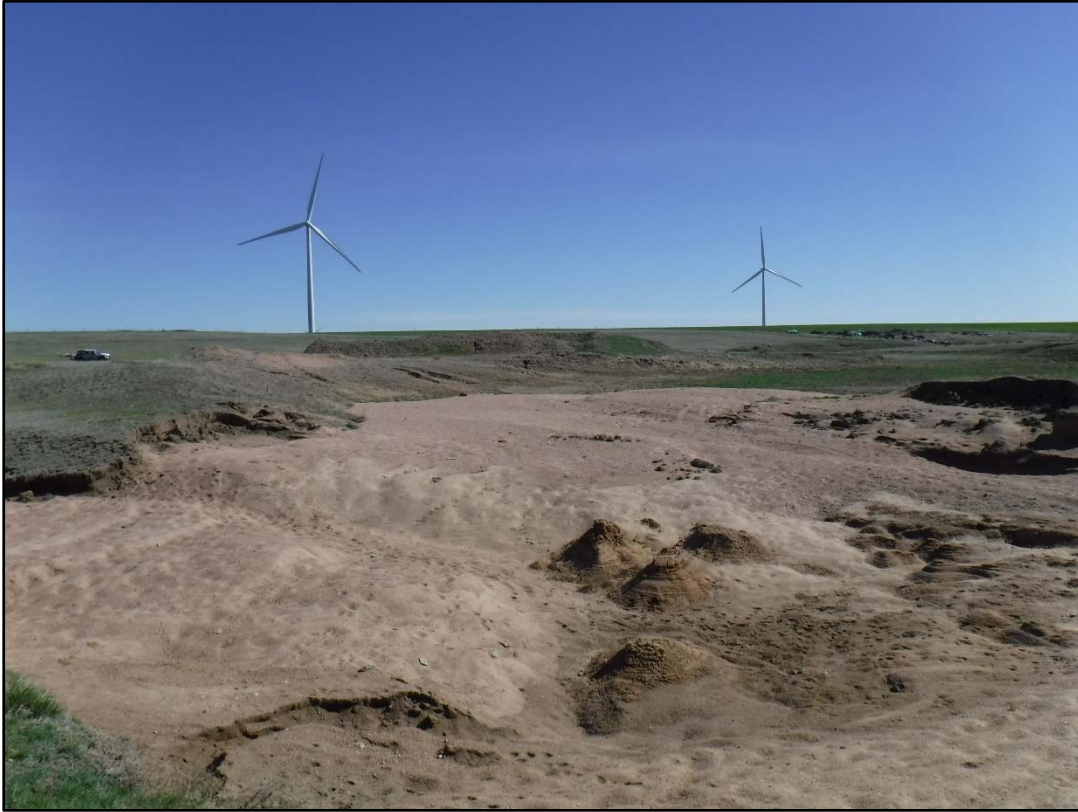
Photo 5: Horseshoe shaped pit in the southern portion of permit

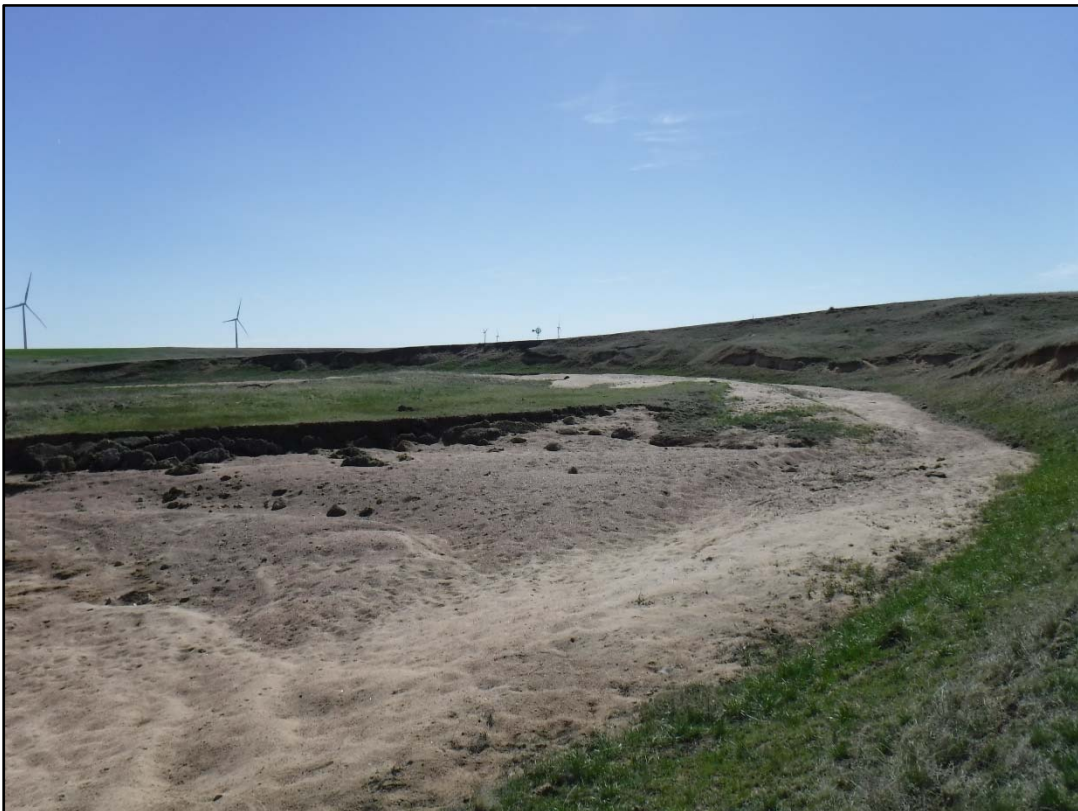
Photo 6: Dugout Creek as it passes around the pit area, southern pit high bank center background of photo

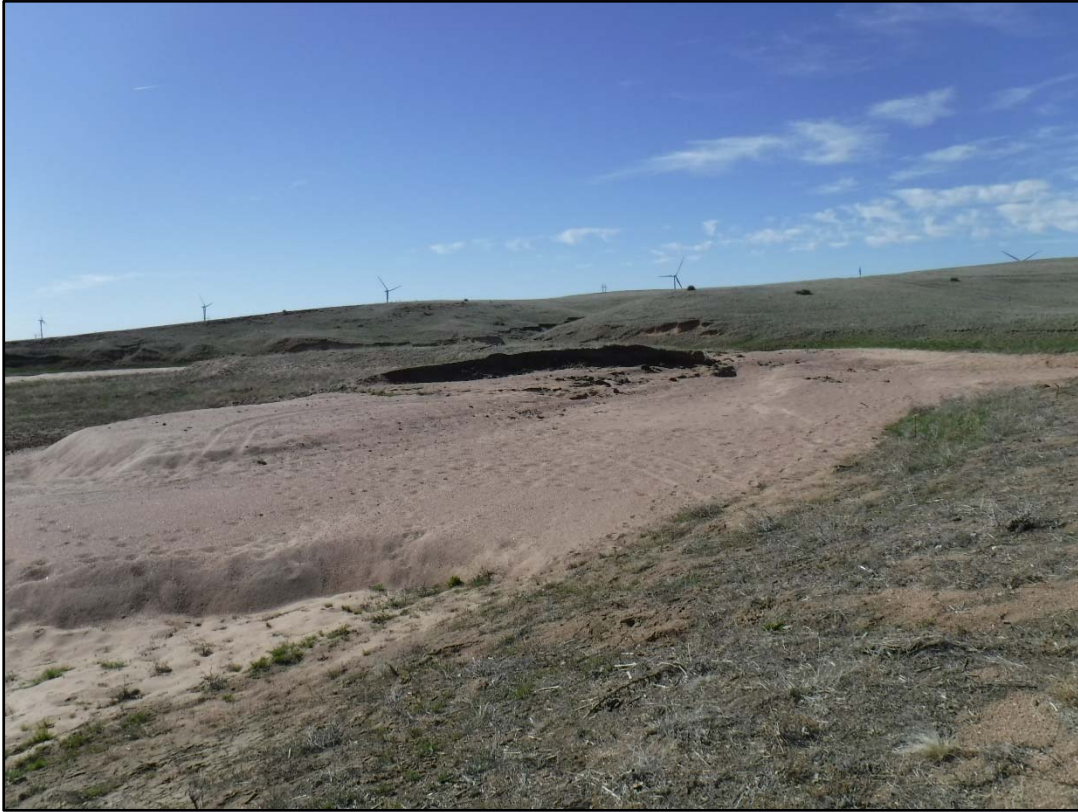
Photo 7: Pit area looking to the south

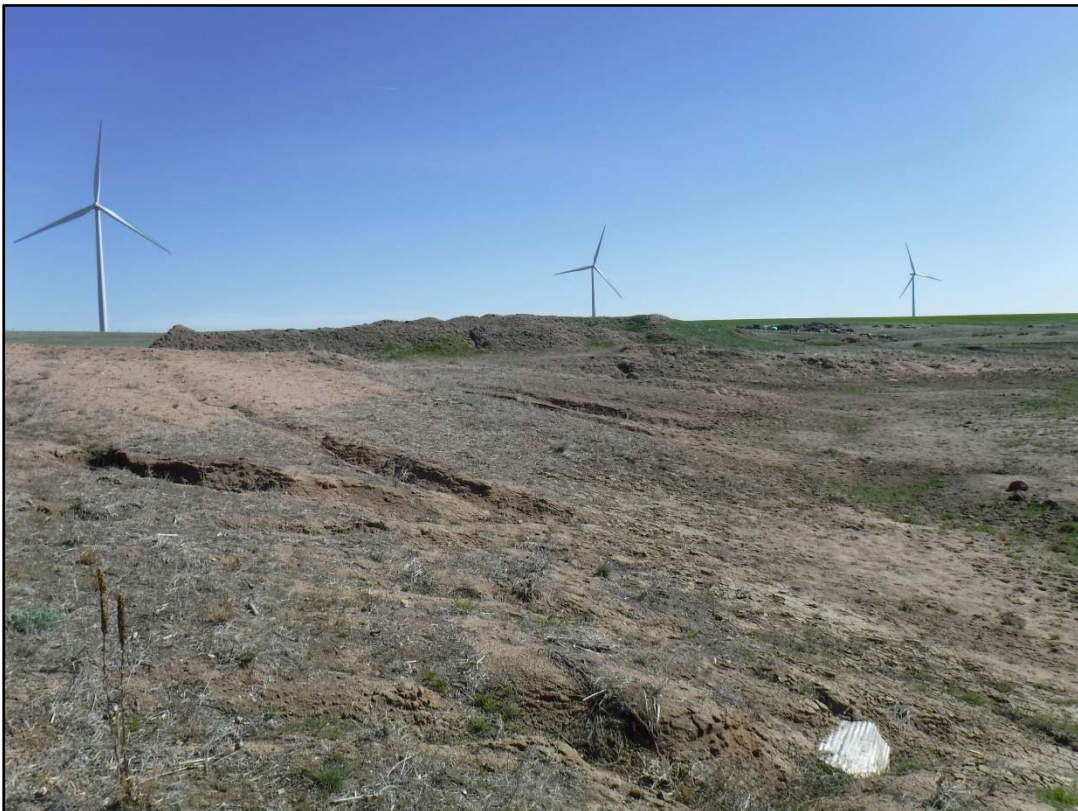
Photo 8: Erosion features along the northern mined area
