MINERALS PROGRAM INSPECTION REPORT**PHONE: (303) 866-3567**

MINE NAME: Higgins Pit II	MINE/PROSPECTING ID#: M-2012-013	MINERAL: Borrow material	COUNTY: Lincoln
INSPECTION TYPE: Preoperation Inspection	INSPECTOR(S): Patrick Lennberg	INSP. DATE: April 26, 2019	INSP. TIME: 07:00
OPERATOR: Smithburg Family Partnership, LLLP	OPERATOR REPRESENTATIVE: None	TYPE OF OPERATION: 112c - Construction Regular Operation

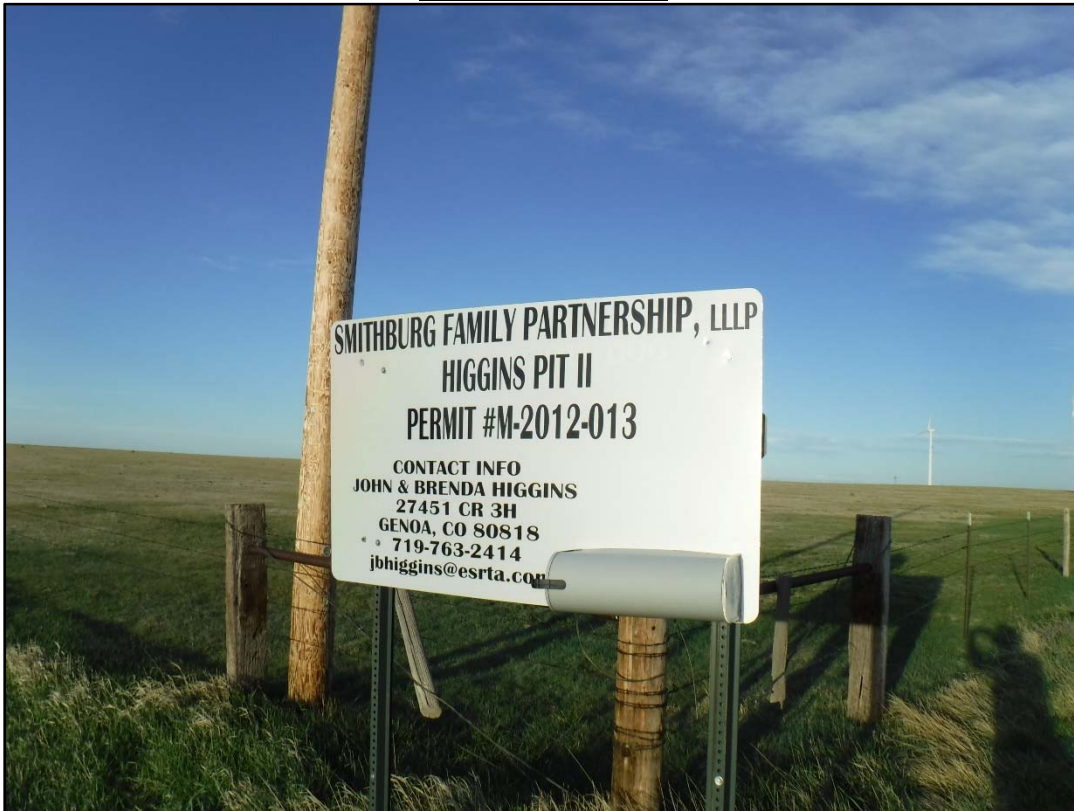
The Higgins Pit II is located 2.5 miles north of Genoa, CO off of Co Rd 28. The pit is a 112c operation is currently permitted for 52.66 acres for the removal of sand and gravel. AM-02 would expand the permit to a total of 70.52 acres. The site is surrounded by pastureland and the post-mining land use is pastureland. A mine sign was observed as required by Rule 3.1.12.

Photo 1: Mine sign at entrance off of County Road 28

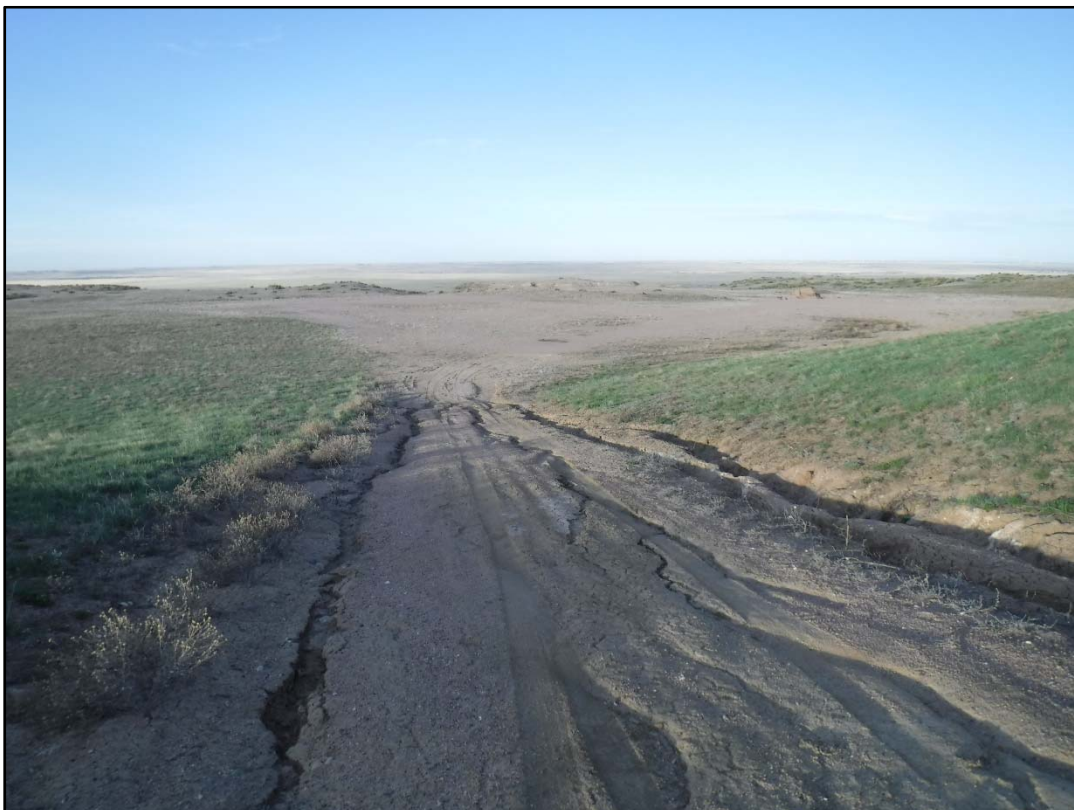
Photo 2: Access road to current pit area

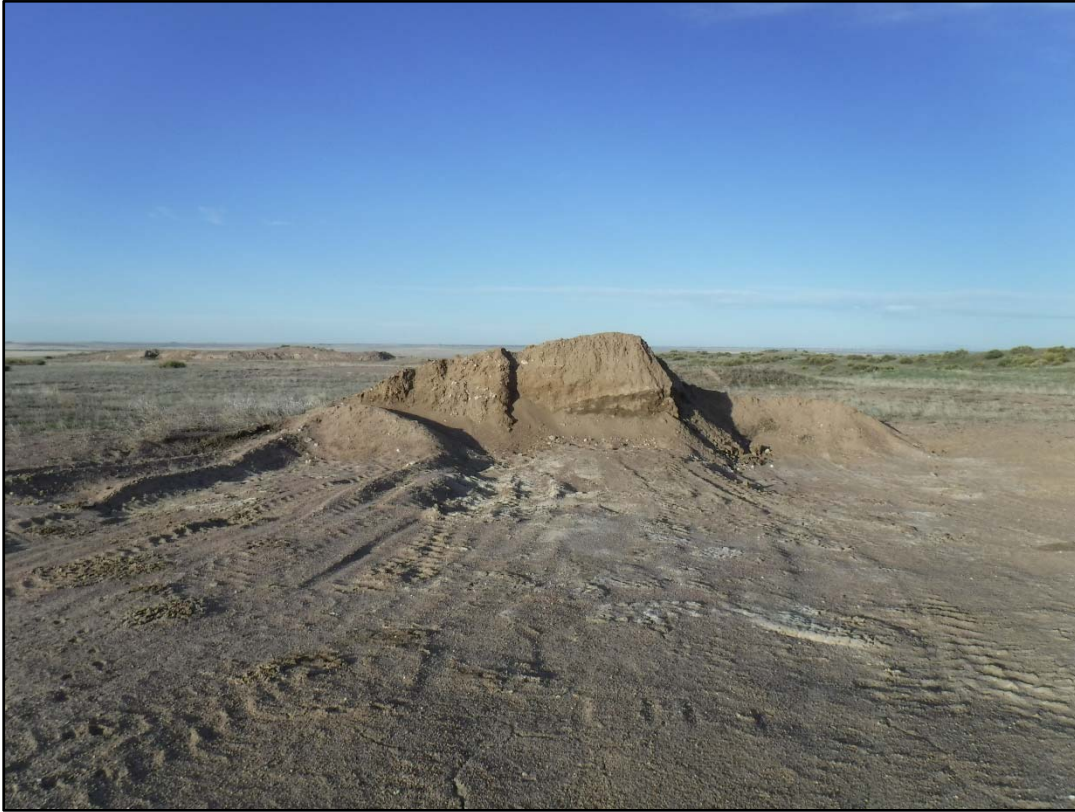
Photo 3: Product stockpile

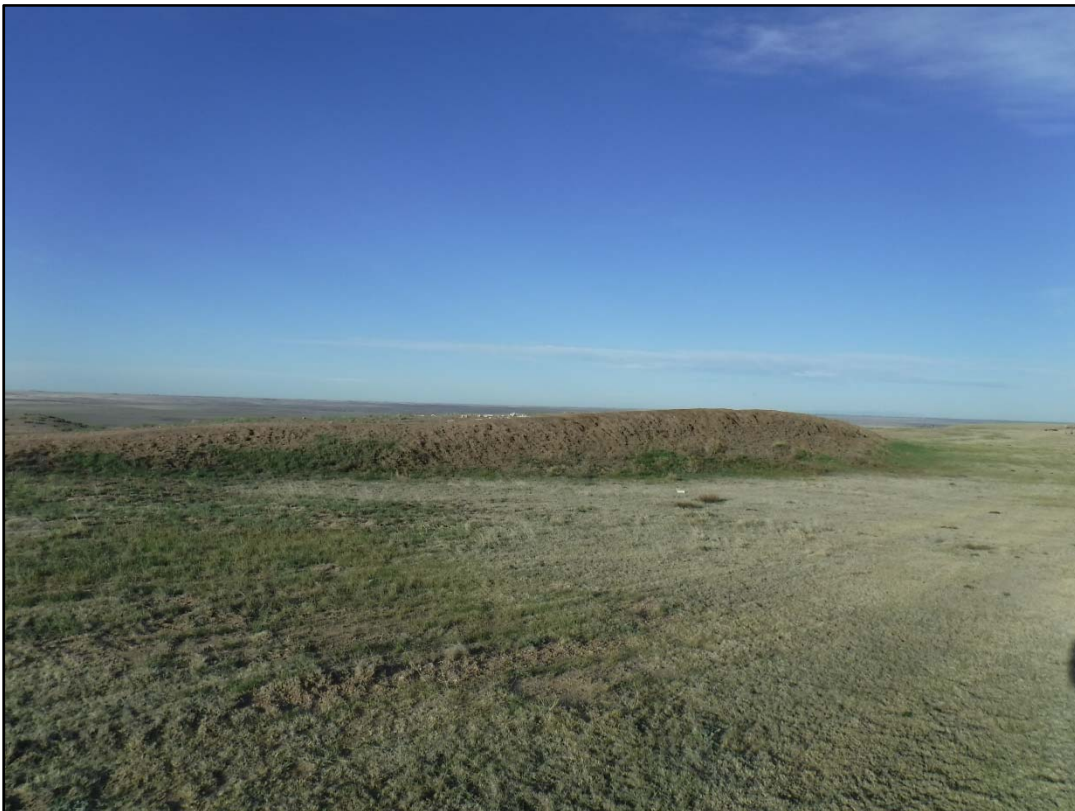
Photo 4: Topsoil stockpile along the northern permit boundary

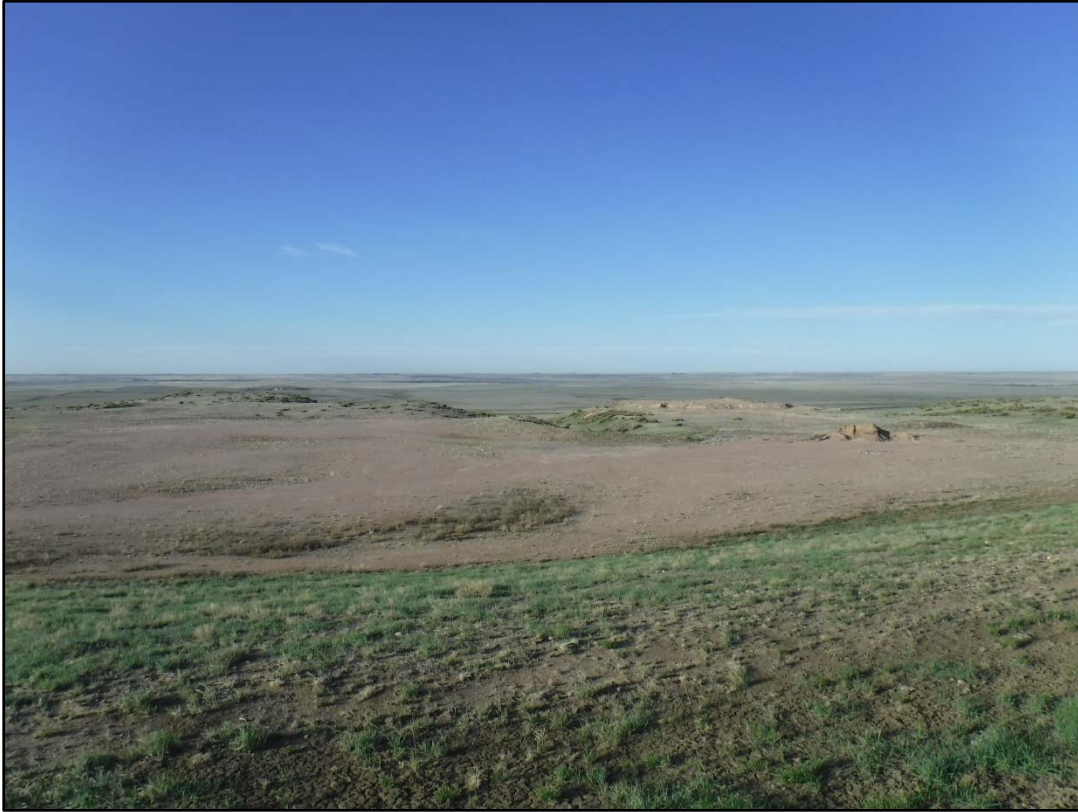
Photo 5: Looking to the south across the current pit area

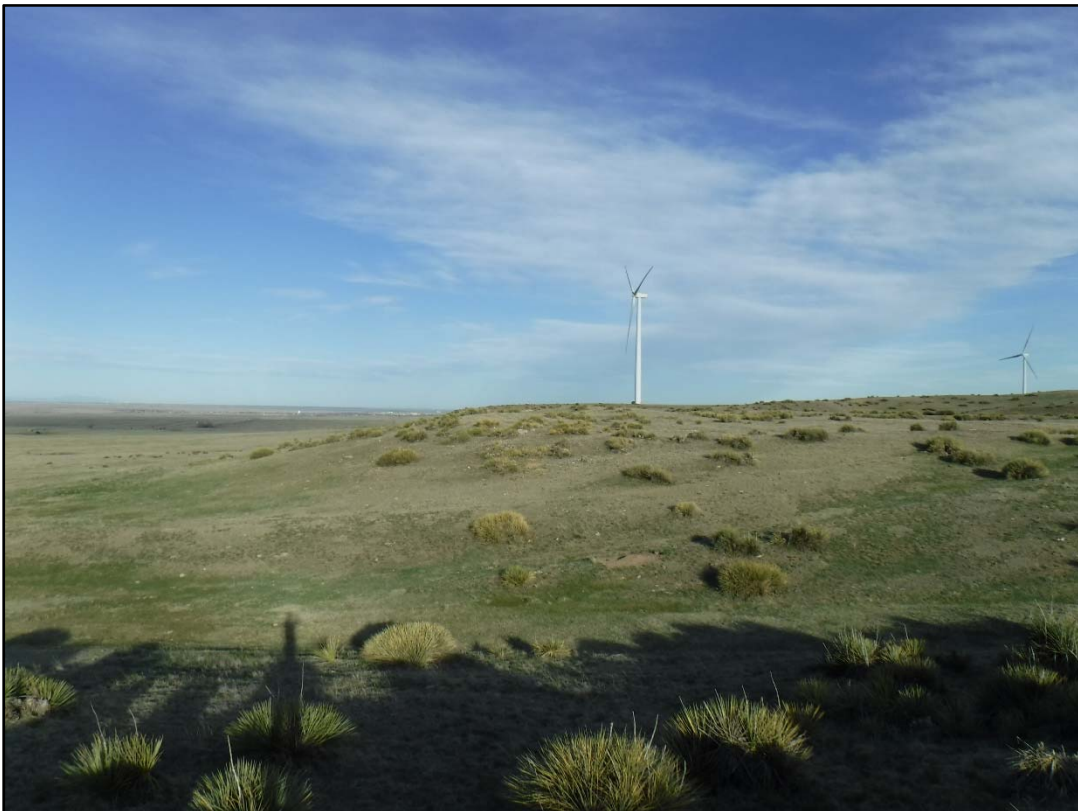
Photo 6: Looking west from the current permit boundary at the amendment area

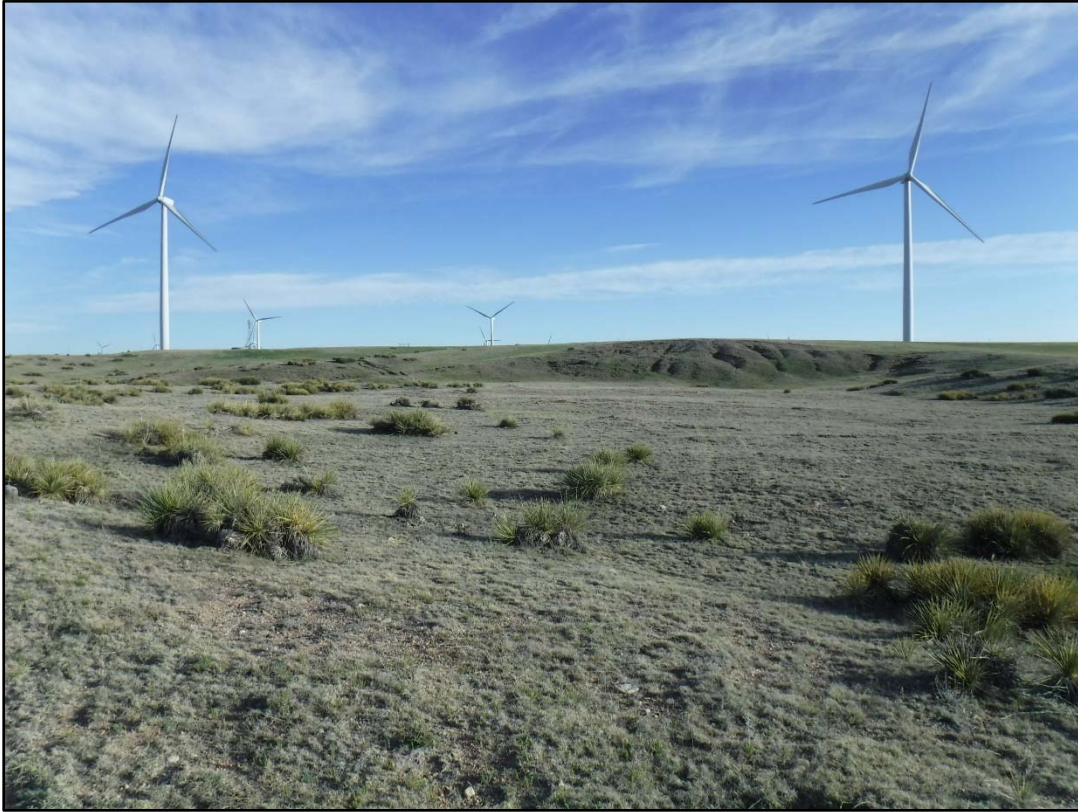
Photo 7: Proposed amendment area looking north

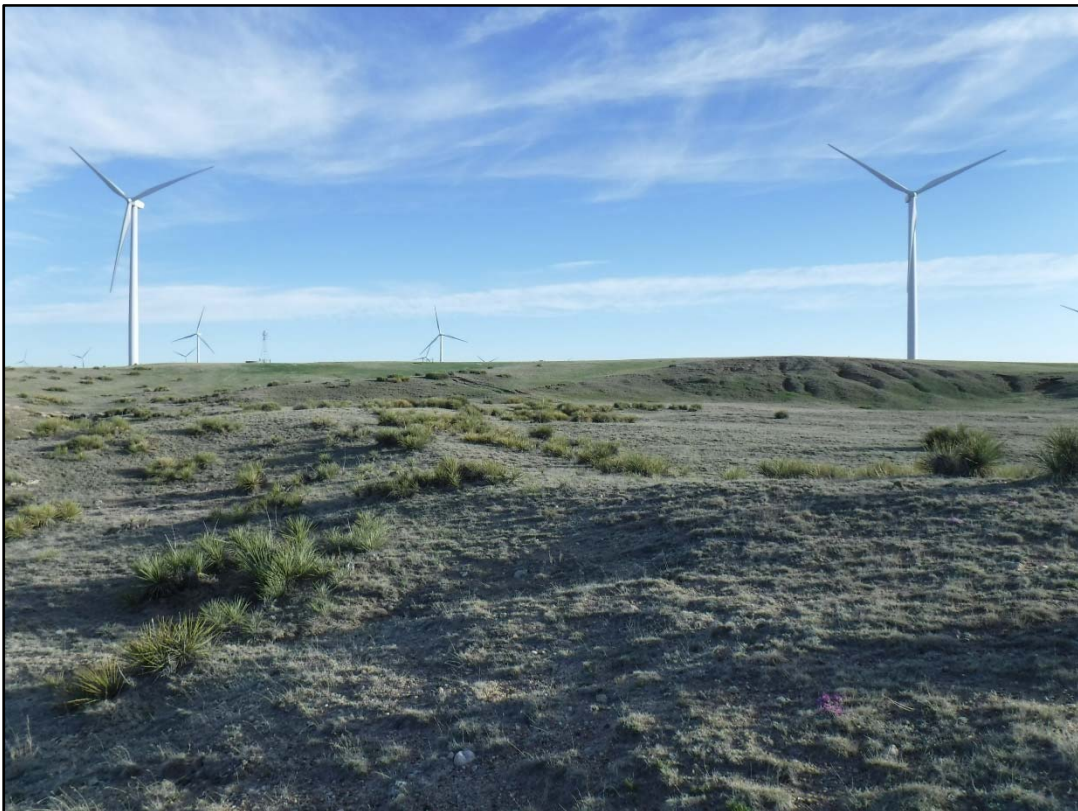
Photo 8: Proposed amendment area looking northeast

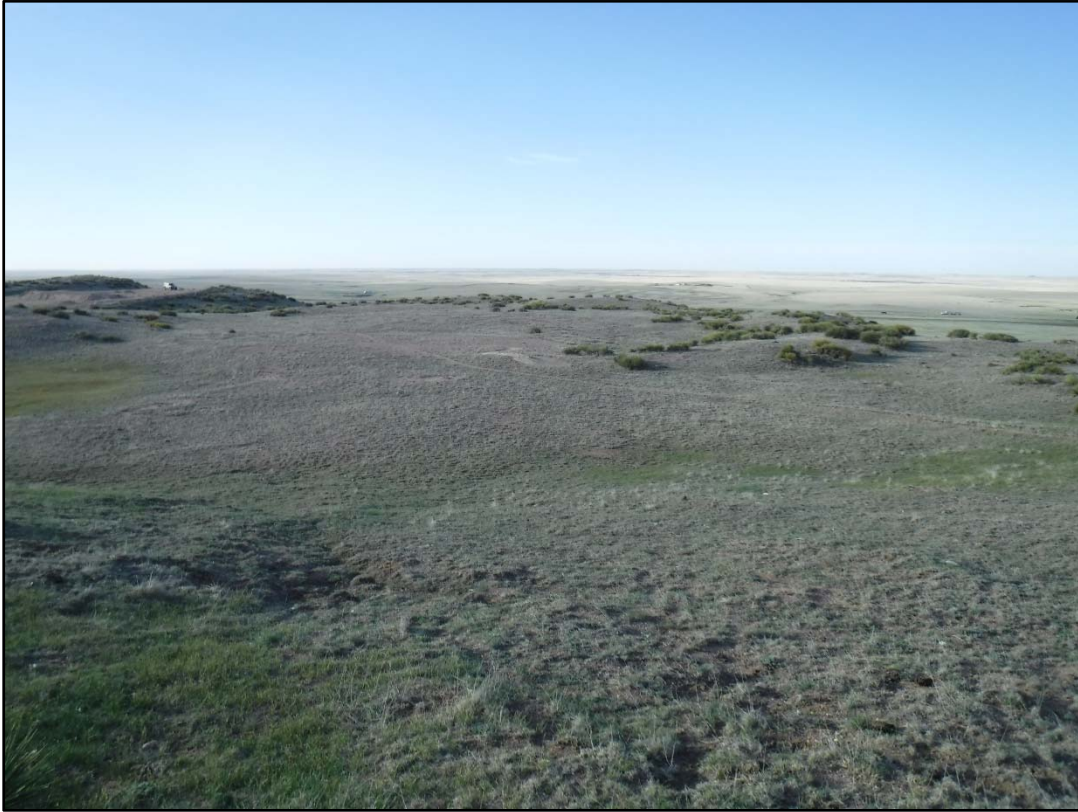
Photo 9: Proposed amendment area looking southeast

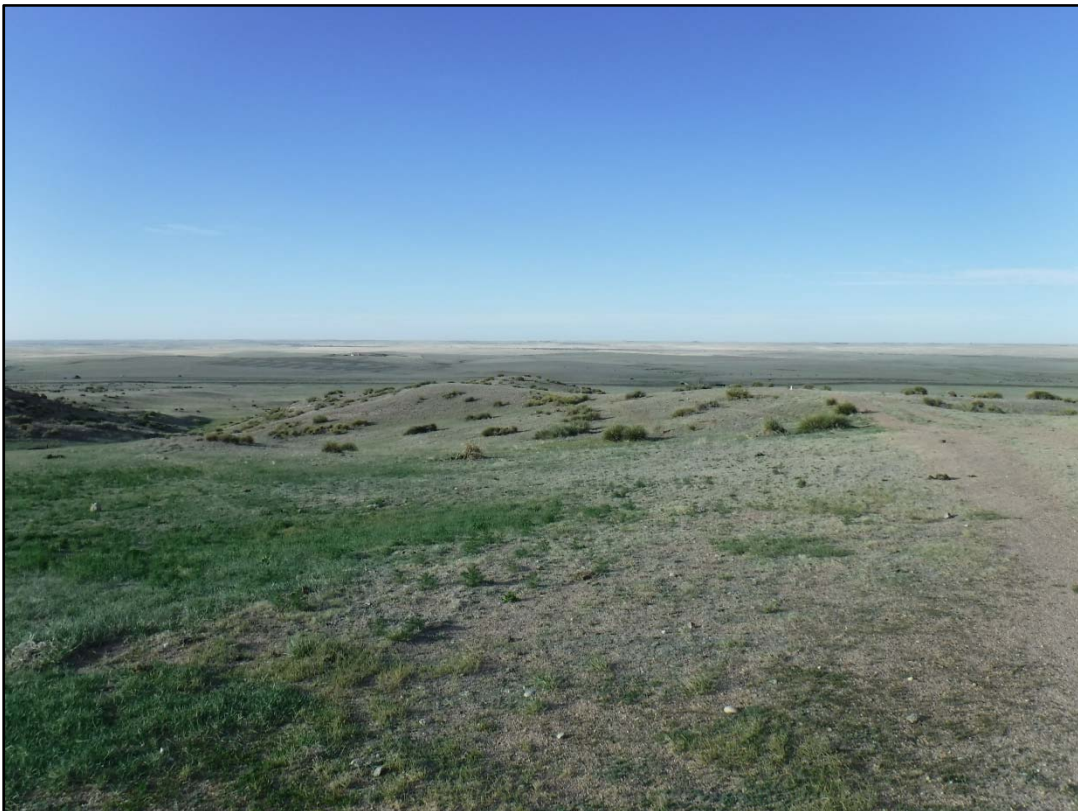
Photo 10: Proposed amendment area looking south along the proposed western boundary
