**MINERALS PROGRAM INSPECTION REPORT**  
**PHONE: (303) 866-3567**

<b>MINE NAME:</b> Newsom Pit	<b>MINE/PROSPECTING ID#:</b> M-2010-083	<b>MINERAL:</b> Sand and gravel	<b>COUNTY:</b> Lincoln
<b>INSPECTION TYPE:</b> Monitoring	<b>INSPECTOR(S):</b> Patrick Lennberg	<b>INSP. DATE:</b> April 26, 2019	<b>INSP. TIME:</b> 11:00
<b>OPERATOR:</b> Lincoln County	<b>OPERATOR REPRESENTATIVE:</b> Fred Lundy	<b>TYPE OF OPERATION:</b> 110c - Construction Limited Impact	
<b>REASON FOR INSPECTION:</b> Normal I&E Program	<b>BOND CALCULATION TYPE:</b> None	<b>BOND AMOUNT:</b> \$0.00	
<b>DATE OF COMPLAINT:</b> NA	<b>POST INSP. CONTACTS:</b> None	<b>JOINT INSP. AGENCY:</b> None	
<b>WEATHER:</b> Clear	<b>INSPECTOR'S SIGNATURE:</b>

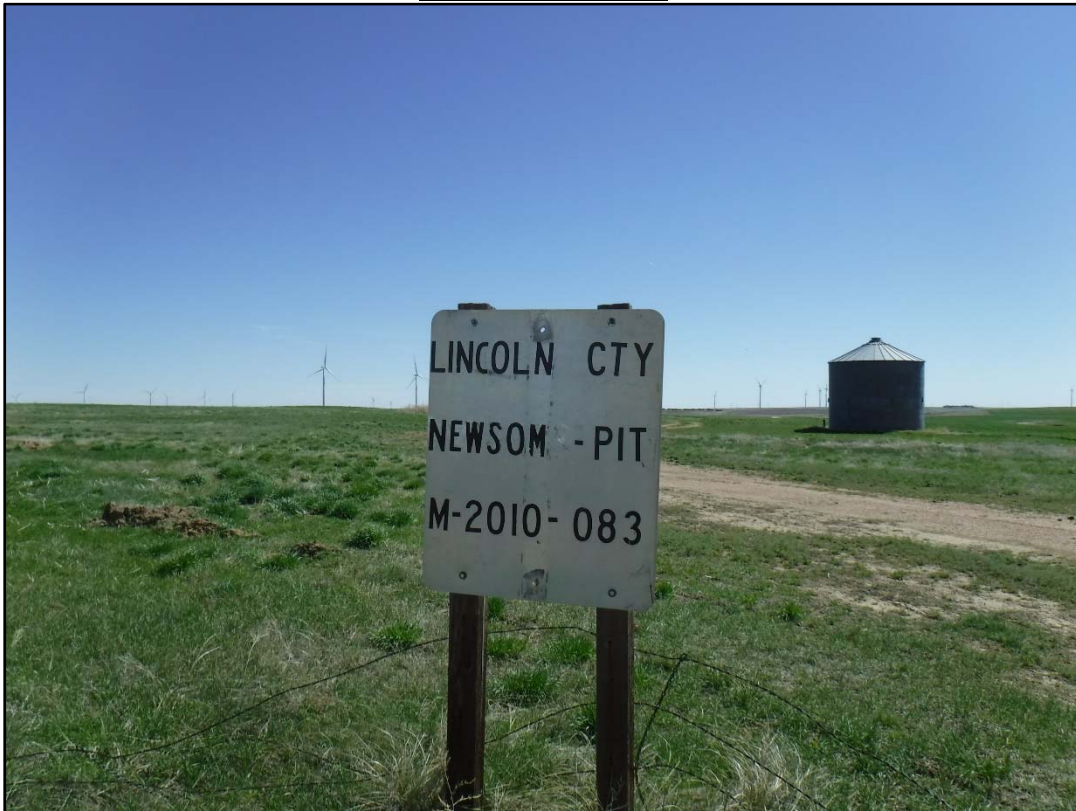
The Newsom Pit is located 13 miles northeast of Limon, CO off of Co Rd 24. The pit is situated on the Arikaree River, which only flows during heavy storm events. When carrying water, the creek flows eastward. The pit is a 110c operation permitted for 9.43 acres for the removal of sand and gravel for county road maintenance and repair. The site is surrounded by rangeland and the post-mining land use is rangeland. A mine sign was observed as required by Rule 3.1.12.

**Photo 1:** Mine sign at entrance off of County Road 24

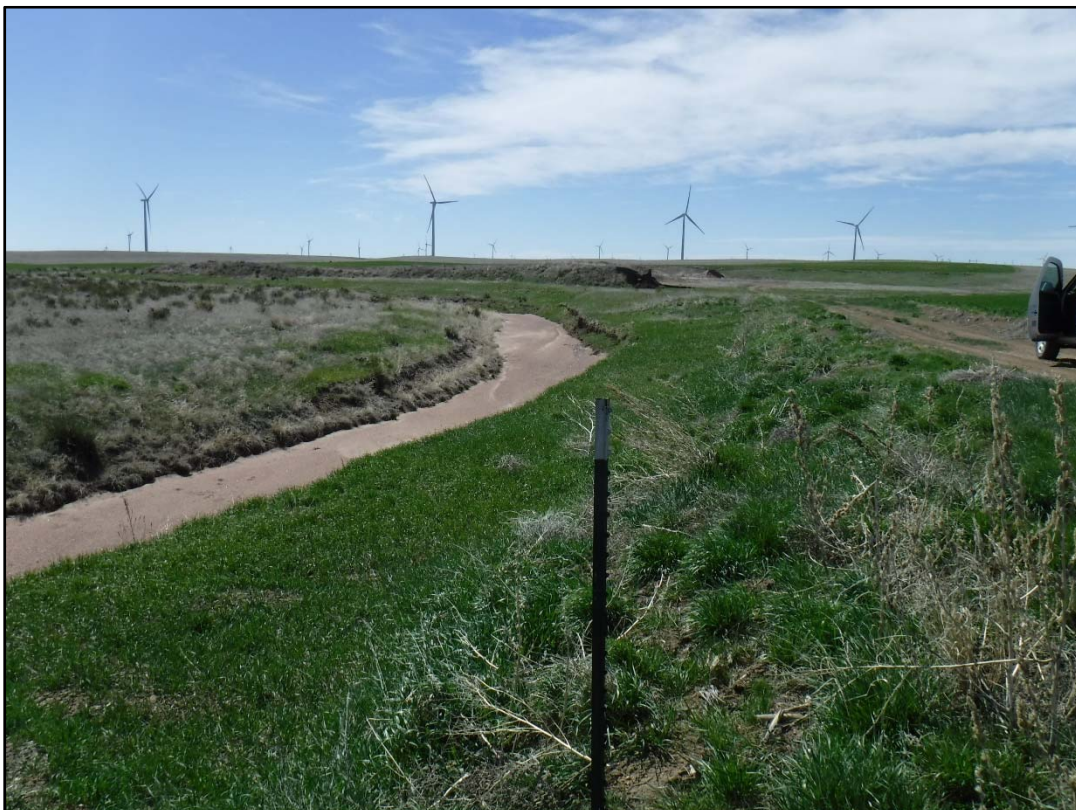
The Division was able to GPS all permit boundary markers. All current mining is within the permit boundaries.

**Photo 2:** Typical boundary marker, topsoil stockpile center background of photo

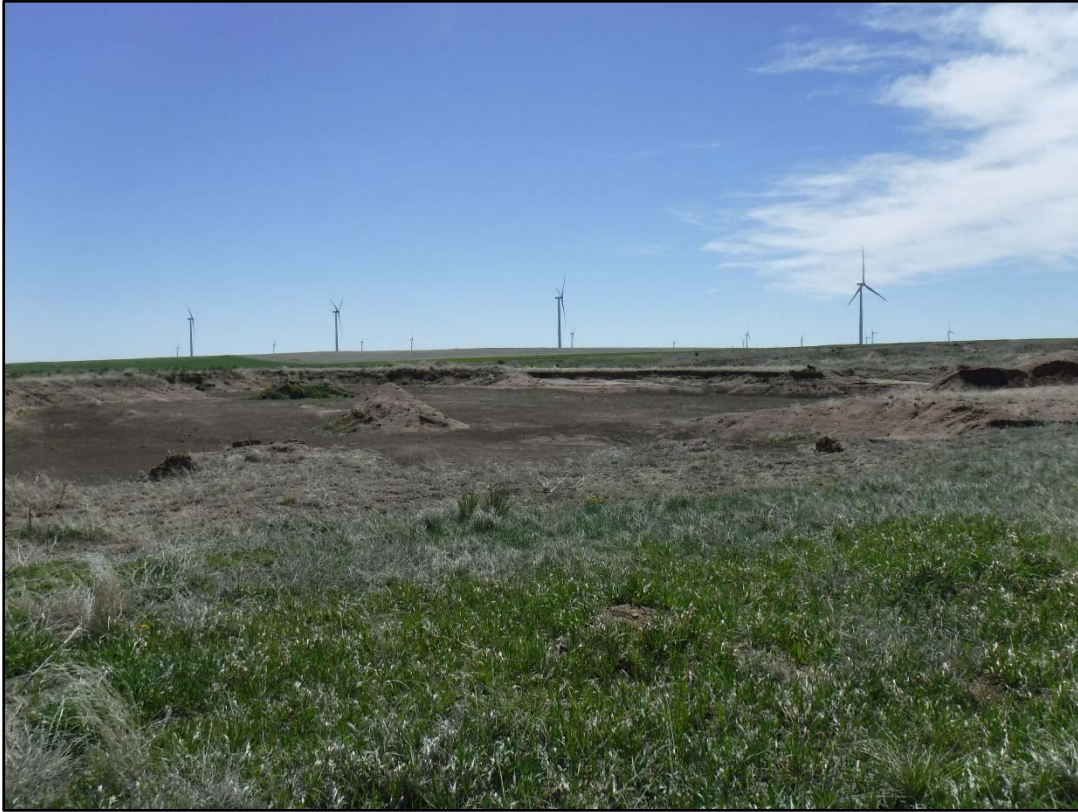
**Photo 3:** Looking southeast across the pit area

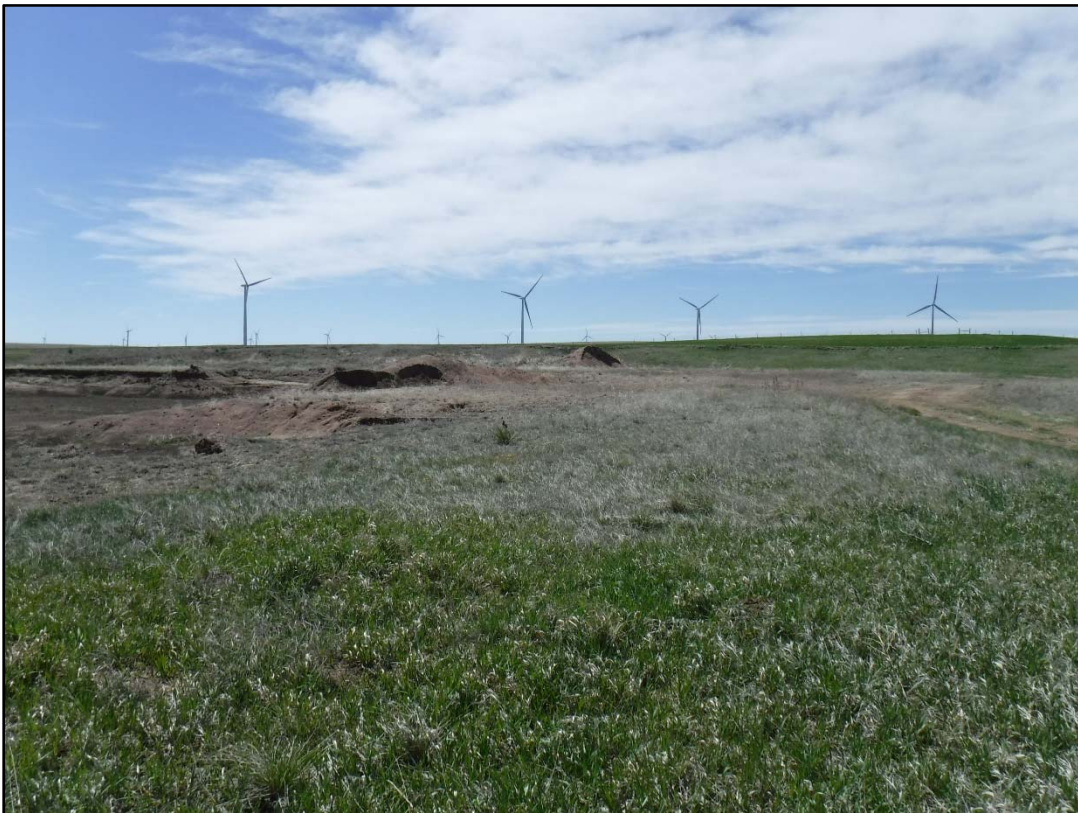
The site was not active during the inspection. However, the county extracts and/or hauls material off site every year, which is in compliance with its intermittent status. The river was dry during the inspection. A material stockpile was stored in the western pit area and appeared to be stable. Another gravel stockpile was stored south of the first stockpile. This stockpile may remain after reclamation for use by the landowner. A topsoil stockpile was stored along the northern edge of the pit, and appeared to be stable with vegetative cover. The pit had an average depth of approximately 5 feet, with slopes of mainly 3H:1V or flatter, except for some portions which had slopes of approximately 2H:1V. The areas located just east of the pit and the northern portion of the permit area (located north of the river) have been undisturbed by mining activities. The riverbed and banks appeared to be stable.

**Photo 4:** Material stockpiles, the one in the background is to be left for property owner

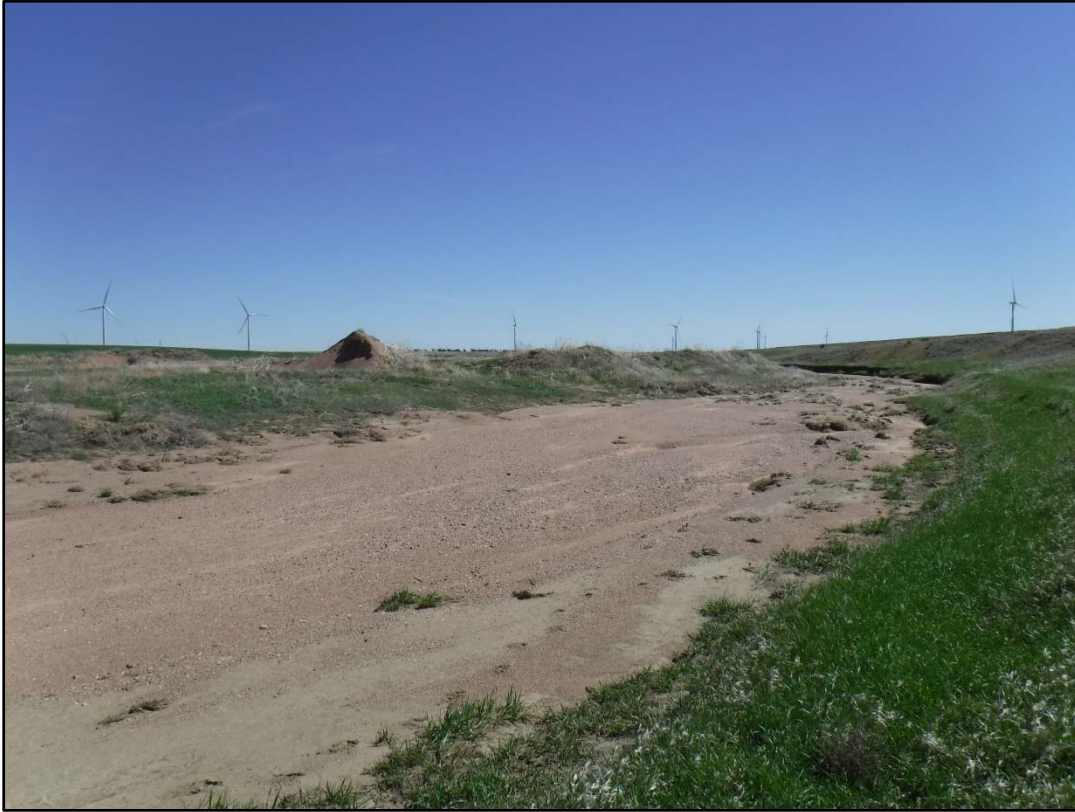
**Photo 5:** Riverbed conditions in the southern portion of permit area

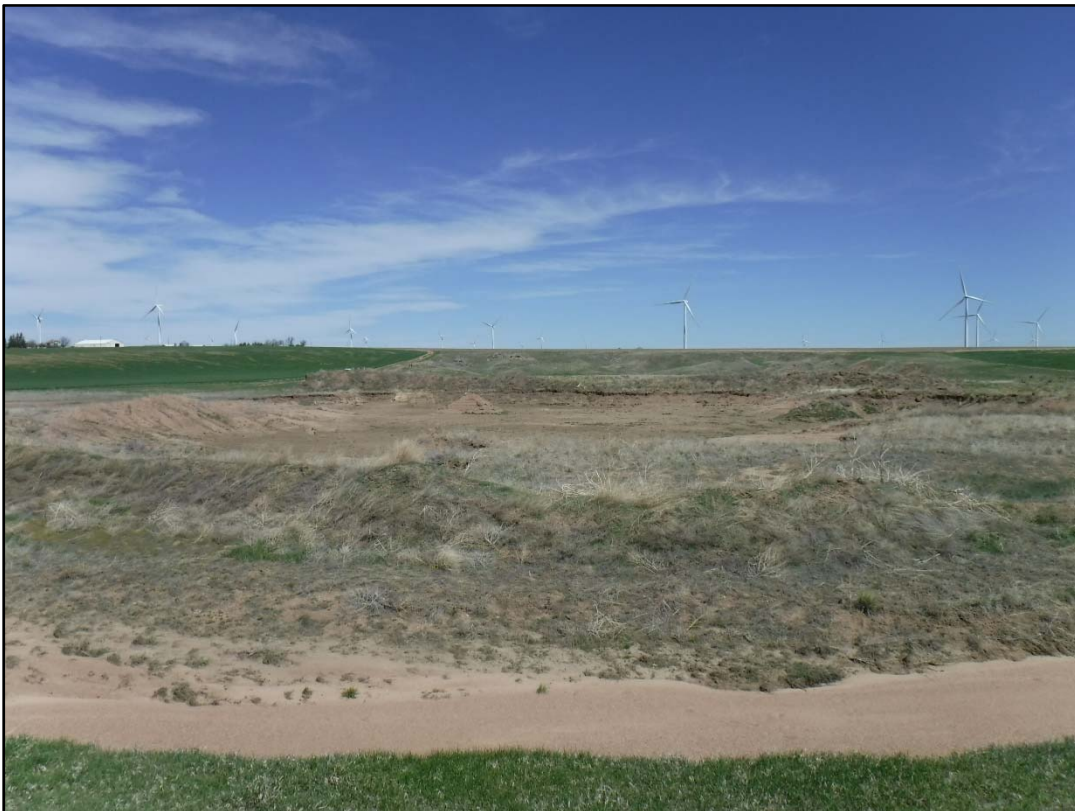
**Photo 6:** Looking north from the southern permit boundary across the pit area

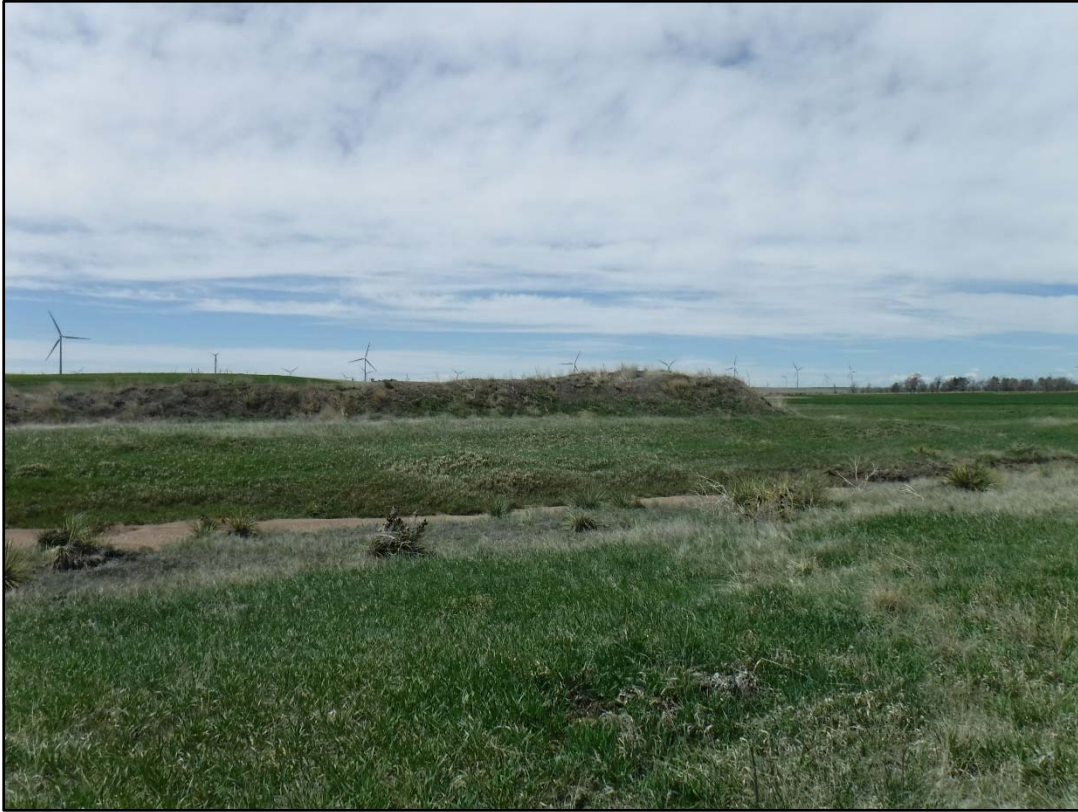
**Photo 7:** North side of the topsoil stockpile

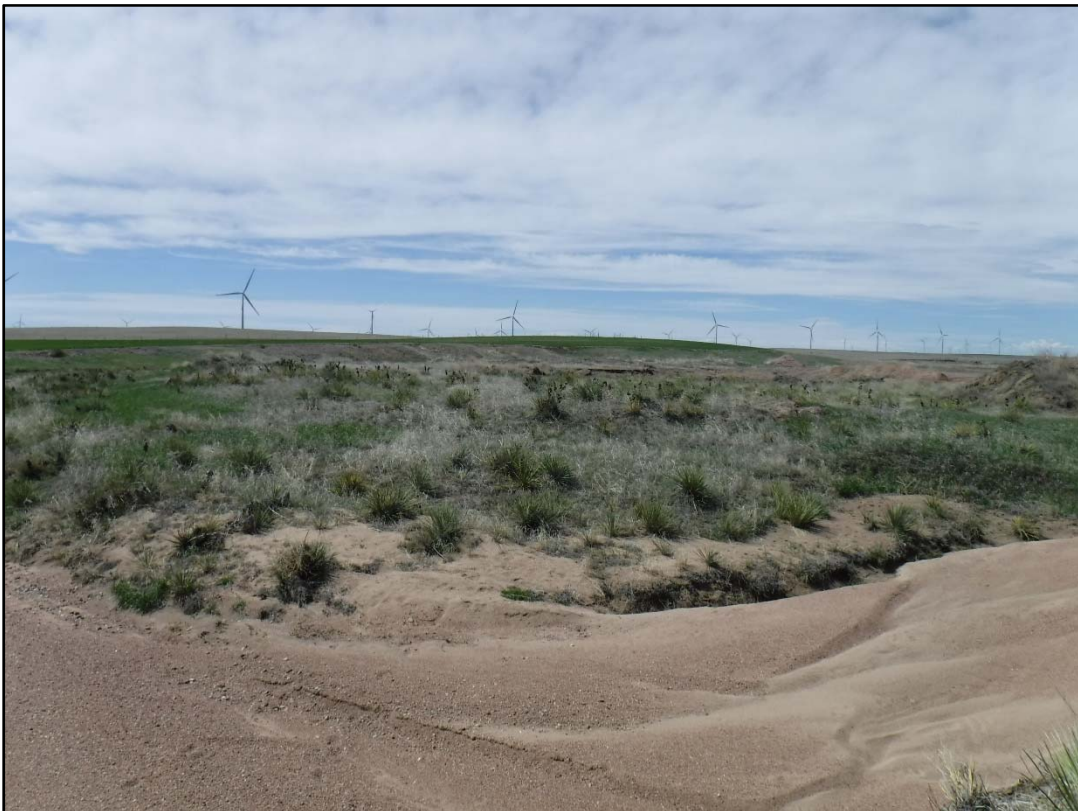
**Photo 8:** Unmined area to the northeast of current pit, riverbed in foreground
