MINERALS PROGRAM INSPECTION REPORT
PHONE: (303) 866-3567

MINE NAME: O'Dwyer	MINE/PROSPECTING ID#: M-2002-017	MINERAL: Sand and gravel	COUNTY: Lincoln
INSPECTION TYPE: Monitoring	INSPECTOR(S): Patrick Lennberg	INSP. DATE: April 26, 2019	INSP. TIME: 09:55
OPERATOR: Lincoln County	OPERATOR REPRESENTATIVE: Fred Lundy	TYPE OF OPERATION: 110c - Construction Limited Impact	
REASON FOR INSPECTION: Normal I&E Program	BOND CALCULATION TYPE: None	BOND AMOUNT: \$0.00	
DATE OF COMPLAINT: NA	POST INSP. CONTACTS: None	JOINT INSP. AGENCY: None	
WEATHER: Clear	INSPECTOR'S SIGNATURE:

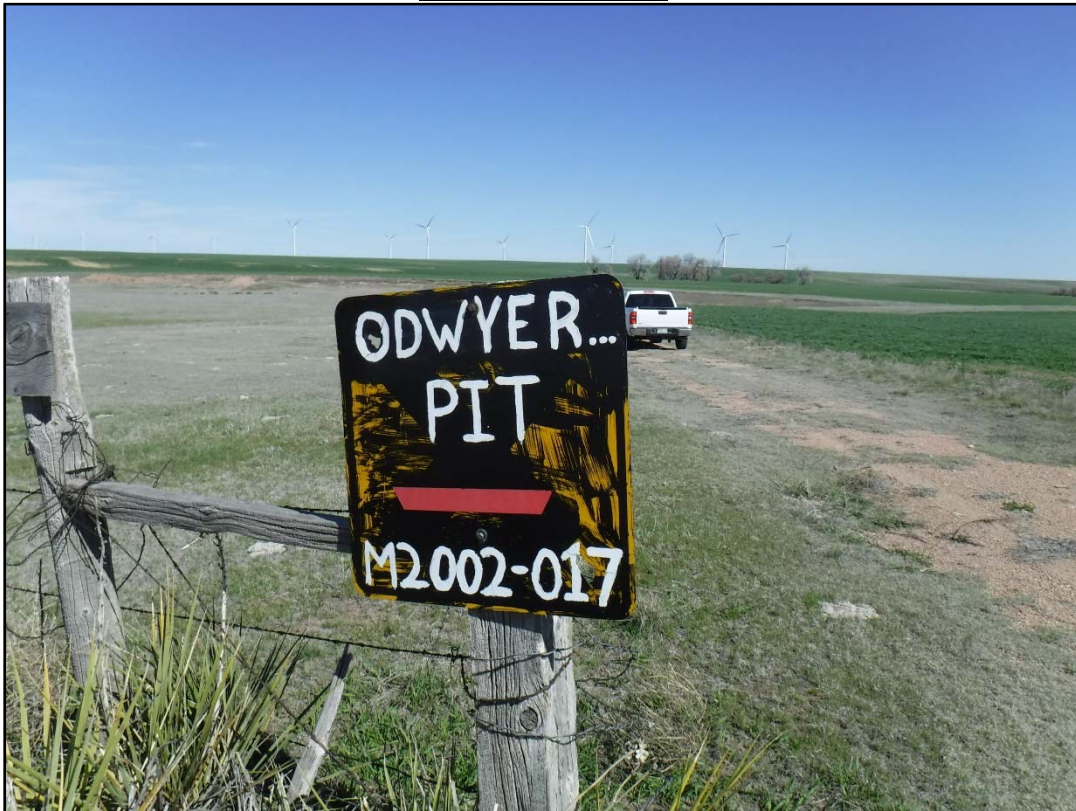
Photo 1: Mine sign at entrance off of County Road 3t

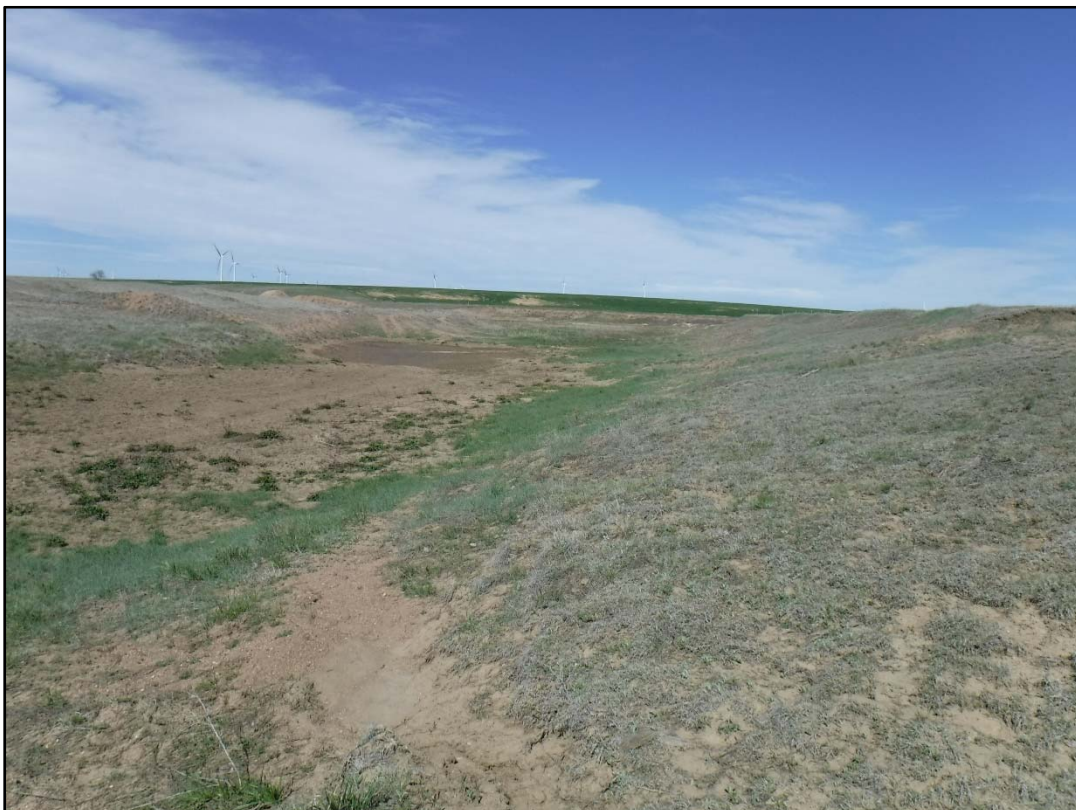
Photo 2: A view to the west from the eastern portion across the mining area

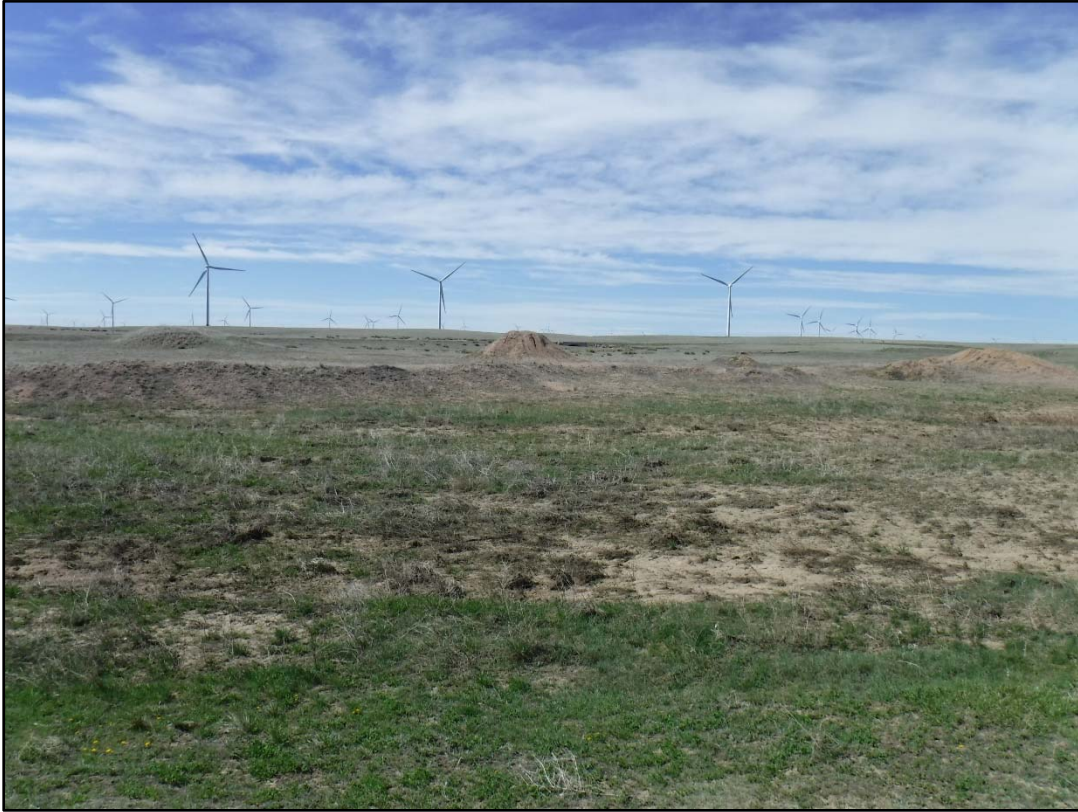
Photo 3: A view to the south from the riverbed with product and topsoil stockpiles

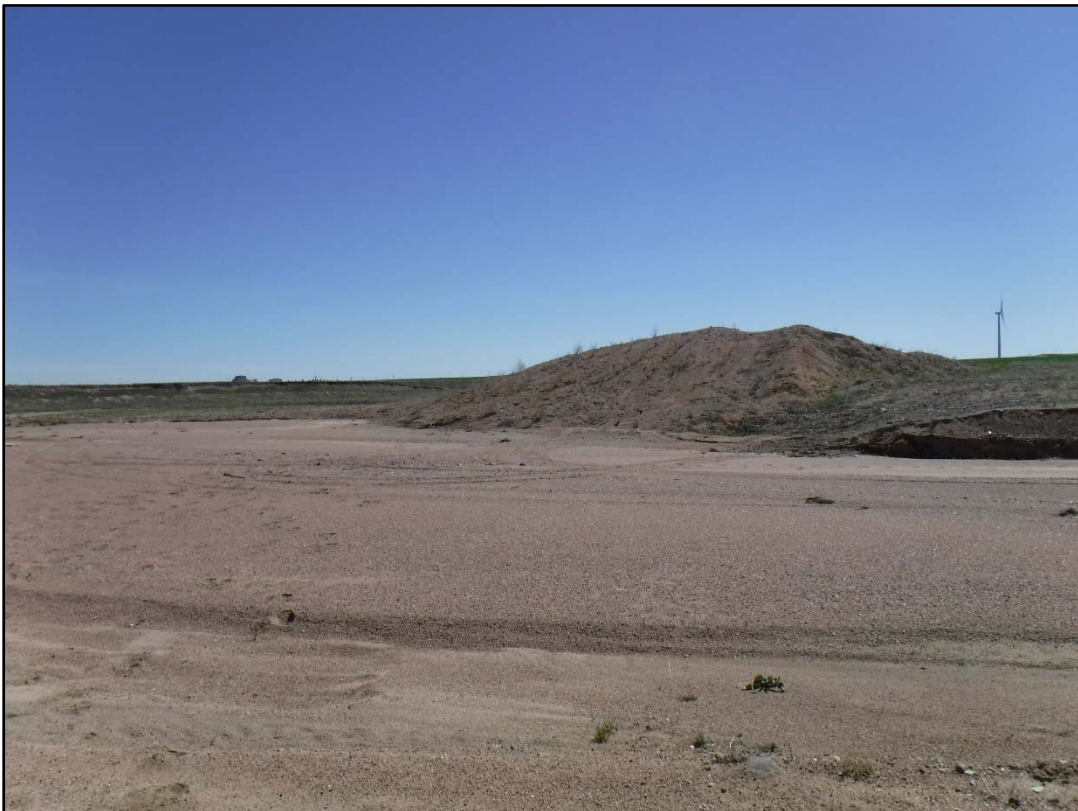
Photo 4: Product stockpile near the southwestern corner of permit adjacent to the riverbed

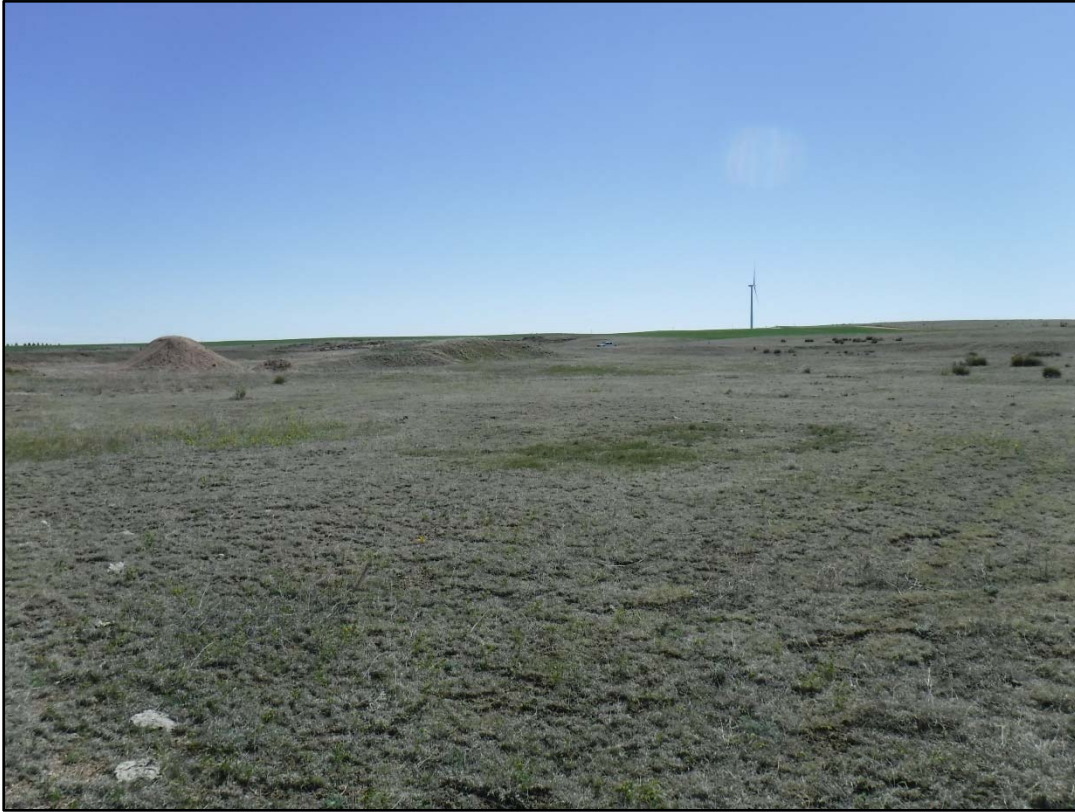
Photo 5: Topsoil stockpile center left of picture

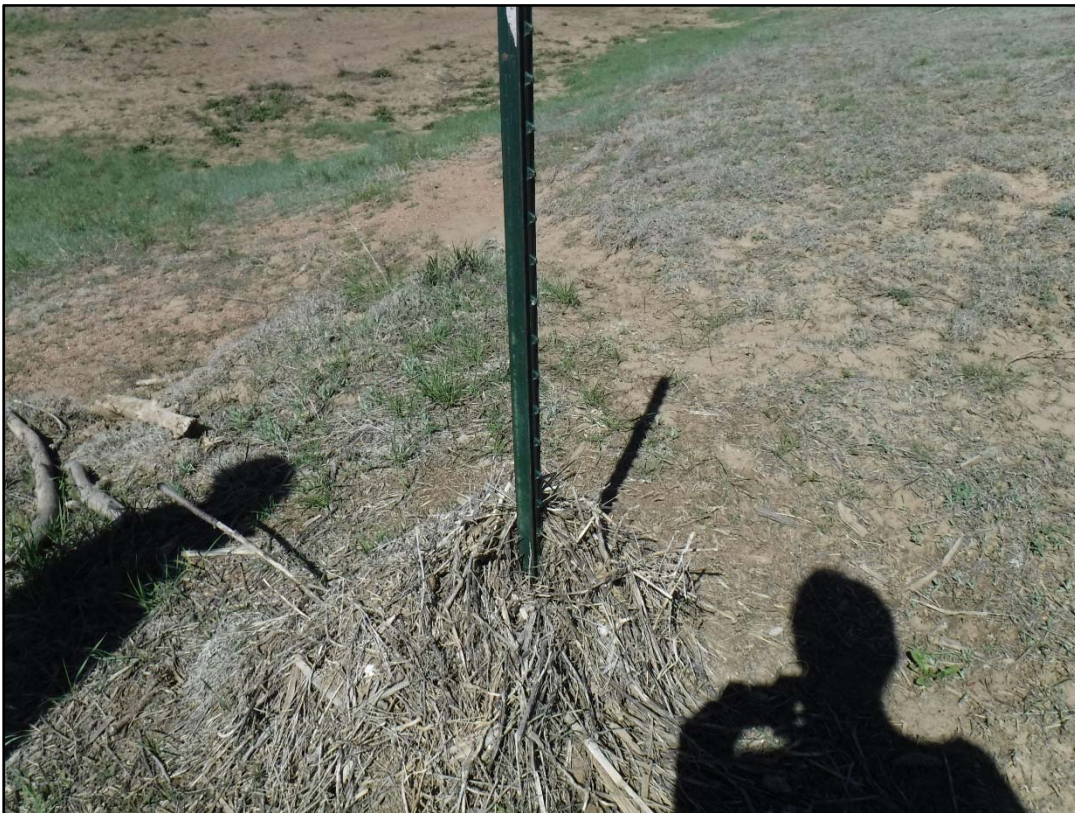
Photo 6: Boundary marker with flow debris around the base
