MINERALS PROGRAM INSPECTION REPORT
PHONE: (303) 866-3567

MINE NAME: Goss Sand & Gravel	MINE/PROSPECTING ID#: M-1985-140	MINERAL: Sand and gravel	COUNTY: El Paso
INSPECTION TYPE: Monitoring	INSPECTOR(S): Timothy A. Cazier	INSP. DATE: March 29, 2019	INSP. TIME: 12:30
OPERATOR: David Goss	OPERATOR REPRESENTATIVE: Dean Goss	TYPE OF OPERATION: 110c - Construction Limited Impact

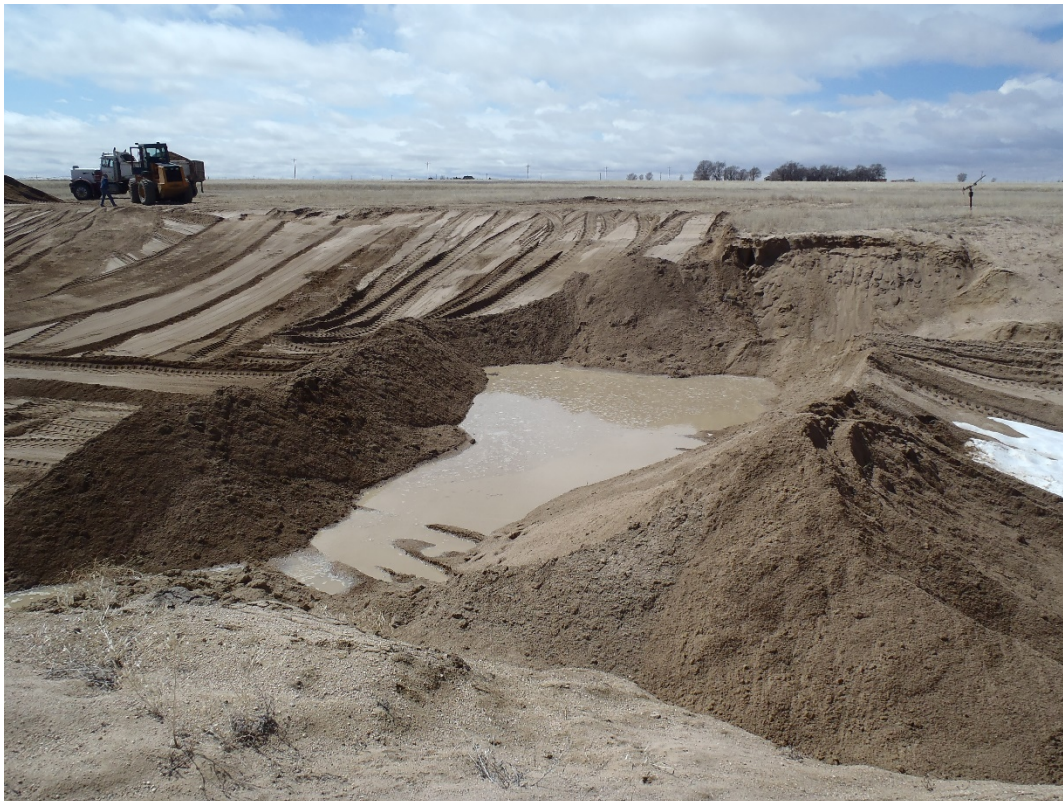
Hydrologic Balance: A small amount of standing water was observed in the 6 to 8 foot deep pit (see **Photo 1**). This was thought to be snowmelt from the recent storm as groundwater is thought to be 5 to 10 feet below the pit bottom. Mr. Goss pushed material over the small amount of ponded water after pointing it out.

Photo 1. Small amount of water observed in the pit (looking west).

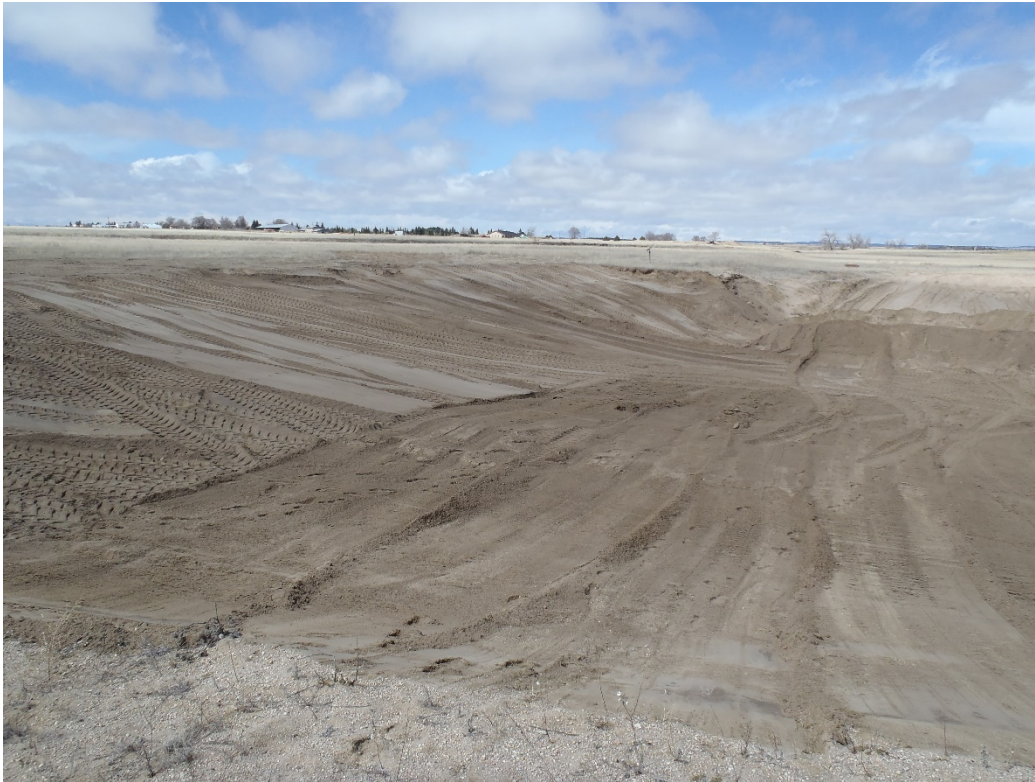
Gen. Compliance with Mine Plan: The operation appeared to be in compliance with the approved mine plan. Google Earth was used to measure the disturbed area, which was estimated to be approximately 0.75 acres, based on 2017 imagery. Highwalls were estimated to vary between 6 and 8 feet in height and appeared stable (see **Photos 2 and 3**).

Photo 2. Stable 6 to 8 foot west side highwalls (looking NW).

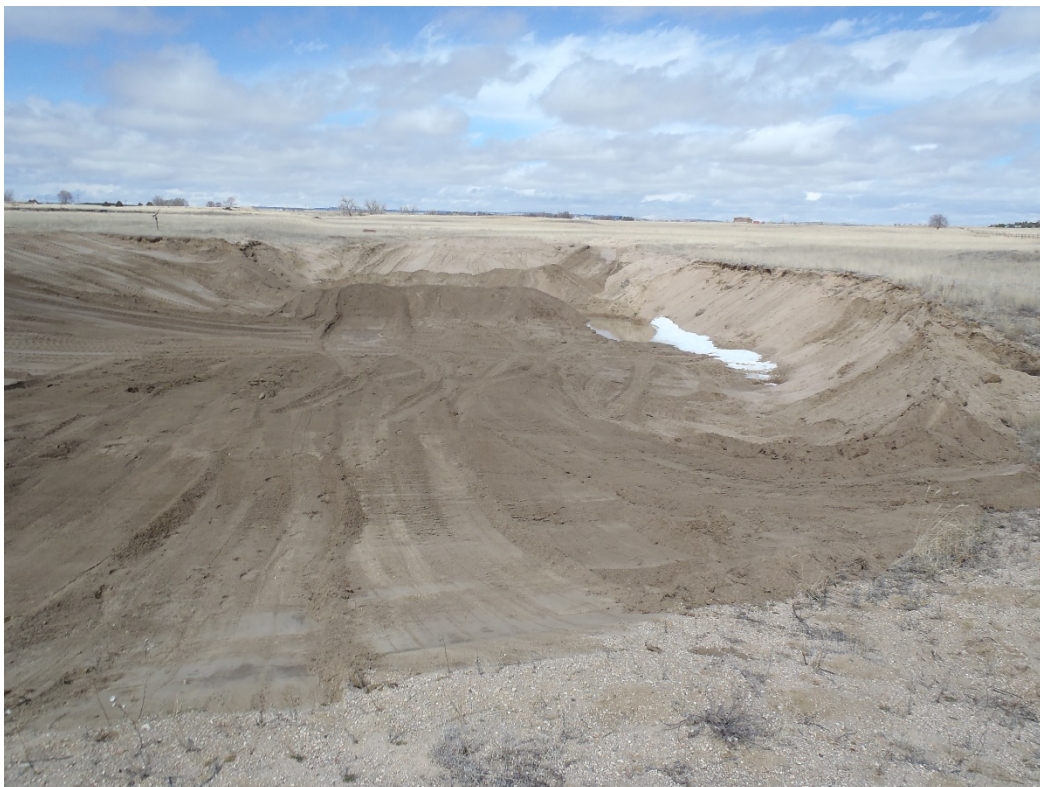
Photo 3. Stable 6 to 8 foot east side highwalls (looking NNW).

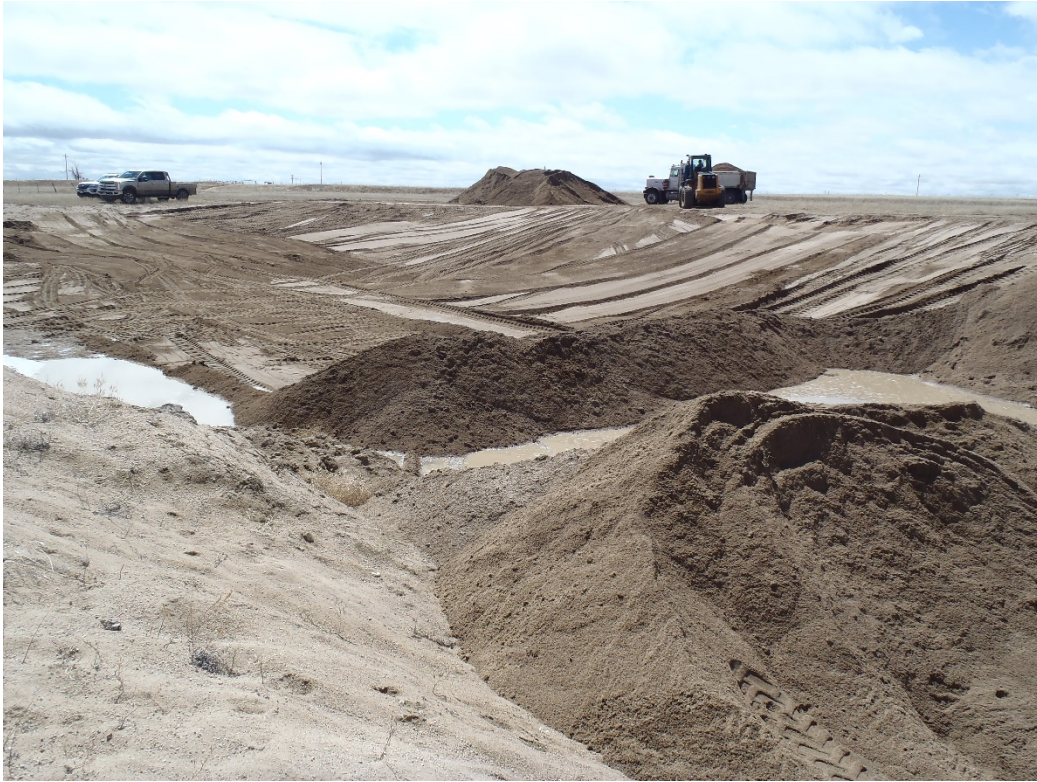
Support Facilities On-site: A loader and dump truck were observed on site (see **Photo 4**).

Photo 4. Loader & dump truck observed during active mining (looking SSW from east side of pit).

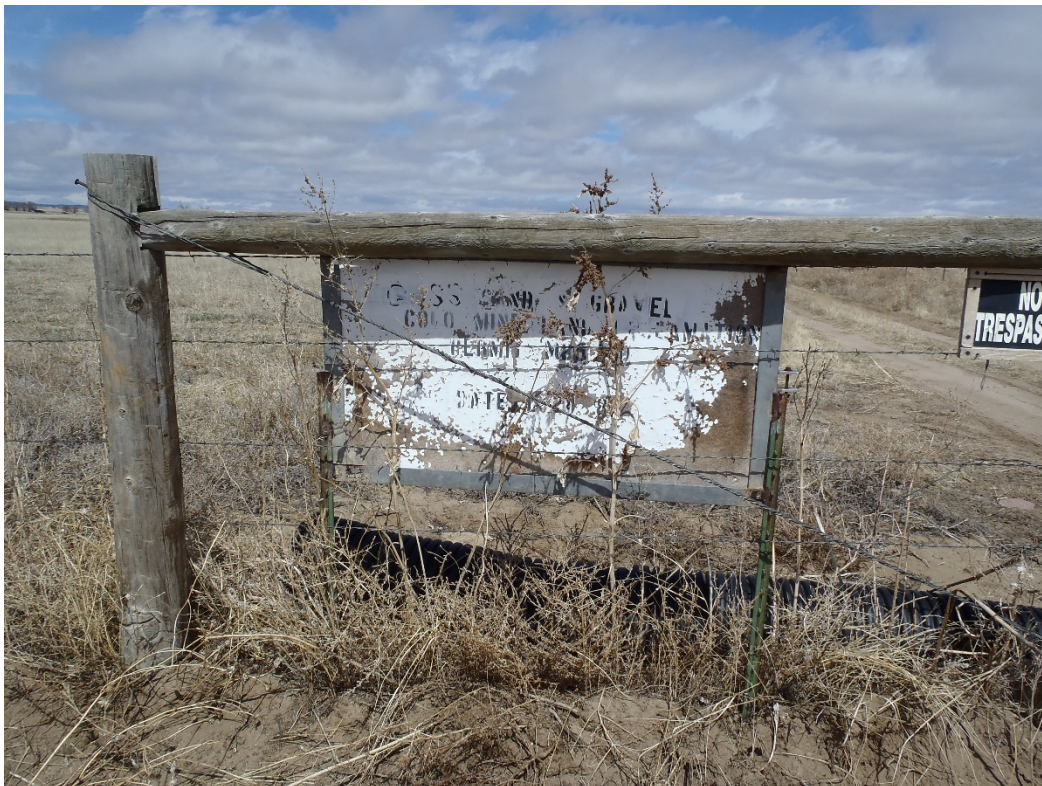
Signs and Markers: The permit sign was properly posted (see **Photo 5**). However, it was partially illegible. [The Permittee should repaint or replace the sign.](#) The east (see **Photo 6**) and south permit boundaries are fenced.

Photo 5. Permit sign at entrance (needs repainting or replacement).

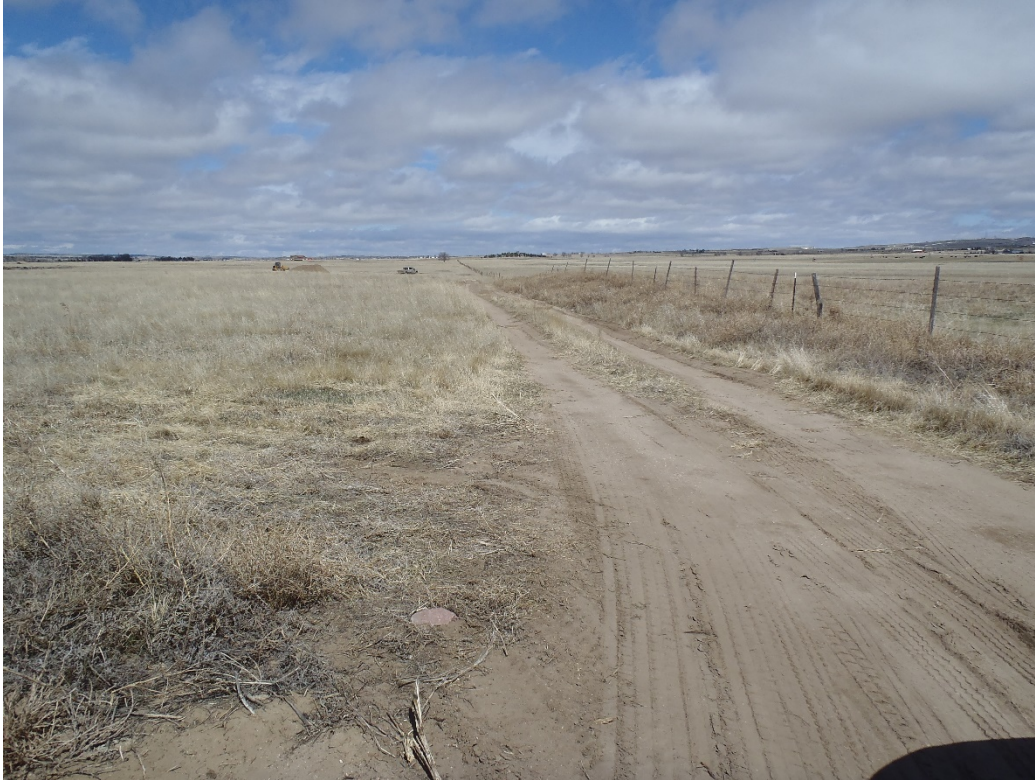
Photo 6. Fenced boundary on east side (looking north from entrance).
