MINERALS PROGRAM INSPECTION REPORT
PHONE: (303) 866-3567

MINE NAME: Hasser Borrow Pit	MINE/PROSPECTING ID#: M-2019-015	MINERAL: Borrow material for construction	COUNTY: Prowers
INSPECTION TYPE: Preoperation Inspection	INSPECTOR(S): Amy Eschberger	INSP. DATE: April 26, 2019	INSP. TIME: 08:45
OPERATOR: Castle Rock Construction Company of Colorado, LLC	OPERATOR REPRESENTATIVE: Darren Janssen	TYPE OF OPERATION: 111c - Construction by Government Agency

CASTLE ROCK CONSTRUCTION
OF COLORADO, LLC
HASSER PIT
MINING PLAN
PROWERS COUNTY, CO
APRIL 16, 2019

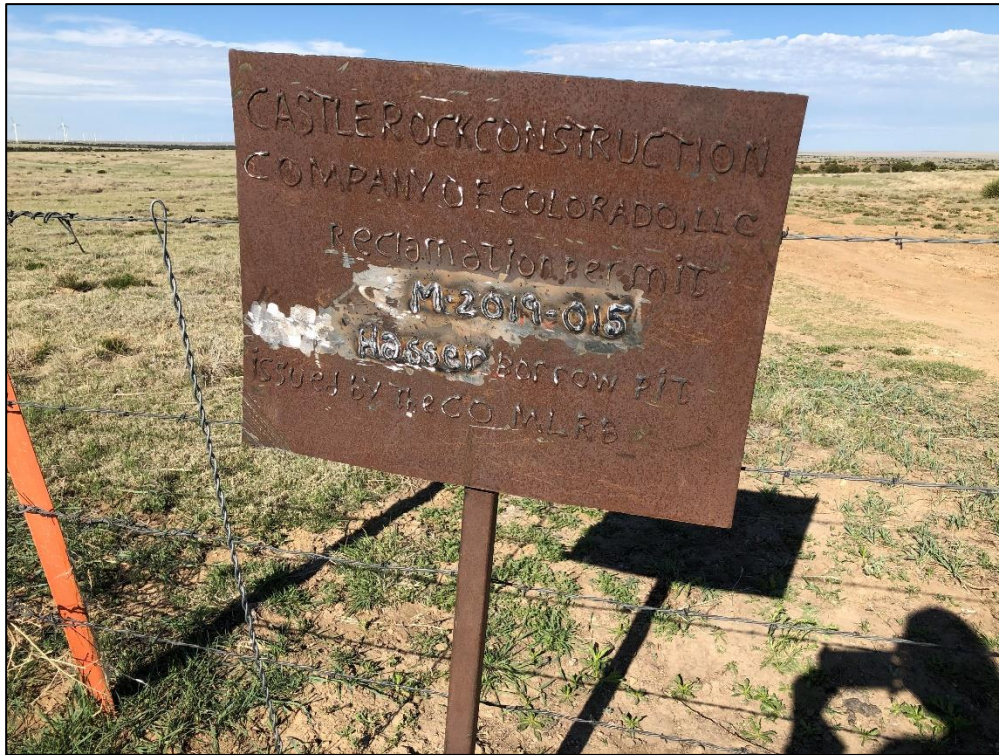
Photo 1. View of permit sign posted at main site entrance off of Hwy 287.

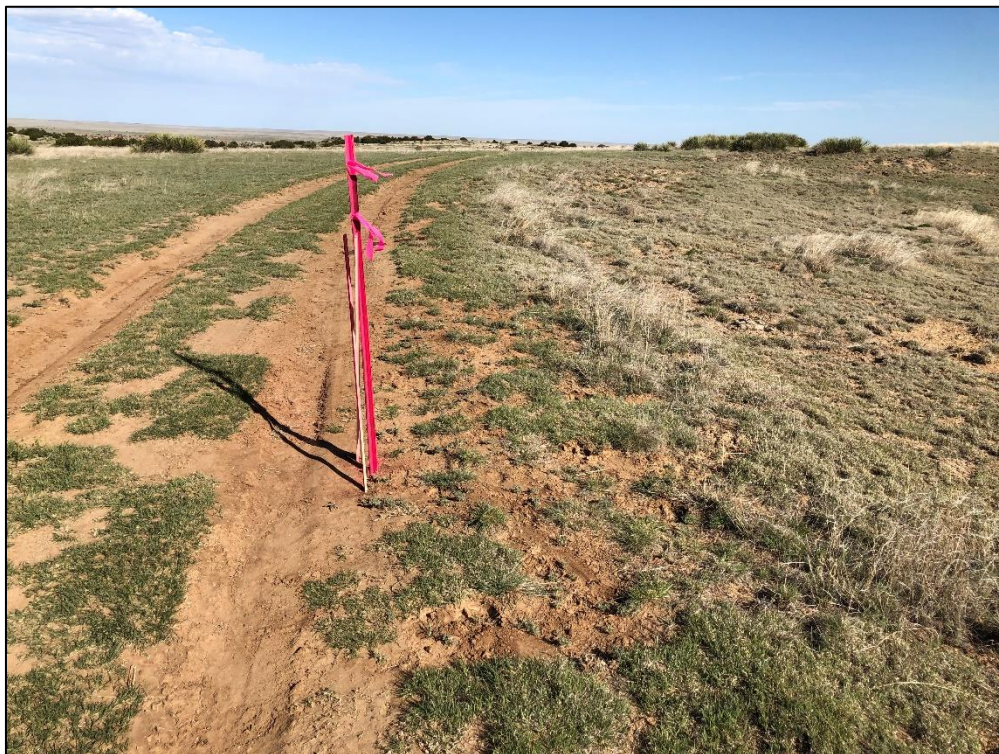
Photo 2. View looking northwest from southwestern corner of permit boundary, marked by a survey stake. Existing ranch road shown at left.

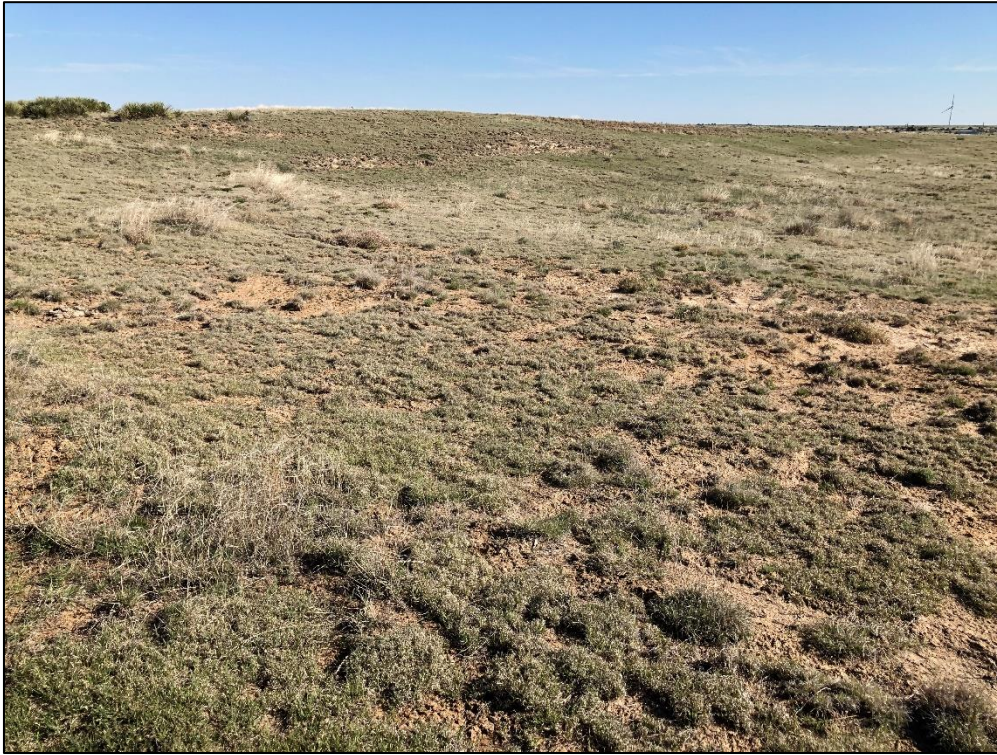
Photo 3. View looking east across proposed permit area from its western boundary.

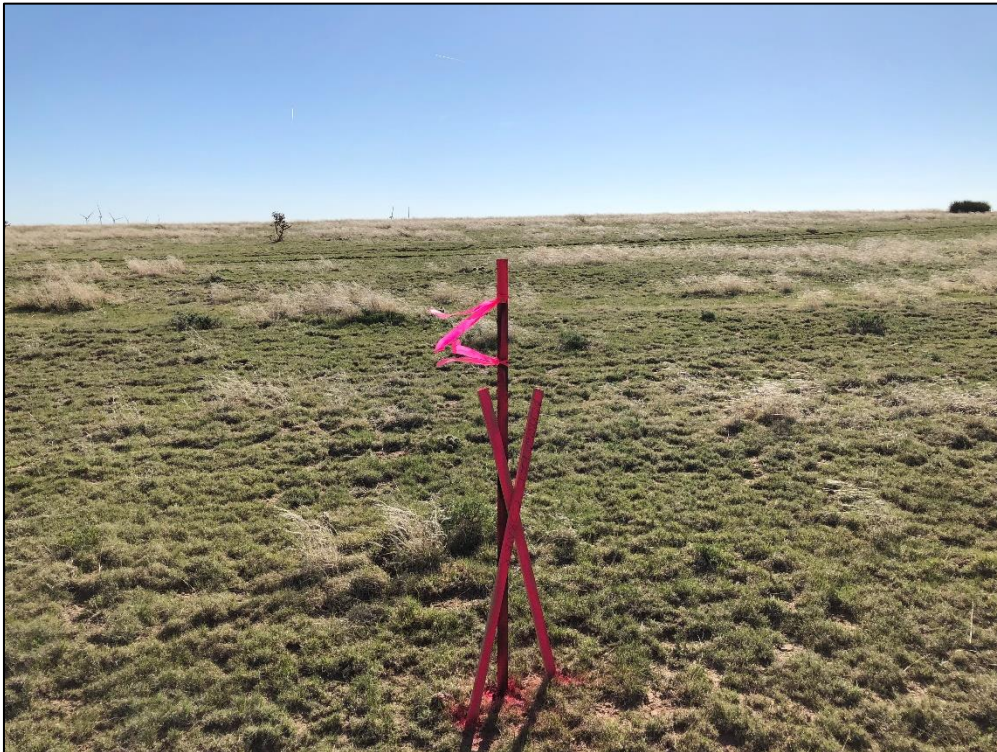
Photo 4. View looking northeast from northwestern corner of permit boundary, marked by a survey stake.

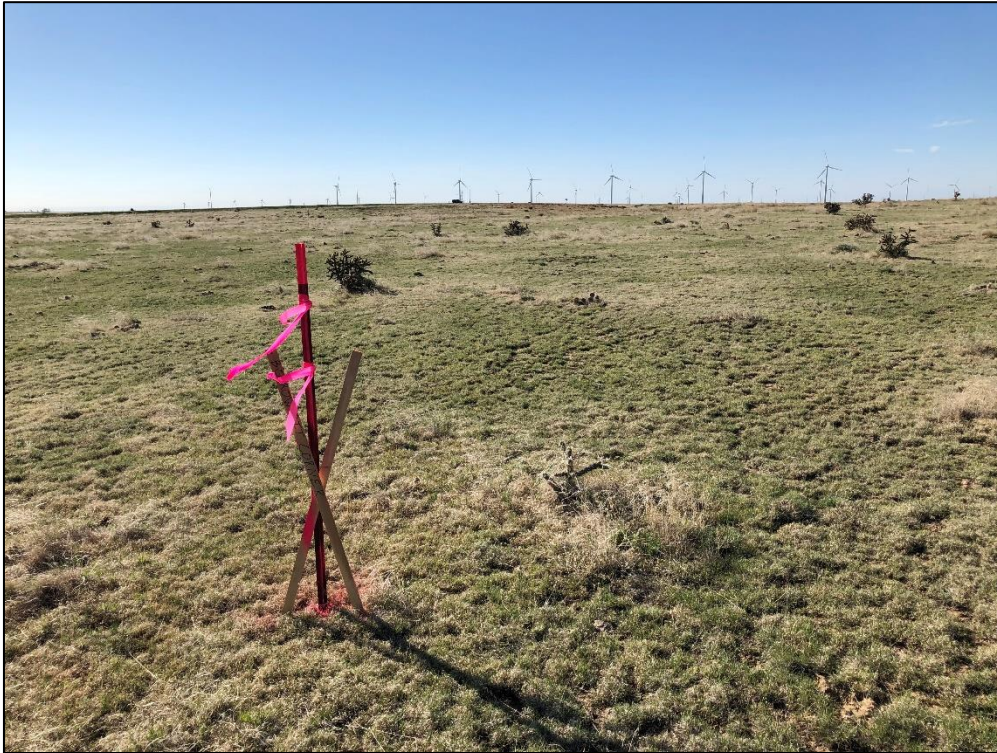
Photo 5. View looking southeast from northeastern corner of permit boundary, marked by a survey stake.

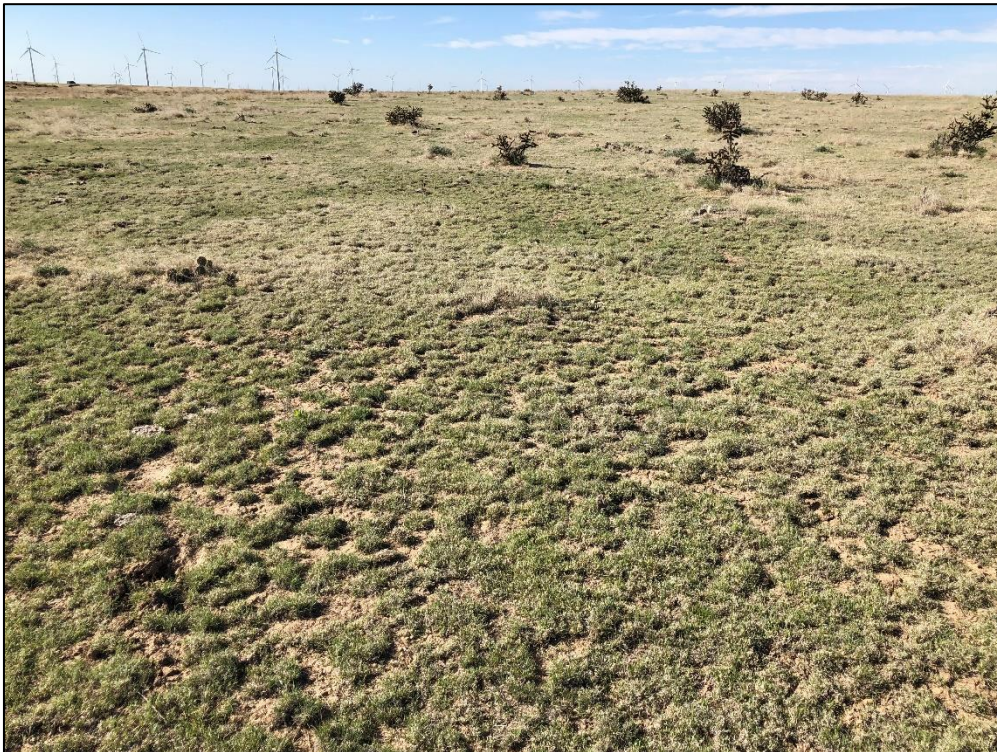
Photo 6. View looking south across proposed permit area from its eastern boundary.

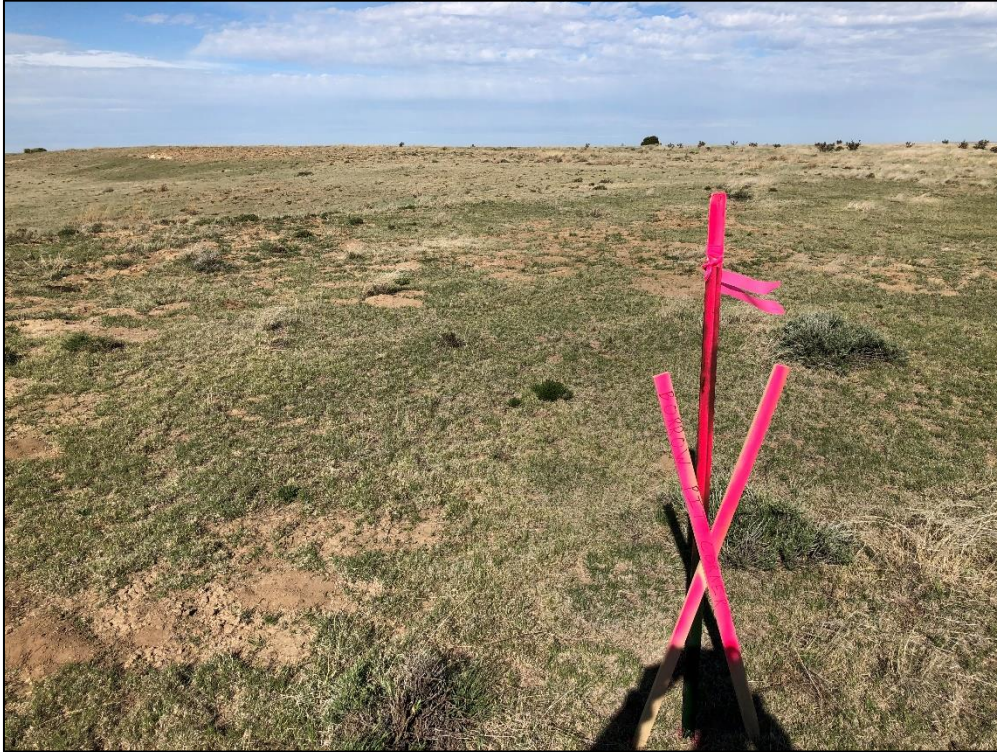
Photo 7. View looking southwest from southeastern corner of permit boundary, marked by a survey stake.

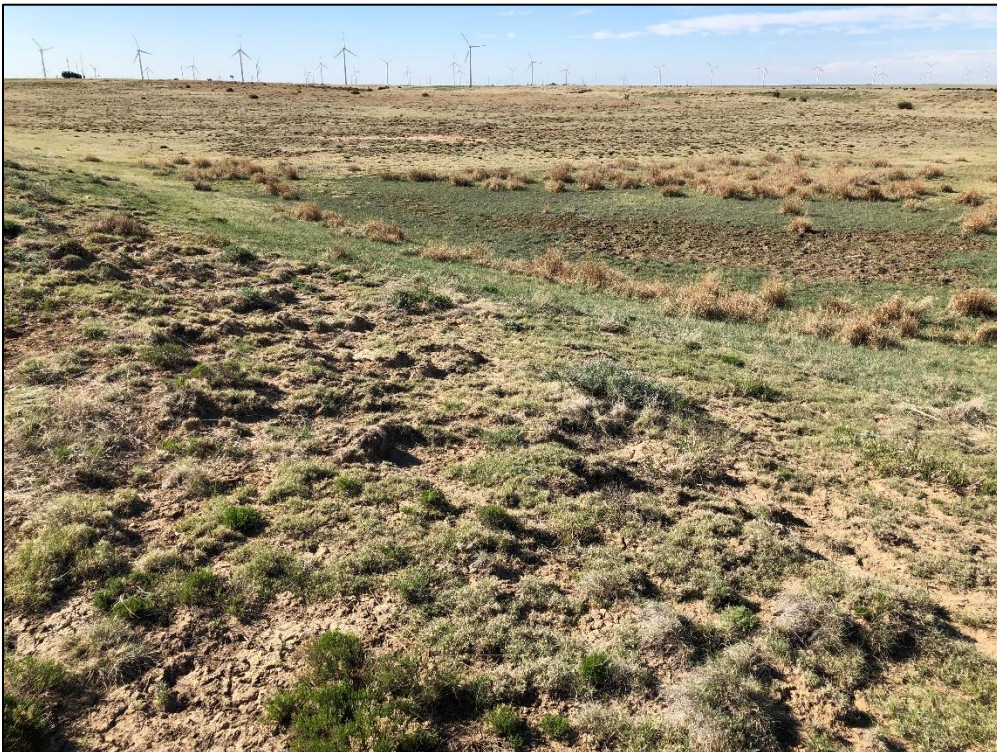
Photo 8. View looking south from southeastern corner of permit boundary, showing reclaimed pit to the southeast (not included in the permit area).

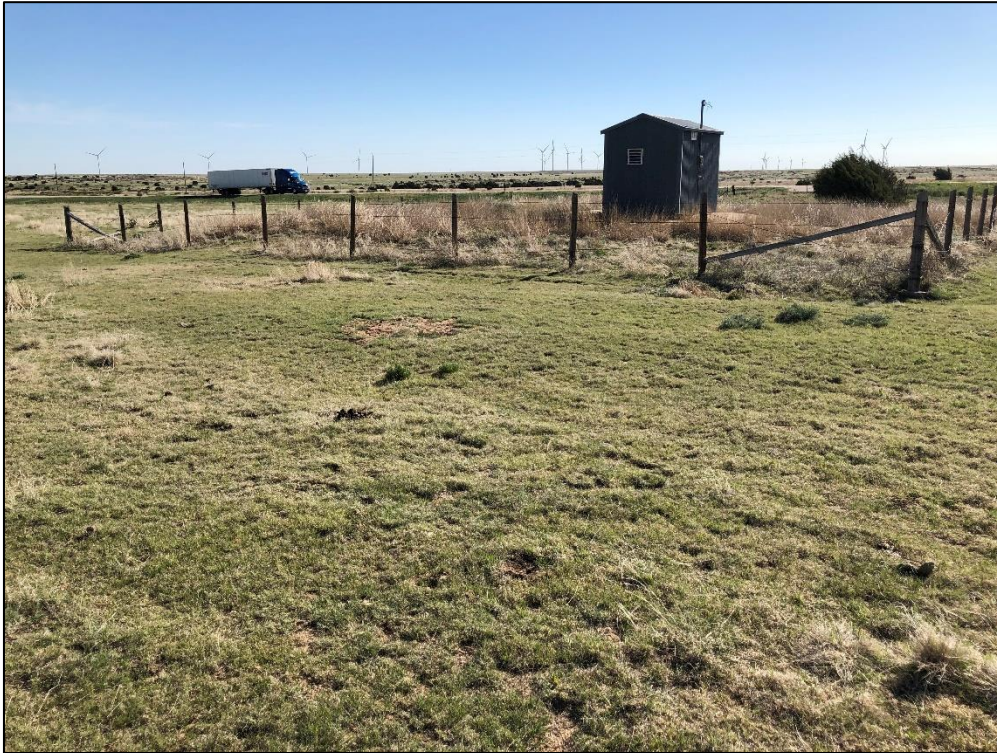
Photo 9. View looking northeast at small AT&T building and surrounding fence located more than 200 feet northeast of the proposed mine site.
