MINERALS PROGRAM INSPECTION REPORT
PHONE: (303) 866-3567

MINE NAME: Earl-Hoffman-Reyher Pit #3	MINE/PROSPECTING ID#: M-1991-086	MINERAL: Sand and gravel	COUNTY: Bent
INSPECTION TYPE: Monitoring	INSPECTOR(S): Amy Eschberger	INSP. DATE: March 7, 2019	INSP. TIME: 15:30
OPERATOR: Bent County	OPERATOR REPRESENTATIVE: Curtis Sniff, Kevin Vanegmond	TYPE OF OPERATION: 112c - Construction Regular Operation	
REASON FOR INSPECTION: Normal I&E Program	BOND CALCULATION TYPE: None	BOND AMOUNT: \$0.00	
DATE OF COMPLAINT: NA	POST INSP. CONTACTS: None	JOINT INSP. AGENCY: None	
WEATHER: Clear	INSPECTOR'S SIGNATURE:

M1991-086 / Earl-Hoffman-Reyher Pit #3 / Bent County

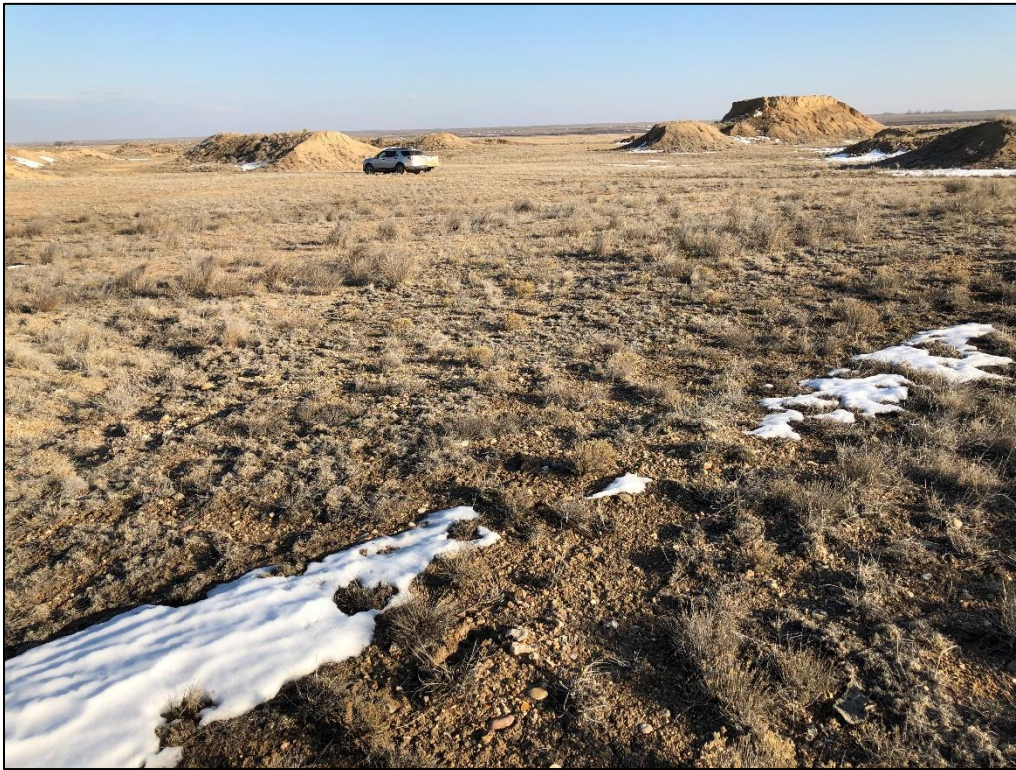
Photo 1. View looking southeast across active pit in western portion of permit area. Note several material stockpiles stored on pit floor (in background).

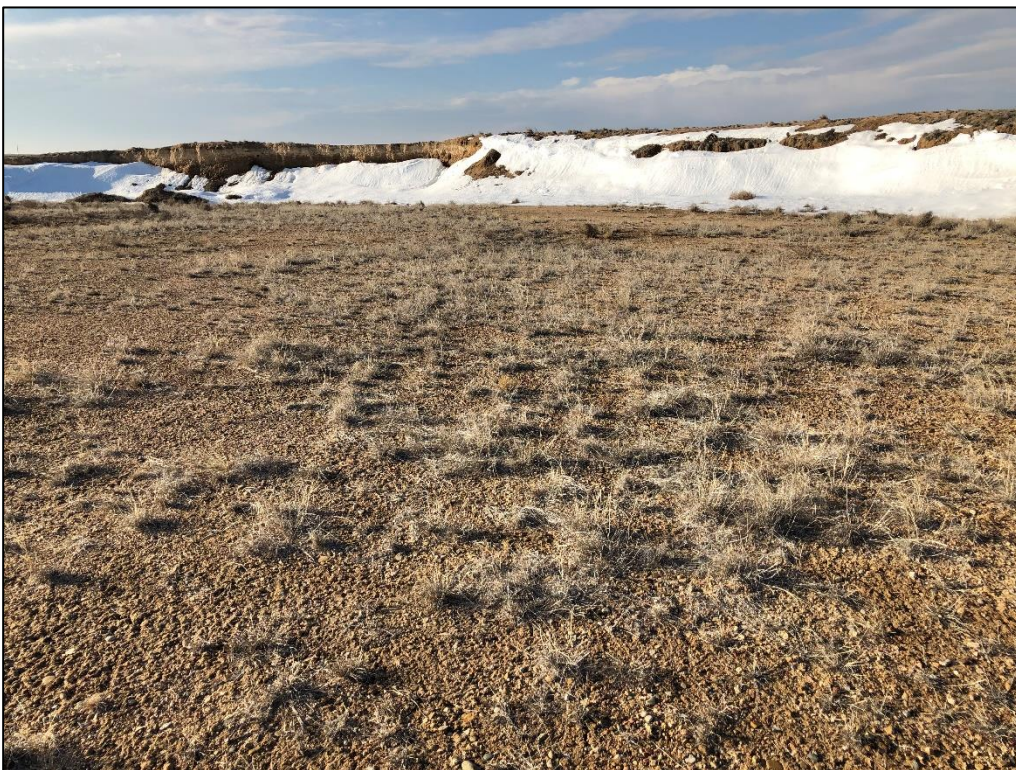
Photo 2. View looking north at highwall along northern edge of active pit. Highwall is approximately 10 feet in height with slopes of near vertical to 1H:1V.

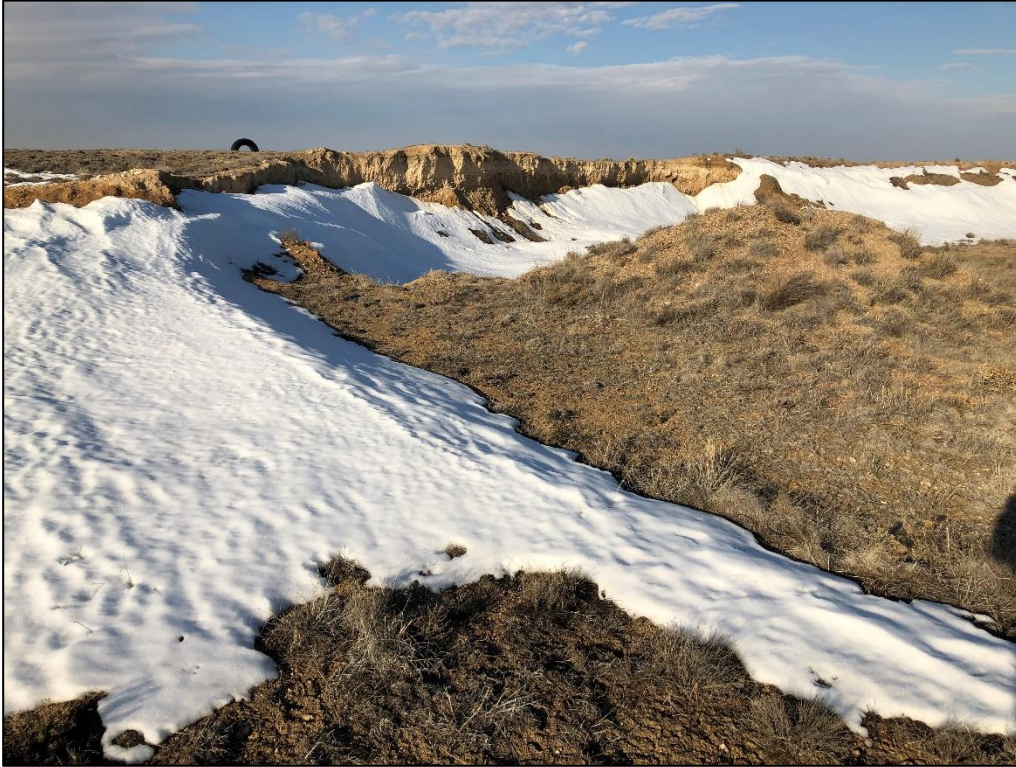
Photo 3. View looking east across highwall along northern edge of active pit. Highwall is approximately 10 feet in height with slopes of near vertical to 1H:1V.

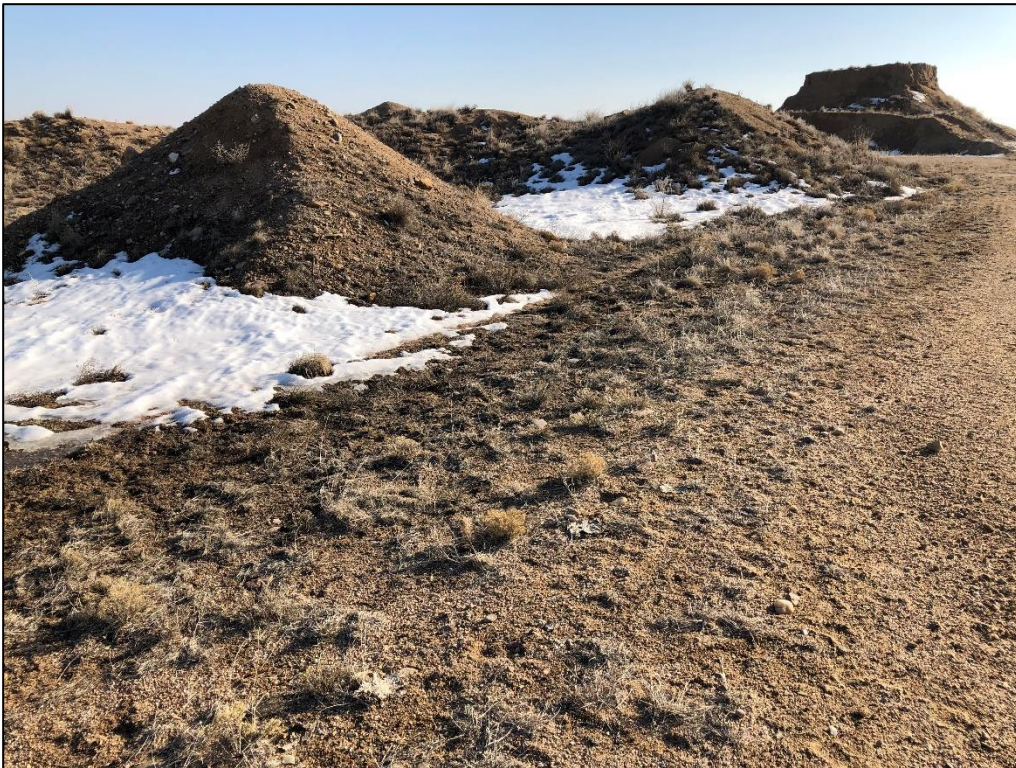
Photo 4. View looking south at several material stockpiles stored in active pit area.

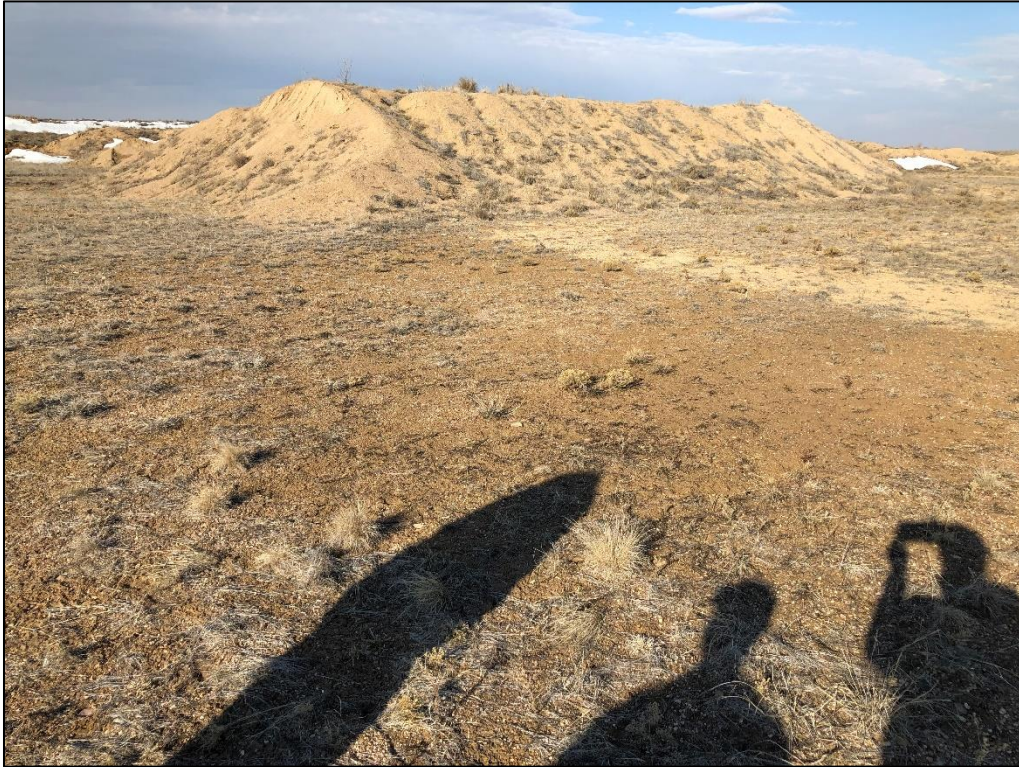
Photo 5. View looking east showing material stockpile stored in active pit area.

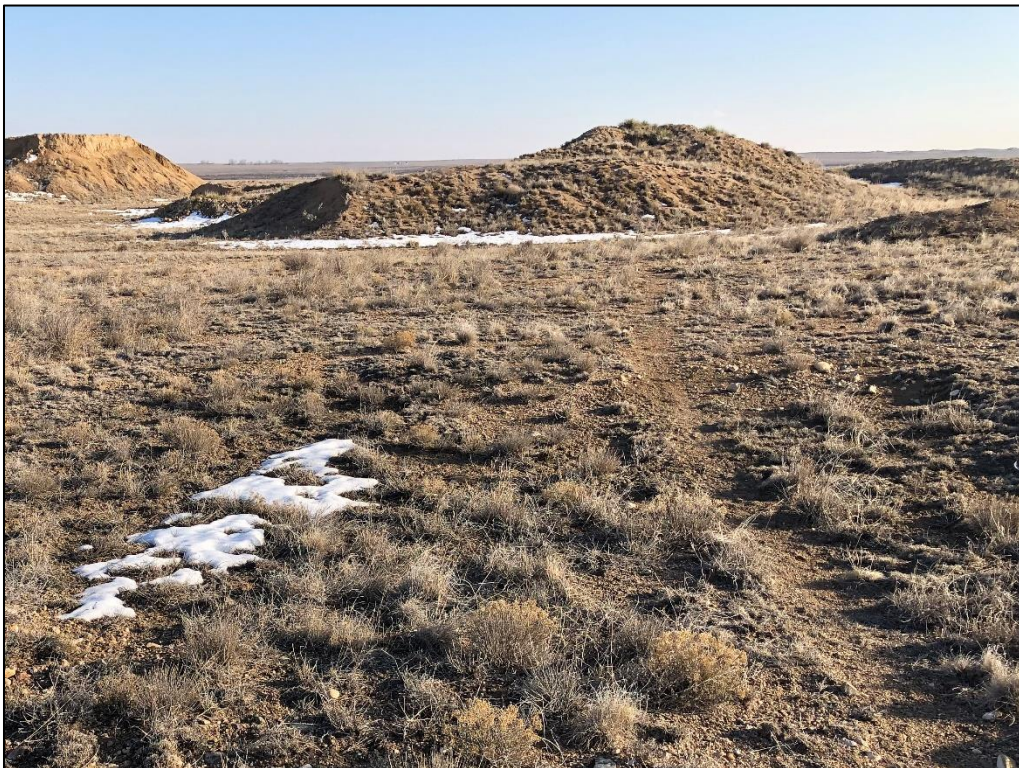
Photo 6. View looking south showing large topsoil stockpile stored at western edge of permit area, stable with grass cover.

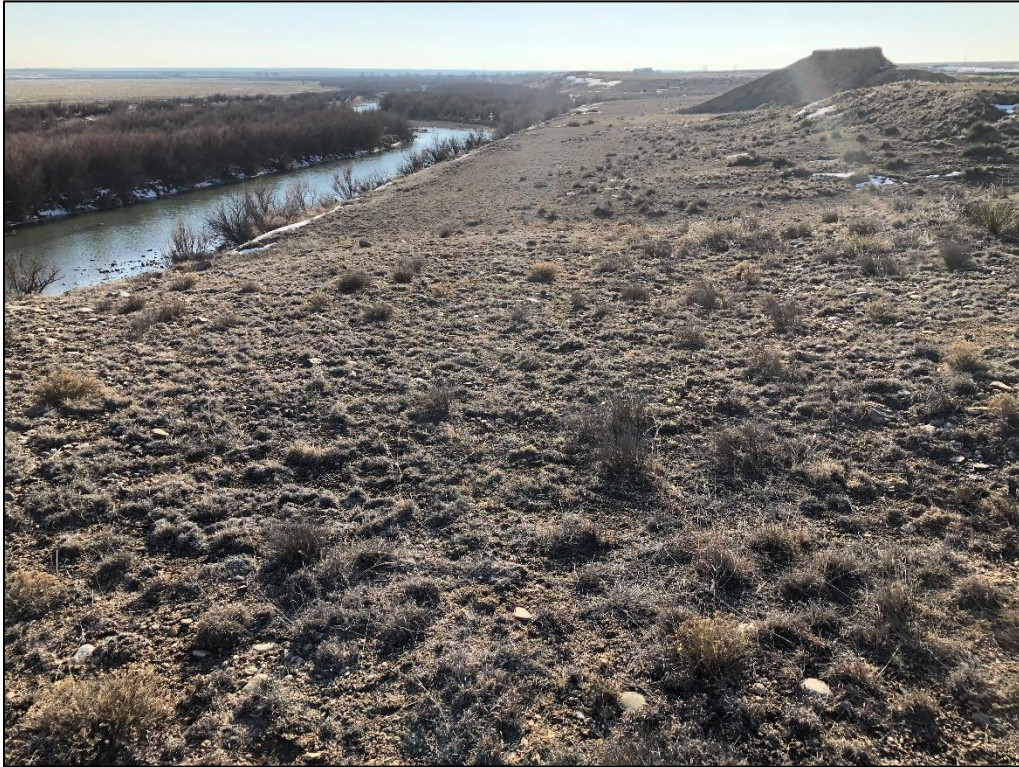
Photo 7. View looking west across southern edge of permit area. Note Arkansas River at left. Also note large sand stockpile stored at southern edge of active pit, visible in background.

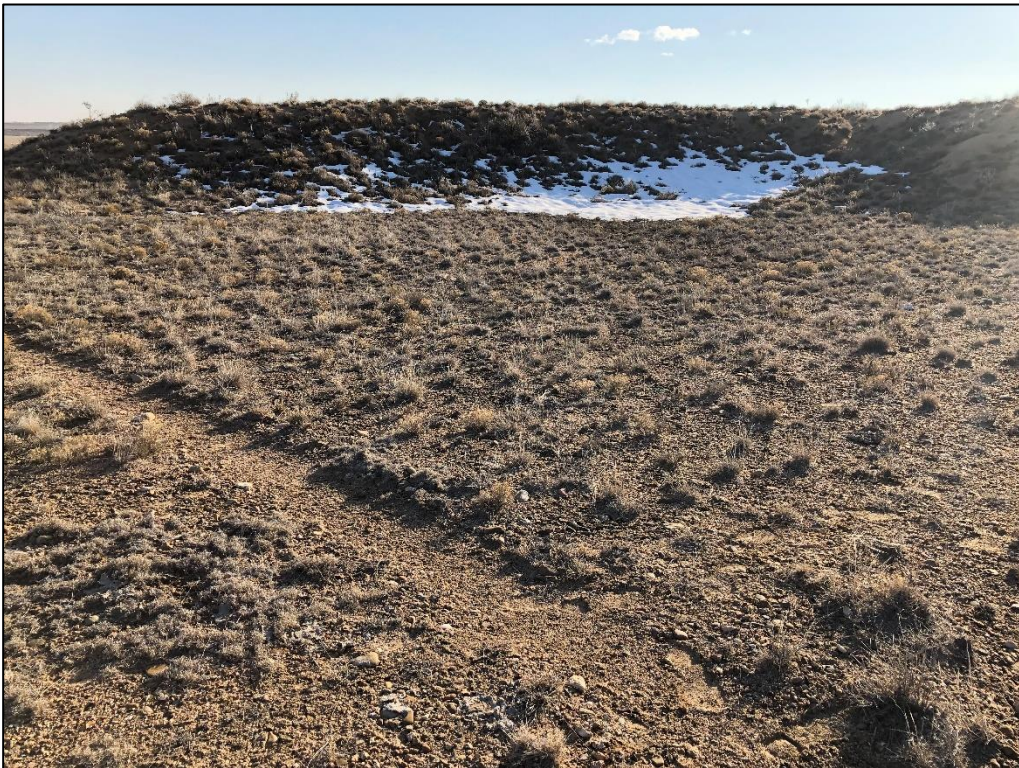
Mining is complete in the eastern half of the permit area. Native grasses, forbs, and some shrubs have volunteered across this area. There are a few steeper slopes in this portion of the permit area that will need to be graded to 3H:1V and seeded for reclamation. The old pit at the far eastern edge of the site was graded to the approved final configuration and well vegetated. A low-lying earthen berm surrounds the perimeter of this area, which helps control erosion on its side slopes. The draw at the southern edge of the permit area appears to have been undisturbed by the operation.

Photo 8. View looking south across reclaimed central portion of permit area. Some steeper slopes in this area will need grading to 3H:1V and reseeding for reclamation.

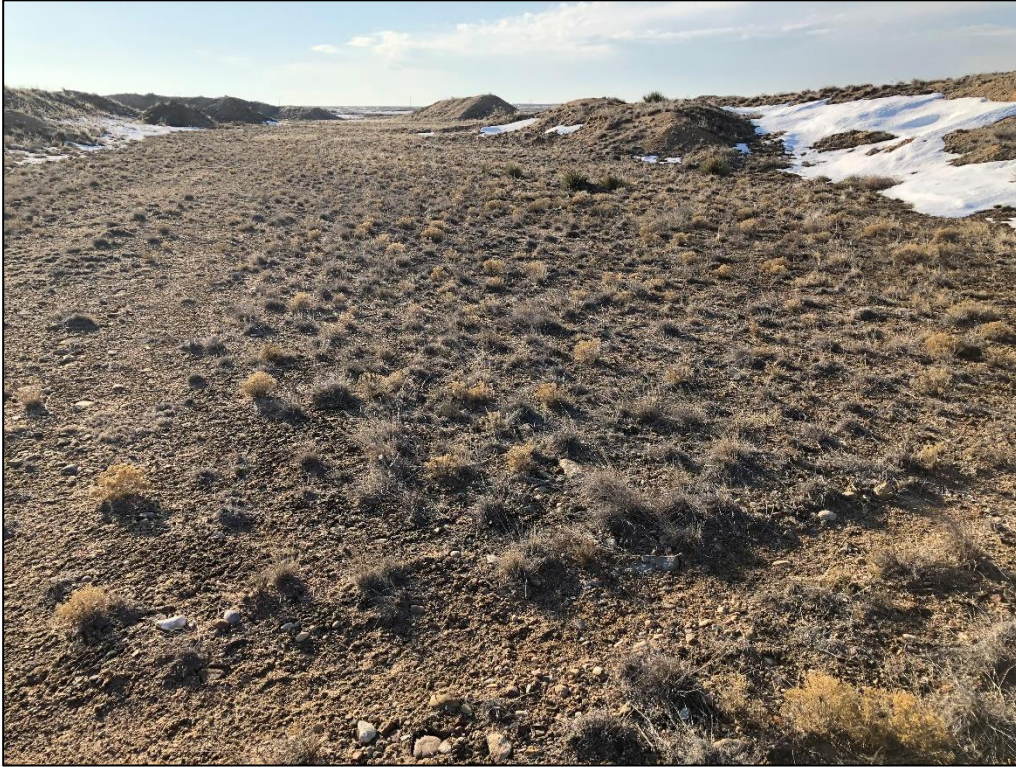
Photo 9. View looking west across reclaimed central portion of permit area. Some steeper slopes in this area will need grading to 3H:1V and reseeding for reclamation.

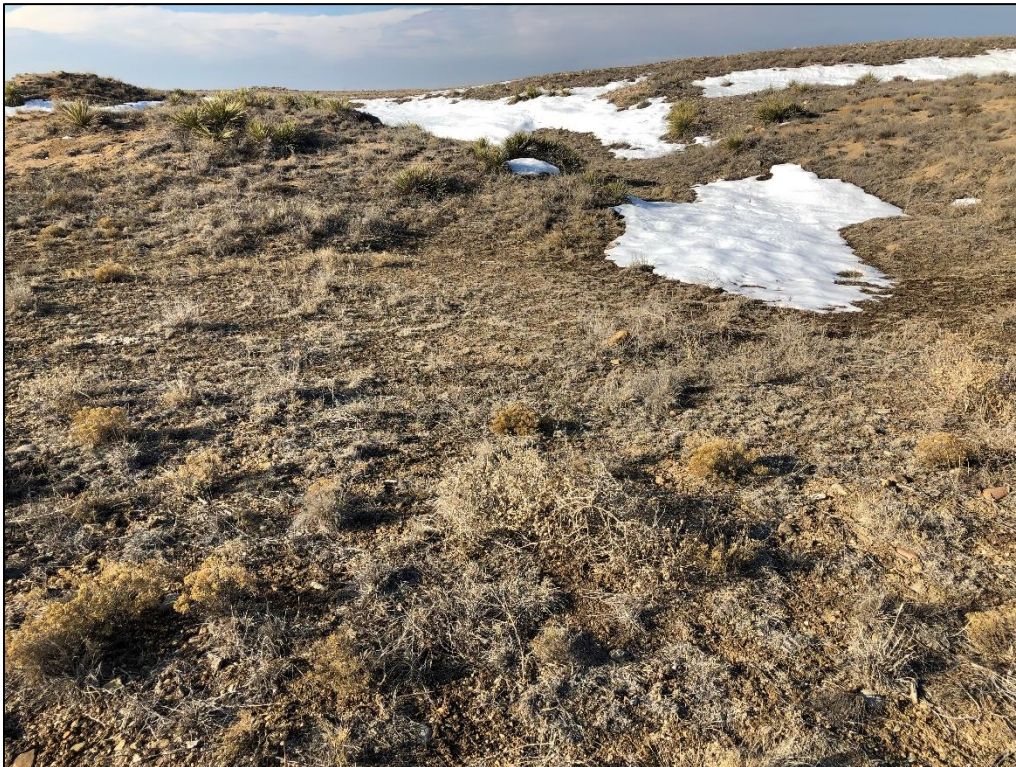
Photo 10. View looking north across reclaimed central portion of permit area.

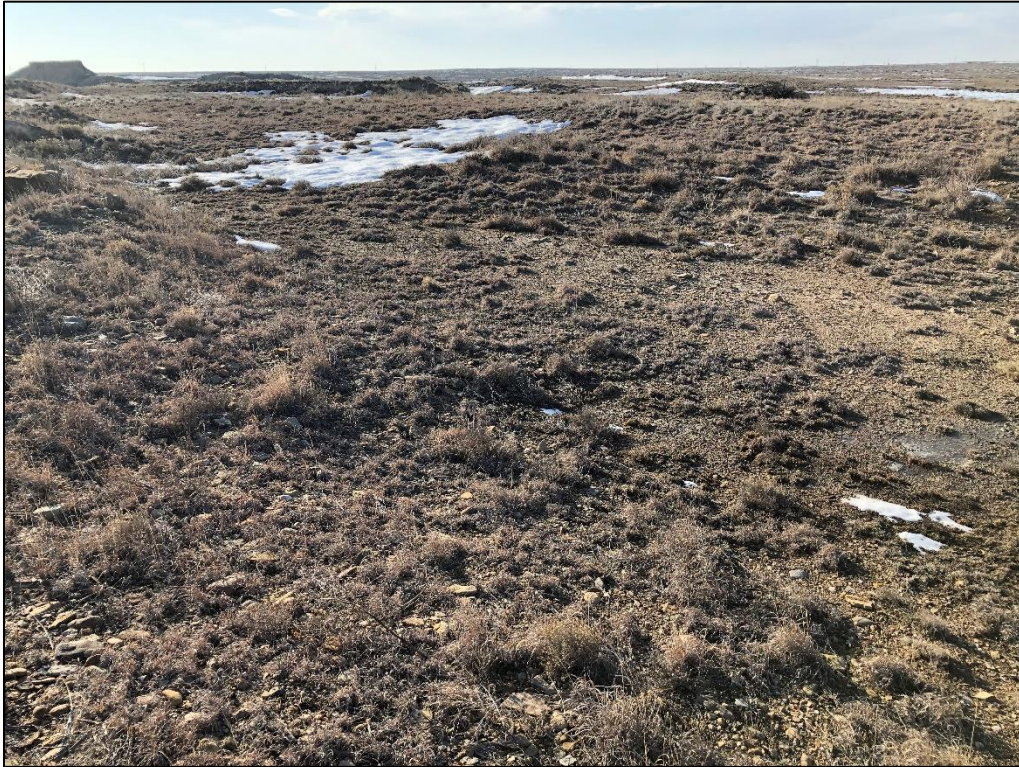
Photo 11. View looking west across reclaimed central portion of permit area.

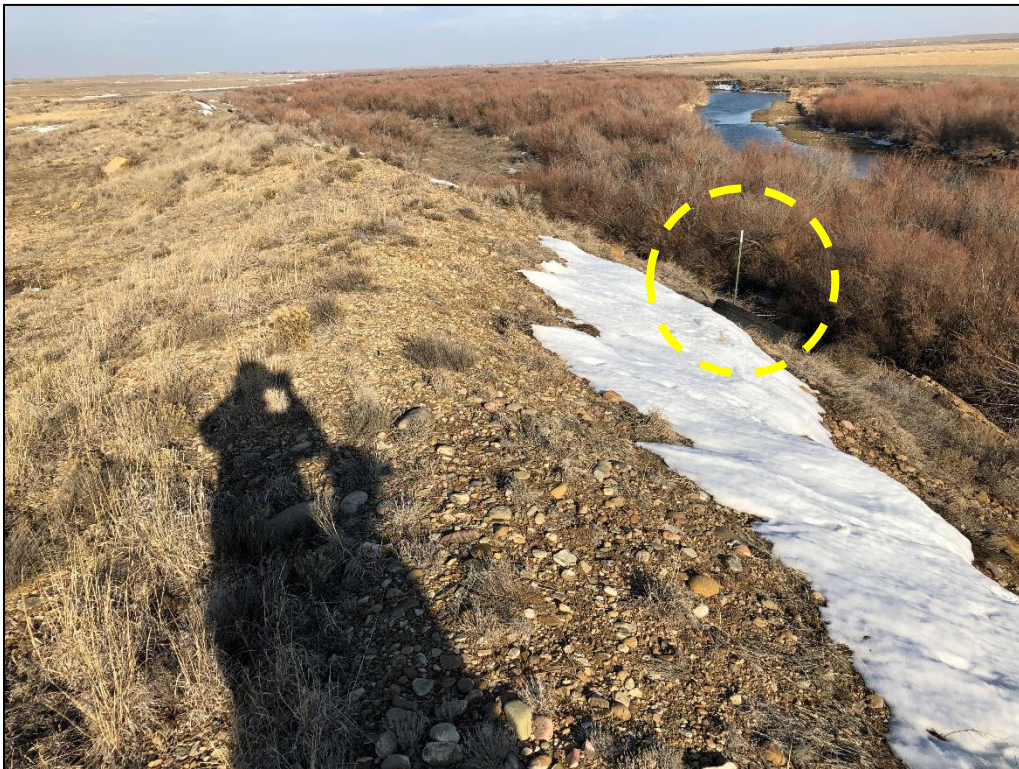
Photo 12. View looking east across southern edge of permit area, showing T-post with tire around it (circled) marking southern boundary.

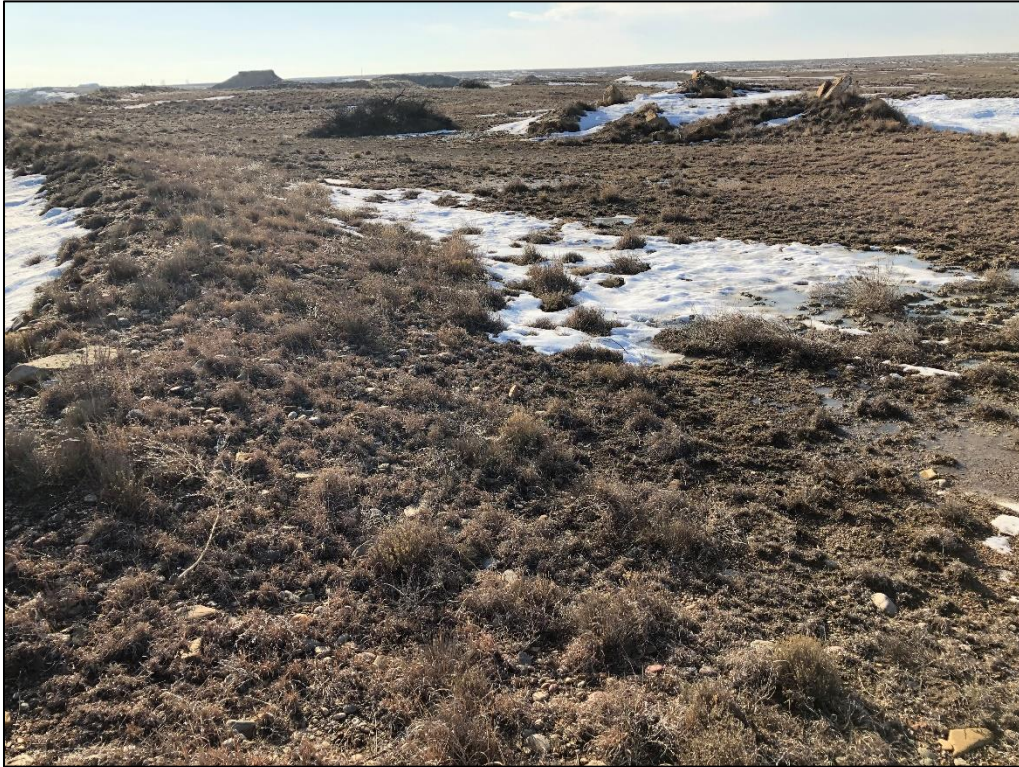
Photo 13. View looking west across reclaimed eastern portion of permit area. Note small rock pile left in this area (at top right).

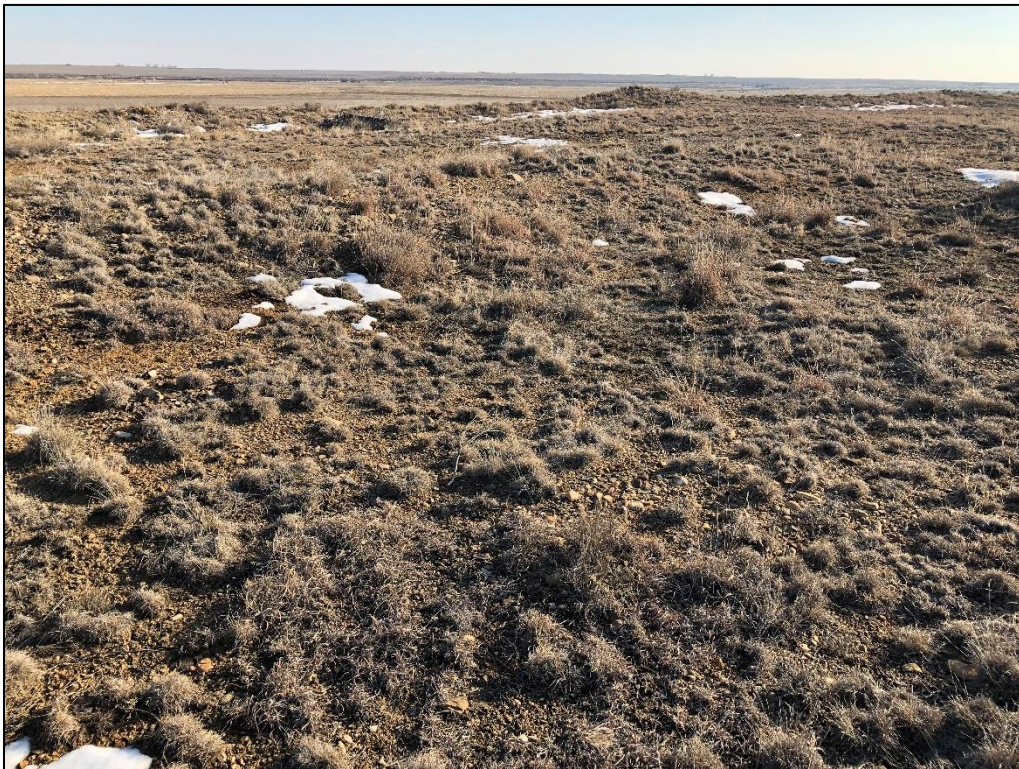
Photo 14. View looking south across reclaimed eastern portion of permit area.

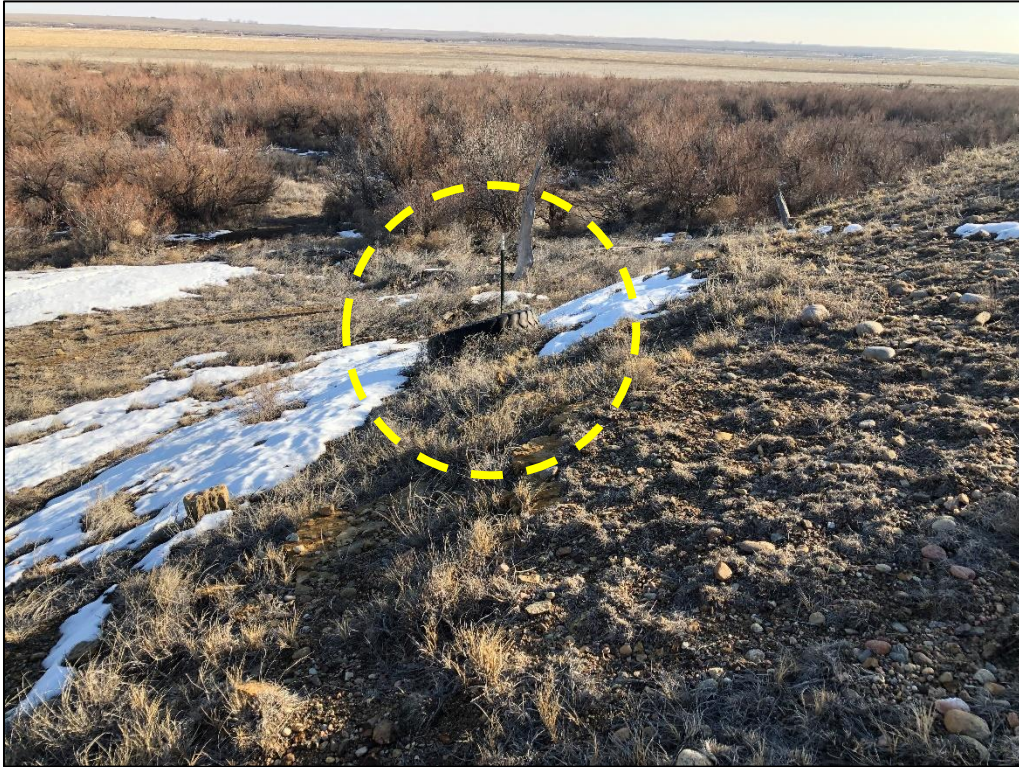
Photo 15. View looking south at southeastern corner of permit boundary marked by T-post with tire around it (circled).

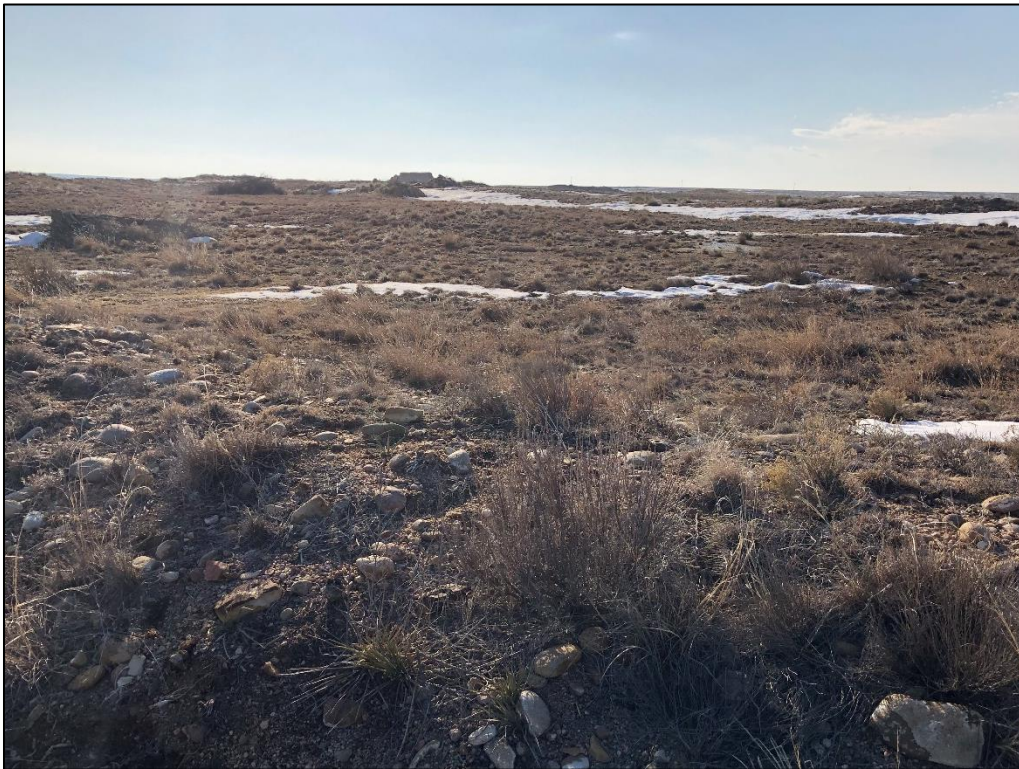
Photo 16. View looking west across reclaimed eastern portion of permit area from top of low-lying berm.
