**MINERALS PROGRAM INSPECTION REPORT**  
**PHONE: (303) 866-3567**

<b>MINE NAME:</b> Bonnie Earl Pit	<b>MINE/PROSPECTING ID#:</b> M-1985-014	<b>MINERAL:</b> Sand and gravel	<b>COUNTY:</b> Bent
<b>INSPECTION TYPE:</b> Monitoring	<b>INSPECTOR(S):</b> Amy Eschberger	<b>INSP. DATE:</b> March 7, 2019	<b>INSP. TIME:</b> 16:20
<b>OPERATOR:</b> Riverside Aggregates, LLC	<b>OPERATOR REPRESENTATIVE:</b> None	<b>TYPE OF OPERATION:</b> 110c - Construction Limited Impact	
<b>REASON FOR INSPECTION:</b> Normal I&E Program	<b>BOND CALCULATION TYPE:</b> None	<b>BOND AMOUNT:</b> \$14,000.00	
<b>DATE OF COMPLAINT:</b> NA	<b>POST INSP. CONTACTS:</b> None	<b>JOINT INSP. AGENCY:</b> None	
<b>WEATHER:</b> Clear	<b>INSPECTOR'S SIGNATURE:</b>

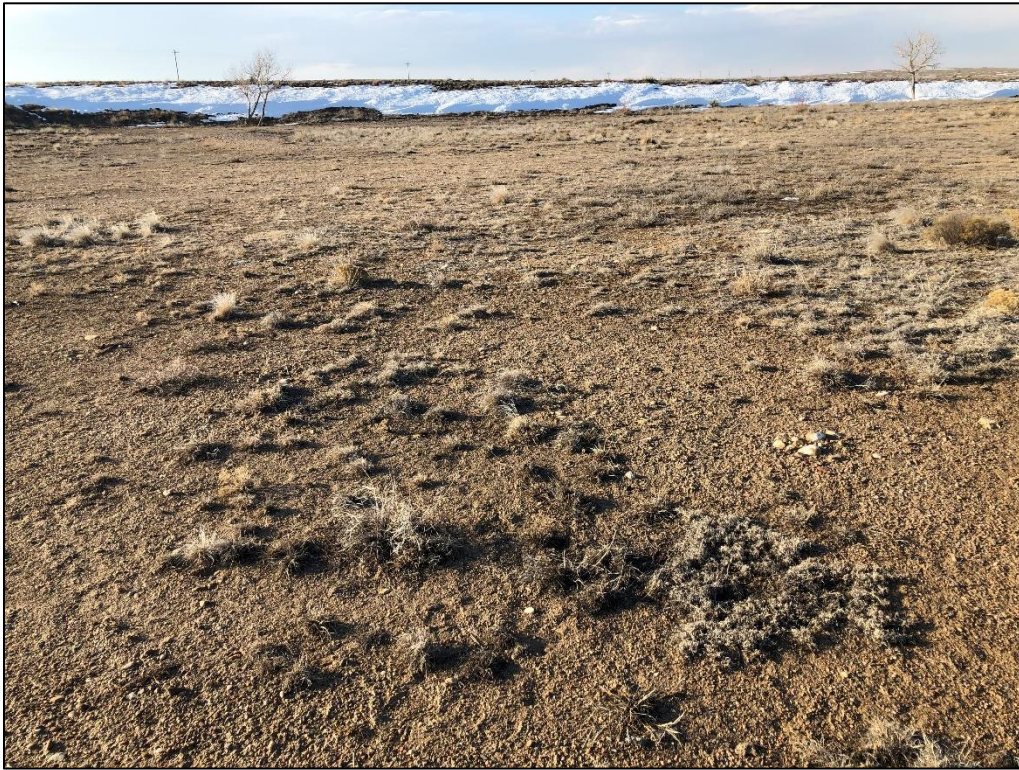
**Photo 1.** View looking north across pit from its southern edge (south-facing pit wall in background). Note sparse grass growth in some areas.

- Reseed portions of the site where grass growth is sparse
- Fill in the gullies on the pit wall with on-site riprap material

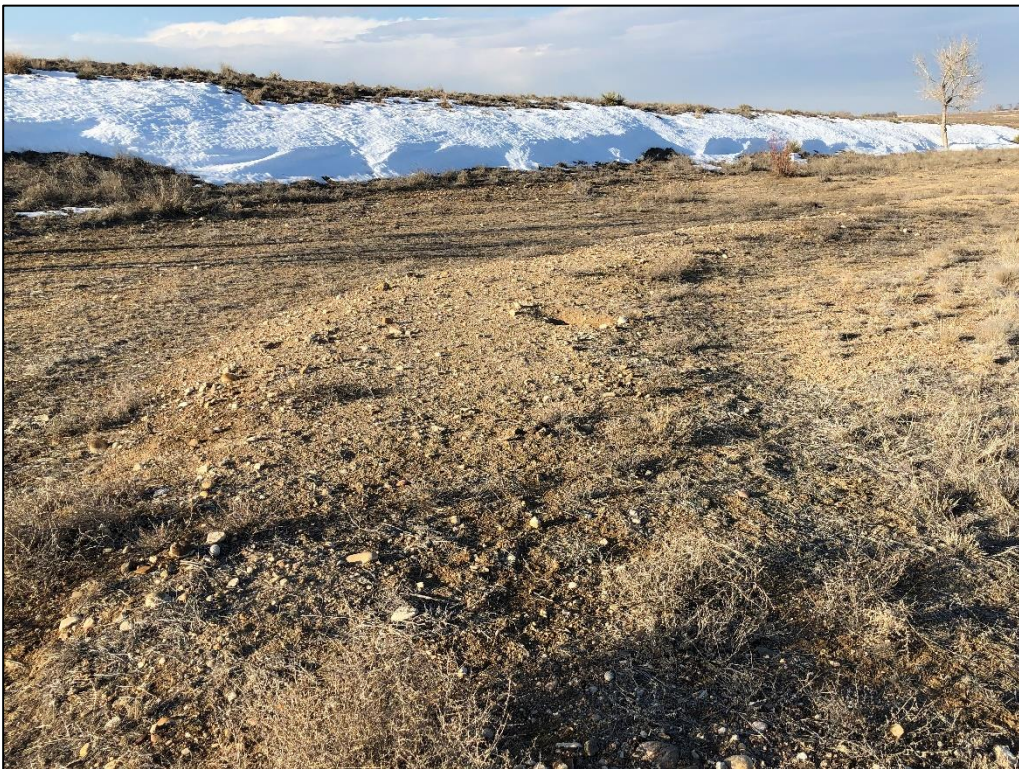
**Photo 2.** View looking northeast at south-facing pit wall. Note pit wall graded to 3H:1V, but vegetative cover difficult to fully assess in some areas due to snow cover.

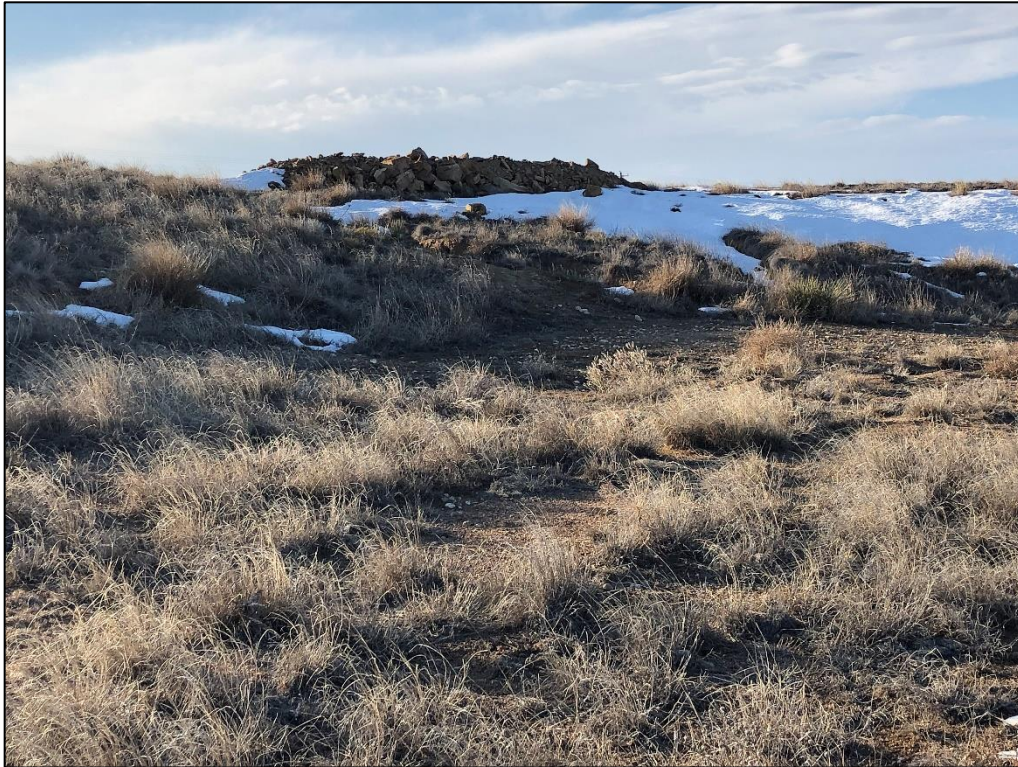
During the Division's 2014 inspection of the site, two erosion gullies were observed along a section of the pit wall. At that time, the operator committed to filling the gullies with riprap to help stabilize the pit wall. During the current inspection, the Division noted a pile of riprap stored above this section of the pit wall, but it appeared that riprap had not yet been placed in the gullies. Due to the extensive grass cover now present across this section of the pit wall, and the riprap pile itself acting as a sort of stormwater control by routing stormwater around this portion of the pit wall, the old erosion features did not appear to have worsened since the last inspection. However, Rule 3.1.5(3) requires that all grading be done in a manner to control erosion and siltation of the affected lands, to protect areas outside the affected land from slides and other damage, and that all highwalls be stabilized. Therefore, to properly stabilize the pit wall and prevent any upgradient (potentially offsite) migration of the erosion features, the Division recommends the operator fill the gullies with the riprap, and do so in a way that minimizes disturbance to the existing grass cover.

**Photo 3.** View looking north, showing section of pit wall where gullies were observed last inspection, now with good grass growth. Note riprap pile stored at top of pit wall.

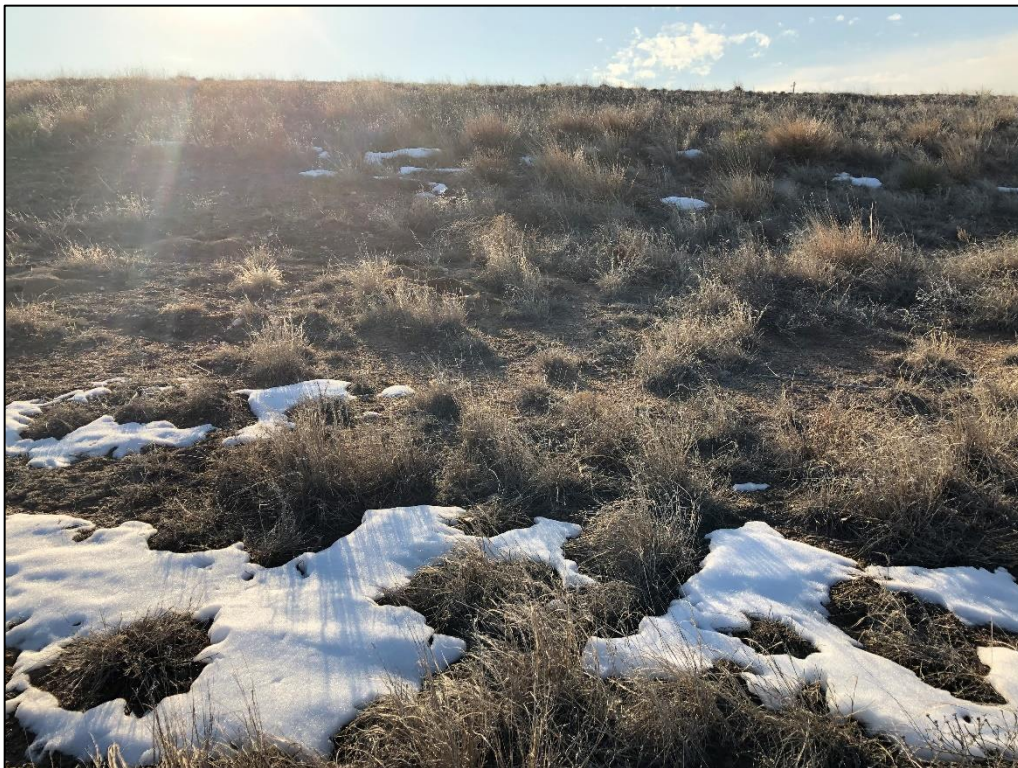
**Photo 4.** View looking north, showing portion of pit wall and pit floor with good grass growth.

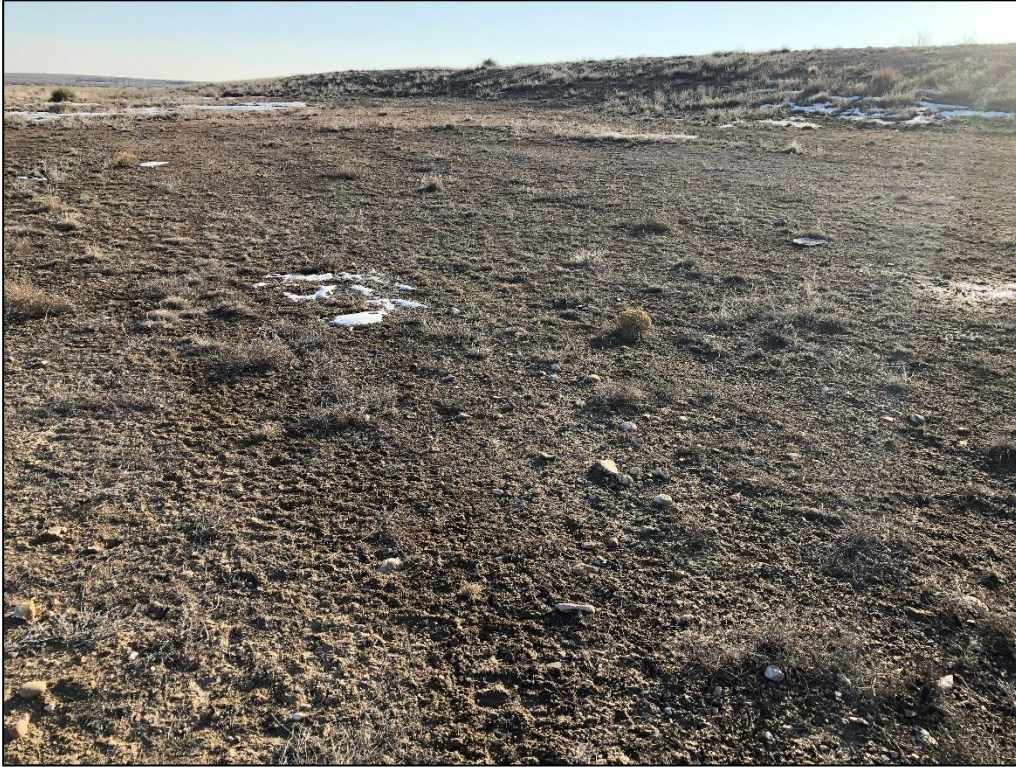
**Photo 5.** View looking northwest across pit (western edge of pit wall visible in background). Note sparse grass growth in some areas of the pit floor.

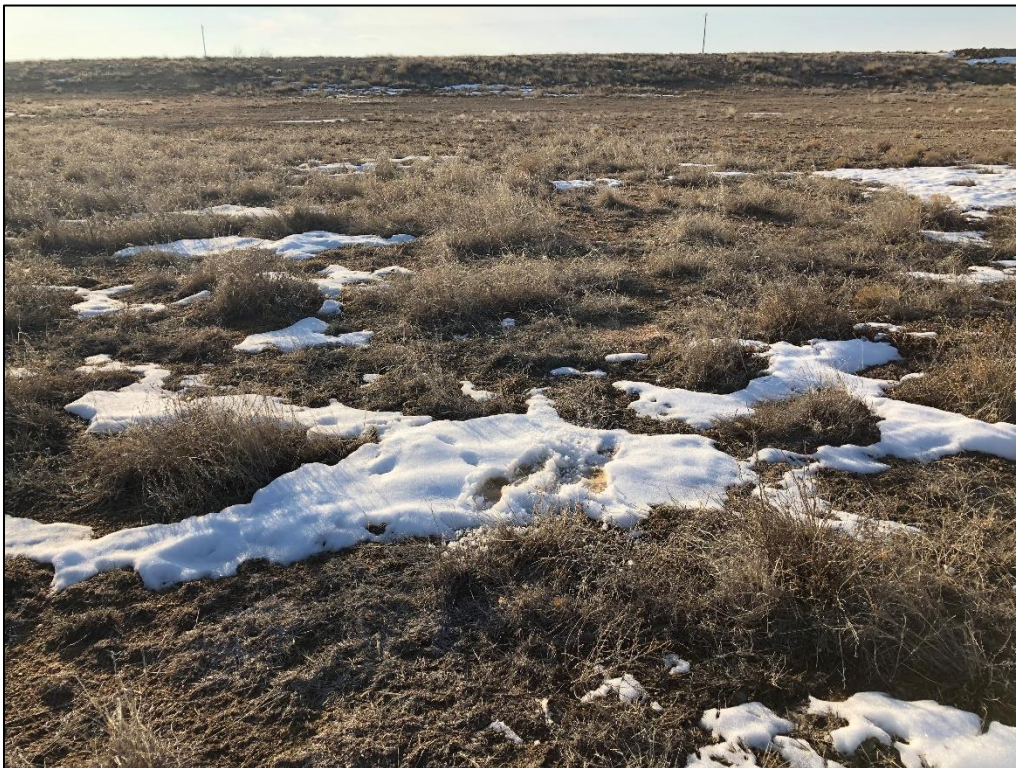
**Photo 6.** View looking north across pit from near access road. Note good grass growth present in this area.

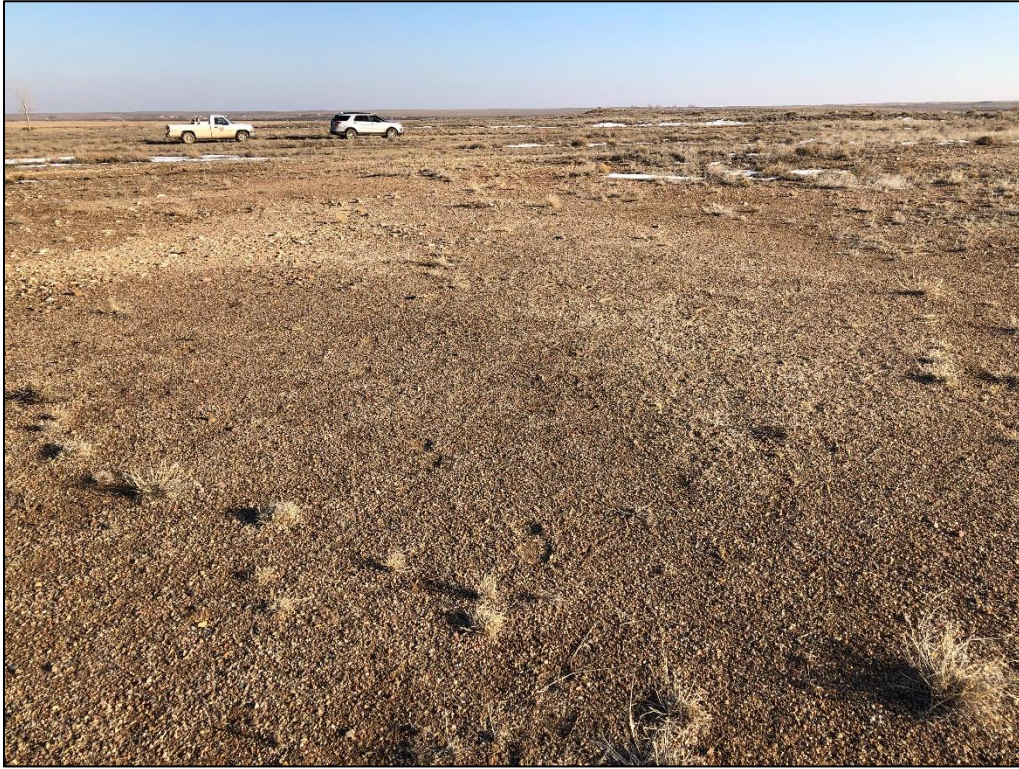
**Photo 7.** View looking south toward access road (where vehicles are parked), showing southern portion of permit area with sparse grass growth.
