**COLORADO**Division of Reclamation,
Mining and Safety

MINERALS PROGRAM INSPECTION REPORT**PHONE: (303) 866-3567**

MINE NAME: Mid-Continent LST	MINE/PROSPECTING ID#: M-1982-121	MINERAL: Limestone (general)	COUNTY: Garfield
INSPECTION TYPE: Monitoring	INSPECTOR(S): Amy C. Yeldell	INSP. DATE: April 10, 2019	INSP. TIME: 10:00
OPERATOR: RMR Aggregates, Inc.	OPERATOR REPRESENTATIVE: Robert Wagner	TYPE OF OPERATION: 112c - Construction Regular Operation	
REASON FOR INSPECTION: Normal I&E Program	BOND CALCULATION TYPE: Complete Bond	BOND AMOUNT: \$222,081.00	
DATE OF COMPLAINT: NA	POST INSP. CONTACTS: None	JOINT INSP. AGENCY: U.S.BLM	
WEATHER: Raining	INSPECTOR'S SIGNATURE:

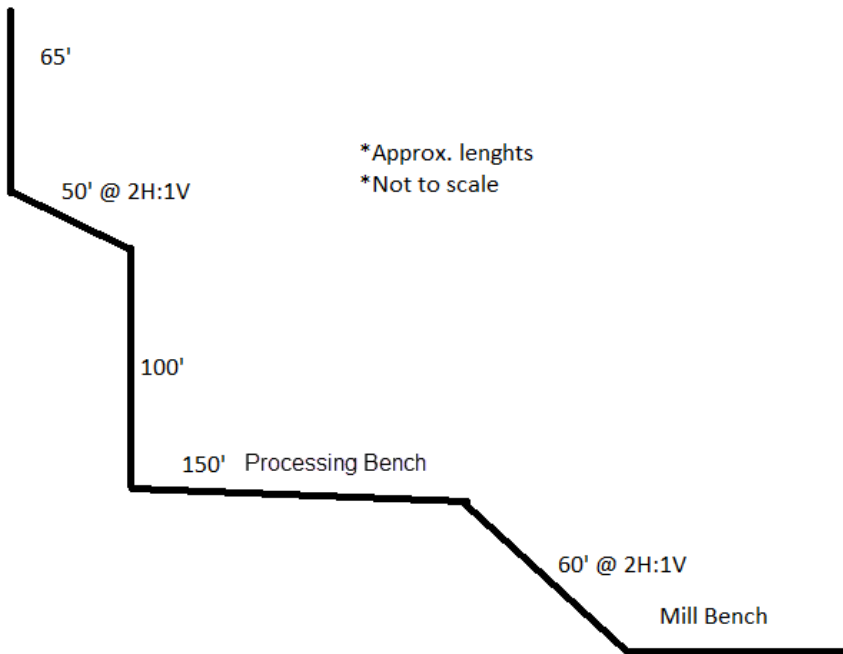
The highwall is made up of two main faces approximately 800 feet wide. The top face is approximately 65 feet high with a 50 foot wide bench below it that's estimated to be at 2H:1V slope. The lower highwall is approximately 100 feet high. See sketch below

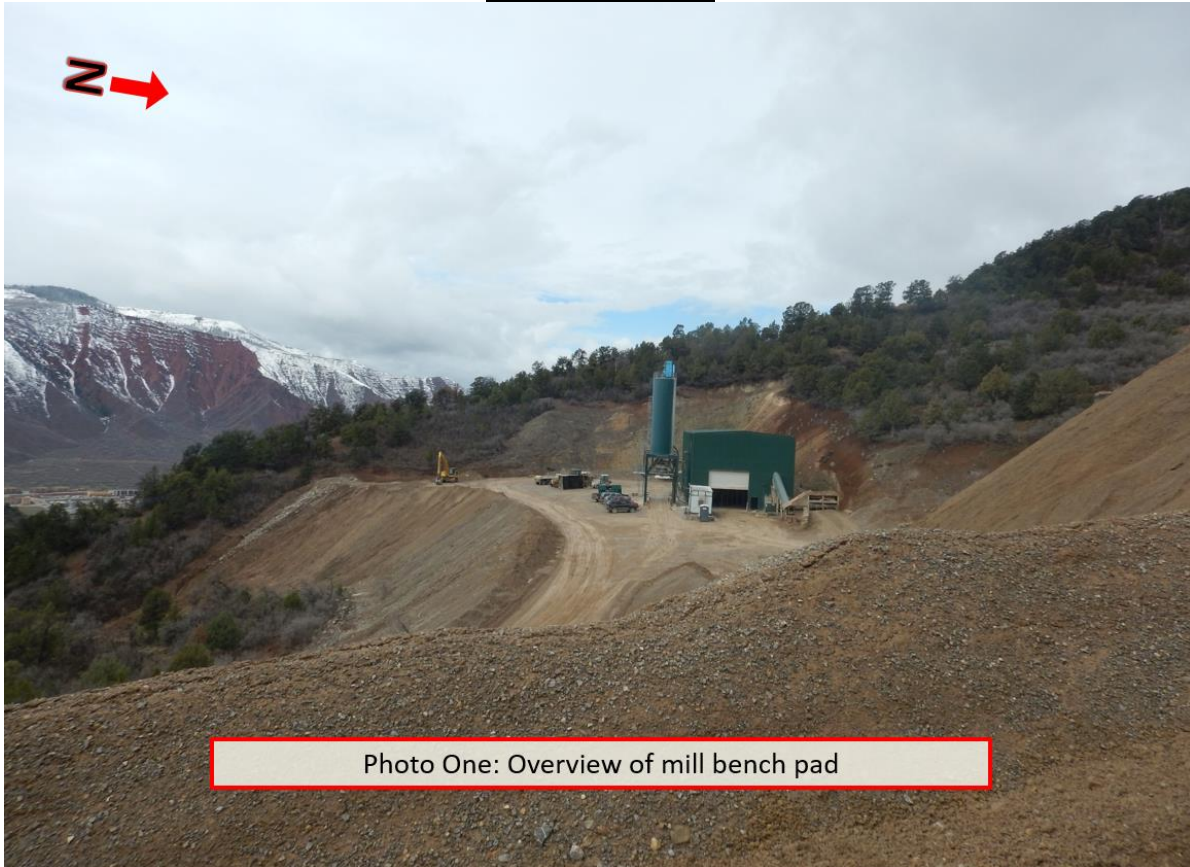
Photo One: Overview of mill bench pad

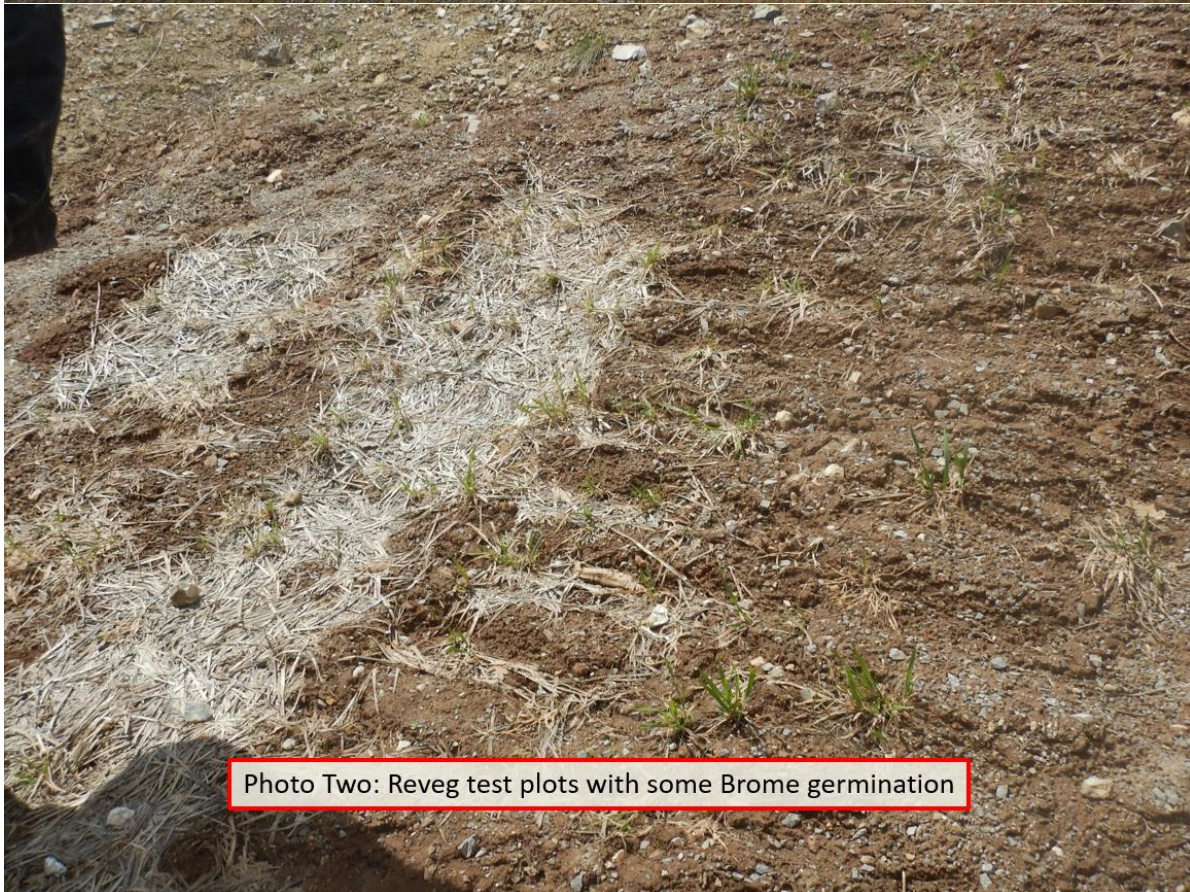
The vegetation plots to the west of the mill building were observed. Some early cool season plants have begun to germinate. All of the germinating plants appear to be of one species of Brome, it is likely that as temperatures warm other species will also germinate (photo two). So far the test plots are proving as a viable option to utilize some of the fine material for reclamation. This area appeared to be weed free. The hill side above the revegetation test plots did have large amounts of Common Mullen. These areas should be treated as soon as practicable. No other weed infestations were observed at this time.

Photo Two: Reveg test plots with some Brome germination

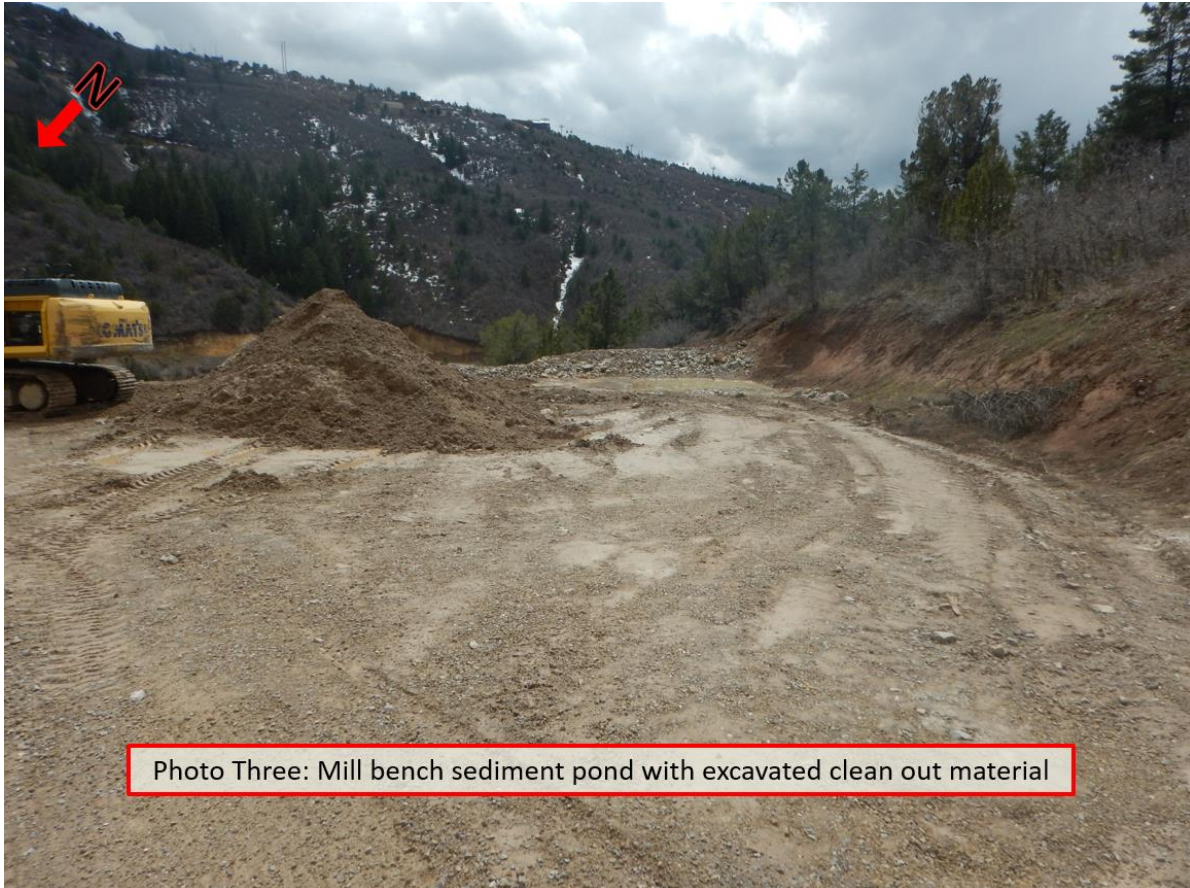
The winter snow pack has completely melted however spring weather continues to bring rain/snow storms. The sediment pond did show some signs of erosion on the outer slope. It appears that the berm became so saturated due to infiltration that water actually began to move through the berm and erode off the back side. It did not appear as though the stormwater overtopped the berm. There was additional erosion within the armored channel farther down the hillside. The rip-rap armor does not go all the way down to the lower sediment pond, these unarmored portions of the channel had increased erosion/cutting visible. A clean out pile was observed adjacent to the sediment pond, this material has yet to be placed in a permanent stockpile location (see photo three). The Division encourages the operator to clean out the remaining sediment within their sediment pond to ensure that ample volume is readily available if necessary. This material should also be stockpiled for reclamation purposes. Once soil conditions become favorable, repairs and armoring to the sediment pond berm and channel are recommended. The Division notes that the 2018-2019 winter snow pack was above average and melted extremely quickly due to rain.

Photo Three: Mill bench sediment pond with excavated clean out material

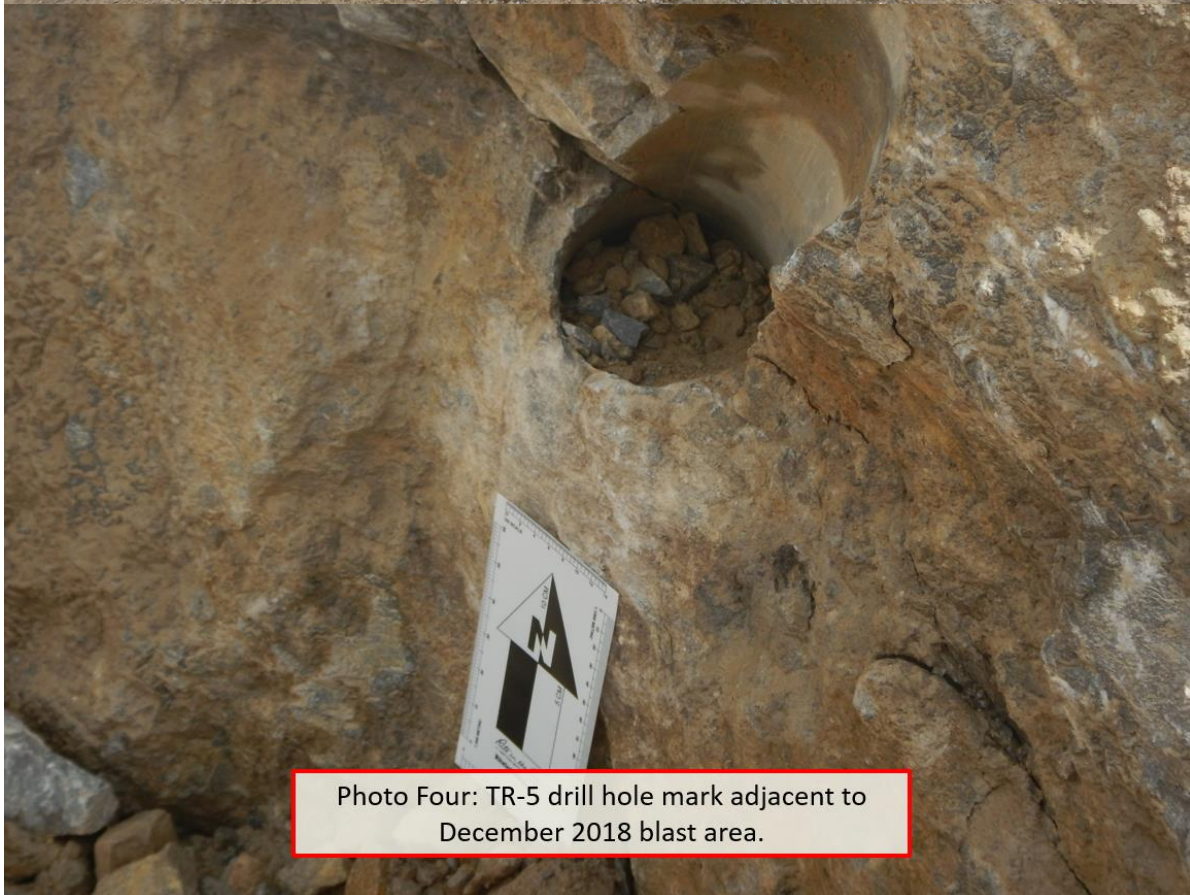
The Division was able to see the TR-5 2018 Drill holes located on the processing bench (photo four). This drilling has concluded and all hole completion information has been submitted. On December 14, 2018 RMR conducted a blast removing approximately 20-30 feet of highwall directly north of the crusher (photo five). This was the same area that the drill holes were located within. The majority of the drill holes are now indistinguishable amongst the blasted rock.

Photo Four: TR-5 drill hole mark adjacent to December 2018 blast area.

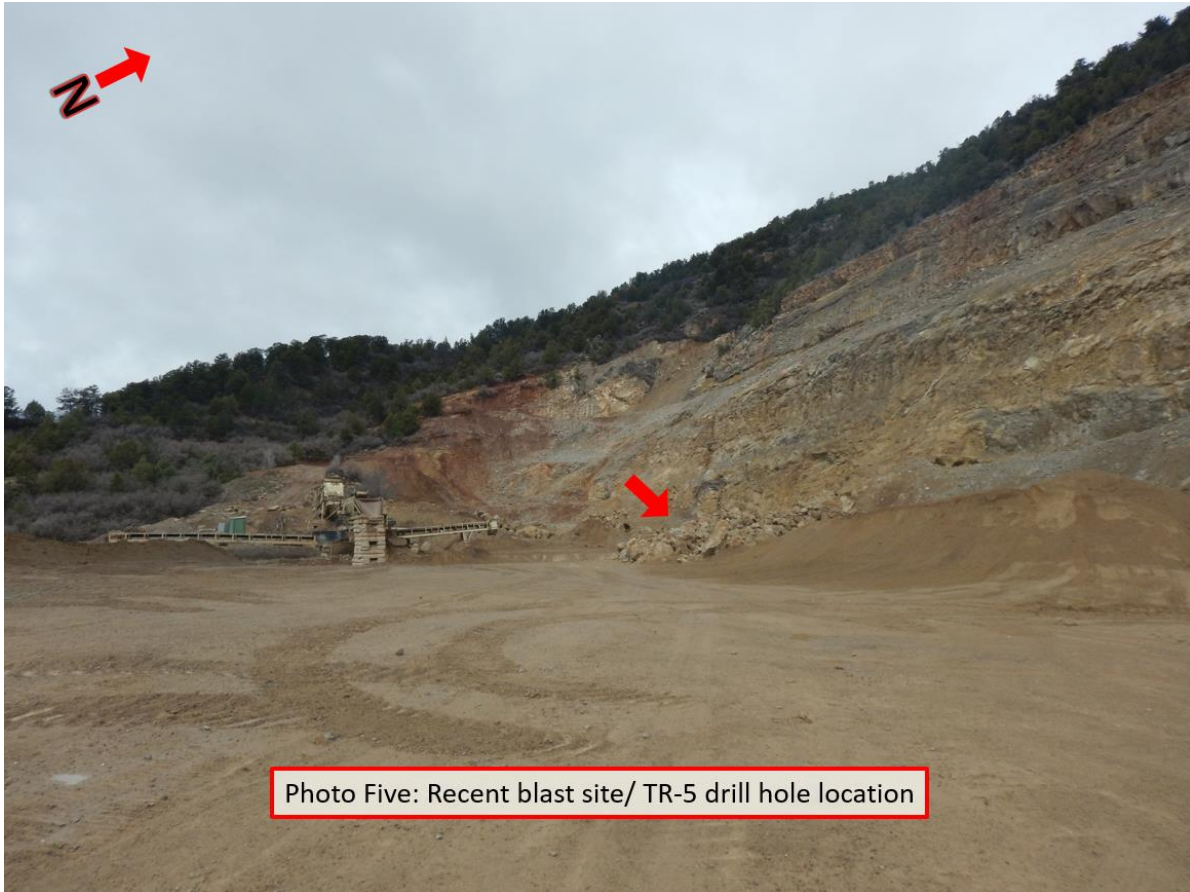
Photo Five: Recent blast site/ TR-5 drill hole location

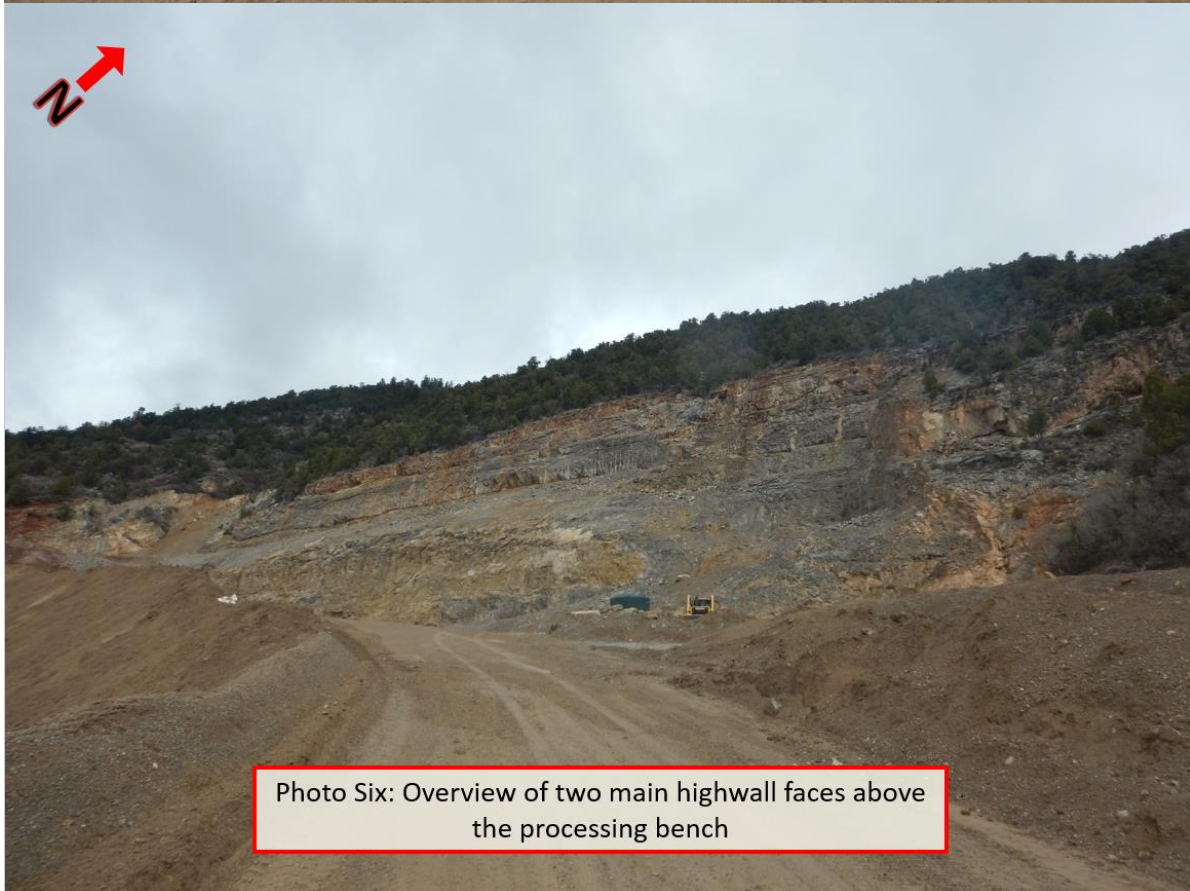
Photo Six: Overview of two main highwall faces above the processing bench
