## MINERALS PROGRAM INSPECTION REPORT

<b>MINE NAME:</b> Weeden Pit No. 30	<b>MINE/PROSPECTING ID#:</b> M-1993-087	<b>MINERAL:</b> Gravel	<b>COUNTY:</b> Prowers
<b>INSPECTION TYPE:</b> Monitoring	<b>INSPECTOR(S):</b> Amy Eschberger	<b>INSP. DATE:</b> March 26, 2019	<b>INSP. TIME:</b> 13:50
<b>OPERATOR:</b> Baca County	<b>OPERATOR REPRESENTATIVE:</b> None	<b>TYPE OF OPERATION:</b> 112c - Construction Regular Operation	
<b>REASON FOR INSPECTION:</b> Normal I&E Program	<b>BOND CALCULATION TYPE:</b> None	<b>BOND AMOUNT:</b> \$0.00	
<b>DATE OF COMPLAINT:</b> NA	<b>POST INSP. CONTACTS:</b> None	<b>JOINT INSP. AGENCY:</b> None	
<b>WEATHER:</b> Clear	<b>INSPECTOR'S SIGNATURE:</b>

# M1993-087 / Weeden Pit No. 30 / Baca County

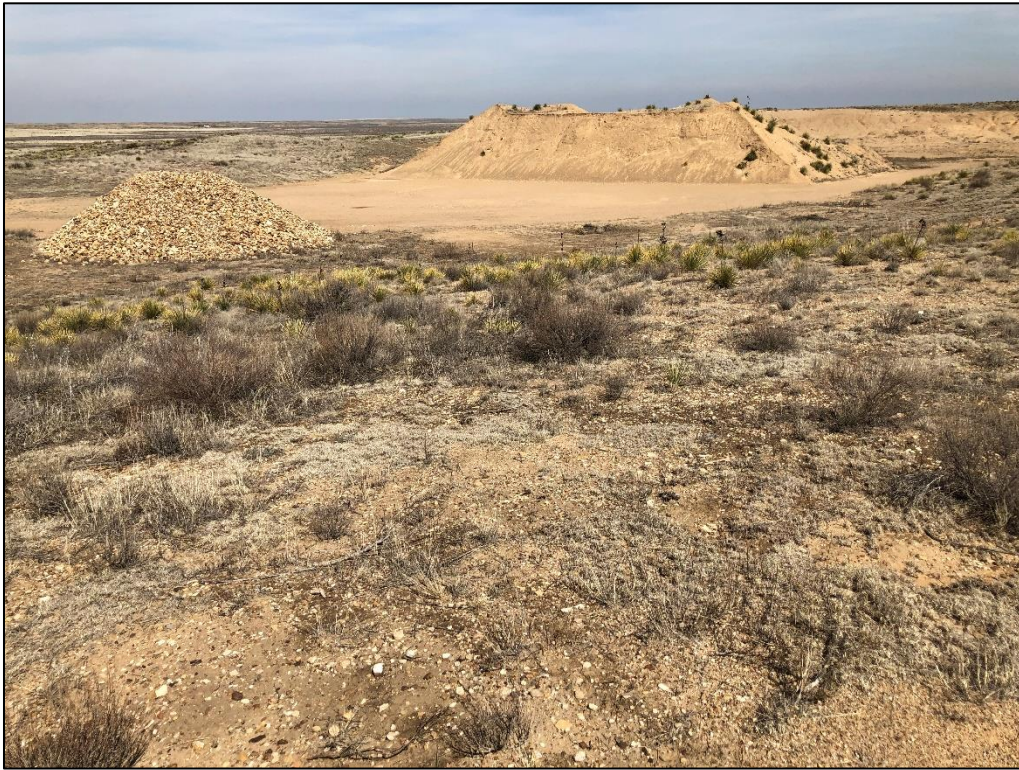
The active pit includes a west-facing highwall approximately 500 feet in length, 20-30 feet in height, with slope gradients of 3H:1V. It appears the pit is being advanced to the east at this time. A large gravel stockpile and a much smaller rock stockpile are stored on the pit floor. Several topsoil and overburden stockpiles are stored along the southern, eastern, and northern edges of the active pit. These stockpiles were stable with good vegetative cover.

**Photo 1.** View looking northeast from haul road toward active pit. Note small rock stockpile (top left) and larger gravel stockpile (top right) stored on pit floor.

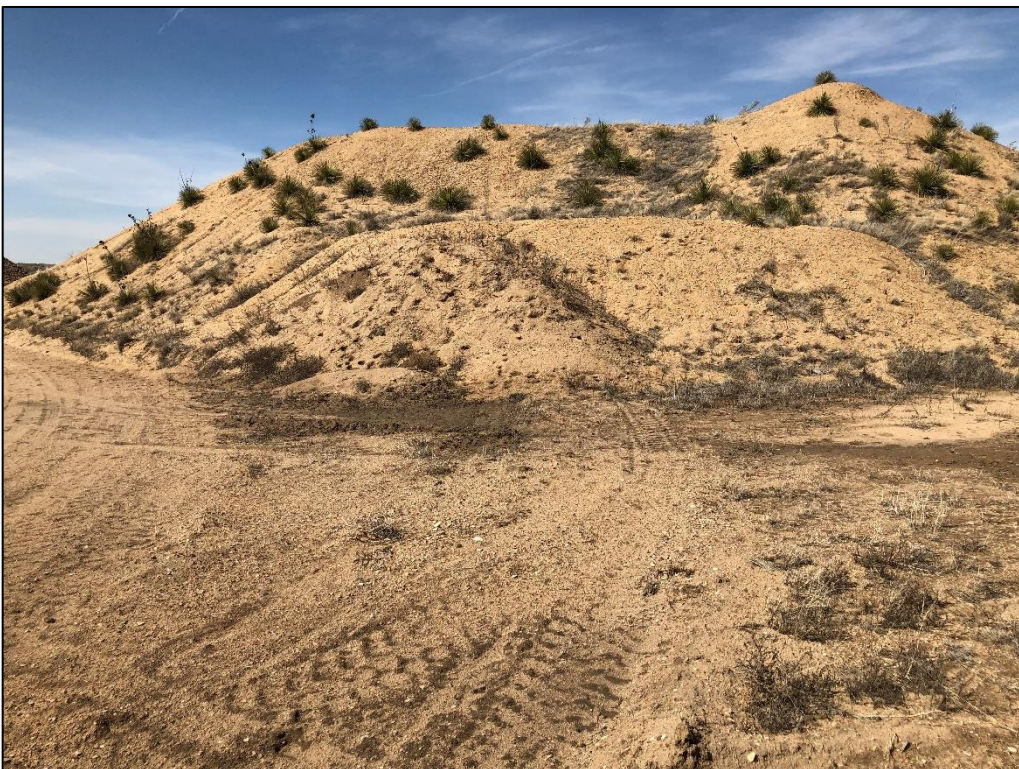
**Photo 2.** View looking north from haul road showing closer view of large gravel stockpile stored on pit floor.

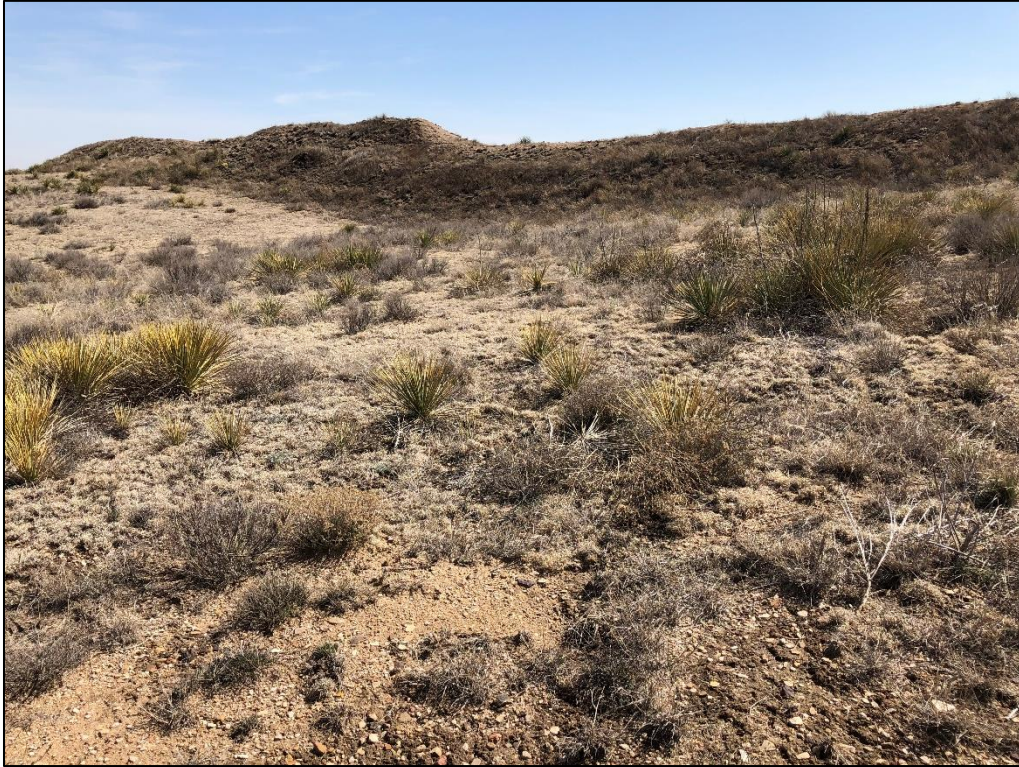
**Photo 3.** View looking south from haul road showing large topsoil stockpile stored south of active pit (top of photo). Note stockpile stable with good vegetative cover.

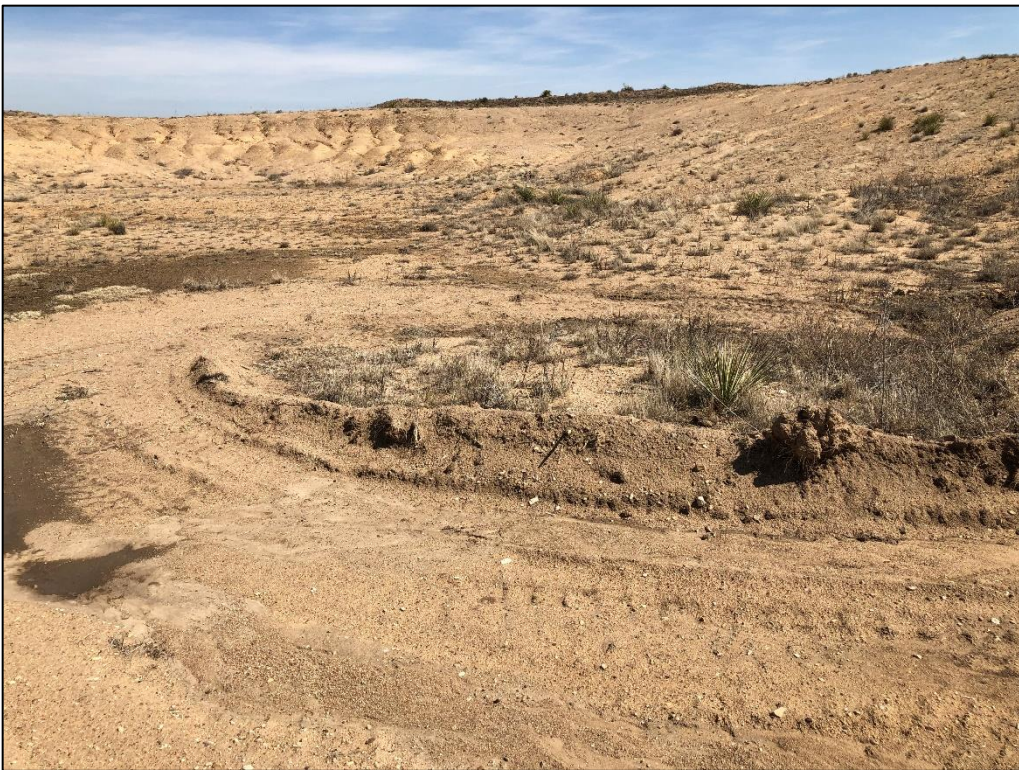
**Photo 4.** View looking east at southern portion of highwall along eastern edge of active pit, approximately 20-30 feet in height with 3H:1V slopes.

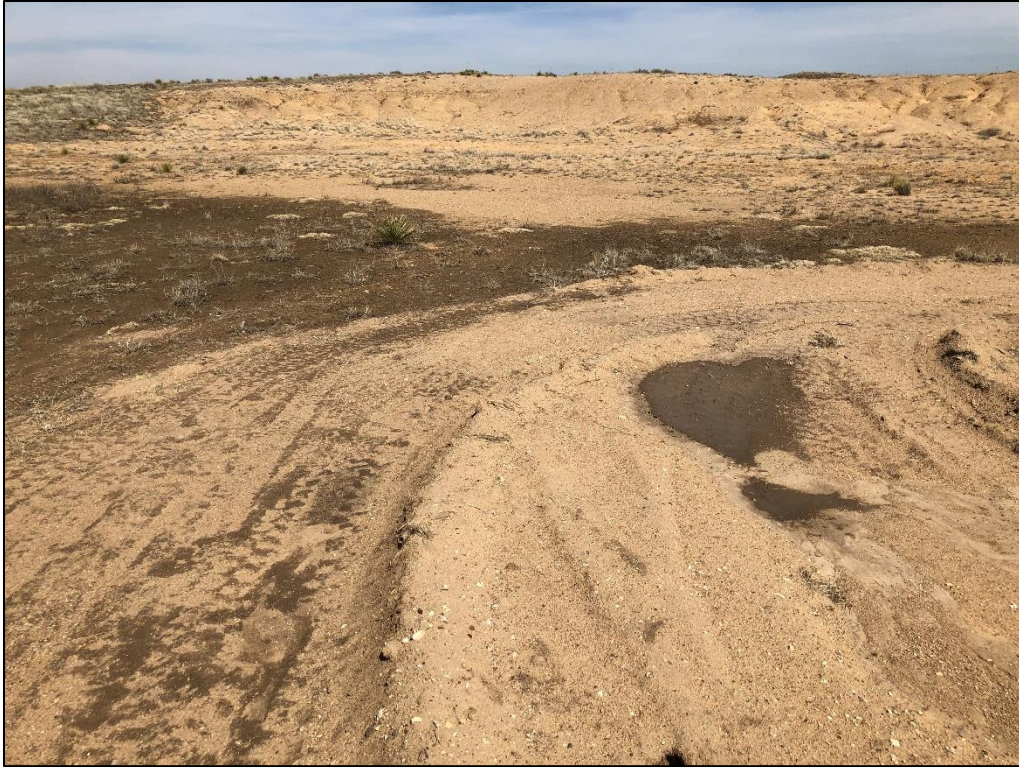
**Photo 5.** View looking east at northern portion of highwall along eastern edge of active pit, approximately 20-30 feet in height with 3H:1V slopes.

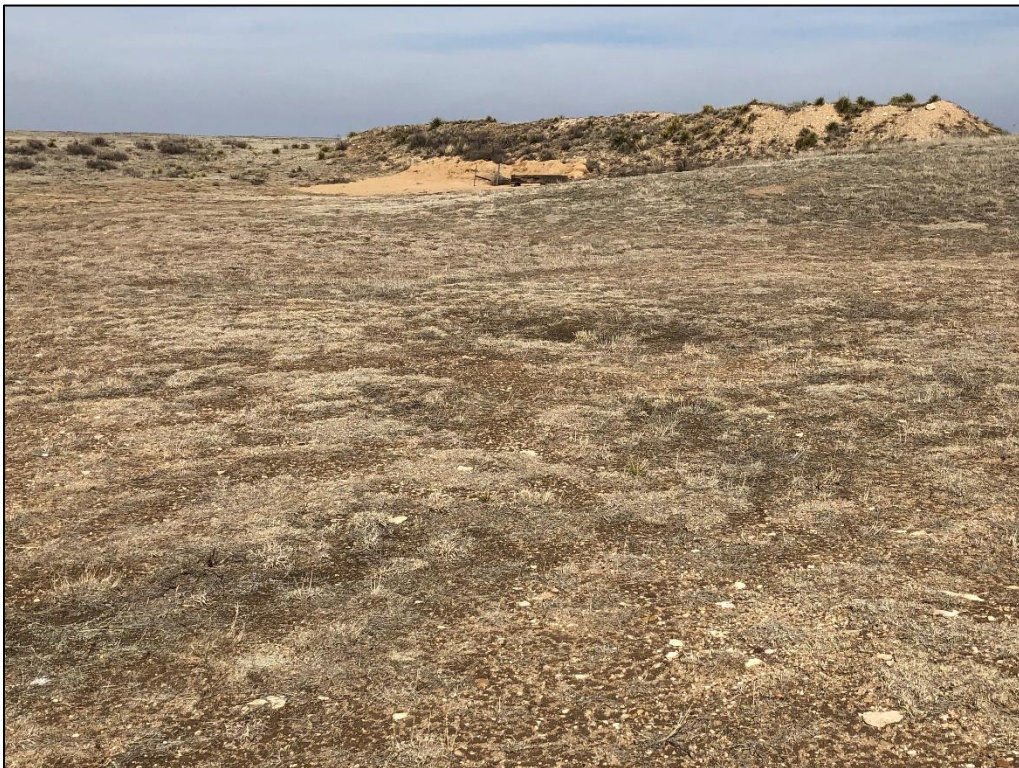
**Photo 6.** View looking northeast at large topsoil stockpile stored north of active pit. Note stockpile stable with good vegetative cover.
