MINERALS PROGRAM INSPECTION REPORT
PHONE: (303) 866-3567

MINE NAME: Randy Shaw Pit	MINE/PROSPECTING ID#: M-1984-134	MINERAL: Sand and gravel	COUNTY: Prowers
INSPECTION TYPE: Monitoring	INSPECTOR(S): Amy Eschberger	INSP. DATE: March 26, 2019	INSP. TIME: 14:20
OPERATOR: Prowers County	OPERATOR REPRESENTATIVE: Mark Dorenkamp	TYPE OF OPERATION: 112c - Construction Regular Operation	
REASON FOR INSPECTION: Normal I&E Program	BOND CALCULATION TYPE: None	BOND AMOUNT: \$0.00	
DATE OF COMPLAINT: NA	POST INSP. CONTACTS: None	JOINT INSP. AGENCY: None	
WEATHER: Clear	INSPECTOR'S SIGNATURE:

M1984-134 / Randy Shaw Pit / Prowers County

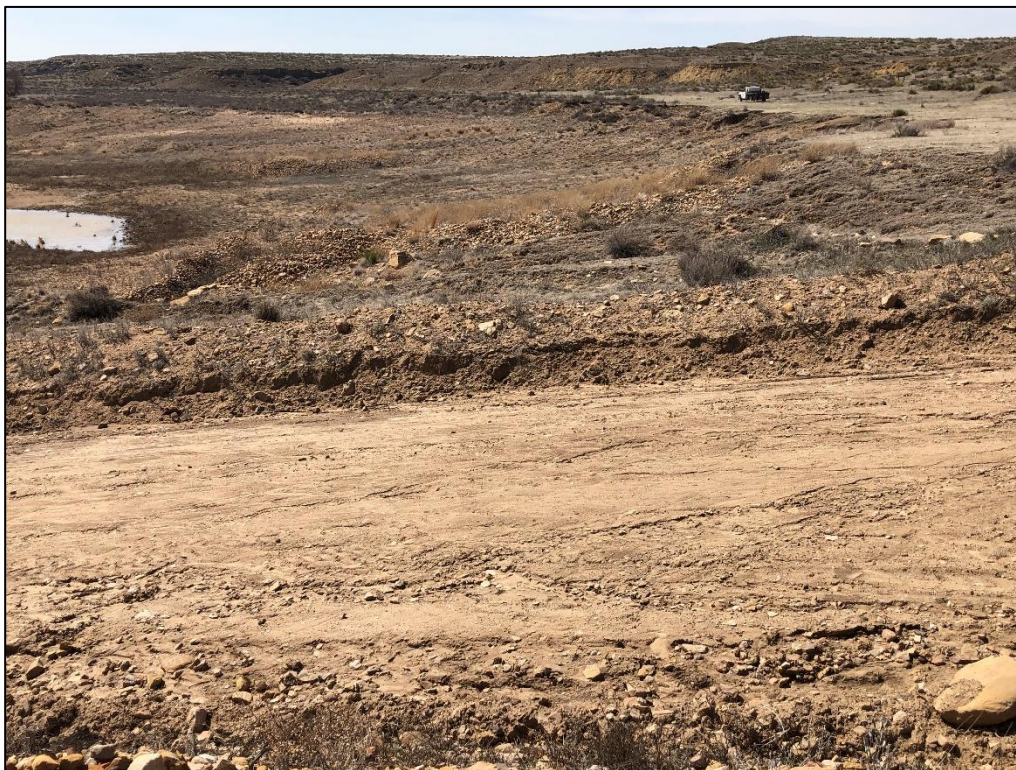
Photo 1. View looking west from access road across northern portion of active pit. Note pit walls graded 3H:1V or flatter and stable.

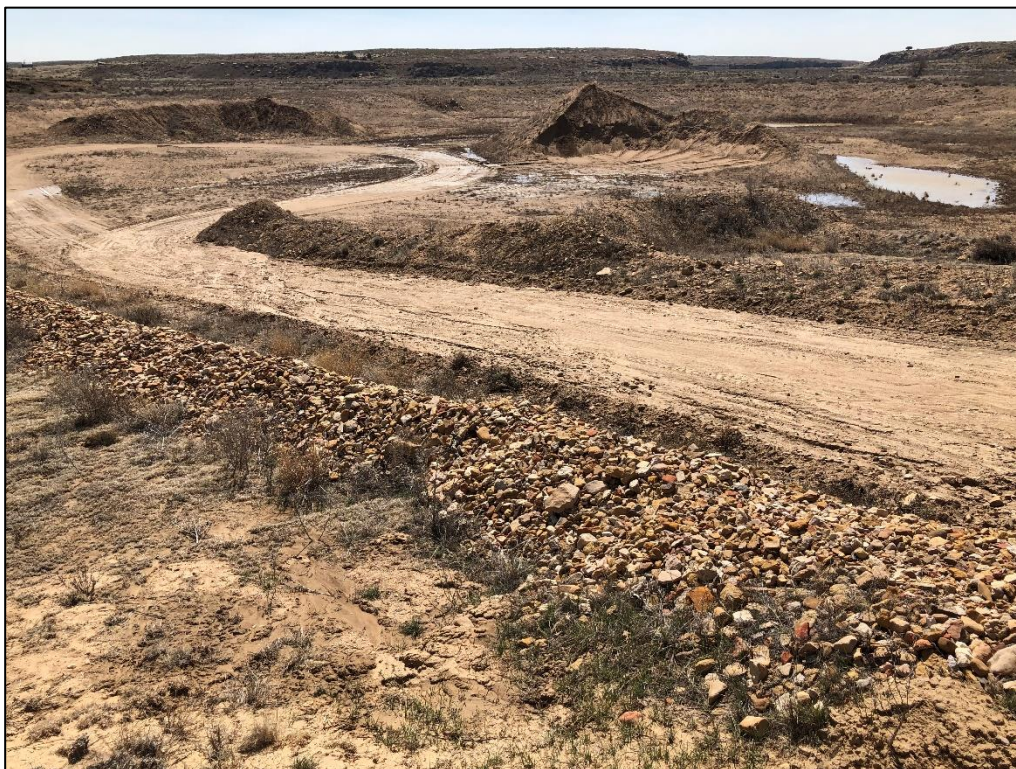
Photo 2. View looking southwest from access road across central portion of active pit. Note material stockpiles stored on pit floor (in background).

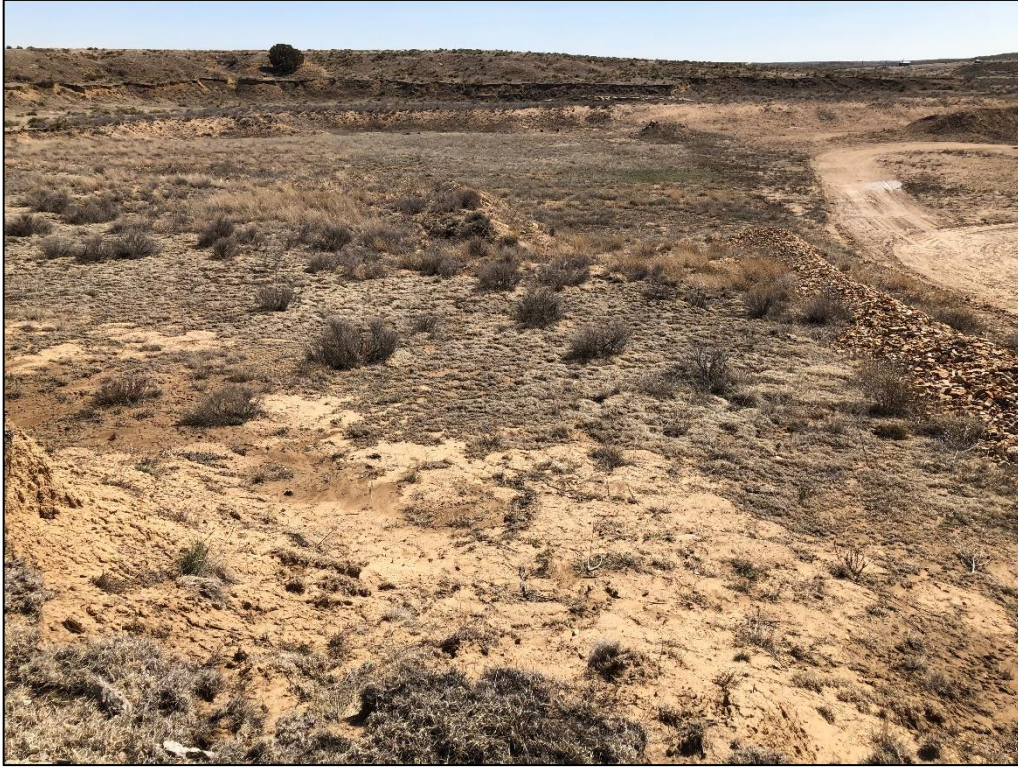
Photo 3. View looking southeast from haul road across eastern portion of active pit. Note native grasses, forbs, and shrubs volunteering across site.

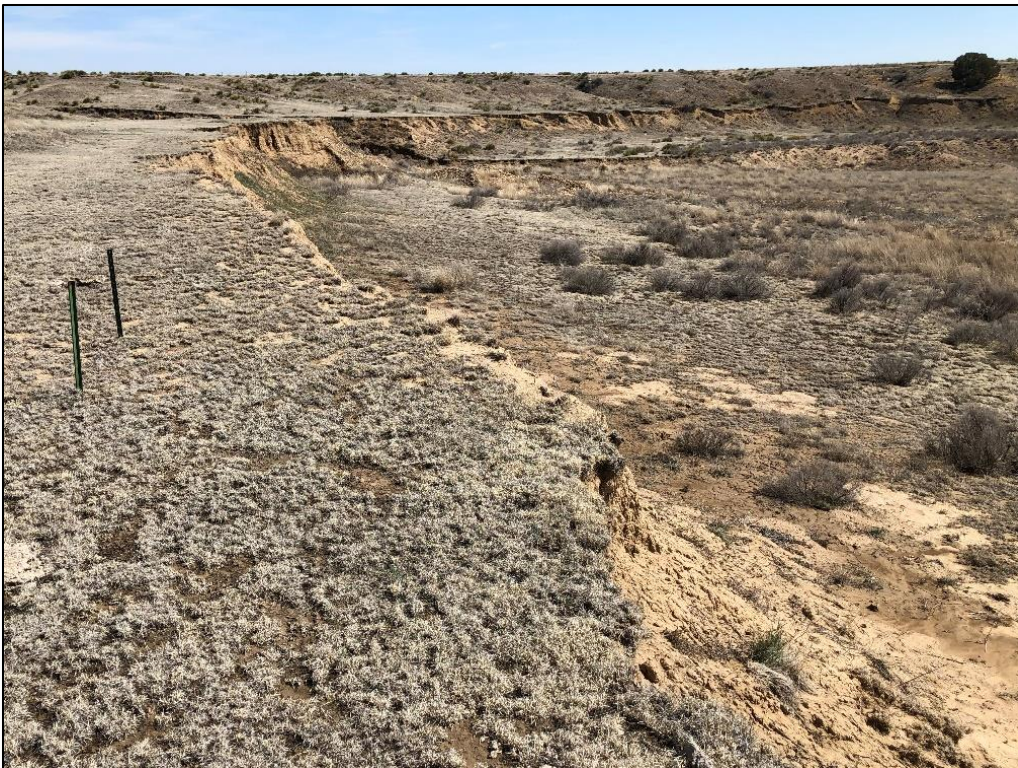
Photo 4. View looking east showing natural slope created by drainage of nearby draw and not by the operation.

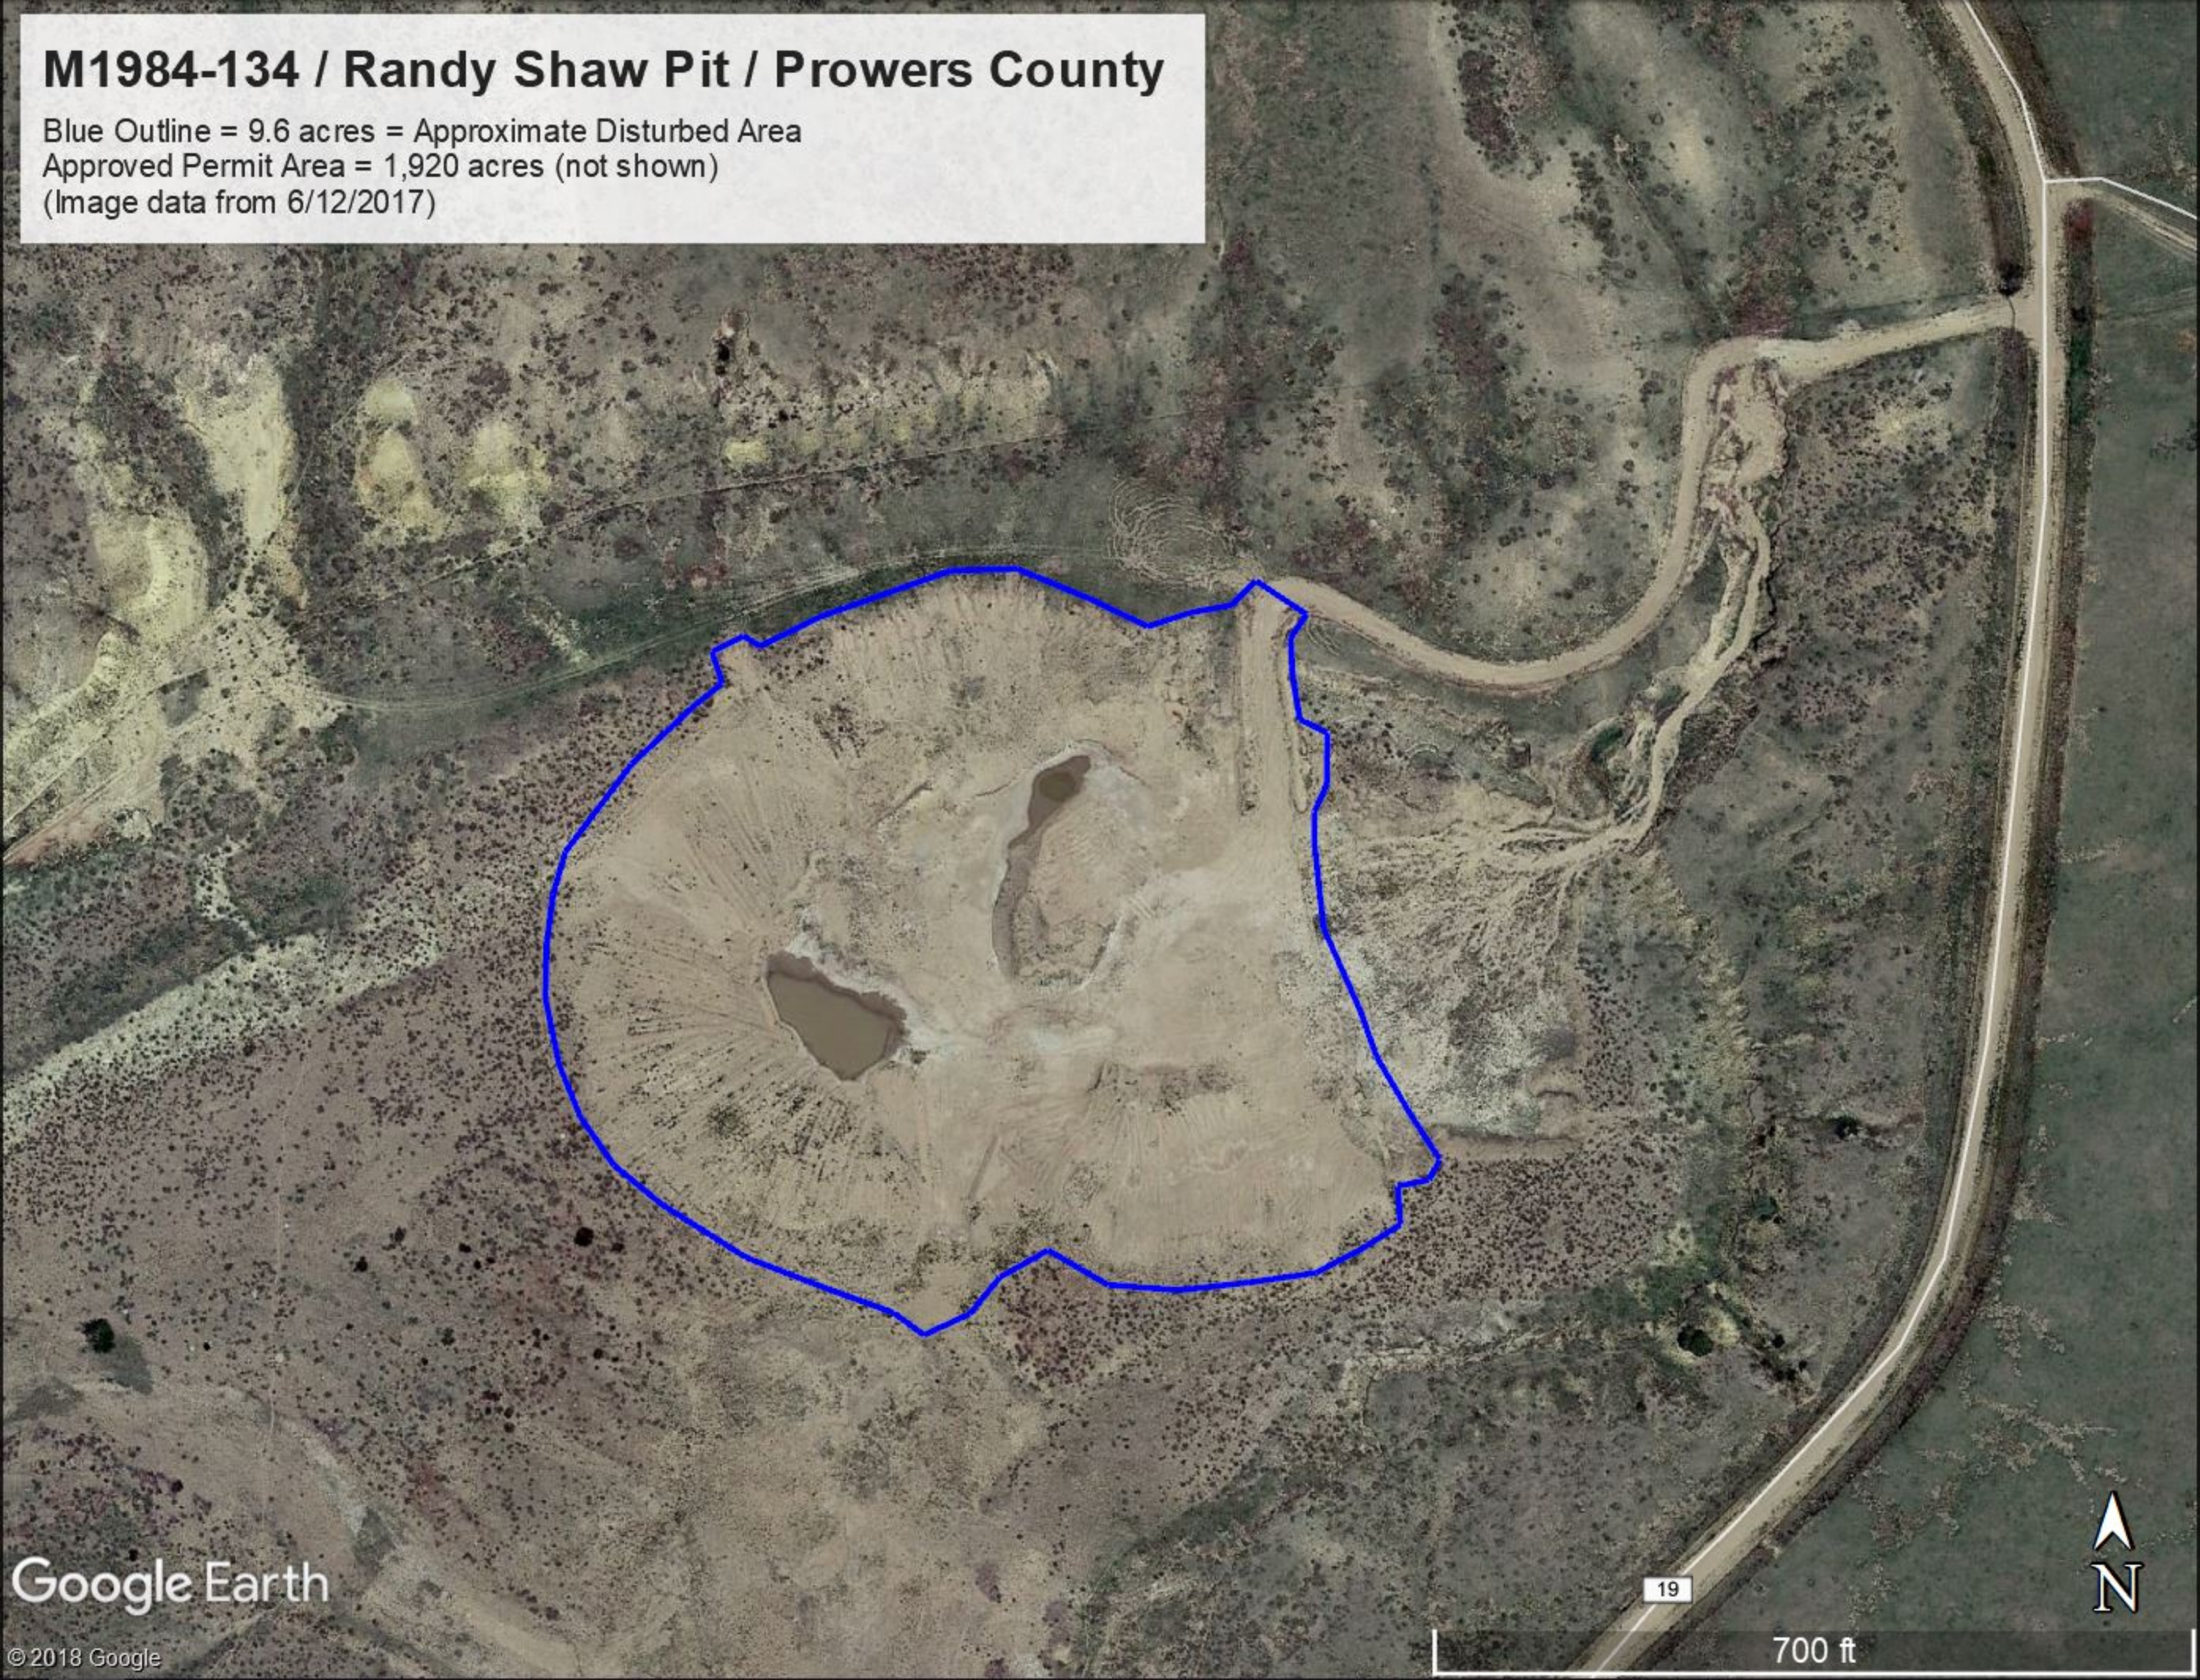
While the permit area is very large in size, the operator is approved to disturb no more than 10 acres at any time. The Division estimates current disturbance to consist of 9.6 acres, which is slightly less than the maximum allowed. Prior to disturbing more than 10 acres, the operator will need to either complete final reclamation of current disturbance, or submit a Technical Revision to increase the maximum allowed disturbed acreage.

Blue Outline = 9.6 acres = Approximate Disturbed Area
Approved Permit Area = 1,920 acres (not shown)
(Image data from 6/12/2017)
