MINERALS PROGRAM INSPECTION REPORT**PHONE: (303) 866-3567**

MINE NAME: Betz Borrow Pit	MINE/PROSPECTING ID#: M-2018-048	MINERAL: Borrow material for	COUNTY: Weld
INSPECTION TYPE: Monitoring	INSPECTOR(S): Peter S. Hays	INSP. DATE: April 9, 2019	INSP. TIME: 13:00
OPERATOR: SEMA Construction, Inc.	OPERATOR REPRESENTATIVE: Addison Halverson	TYPE OF OPERATION: 111 - Construction by Government Agency

April 9, 2019 Inspection Map

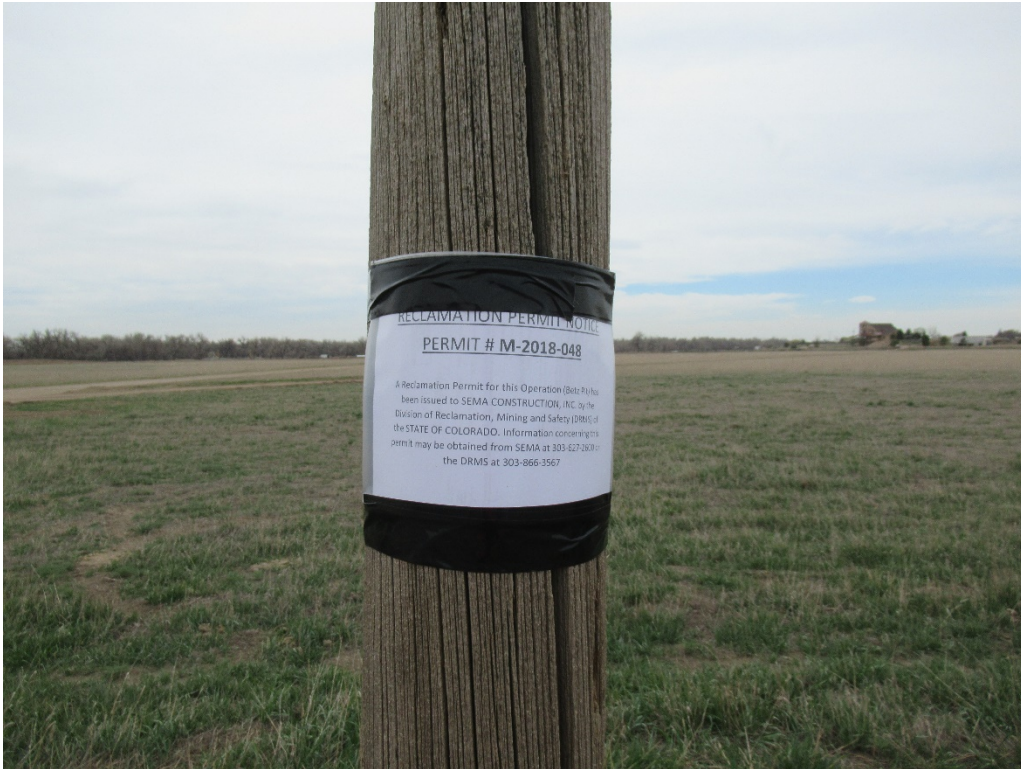
The mine identification sign was observed on a powerline post adjacent to CR 46 pursuant to Rule 3.1.12. The required boundary markers were not observed during the inspection. The north, east and west boundaries were roughly defined by CR 46, a fence line and the landowners driveway, respectively. As cited as a problem, the Division will require the Operator to survey the site, install the required boundary markers and submit proof of the installed markers.

Betz Borrow Pit mine sign

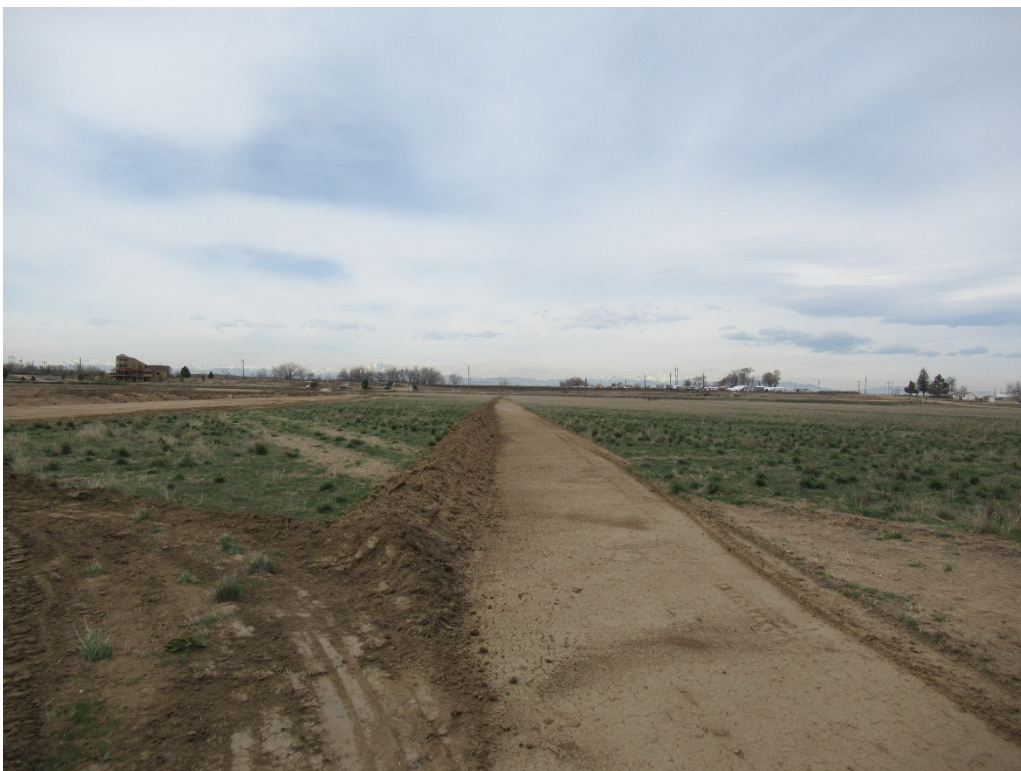
Berm delineating the southern offset distance from the oil and gas no work zone

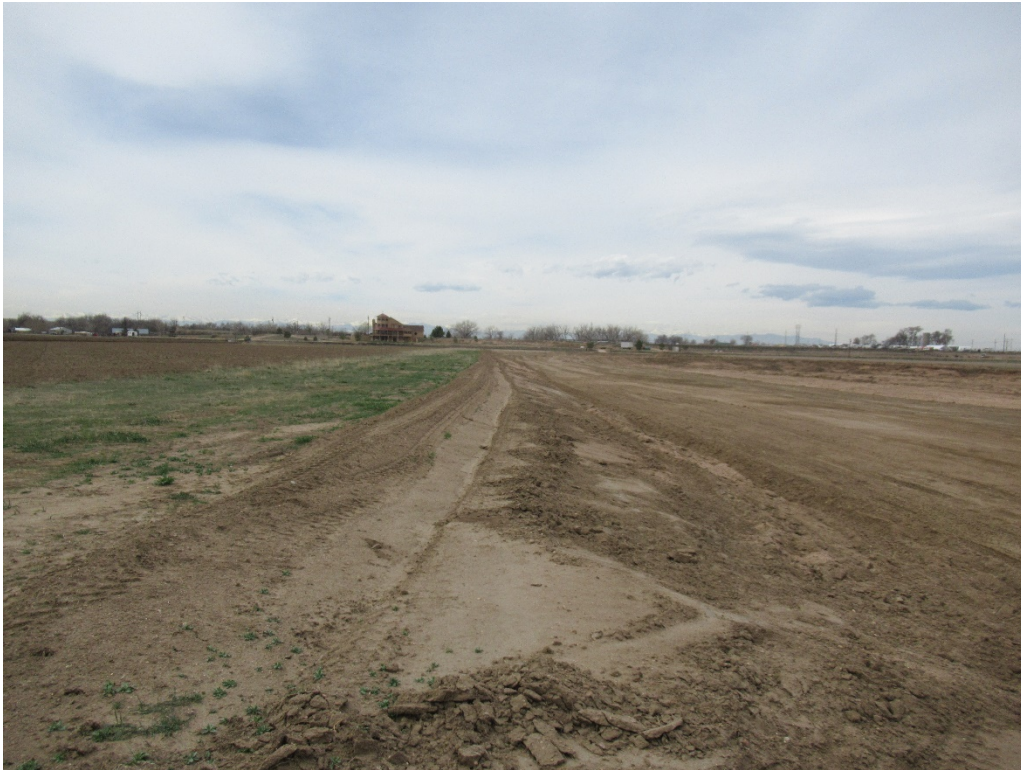
The approved post-mining land use for the site is rangeland. All reclaimed slopes will be graded to 3H:1V or less with 10-12 inches of topsoil replaced during reclamation. The Operator is performing concurrent reclamation of the site. The southern highwall and the southern portion of the east and west highwalls were regraded to the approved final reclamation slope of 3H:1V. Topsoil was replaced at a depth of approximately 12 inches on the regraded slopes and approximately 150 feet of the pit floor was topsoiled from the southern slope to the north. Topsoil was observed in the excavation area. The Operator was reminded of the requirement to salvage and stockpile all available topsoil on site for use during reclamation.

View of the site from the southeast corner looking west, southern highwall reggraded and topsoiled

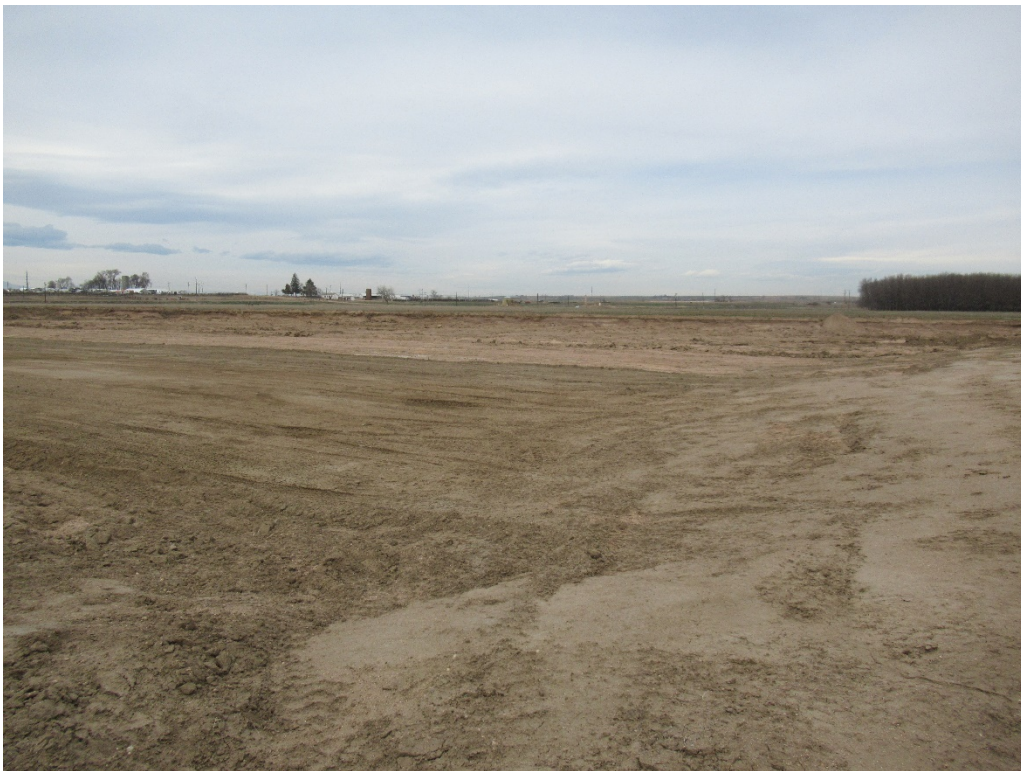
View of the site from the southeast corner looking northwest, topsoil replaced on pit floor

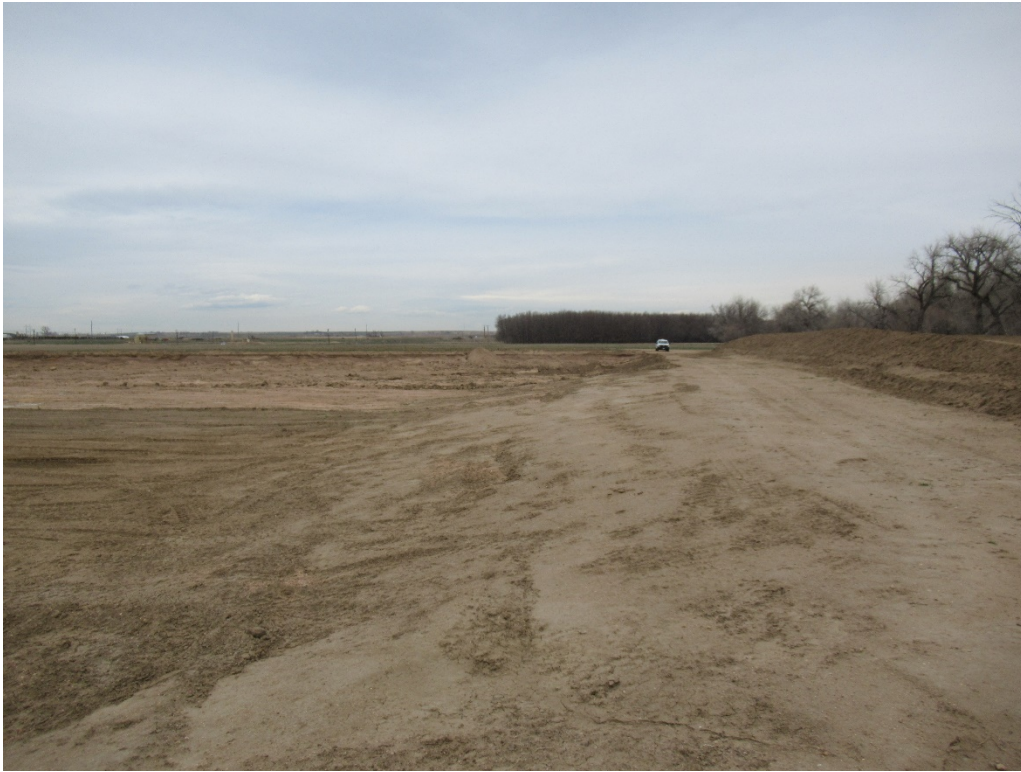
View of the site from the southeast corner looking north, southern portion of east highwall regraded and topsoiled

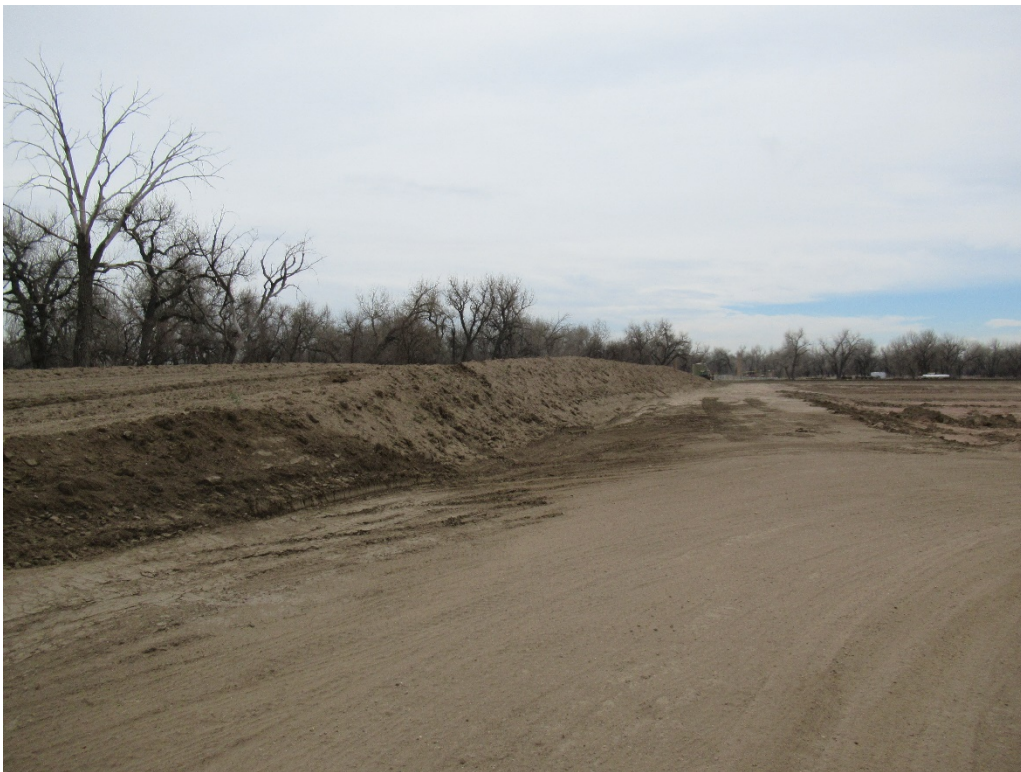
View of the topsoil stockpile in the southeast corner of the site

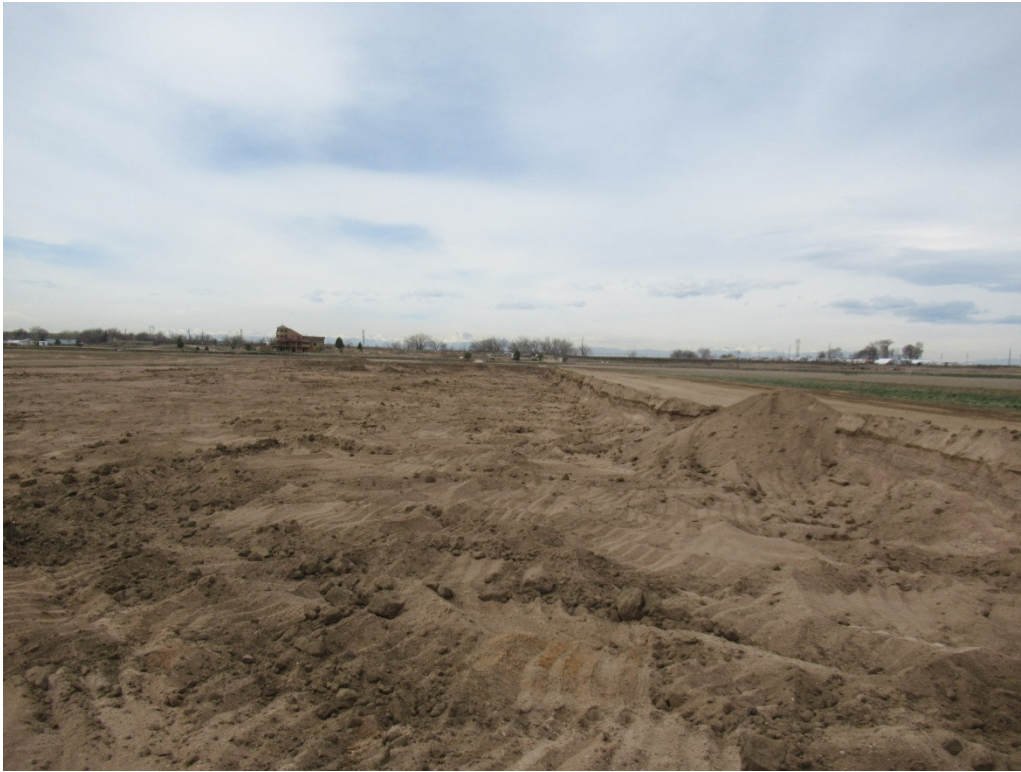
View of the current vertical highwall, 5' in height, looking west

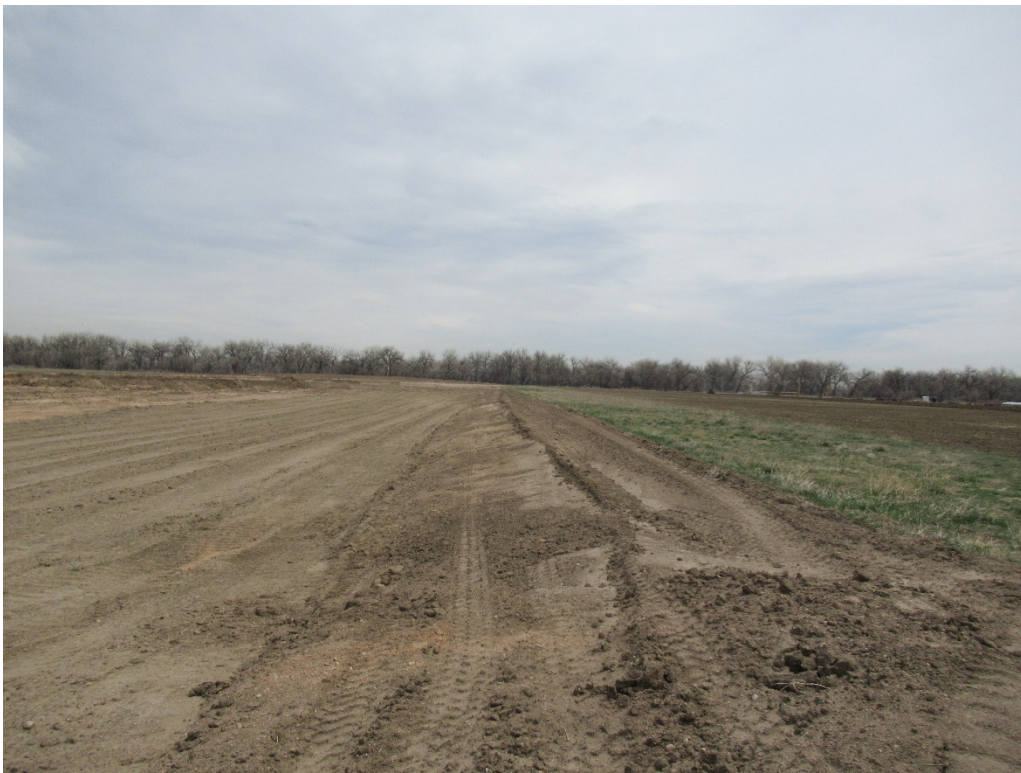
View of the site from the southwest corner looking east, southern highwall regraded and topsoiled

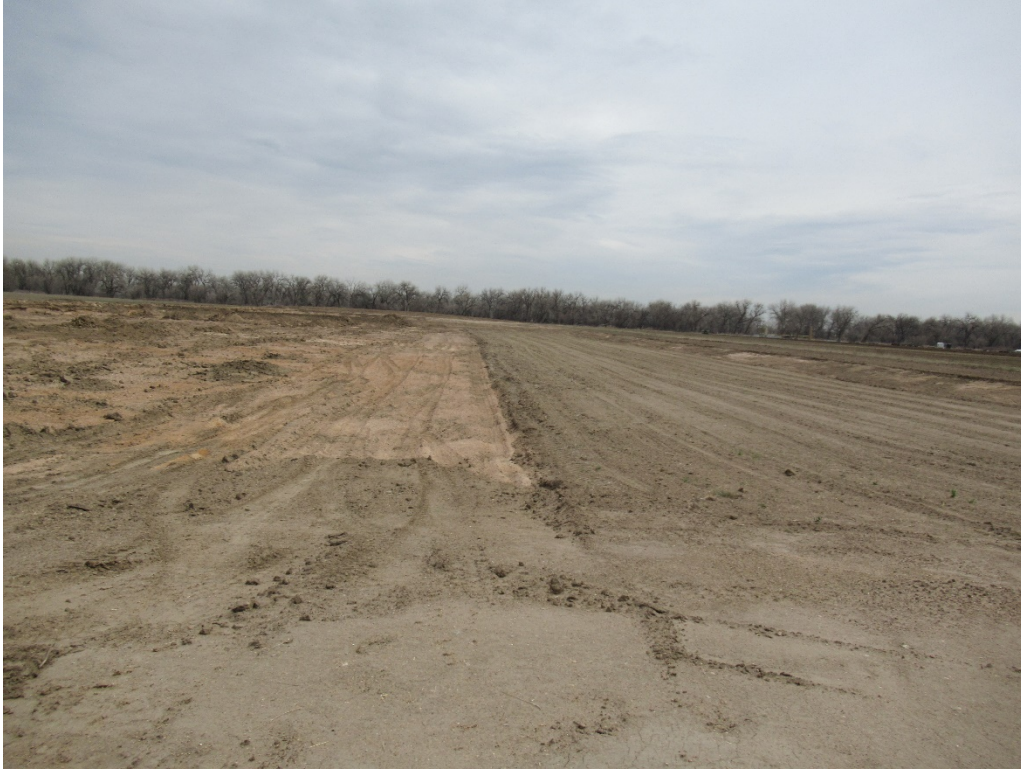
View of the concurrent reclamation in the southwest corner of the site looking east
