MINERALS PROGRAM INSPECTION REPORT
PHONE: (303) 866-3567

MINE NAME: Henderson Mine	MINE/PROSPECTING ID#: M-1977-342	MINERAL: Molybdenum	COUNTY: Clear Creek, Grand
INSPECTION TYPE: Monitoring	INSPECTOR(S): Peter S. Hays	INSP. DATE: April 17, 2019	INSP. TIME: 10:00
OPERATOR: Climax Molybdenum Company	OPERATOR REPRESENTATIVE: Aaron Hilshorst	TYPE OF OPERATION: 112d-3 - Designated Mining Operation	
REASON FOR INSPECTION: Normal I&E Program	BOND CALCULATION TYPE: None	BOND AMOUNT: \$37,993,785.00	
DATE OF COMPLAINT: NA	POST INSP. CONTACTS: None	JOINT INSP. AGENCY: None	
WEATHER: Clear	INSPECTOR'S SIGNATURE:

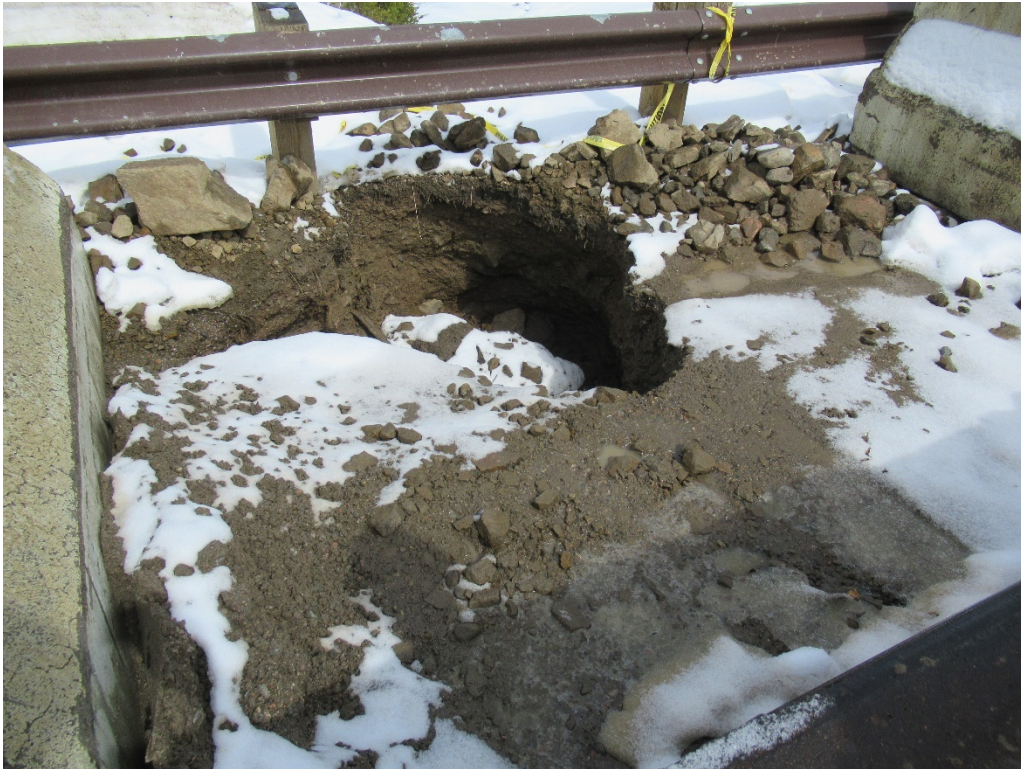
On April 9, 2019, Henderson staff informed the Division of a sink hole along the left abutment of the East Branch Dam. The dam is listed as an EPF with the Division, however since it was determined not to be a failure or imminent failure of the EPF the sink hole was not reported under Rule 8.1(b) by Henderson. Henderson reported the sink hole to the Dam Safety office and is coordinating with the Dam Safety staff regarding the investigation and repair of the sink hole. The source of the sink hole is believed to be a pipe failure from Ute

Creek Reservoir. Water from Ute Creek Reservoir is piped through two (2) eight (8) inch diameter pipes under County Road 3 and along the left abutment of the East Branch Dam to the East Branch pump house. The sink hole area was potholed by Henderson the day before this inspection, however the pipeline was not located. Henderson intends to excavate the area to locate the pipe once the appropriate notice and permits are received from Grand County to operate in County Road 3.

View of sink hole above the East Branch Dam left abutment along CR 3 shoulder
