**MINERALS PROGRAM INSPECTION REPORT**  
**PHONE: (303) 866-3567**

<b>MINE NAME:</b> Arnold Pit No. 1	<b>MINE/PROSPECTING ID#:</b> M-2016-022	<b>MINERAL:</b> Borrow material	<b>COUNTY:</b> Weld
<b>INSPECTION TYPE:</b> Monitoring	<b>INSPECTOR(S):</b> Peter S. Hays	<b>INSP. DATE:</b> April 23, 2019	<b>INSP. TIME:</b> 10:00
<b>OPERATOR:</b> Arnolds Custom Seeding, LLC	<b>OPERATOR REPRESENTATIVE:</b> None	<b>TYPE OF OPERATION:</b> 110c - Construction Limited Impact

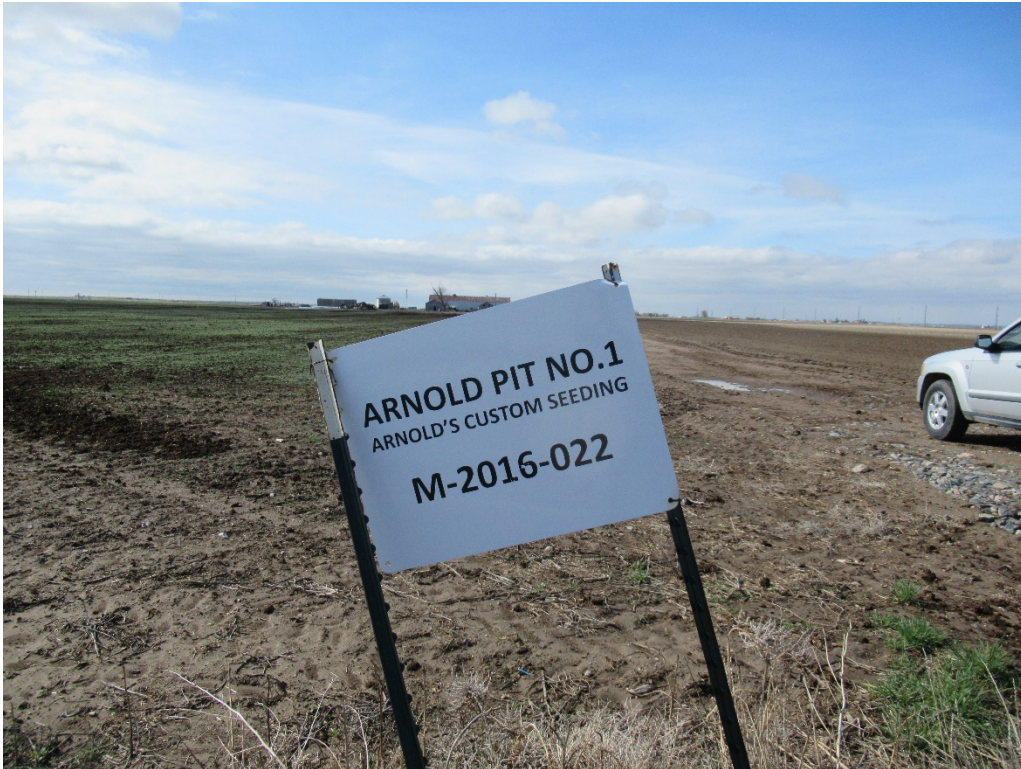
**PROBLEM:** The mine identification sign and affected area boundary markers were not observed or were not compliant per the requirements of Rule 3.1.12.

The mine identification sign located at the entrance of the site identified the site name, Operator and permit number, however the sign did not indicate a reclamation permit for the operation has been issued by the Colorado Mined Land Reclamation Board. Additionally, only the northeast boundary markers was identified by the Division during the inspection. As cited as a problem, the Division will require the Operator to update the mine sign, install the markers for the 110c permit boundary and provide photographic evidence both items are corrected by the corrective action date.

Arnold Pit No. 1 mine sign

**CORRECTIVE ACTIONS:** The Operator must post a sign at the entrance to the mine site which shall be clearly visible from the access road and specify the following; the name of the Operator, **indicate that a reclamation permit for the operation has been issued by the Colorado Mined Land Reclamation Board**, and the permit number. The boundaries of the affected area must be marked by monuments or other markers that are clearly visible and adequate to delineate such boundaries.

**CORRECTIVE ACTION DUE DATE:** 6/8/19

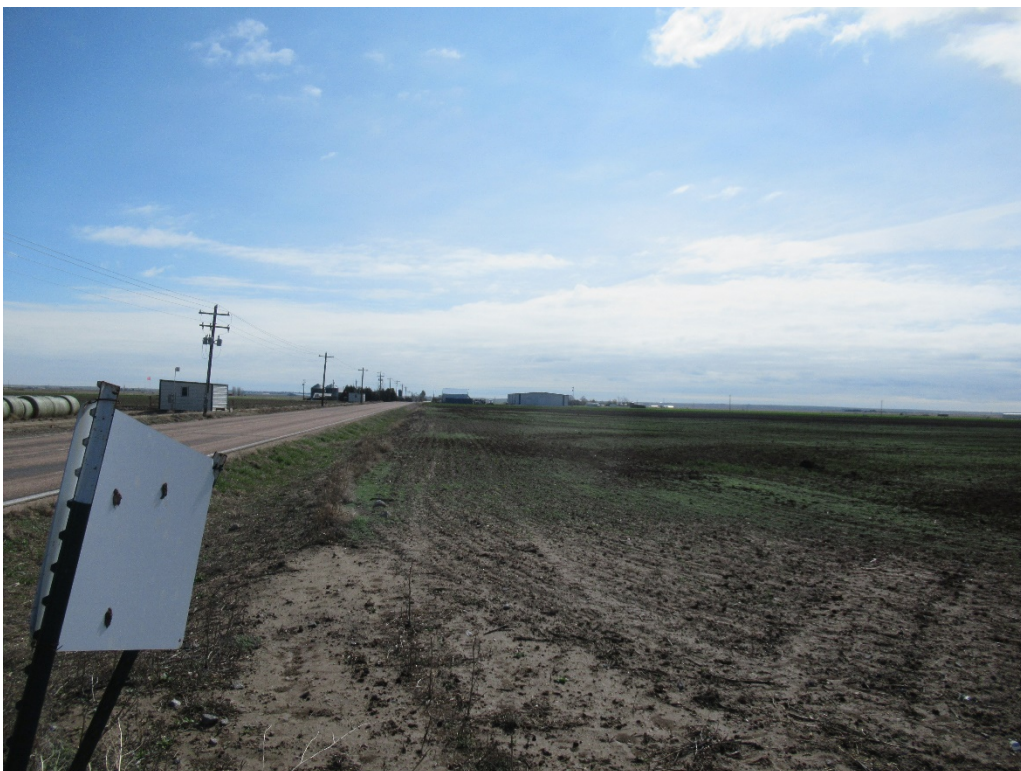
View of the 110 permit area from the northwest corner looking east

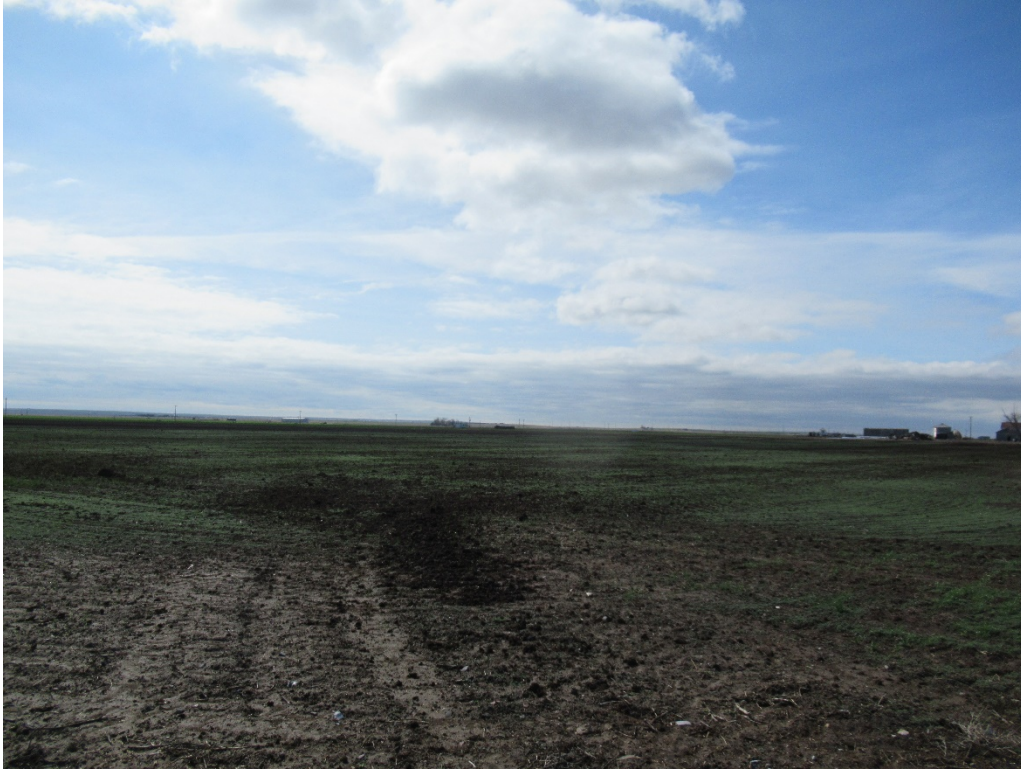
View of the 110 permit area from the northwest corner looking southeast

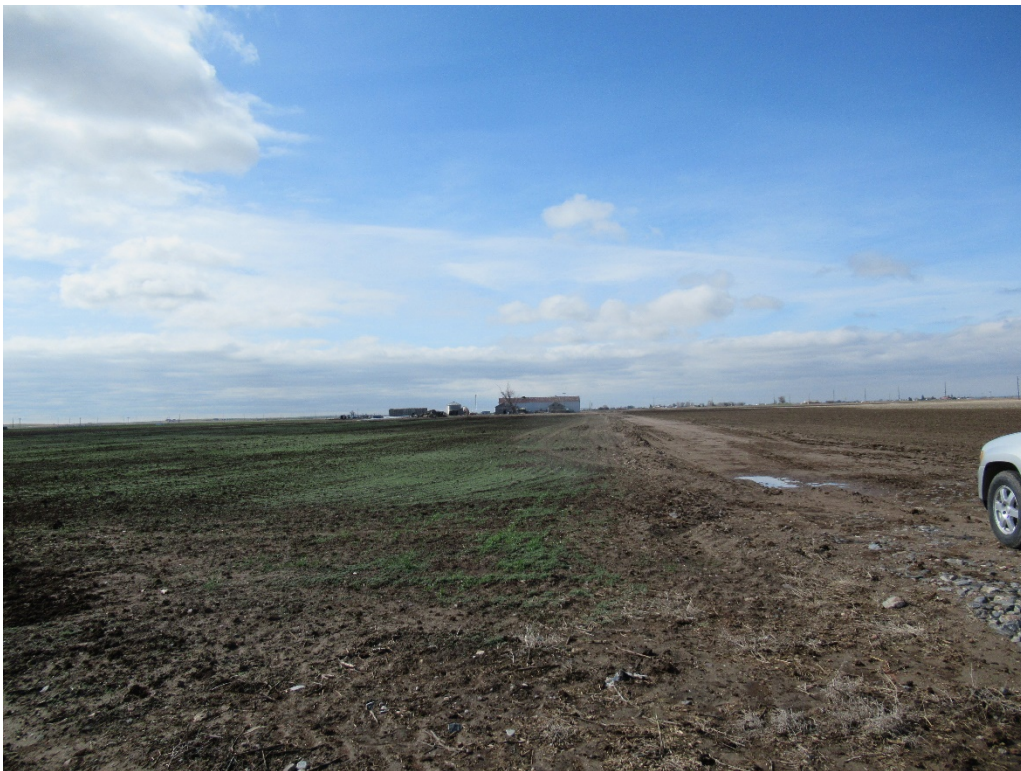
View of the 110 permit area from the northwest corner looking south

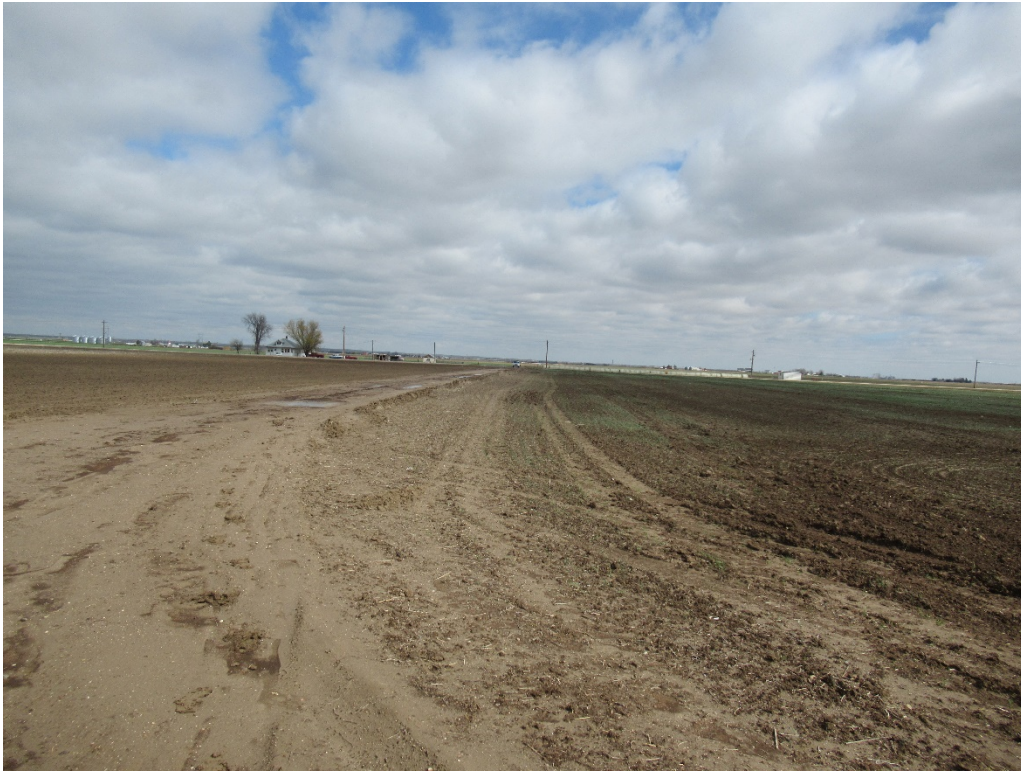
View of the 110 permit area from the southwest corner looking north

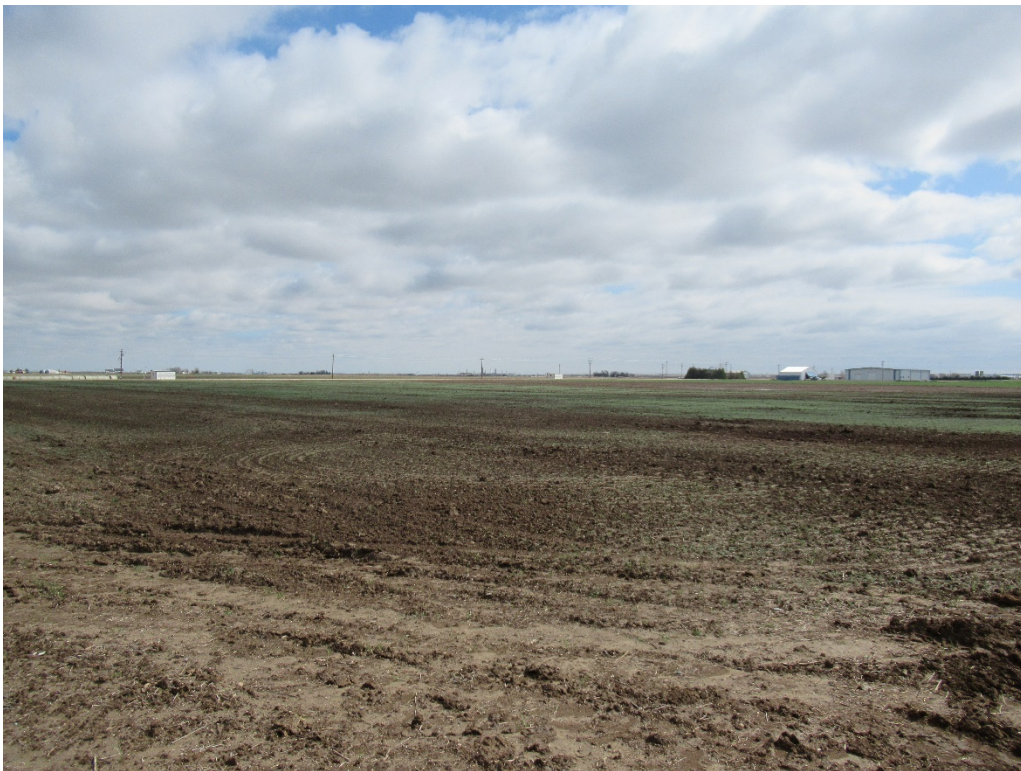
View of the 110 permit area from the southwest corner looking northeast

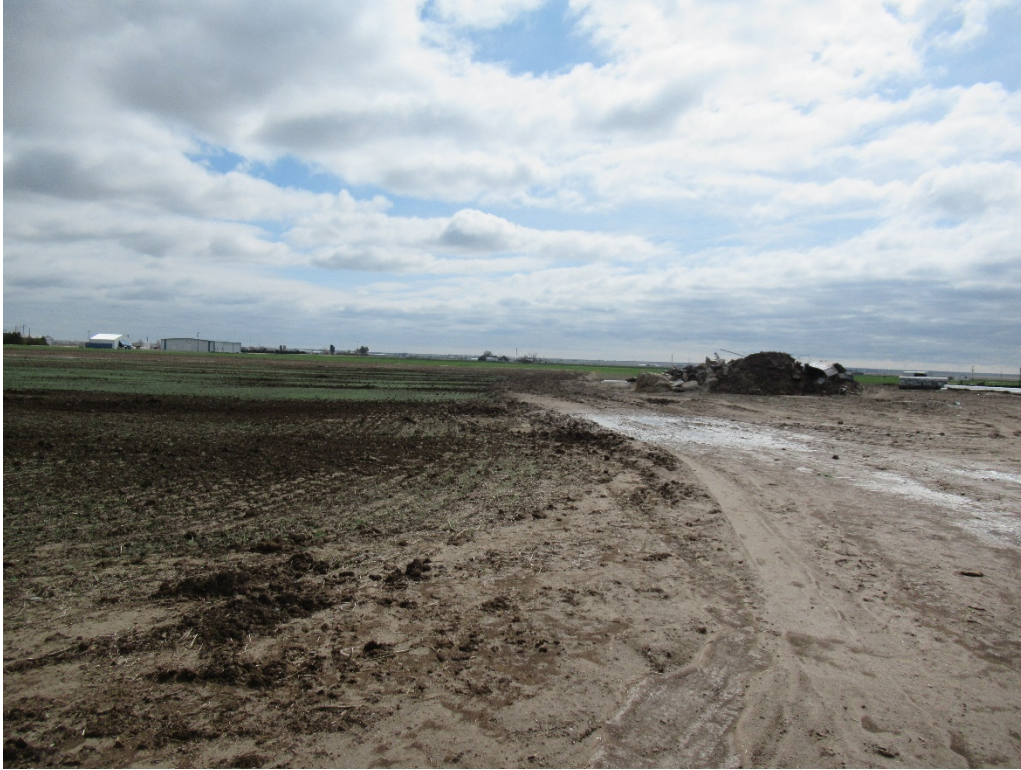
View of the 110 permit area from the southwest corner looking east

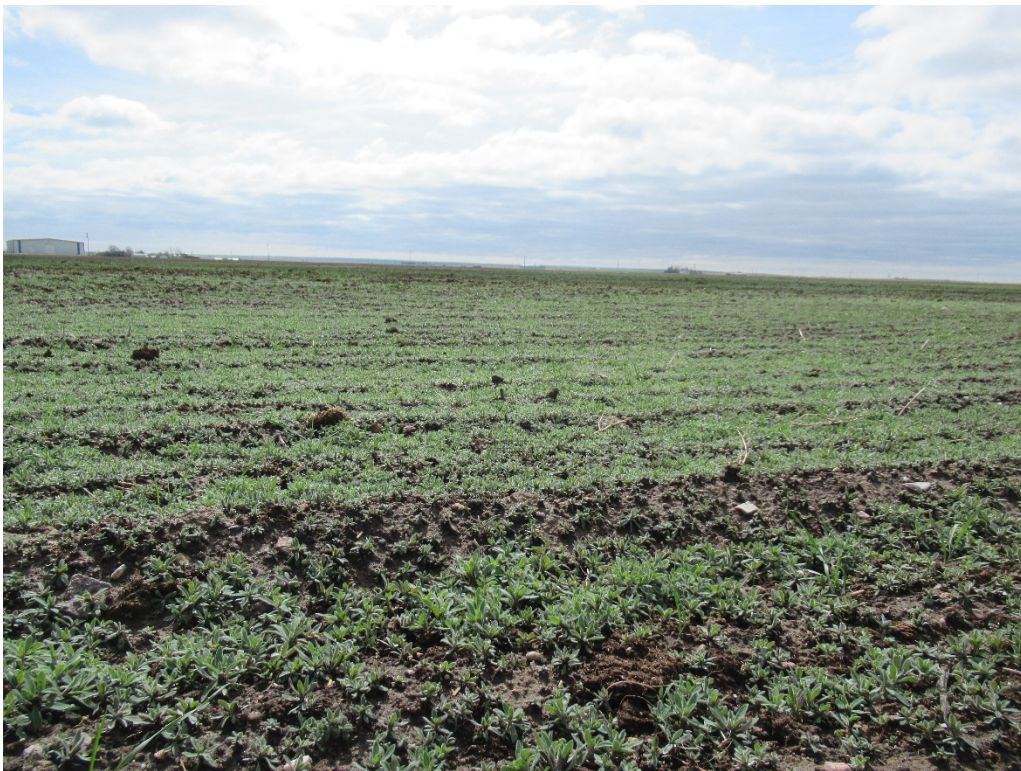
The approved post-mining land use is cropland. The site is in final reclamation. The 110 permit area has been regraded to the approximate original elevation. The western portion of the site contained vegetation and the eastern portion was bare tilled ground. The Operator stated manure was hauled on-site and blended with the native material to reclaim the disturbance area to the approximate original elevation. The 110c permit area was consistent with the surrounding areas other than the amount of vegetation.

View of the typical vegetation on the western portion of the 110c permit area

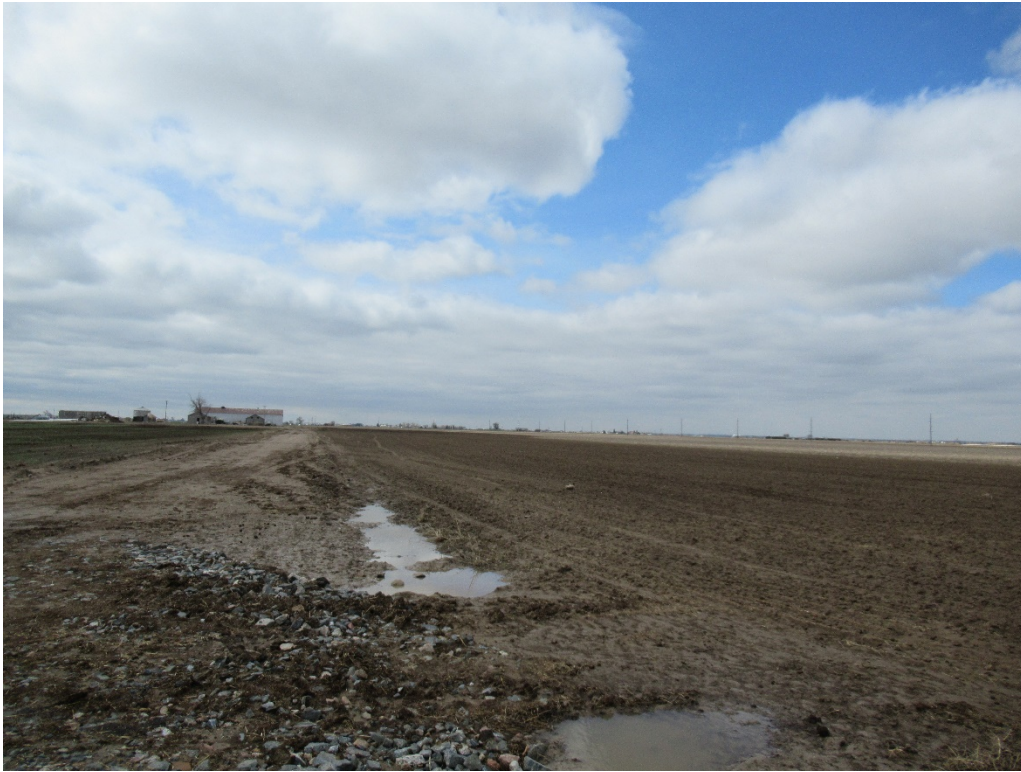
The Division identified an area approximately 200 feet wide and 500 feet long during the inspection which appeared to have been recently disturbed based on the lack of vegetation. The disturbance area had been regraded, disked and was consistent with the surrounding area.

View of the disturbance area outside of the 110c permit area looking south from the east side of the access road

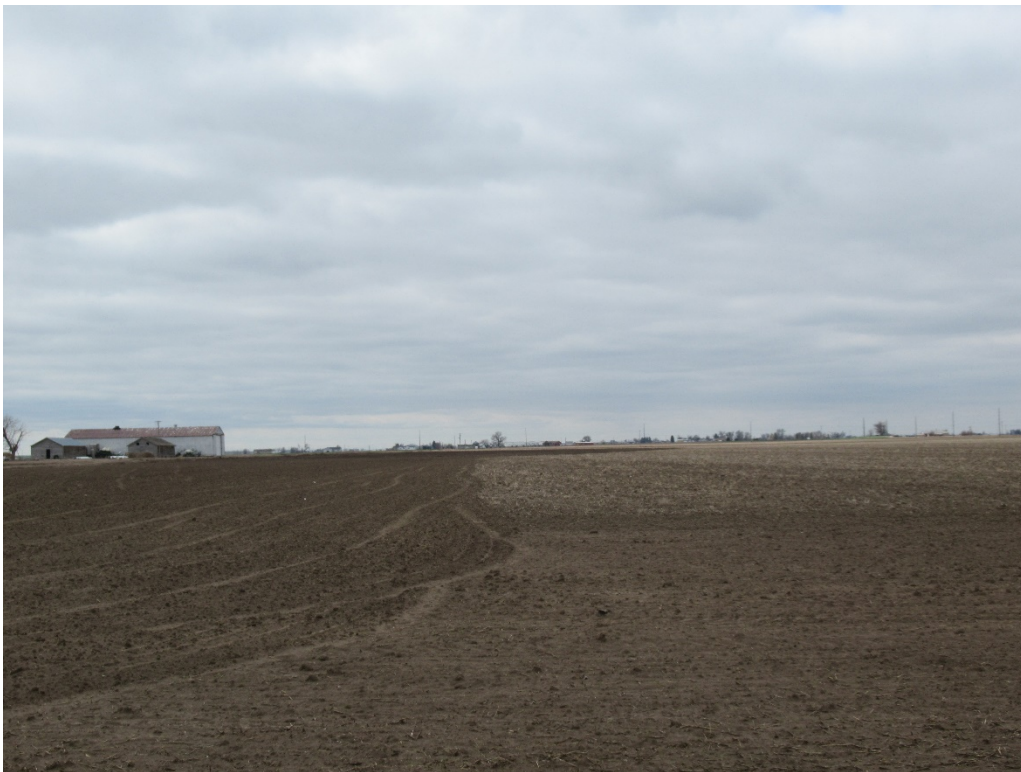
View of the disturbance area outside of the 110c permit area looking south from CR 16 at the difference in vegetation
