MINERALS PROGRAM INSPECTION REPORT
PHONE: (303) 866-3567

MINE NAME: Arnold Pit No. 1	MINE/PROSPECTING ID#: M-2016-022	MINERAL: Borrow material	COUNTY: Weld
INSPECTION TYPE: Pre-Operation Inspection	INSPECTOR(S): Peter S. Hays	INSP. DATE: April 23, 2019	INSP. TIME: 11:00
OPERATOR: Arnolds Custom Seeding, LLC	OPERATOR REPRESENTATIVE: Doug Cook	TYPE OF OPERATION: 110c - Construction Limited Impact	
REASON FOR INSPECTION: Pre-Operation Inspection	BOND CALCULATION TYPE: Complete Bond	BOND AMOUNT: \$11,675.00	
DATE OF COMPLAINT: NA	POST INSP. CONTACTS: None	JOINT INSP. AGENCY: None	
WEATHER: Clear	INSPECTOR'S SIGNATURE:

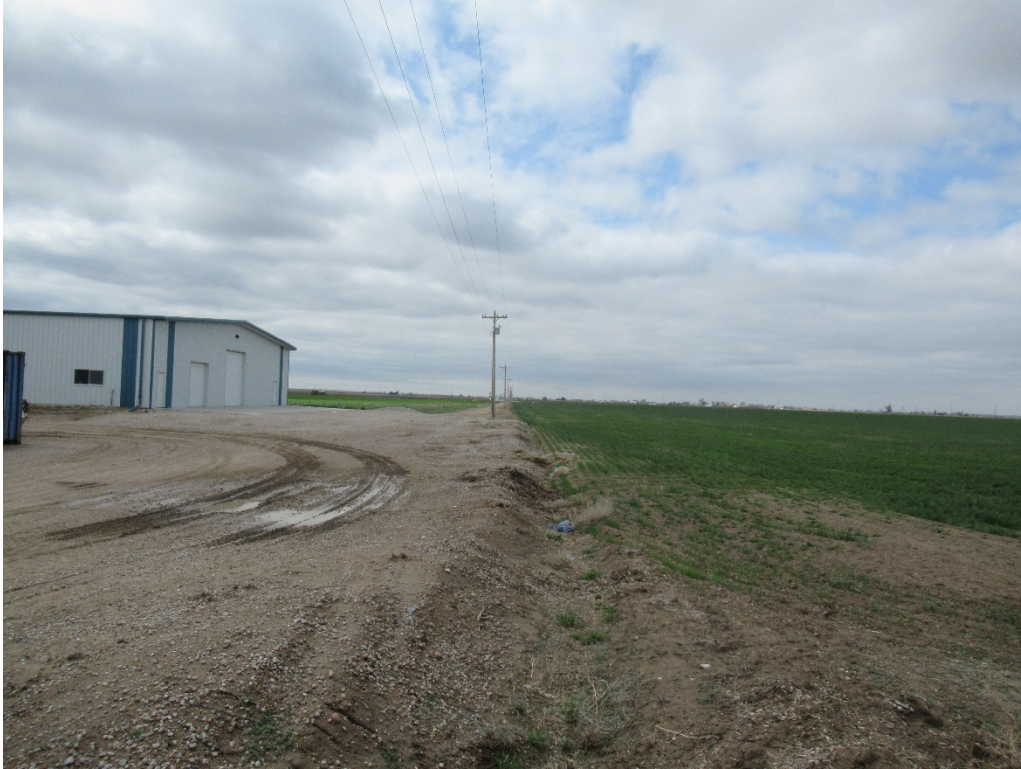
View of conversion area from the northeast corner looking south

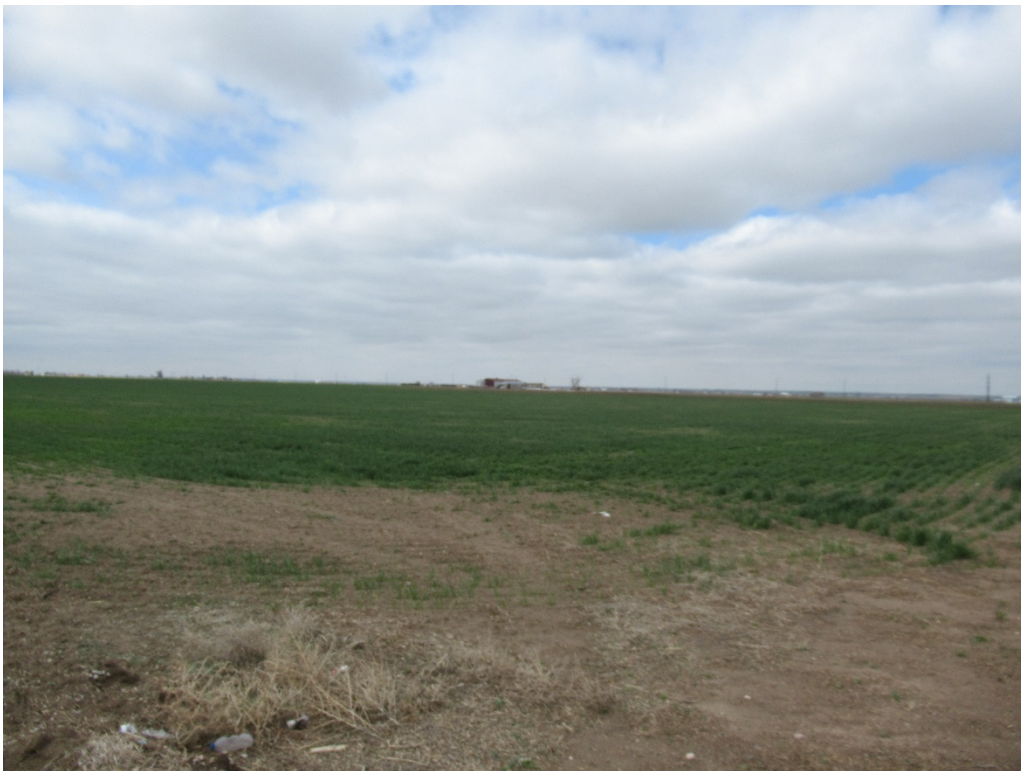
View of conversion area from the northeast corner looking southwest

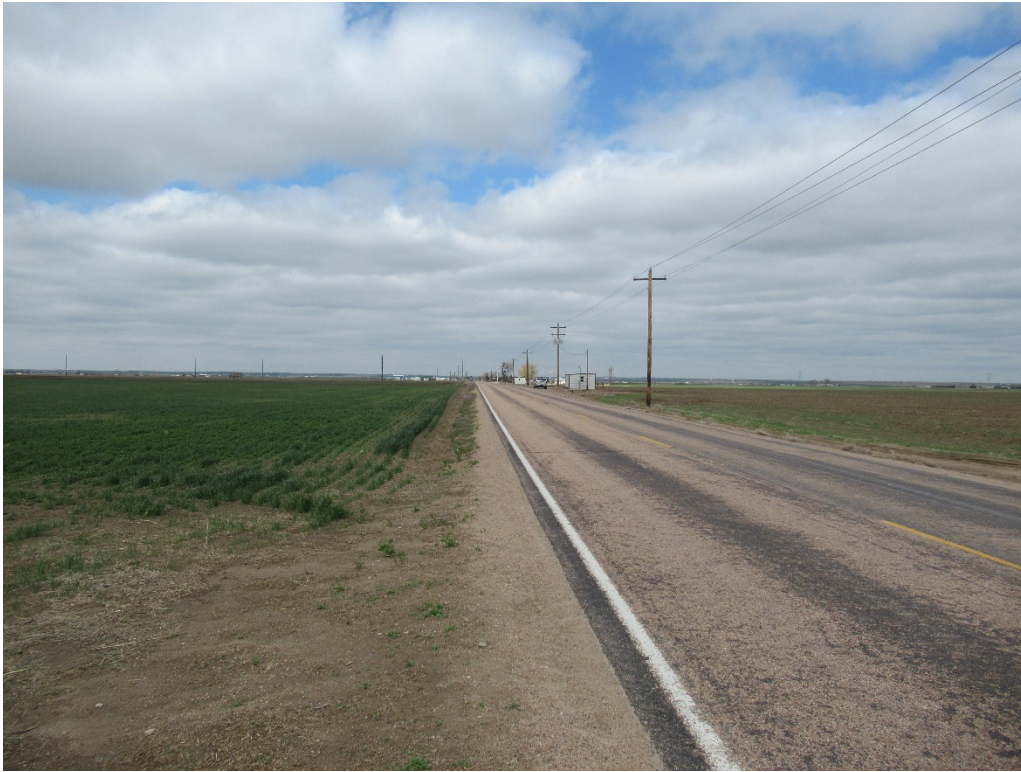
View of conversion area from the northeast corner looking west

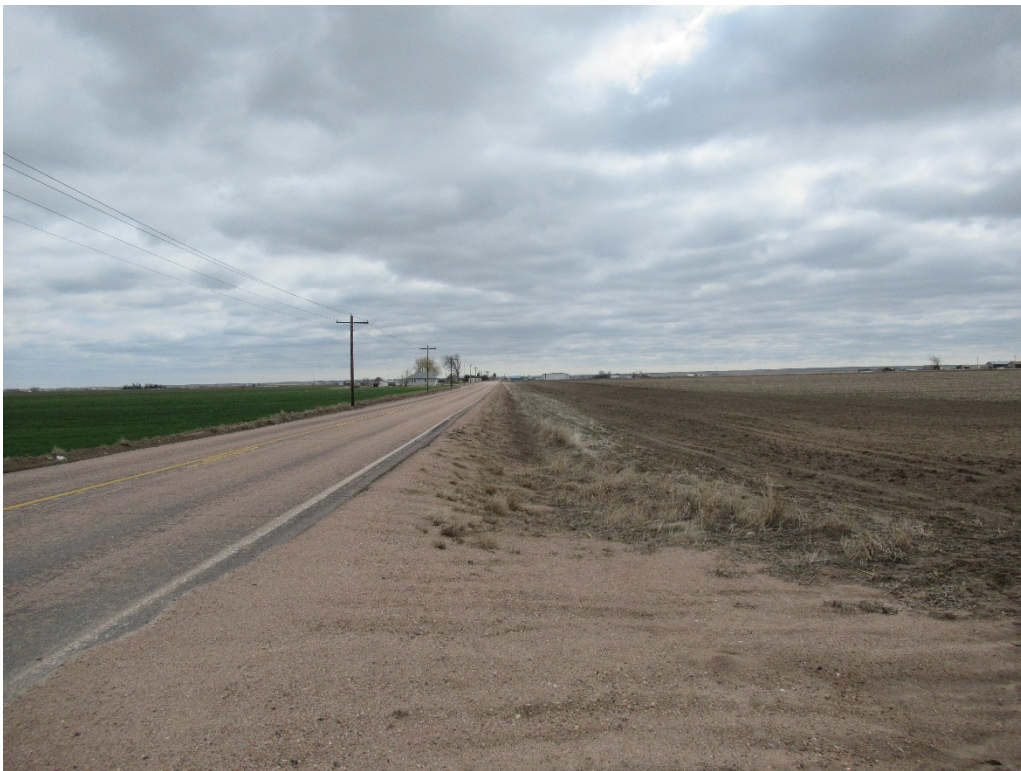
View of conversion area from the northwest corner looking east

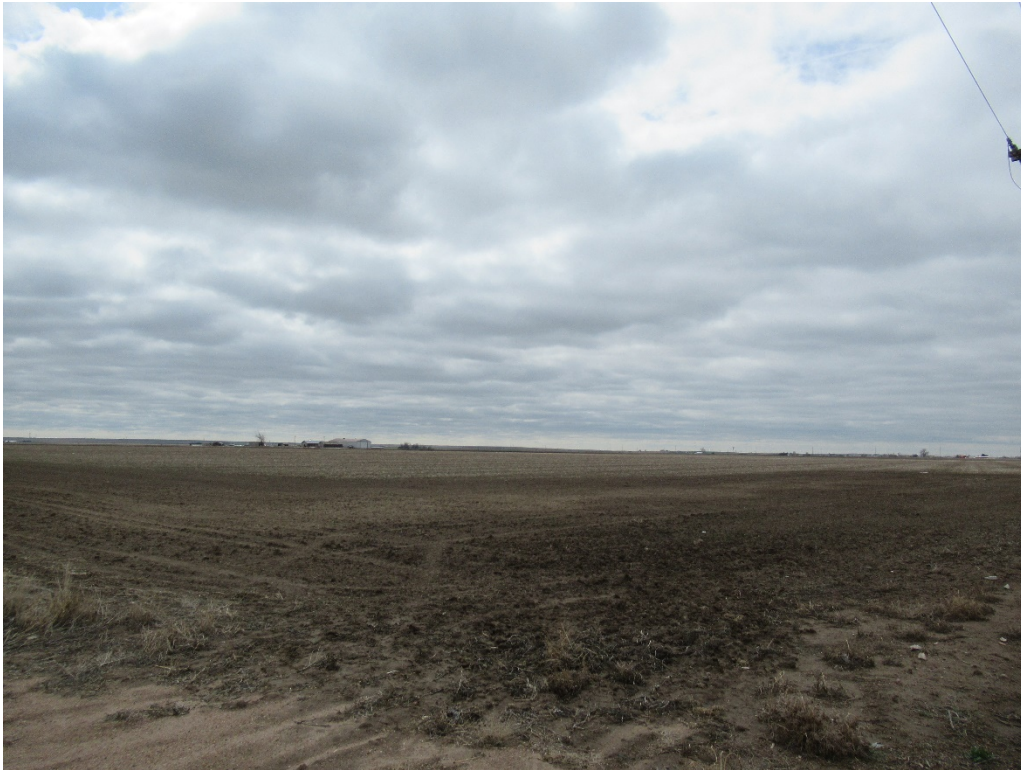
View of conversion area from the northwest corner looking southeast

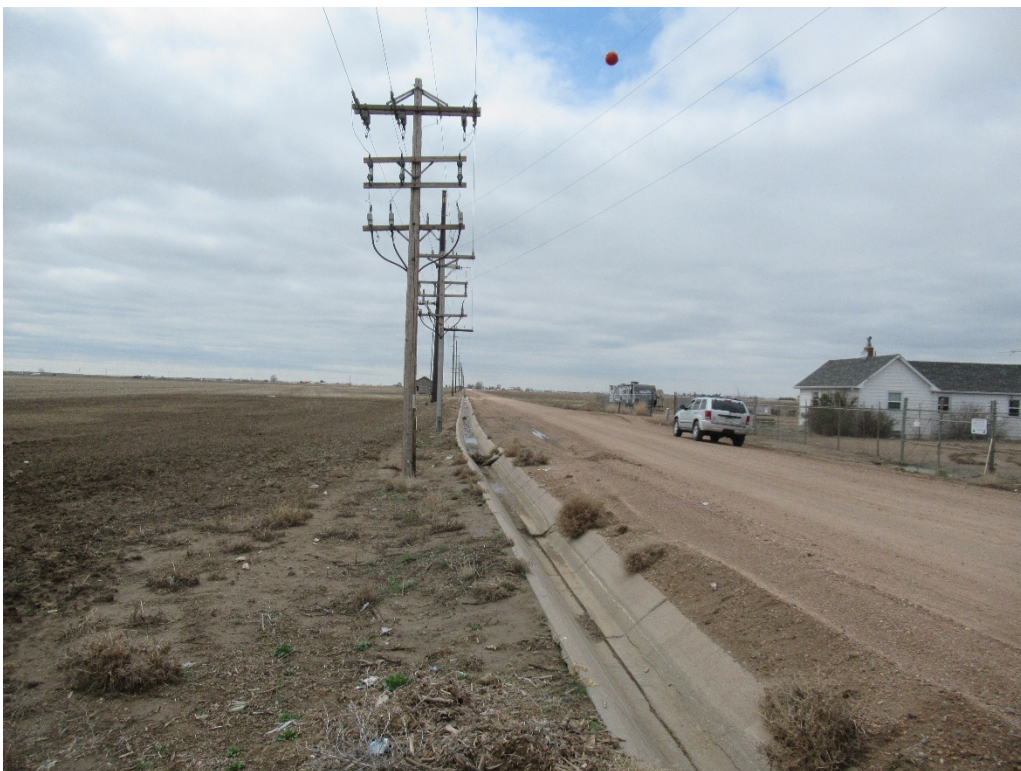
View of conversion area from the northwest corner looking south

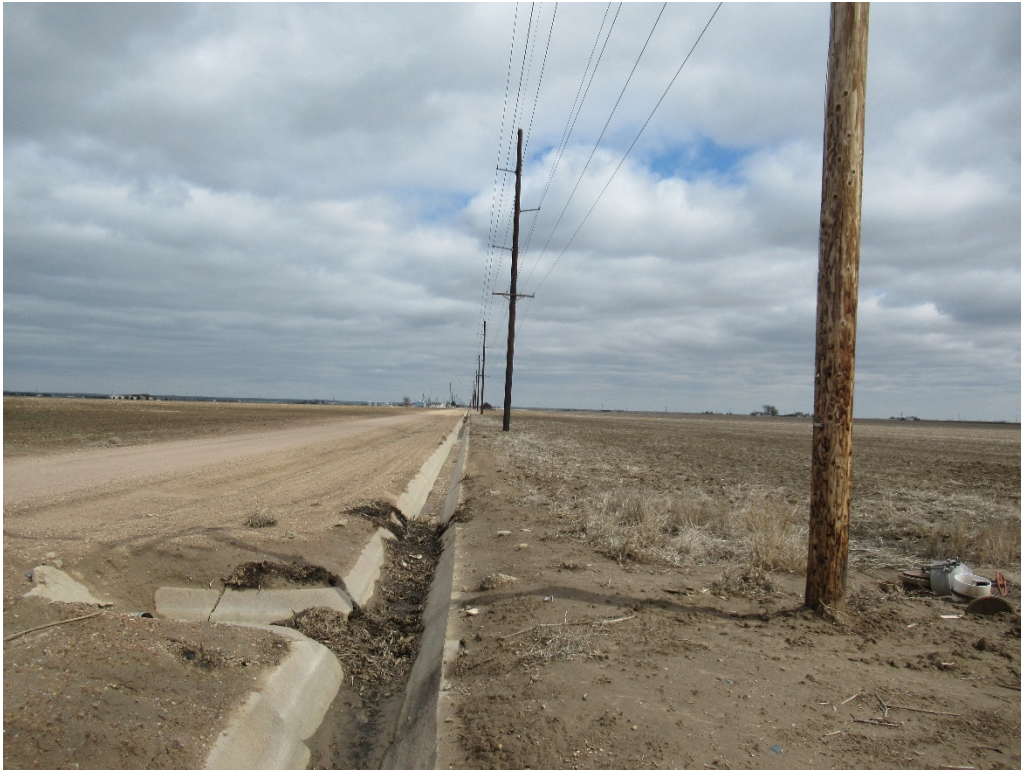
View of conversion area from the southwest corner looking north

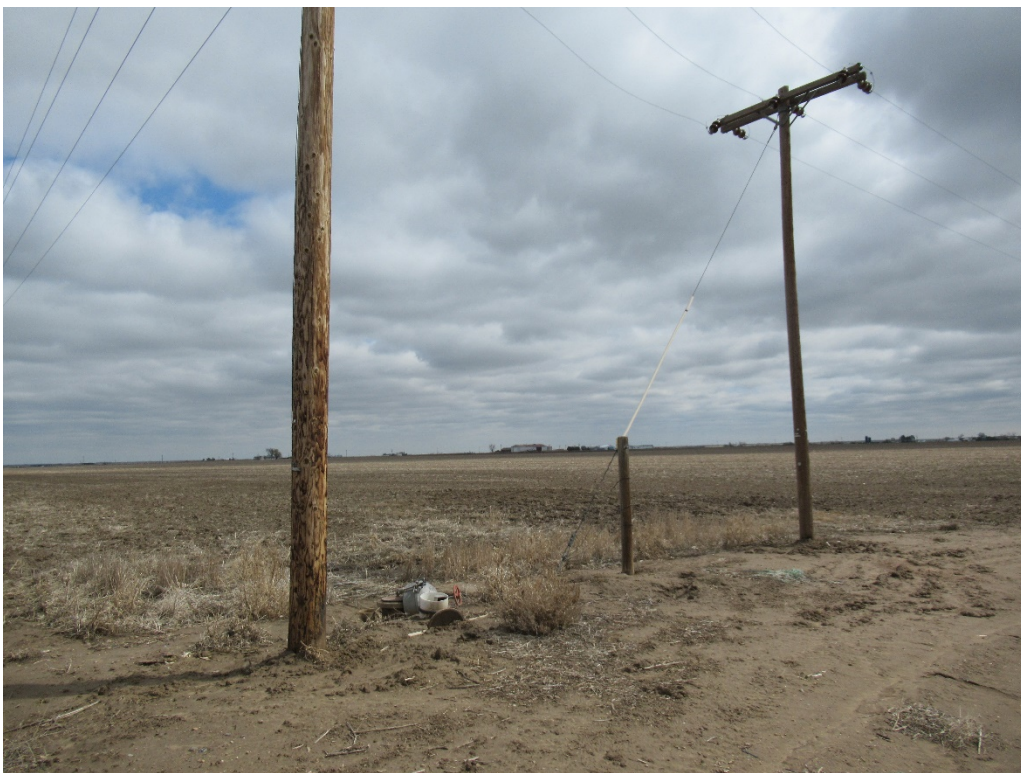
View of conversion area from the southwest corner looking northeast

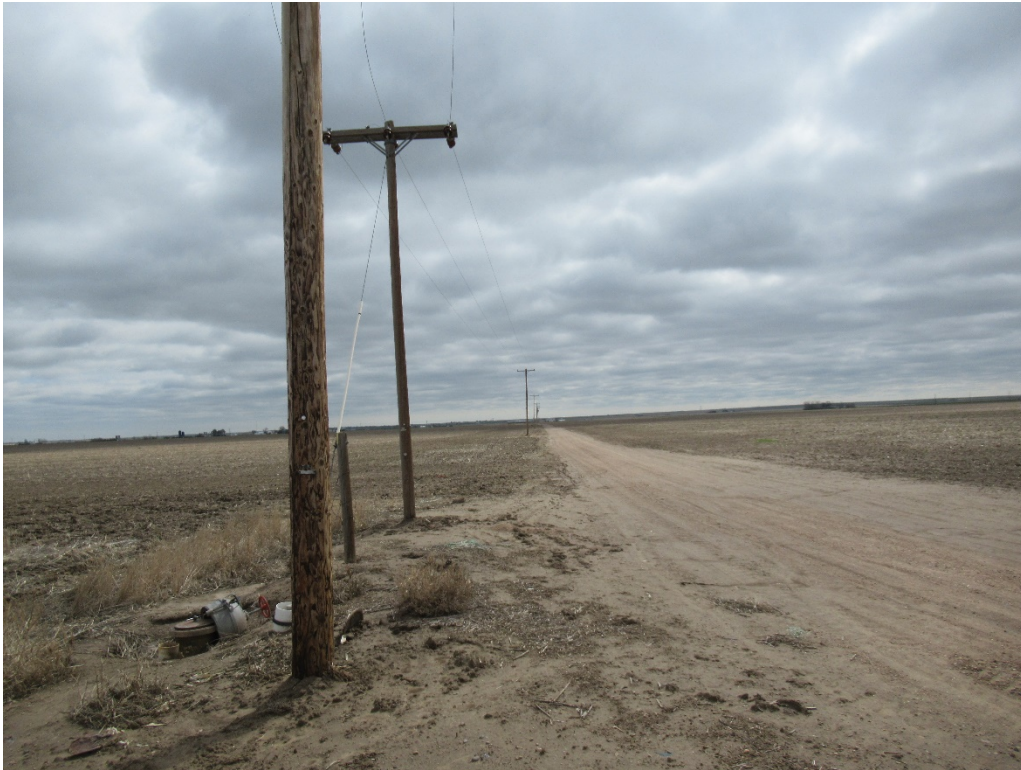
View of conversion area from the southwest corner looking east
