**COLORADO DIVISION OF RECLAMATION, MINING AND SAFETY**  
**MINERALS PROGRAM INSPECTION REPORT**  
**PHONE: (303) 866-3567**

<b>MINE NAME:</b> Dawson Gold Project	<b>MINE/PROSPECTING ID#:</b> P-2013-002	<b>MINERAL:</b> Gold	<b>COUNTY:</b> Fremont
<b>INSPECTION TYPE:</b> Monitoring	<b>INSPECTOR(S):</b> Timothy A. Cazier	<b>INSP. DATE:</b> March 20, 2019	<b>INSP. TIME:</b> 09:40
<b>OPERATOR:</b> Zephyr Gold USA Ltd	<b>OPERATOR REPRESENTATIVE:</b> Angela Bellantoni	<b>TYPE OF OPERATION:</b> MP - Mineral Prospecting

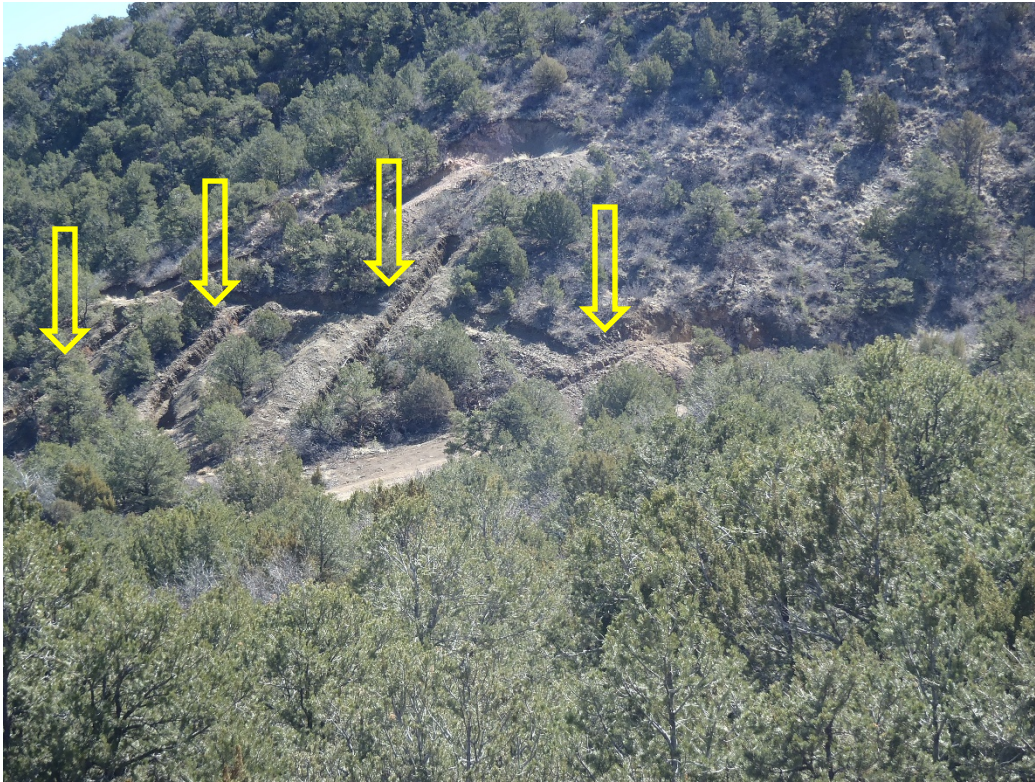
**PROBLEM/POSSIBLE VIOLATION:** Problem: The financial warranty for trenching (\$90 in 2013) was released with the approval of surety reduction SR-1 in 2013. The original NOI approval required immediate backfill of trenches.

Prior to this inspection, no trenching had been observed on site and the financial warranty for trenching was released in August of 2013. Four exploration trenches were observed (see **Photos 1, 2 and 3**). **The existence of these four trenches are cited as a Problem on page 1 of this report.**

Photo 1. Exploration trenches north of DA-18-13 (looking east).

**CORRECTIVE ACTIONS:** Backfill the exploration trenches by the corrective action due date AND if additional trenches are anticipated, an NOI modification is required to properly adjust the financial warranty.

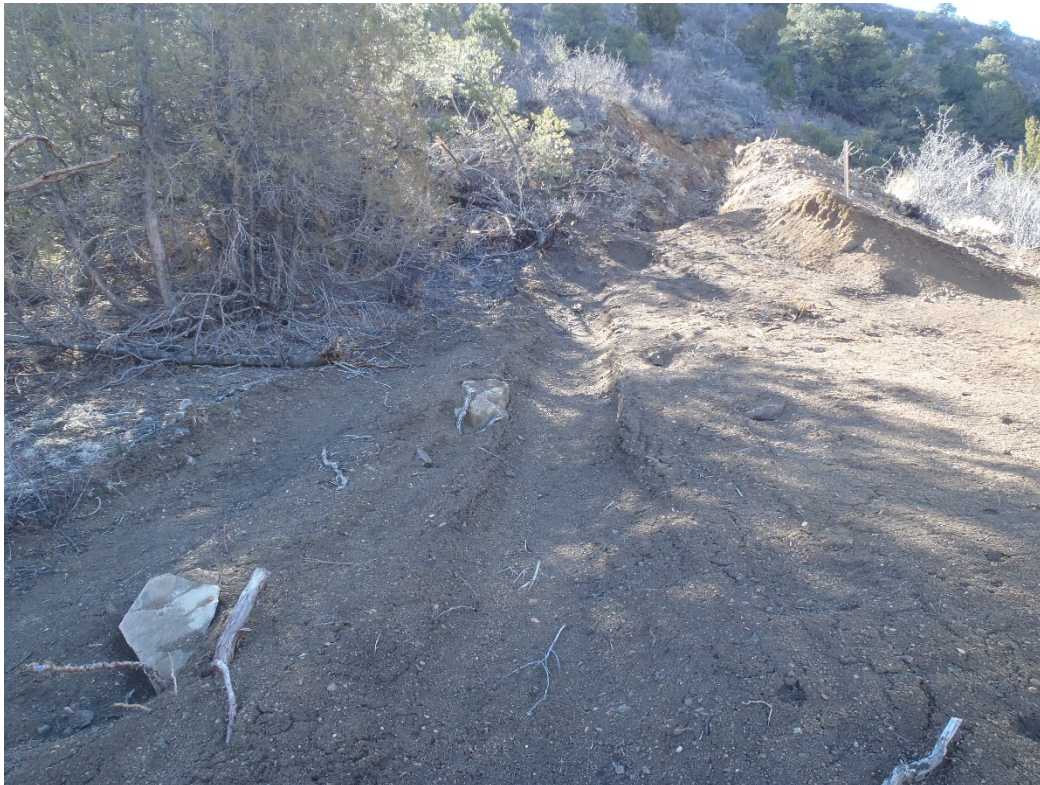
Photo 2. Eastern most exploration trench (looking south).

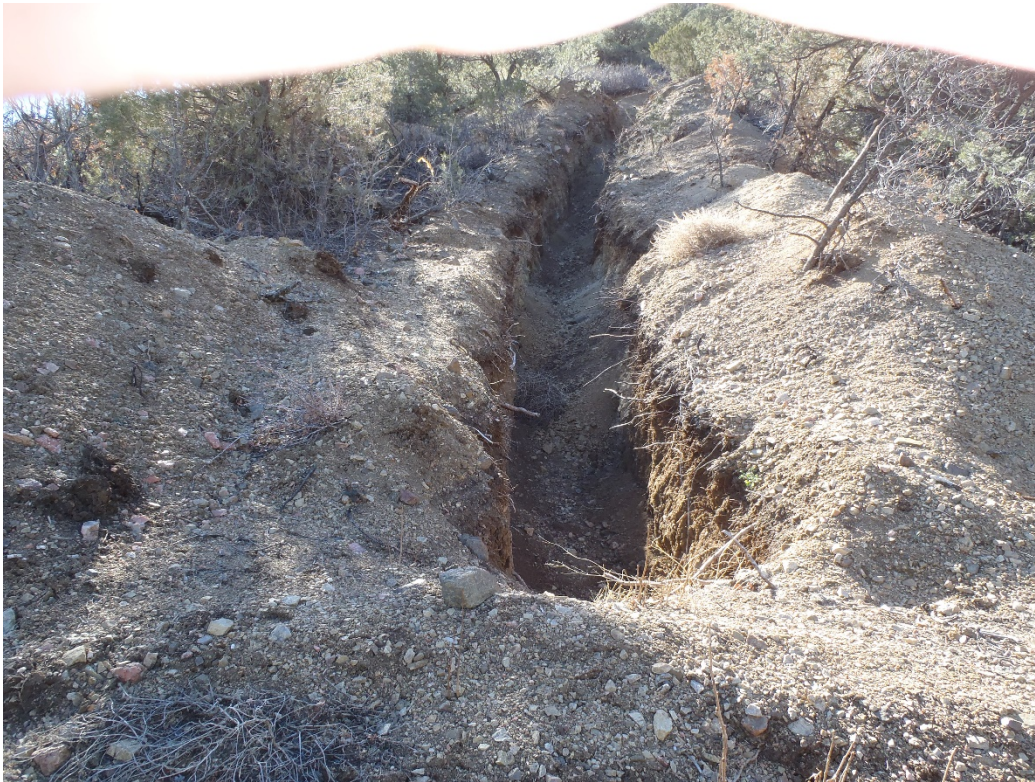
Photo 3. Third exploration trench (looking south).

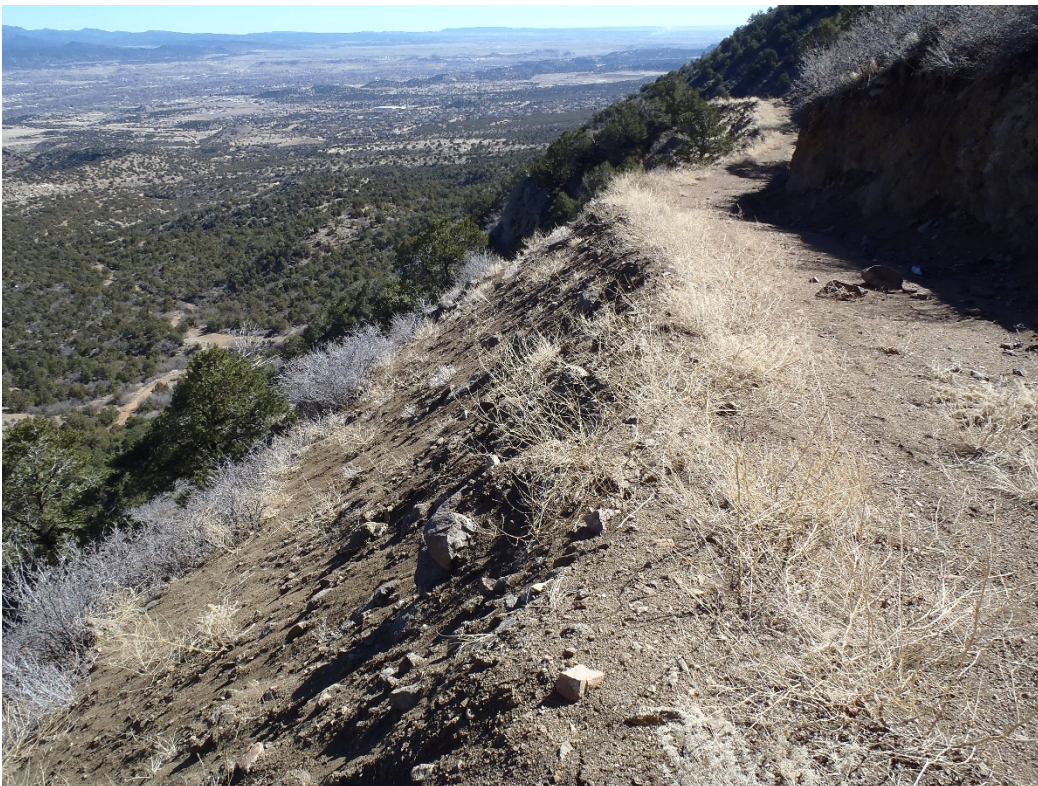
**Roads:** Access roads are cut and cast construction (see **Photo 4**) and did not appear to be a source of sediment that could be tracked offsite.

Photo 4. Typical access road cut and cast construction (between DA-18-14 & CK-18-08).

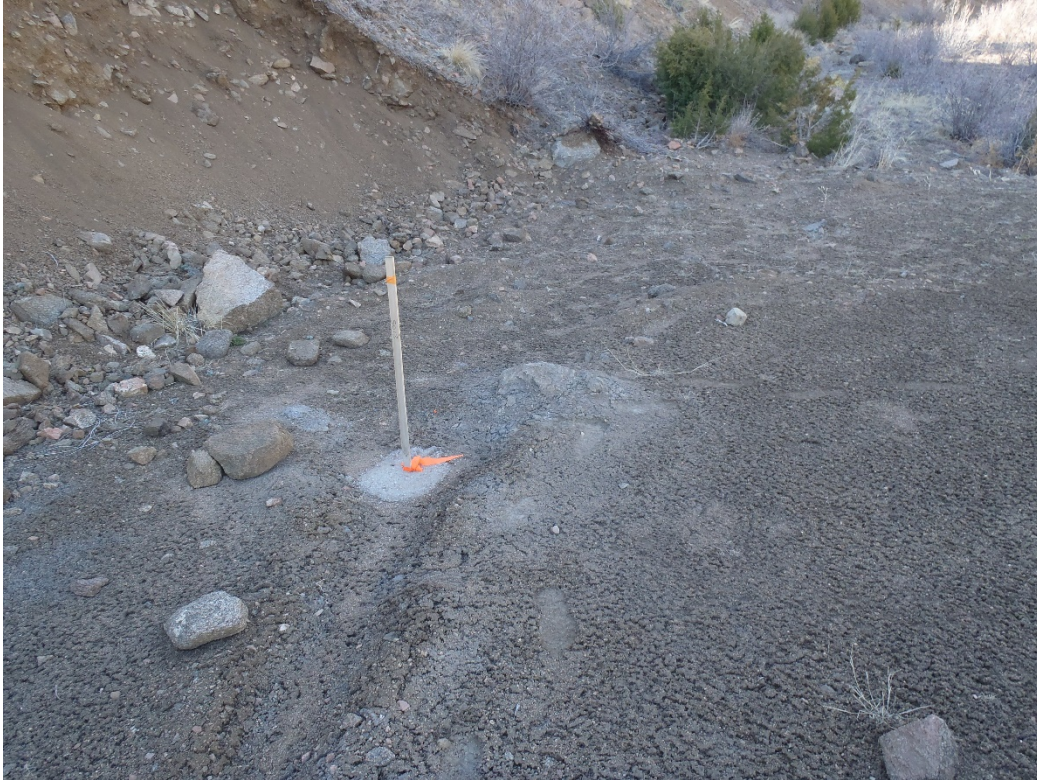
**Reclamation Success:** The only reclamation completed at the time of the inspection was the borehole abandonment (see **Photo 5**). Some drill pads observed showed evidence of complete (see **Photo 6**) or partial backfill (see **Photo 7**) of the mud pits. **Table 1** summarizes the status of reclamation. No other grading or seeding had been initiated.

Photo 5. Typical borehole abandonment surface cement plug (drill pad DA-18-13, looking south).

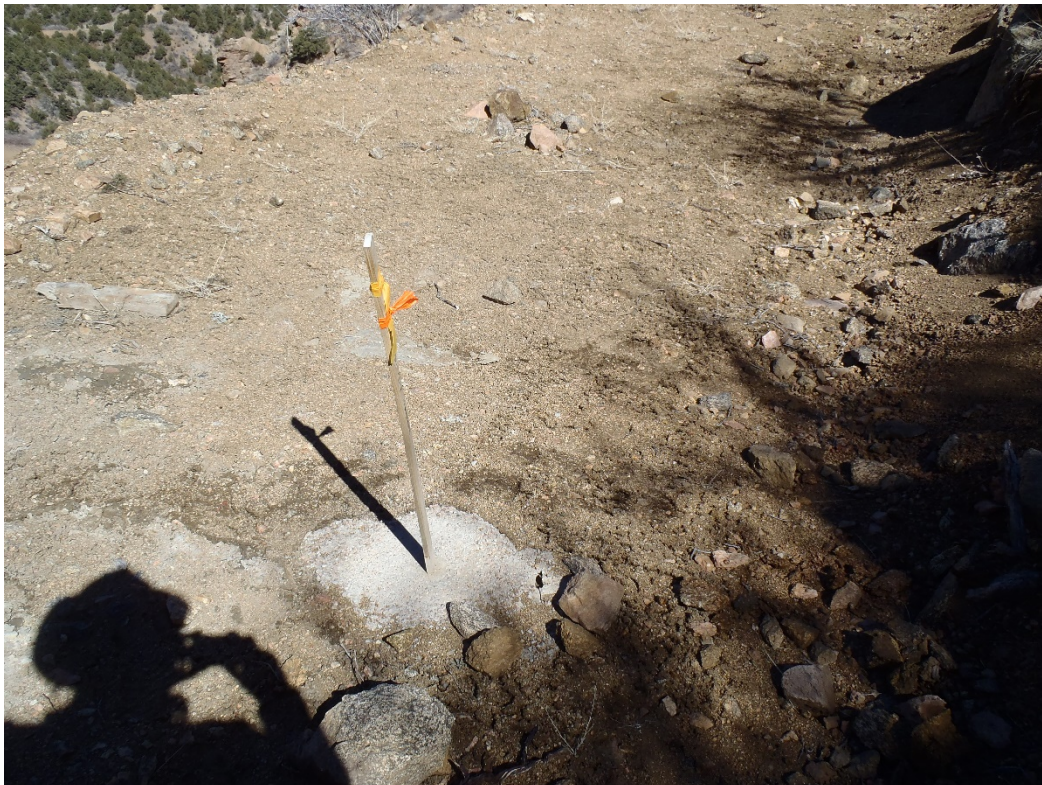
Photo 6. Complete mud pit backfill (drill pad WG-18-37, looking north).

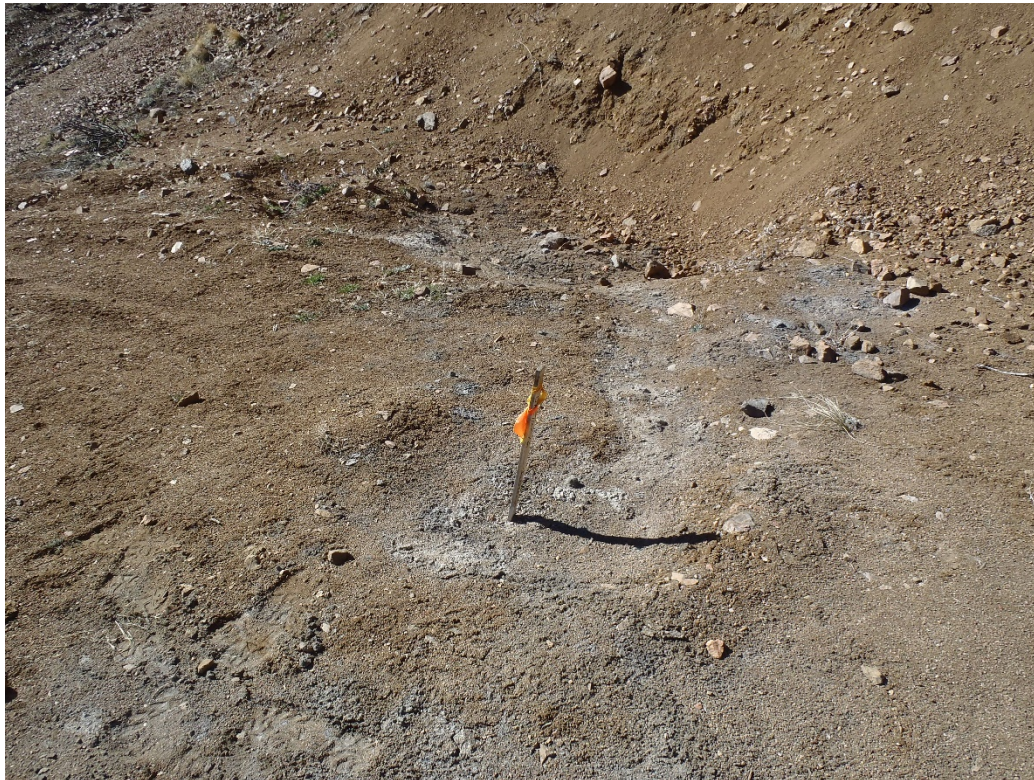
Photo 7. Partial mud pit backfill (drill pad DA-18-16, looking south).

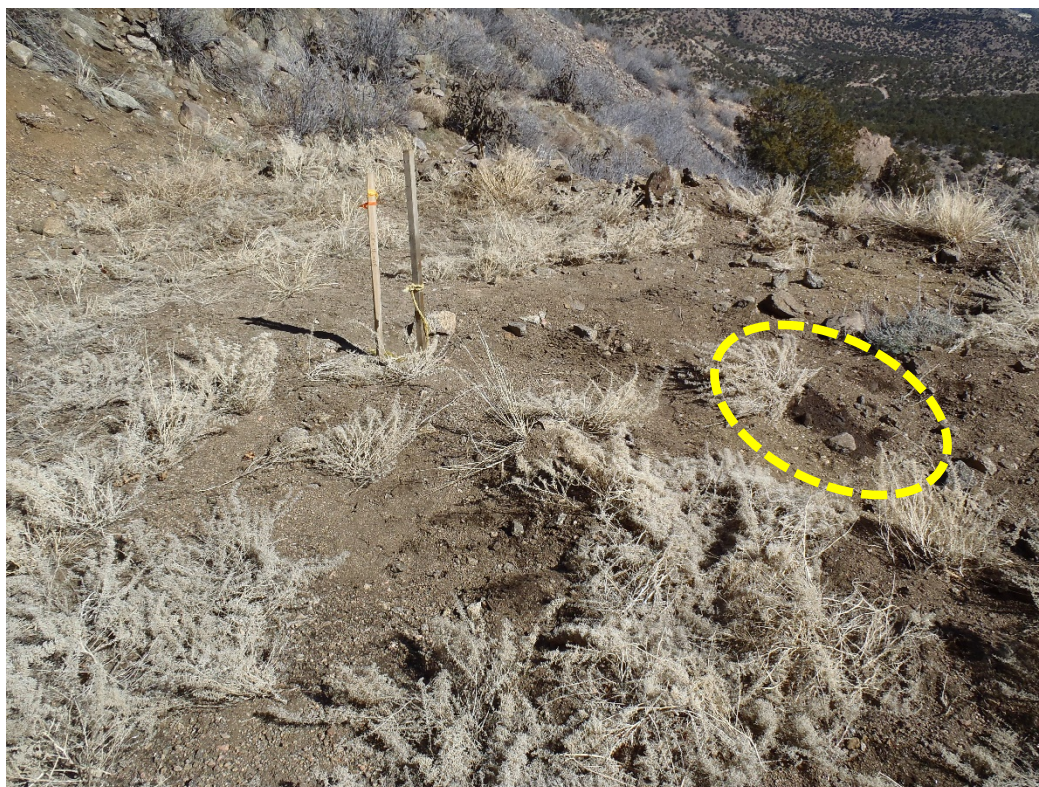
**PROBLEM/POSSIBLE VIOLATION:** Problem: A petroleum product spill has occurred at the site (drill pad CK-18-08) which has impacted soils, surface water or groundwater.

**Storm Water MGT Plan:** **Petroleum product staining was observed at CK-18-08 drill site (see Photos 8 and 9) and is cited as a Problem on page 1 of this report.**

Photo 8. CK-18-08 drill site (looking NW, product spill circled).

**CORRECTIVE ACTIONS:** The operator shall immediately remediate the spill and submit a final report to the Division containing a description of how the spill was cleaned up and photo documentation.

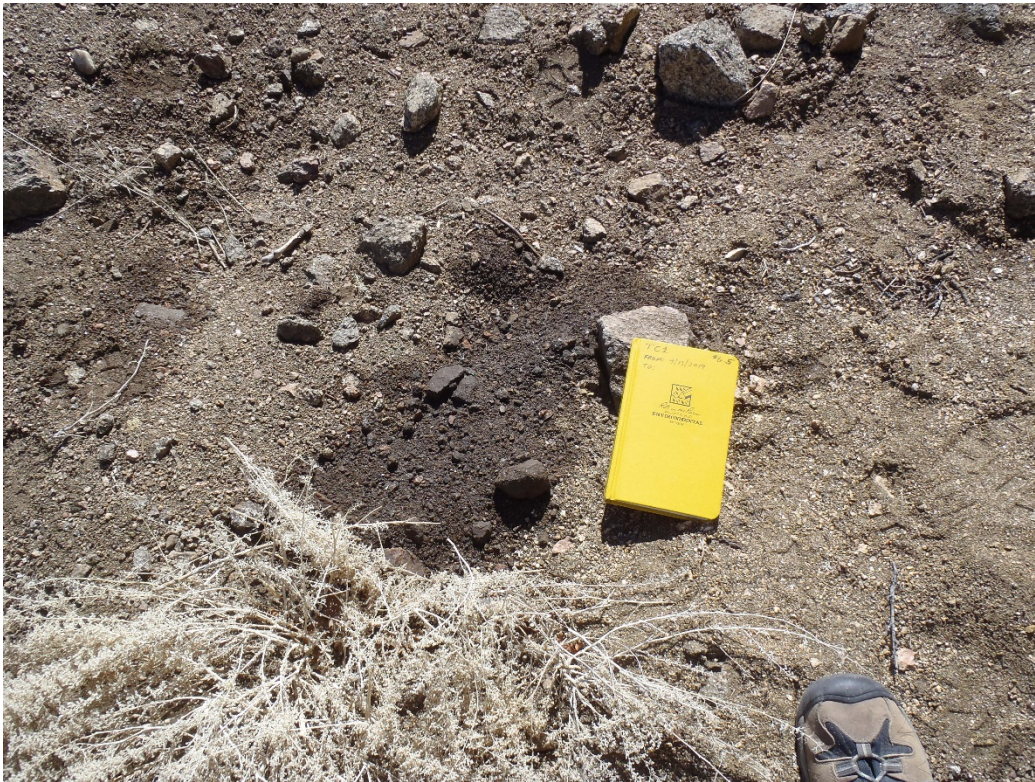
Photo 9. Petroleum product spill on CK-18-08, requiring cleanup.
