## MINERALS PROGRAM INSPECTION REPORT

<b>MINE NAME:</b> Cresson Project	<b>MINE/PROSPECTING ID#:</b> M-1980-244	<b>MINERAL:</b> Gold	<b>COUNTY:</b> Teller
<b>INSPECTION TYPE:</b> Monitoring	<b>INSPECTOR(S):</b> Timothy A. Cazier	<b>INSP. DATE:</b> March 21, 2019	<b>INSP. TIME:</b> 09:50
<b>OPERATOR:</b> Cripple Creek & Victor Gold Mining Company	<b>OPERATOR REPRESENTATIVE:</b> Justin Bills & Katie Blake	<b>TYPE OF OPERATION:</b> 112d-3 - Designated Mining Operation

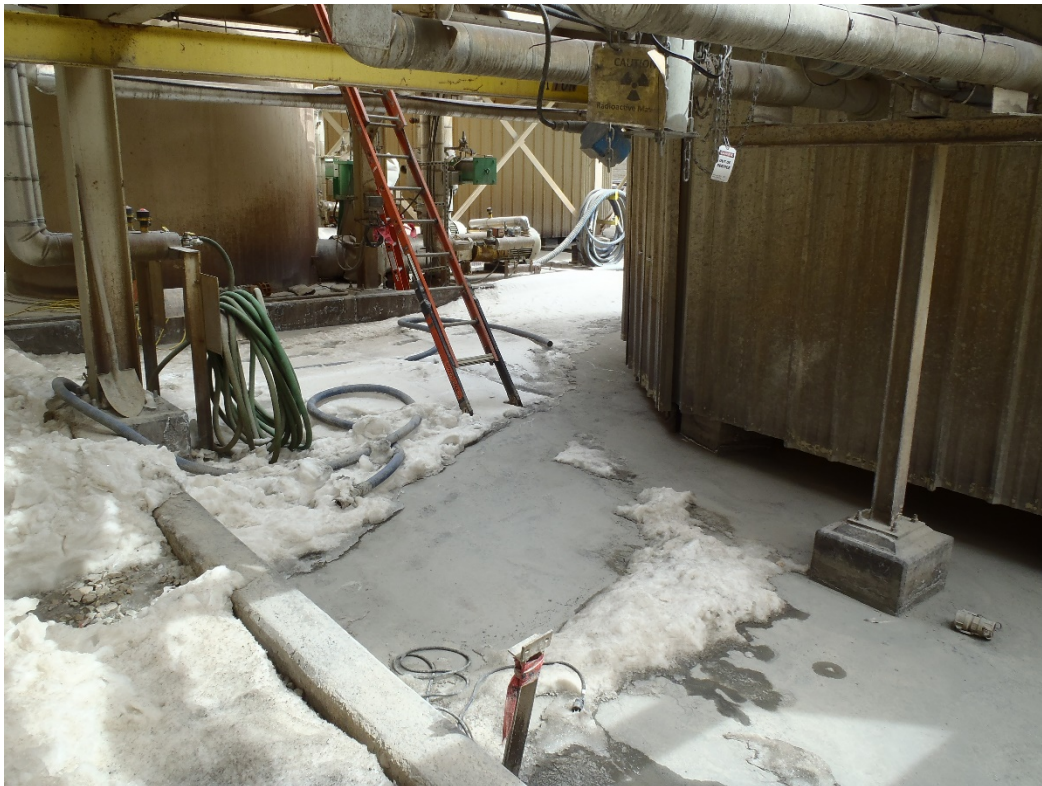
Photo 1. Blown in snow observed on west side of secondary containment of High pH Thickener Tank.

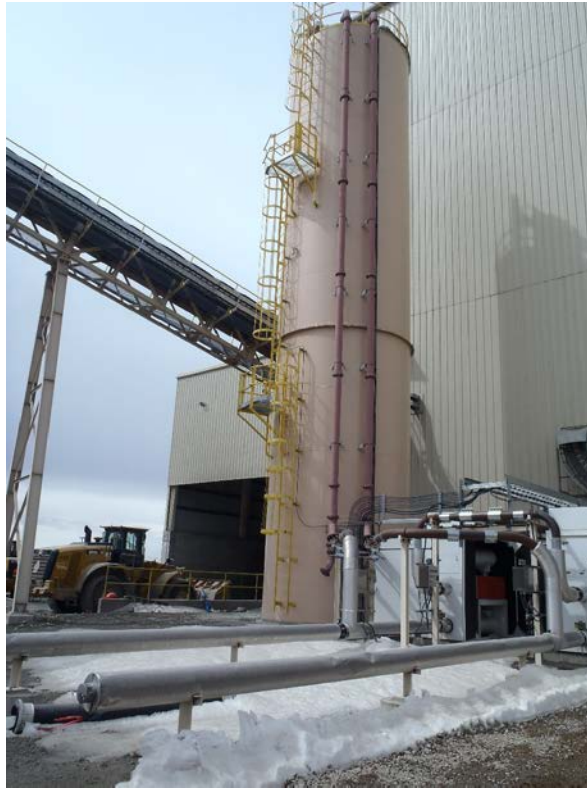
CC&V personnel pointed out the silo that is to be moved as proposed in TR-114 (See **Photo 2**)

Photo 2. High Grade Mill silo to be moved as proposed in TR-114.

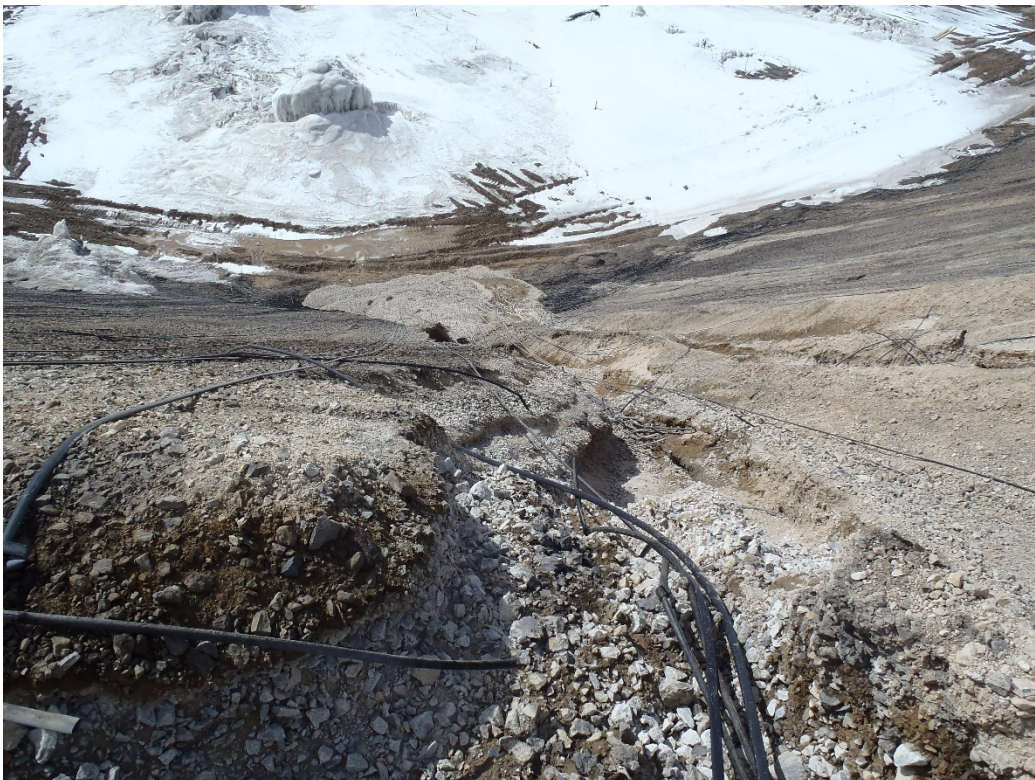
Arequa Gulch Valley Leach Facility (VLF1): The 10,300 washout area (See **Photo 3**) from the day before was observed along with active leaching areas (primarily elevation 10,200 and 10,400 - See **Photo 4**). The washout area appeared to have only a surficial impact. CC&V geotechnical personnel were evaluating potential impact to slope stability, but none were expected. No significant ponding was observed. However, due to the cold temperatures, lots of ice (most of it process solution) was observed. Discussions with CC&V personnel indicated the mine intends to better manage the frozen pipe and valve issues that has led to this situation during the 2019 – 2020 winter.

Photo 3. VLF 1 ice (elevation 10,200) and 3/20/2019 washout (from elevation 10,300).

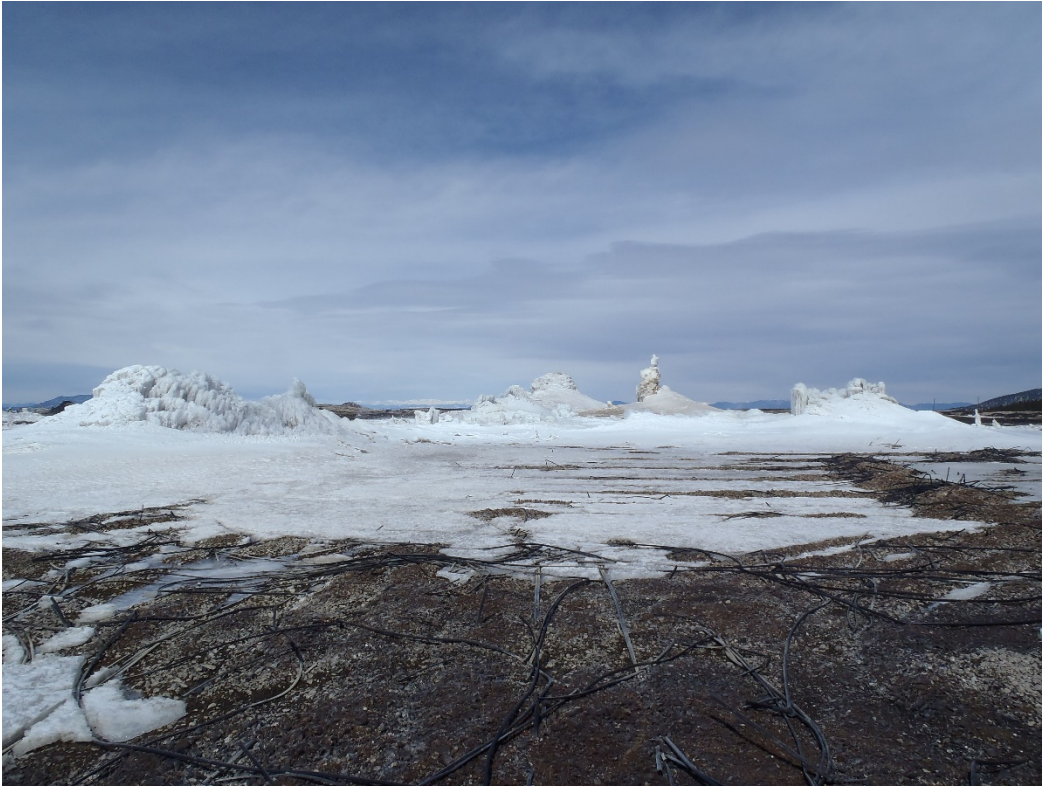
Photo 4. VLF 1 ice (elevation 10,400,).

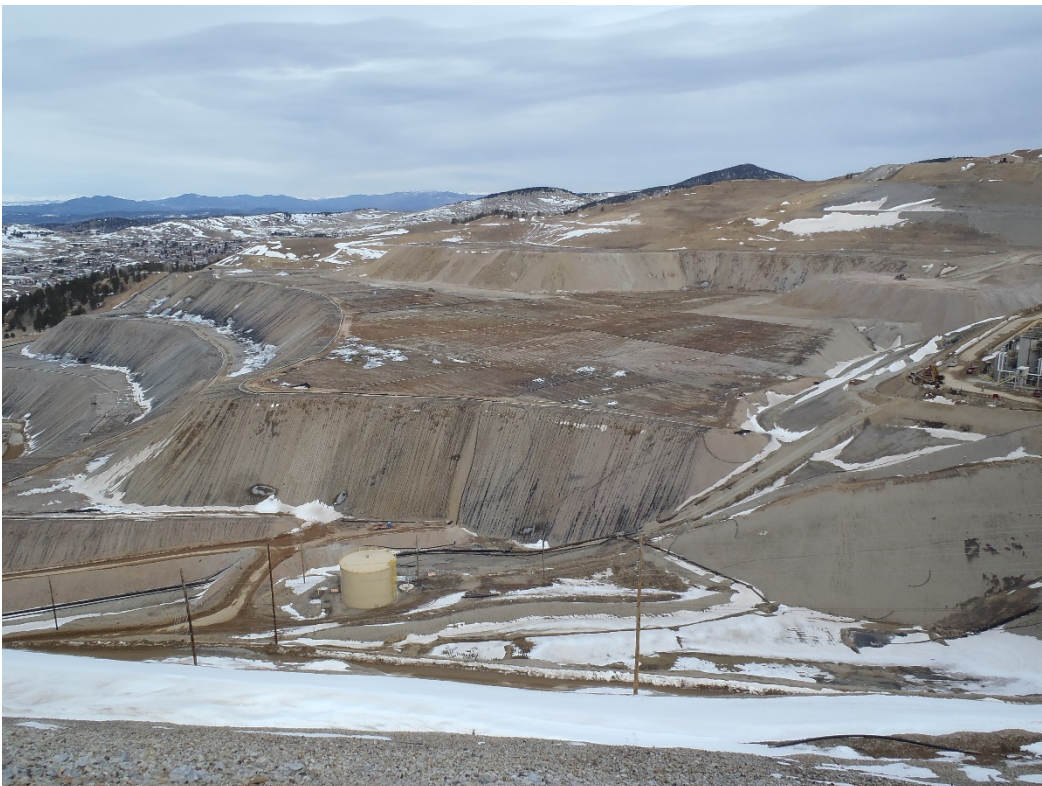
Squaw Gulch Valley Leach Facility (VLF 2): Mr. Bills and Ms. Blake accompanied the DRMS to the VLF 2. Although some frozen process solution was observed (See **Photo 5**), it was considerably less than that observed on VLF 1.

Photo 5. VLF 2 – relatively clear of ice on benches.

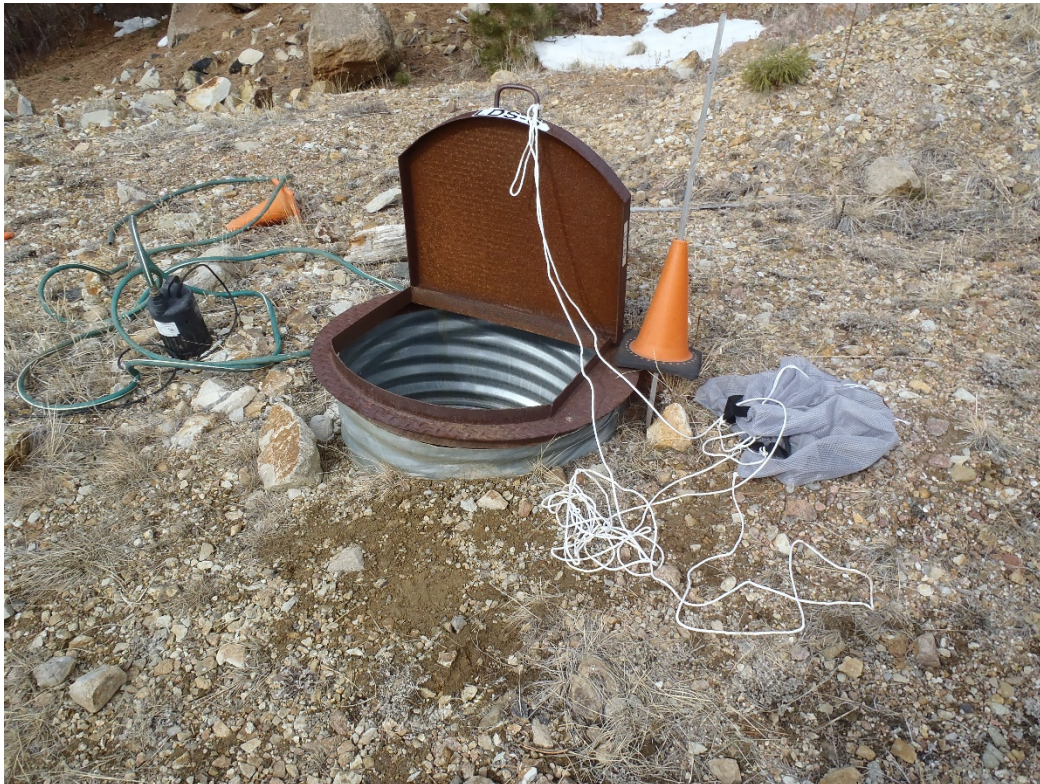
**PROBLEM/POSSIBLE VIOLATION:** Problem: Water in the LDS-6 VLF 1 leak detection sump has not been removed, nor have water quality laboratory results been provided to the DRMS characterizing the water.

VLF liners are leaking. If water is not sampled for characterization and removed upon the initial observance, it is difficult to ascertain whether the liner is leaking. As such, LDS-6 was a priority inspection for March 2019. Although absorbent pads and a pump were positioned near LDS-6 (See **Photo 6**), water was still present in the bottom of the sump (See **Photo 7**). **The continued presence of water in LDS-6 is cited as a problem on page 1 of this report.**

Photo 6. LDS-6 sump, note pump and absorbent pad bag.

**CORRECTIVE ACTIONS:** Provide photographic evidence of removing all water in the LDS-6 sump and water quality laboratory test results to the DRMS.

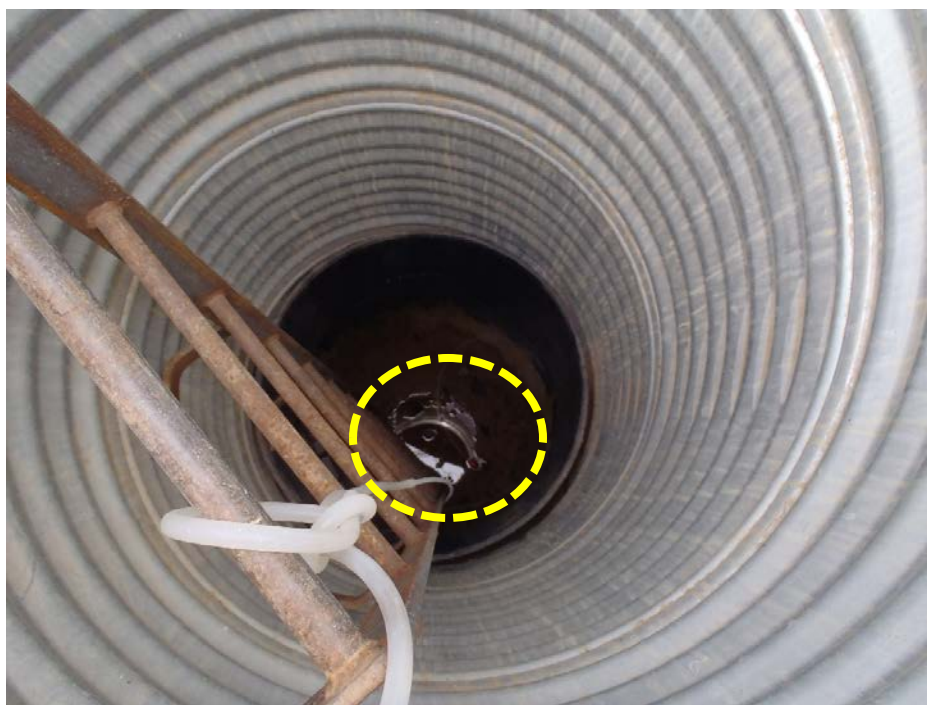
Photo 7. LDS-6 sump bottom, note reflection in standing water.

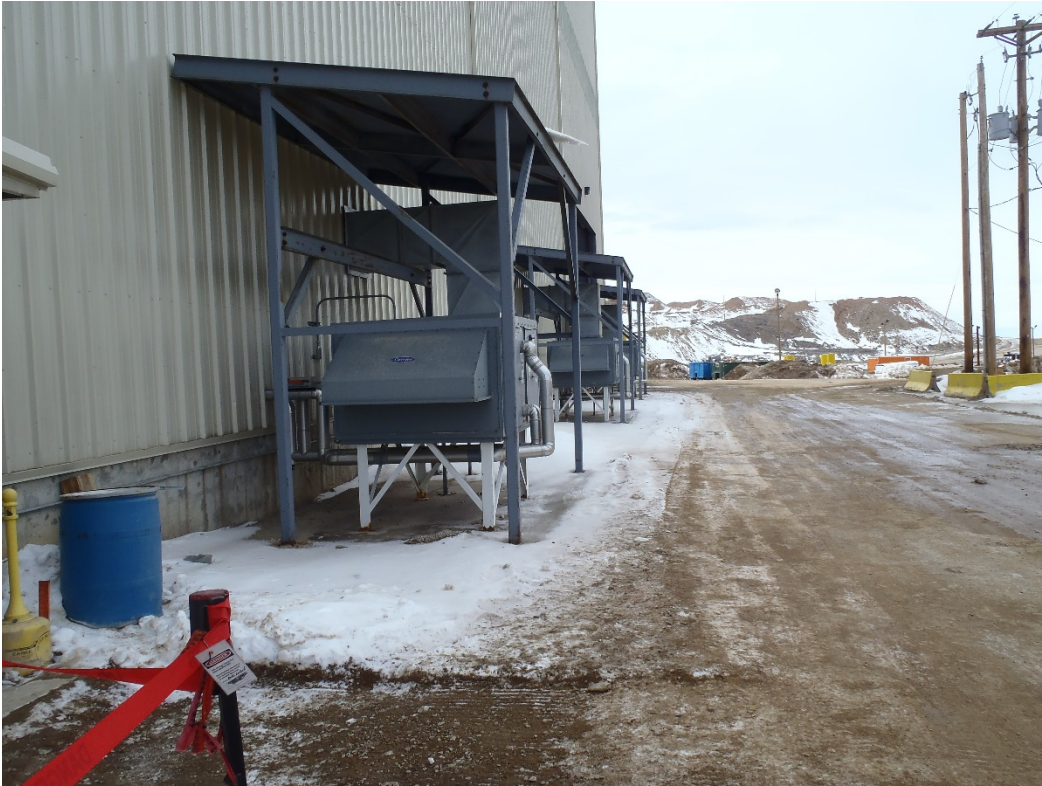
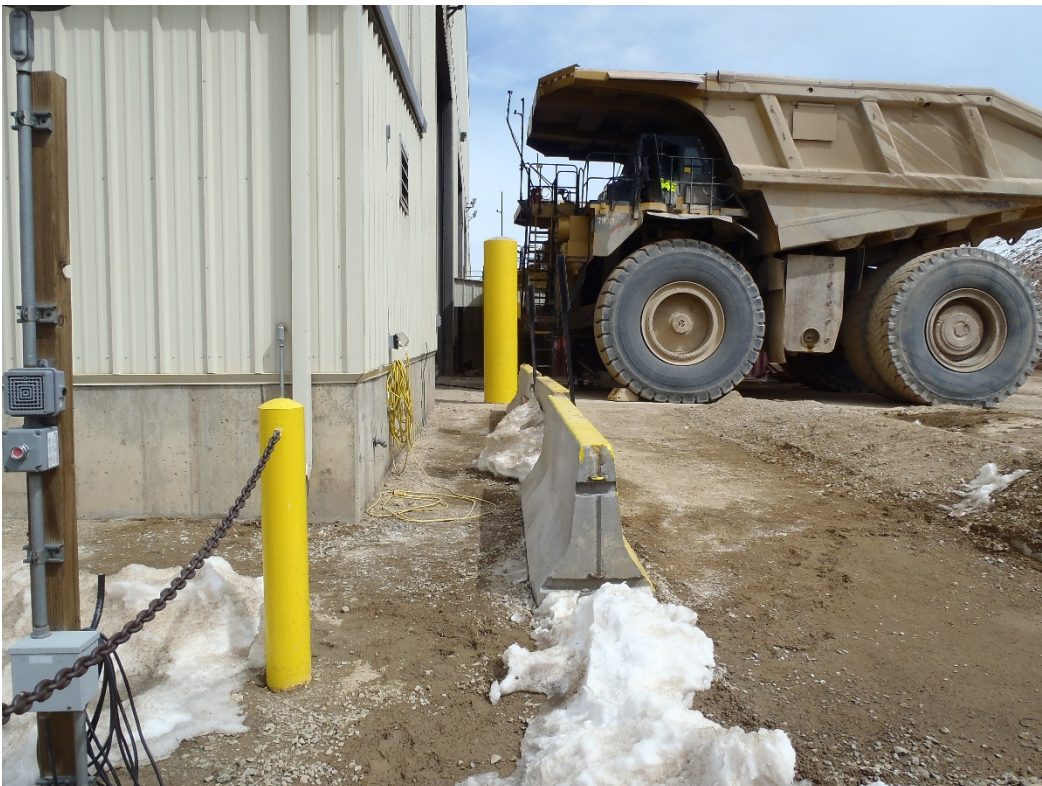
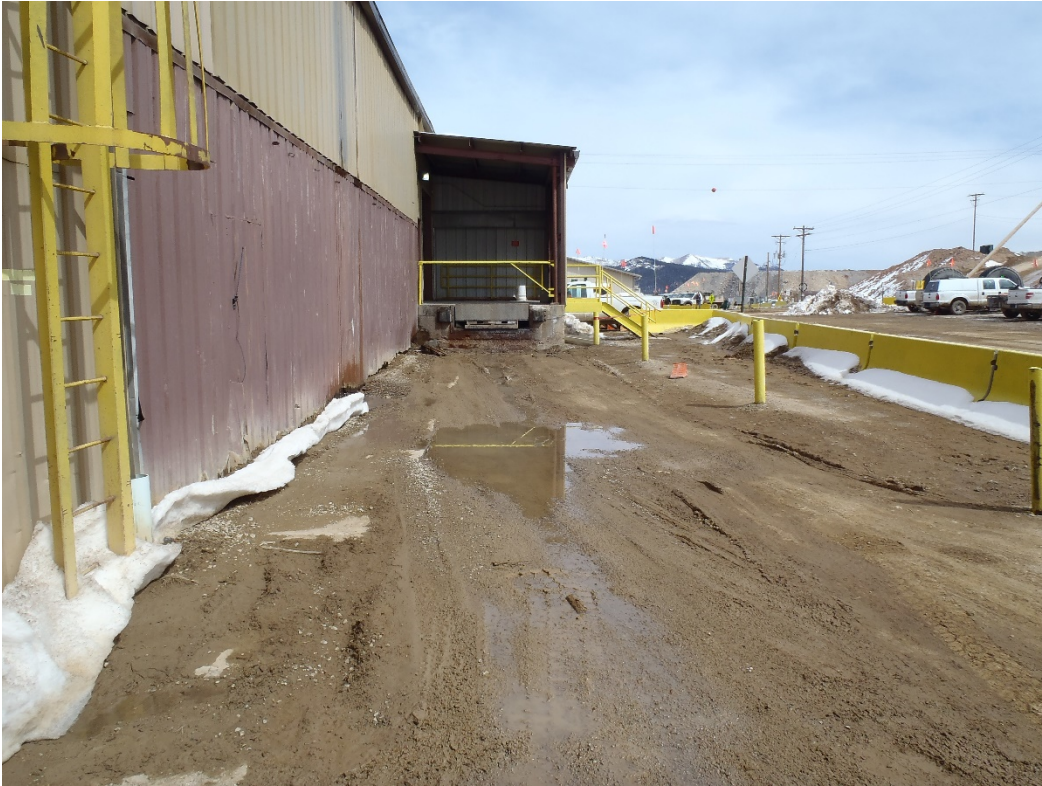
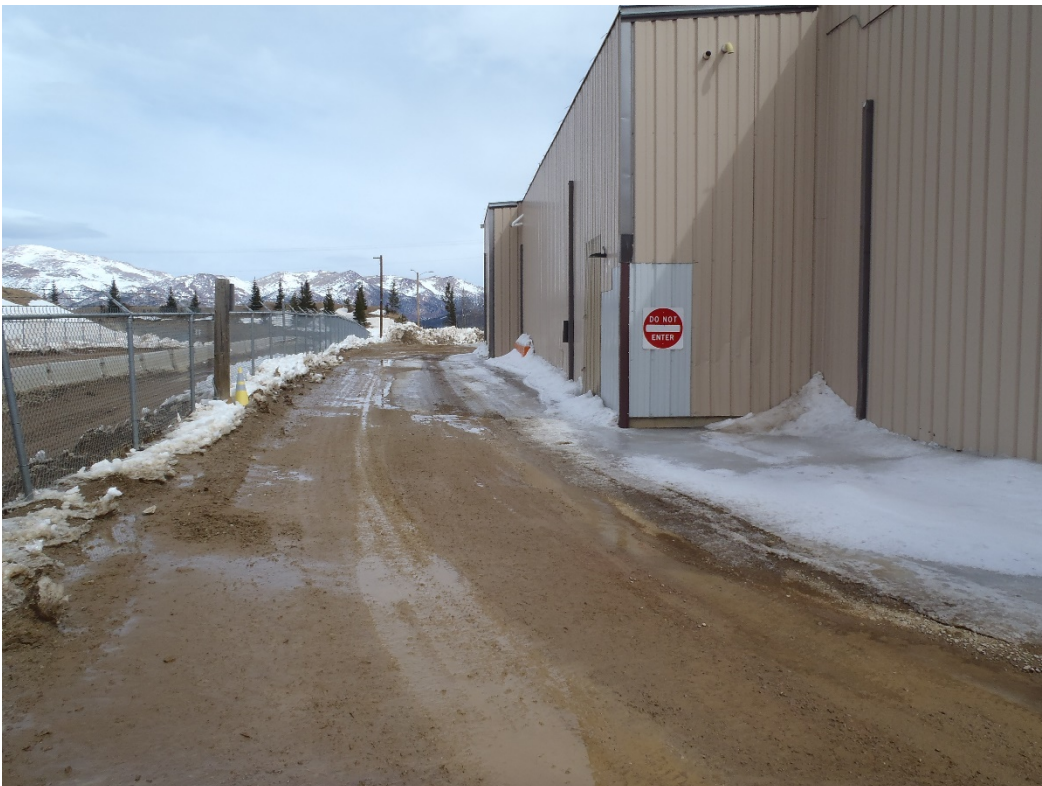
**Ironclad Shops:** Mr. Bills and Ms. Blake accompanied the DRMS on the Ironclad Maintenance Shops (large truck shop to the south and the warehouse/small truck shop to the north) inspection. The perimeter of both building was walked (See **Photos 8 through 11**). No problems were observed.

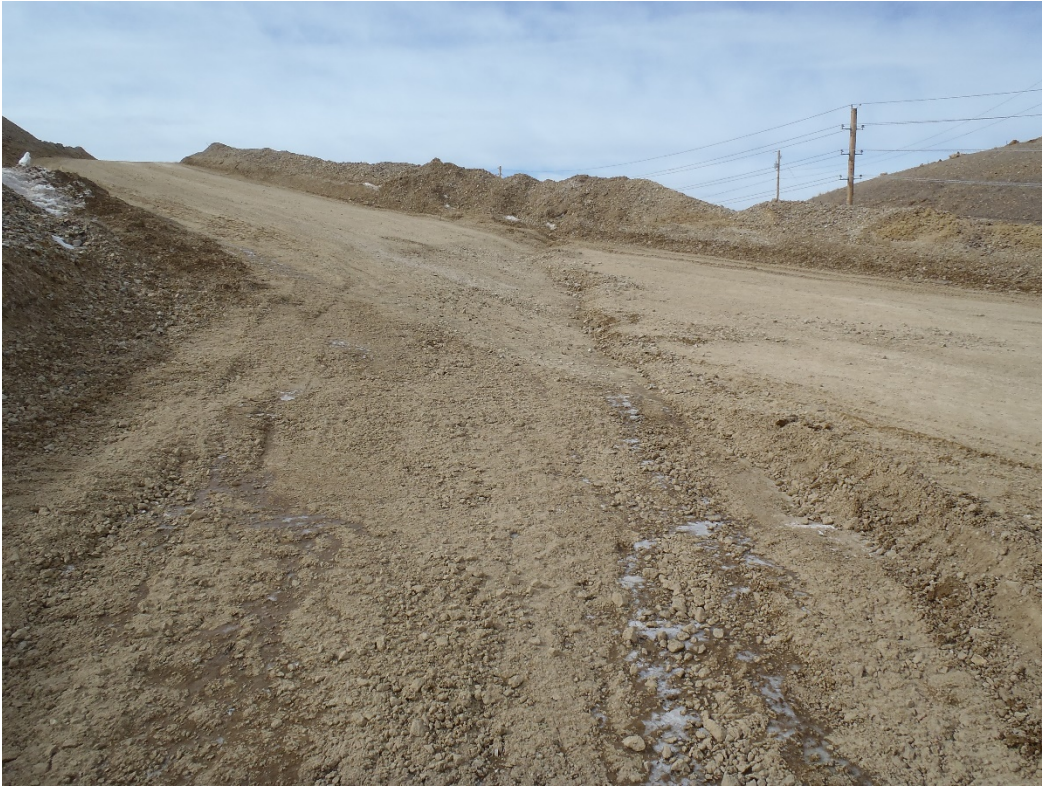
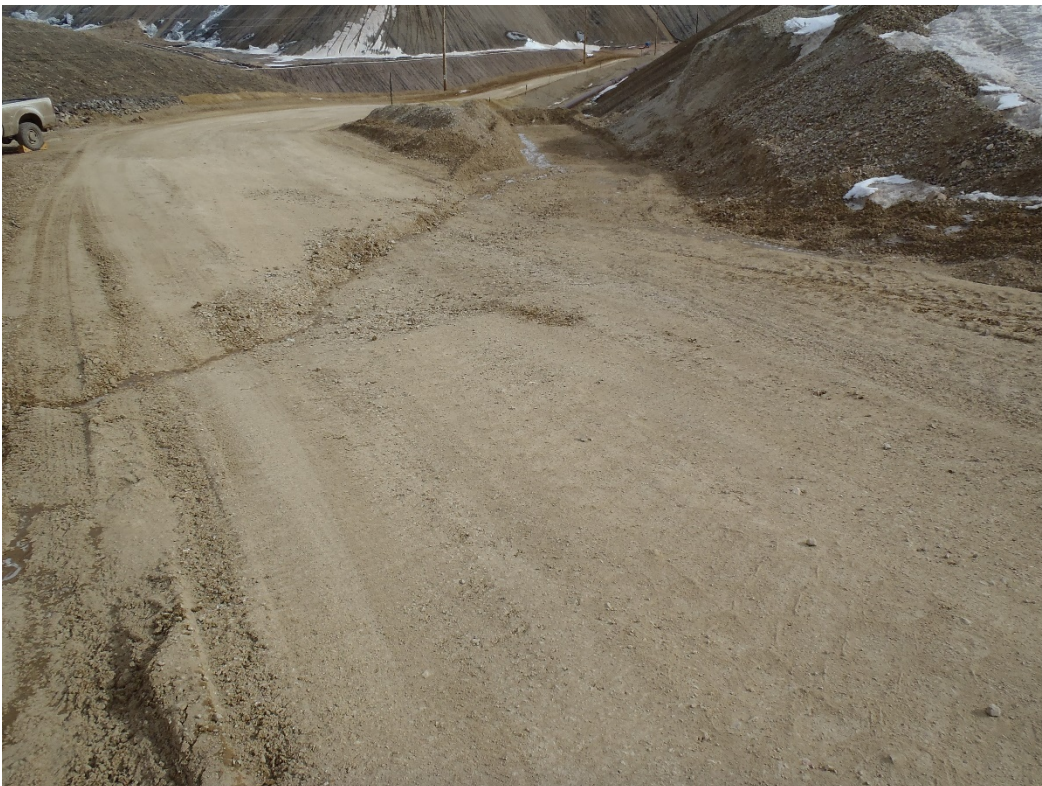
**Stormwater Repairs on the north side of VLF 1:** The DRMS was accompanied by Mr. Bills and Ms. Blake to inspect the area near the northwest toe of the VLF 1 where the Division has been periodically checking an area of concern relating to stormwater control where the access road crosses the edge of liner (*UTM coordinates: Zone 13 S, 485856.96 m E, 4286300.68 m N*). CC&V indicated the mine also periodically inspects this area and conducts repairs as need to ensure runoff from the access road remains on the VLF over the liner system as runoff is considered impacted water. The recent grading repairs made to the drainage controls appeared to be adequate and functioning as intended (See **Photos 12 and 13**).
