**MINERALS PROGRAM INSPECTION REPORT**  
**PHONE: (303) 866-3567**

| <b>MINE NAME:</b><br>Cresson Project | <b>MINE/PROSPECTING ID#:</b><br>M-1980-244 | <b>MINERAL:</b><br>Gold | <b>COUNTY:</b><br>Teller |
| <b>INSPECTION TYPE:</b><br>Monitoring | <b>INSPECTOR(S):</b><br>Amy Eschberger, Patrick Lennberg | <b>INSP. DATE:</b><br>April 23, 2019 | <b>INSP. TIME:</b><br>09:45 |

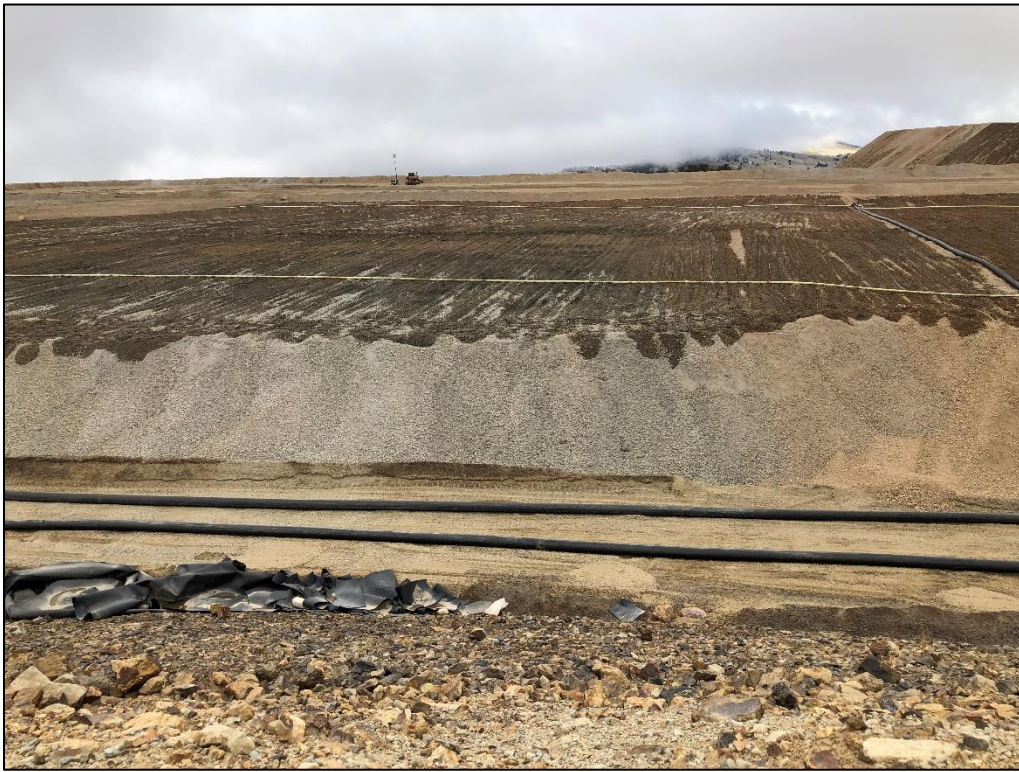
**Photo 1.** View looking west from top of HGM platform, showing SGVLF leaching surface. No solution ponding greater than 3 feet x 3 feet in size was observed.

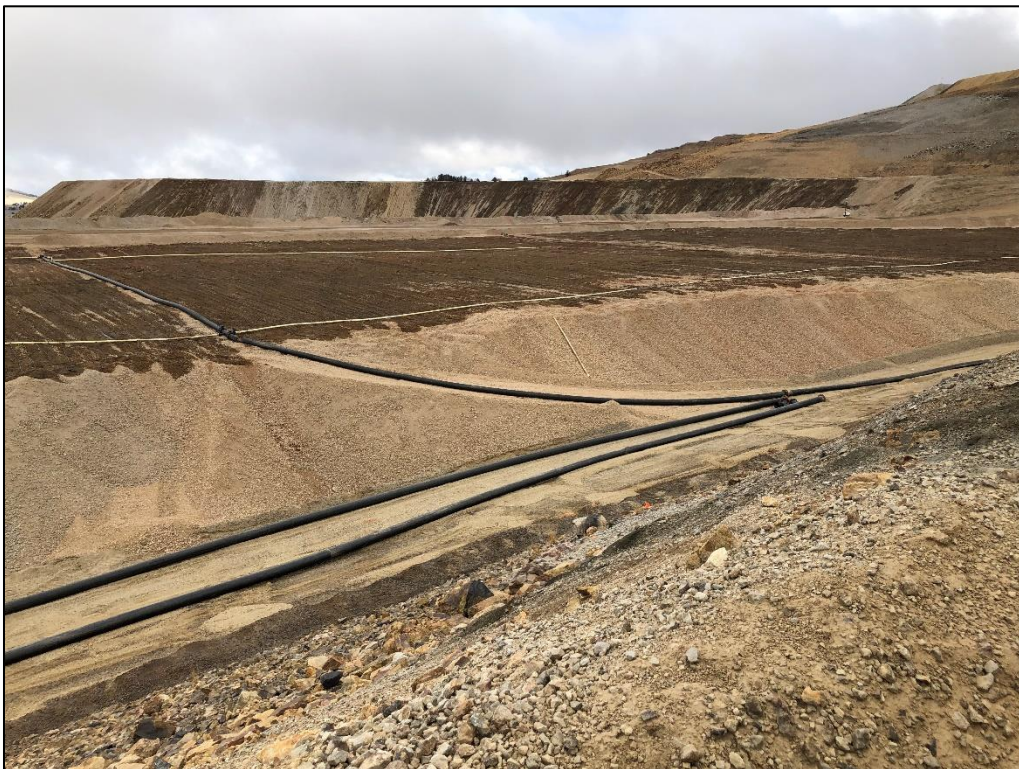
**Photo 2.** View looking northwest from top of HGM platform, showing SGVLF leaching surface. No solution ponding greater than 3 feet x 3 feet in size was observed.

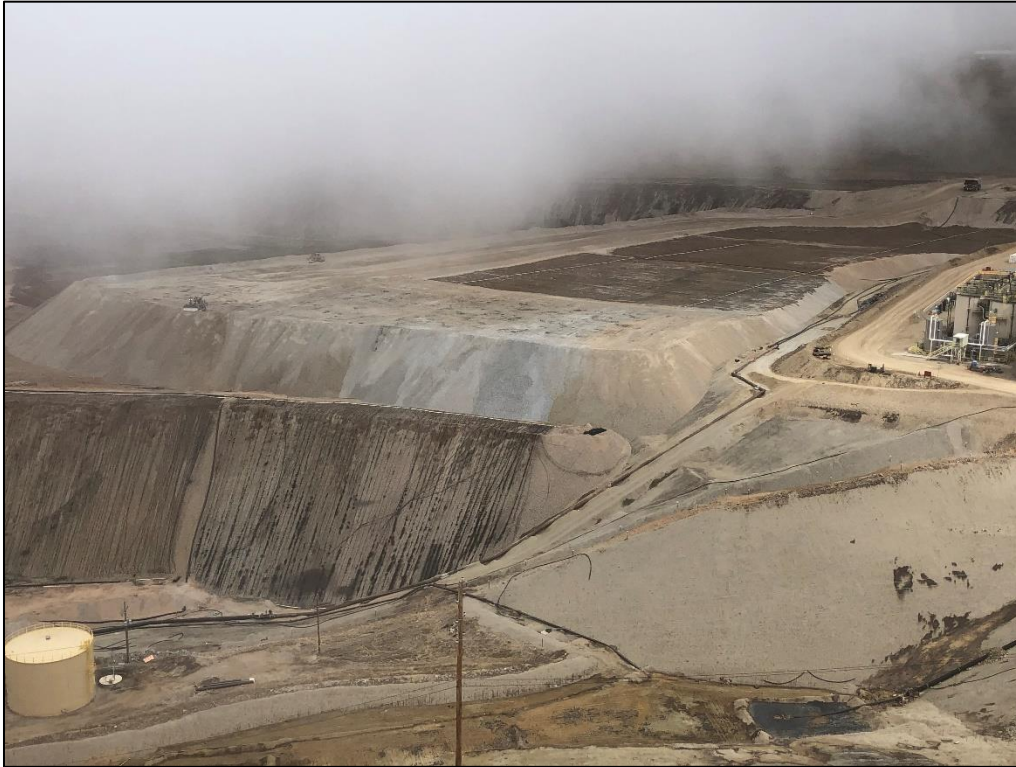
**Photo 3.** View looking northwest from overlook located south of HGM, showing SGVLF leaching surfaces. No solution ponding greater than 3 feet x 3 feet in size was observed. Note dense fog reducing visibility of northwestern portion of SGVLF.

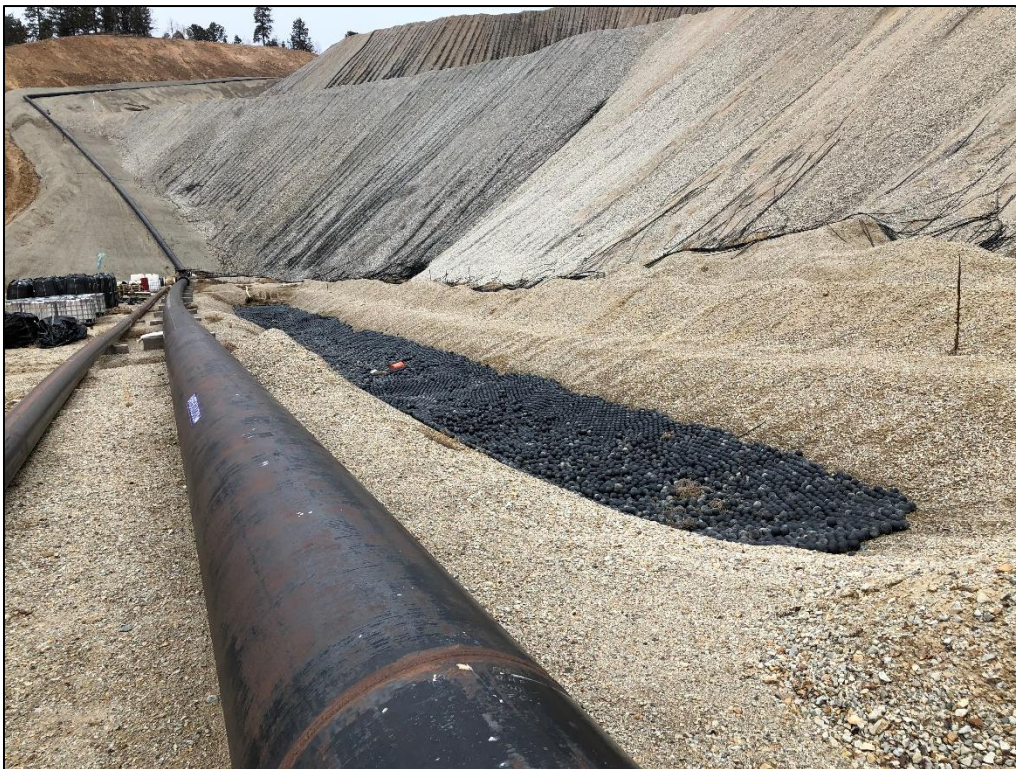
**Photo 4.** View looking northwest across sump at SGVLF toe filled with bird balls. This sump appeared to be dry during the inspection.

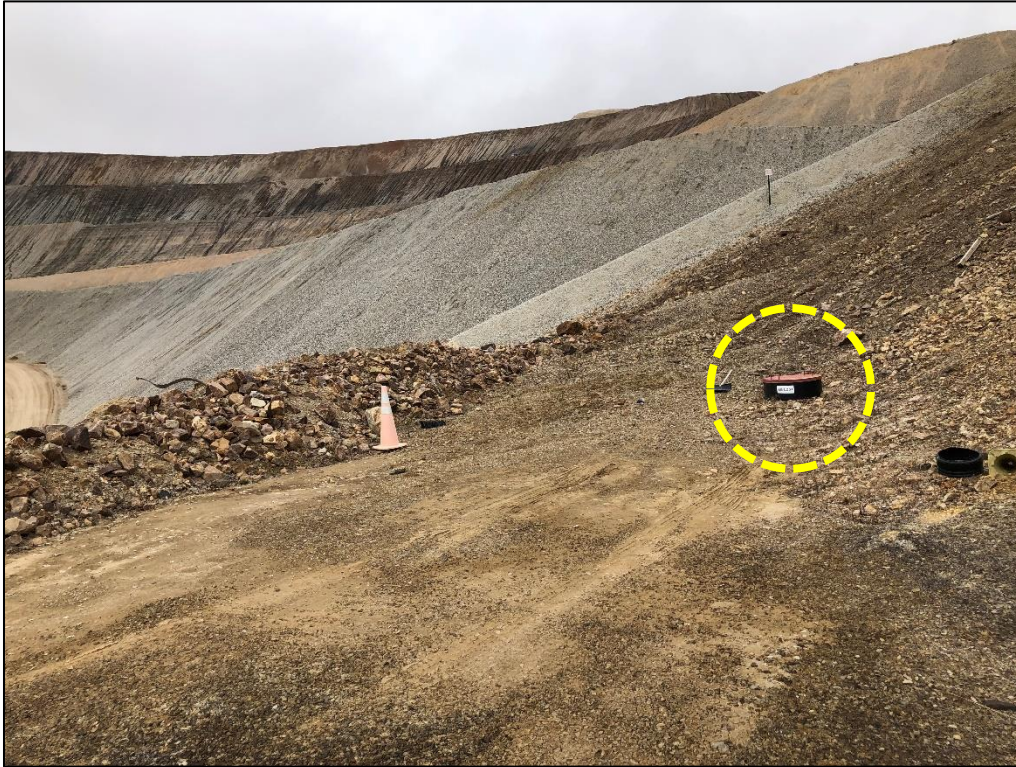
All three of the SGVLF Leak Detection System (LDS) sumps were inspected, including SG-LDS-1, SG-LDS-2, and SG-LDS-3. All of the sumps inspected were dry. The operator must inspect these sumps weekly, and sample and characterize any water present. The water should be removed after sampling so it can be determined if water continues to enter the sump.

**Photo 5.** View looking northeast, showing location of LDS sump SG-LDS-1 (circled) at southern edge of SGVLF.

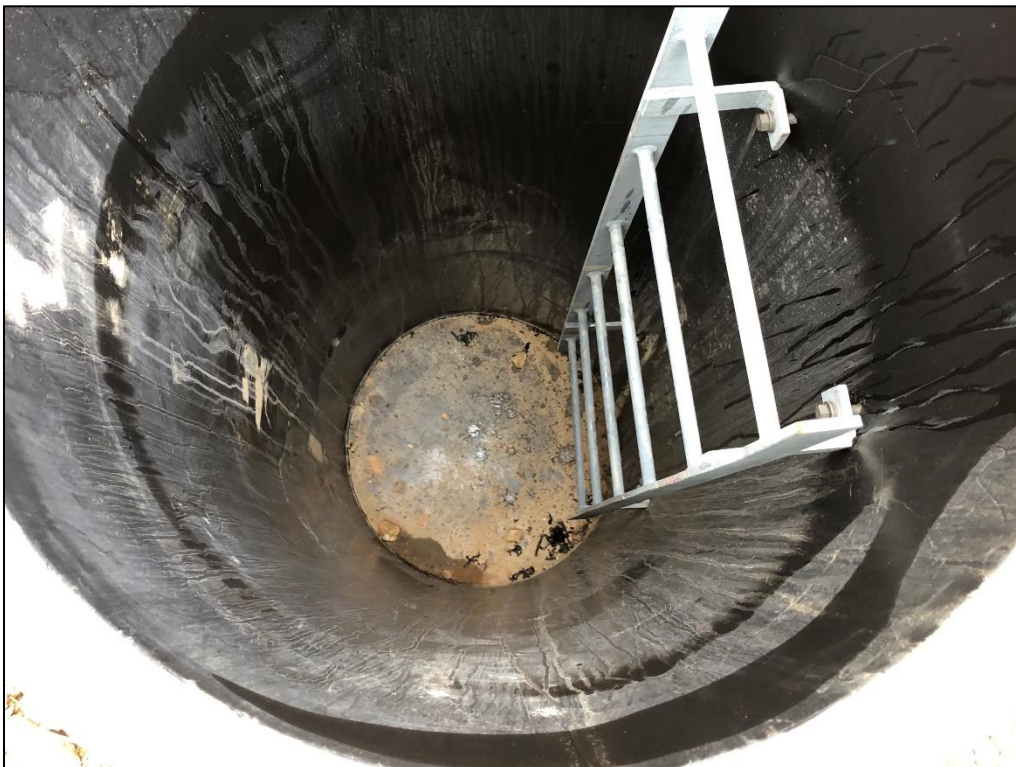
**Photo 6.** View looking inside LDS sump SG-LDS-1, showing sump dry during inspection.

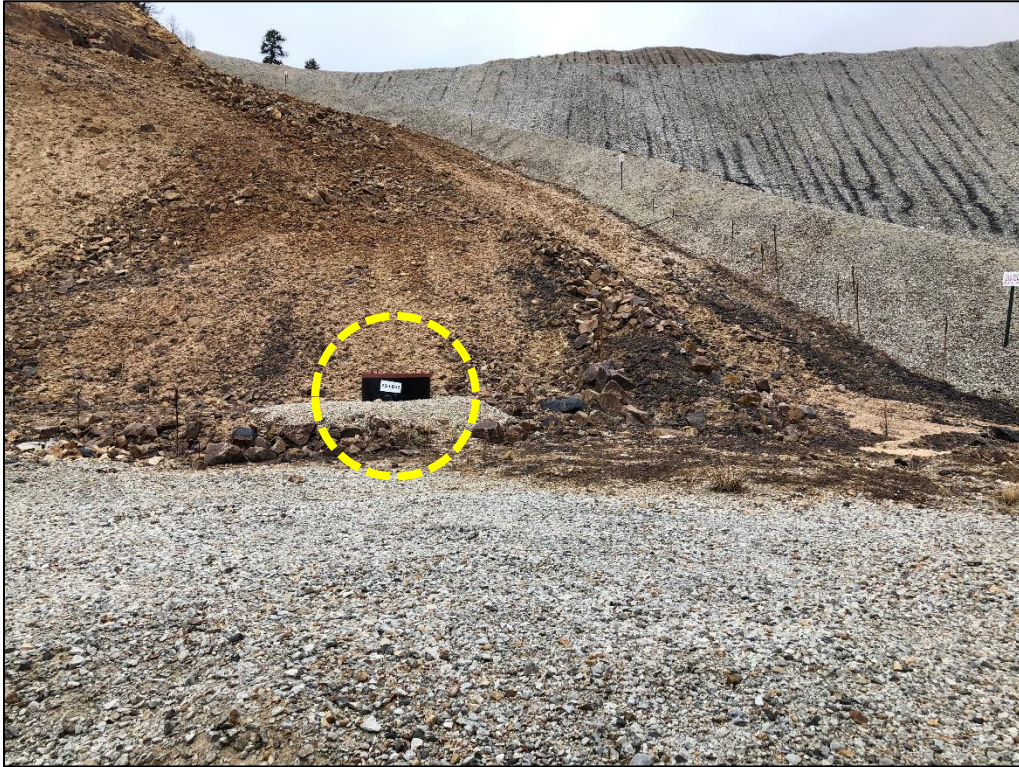
**Photo 7.** View looking north, showing location of LDS sump SG-LDS-2 (circled) at southwestern edge of SGVLF.

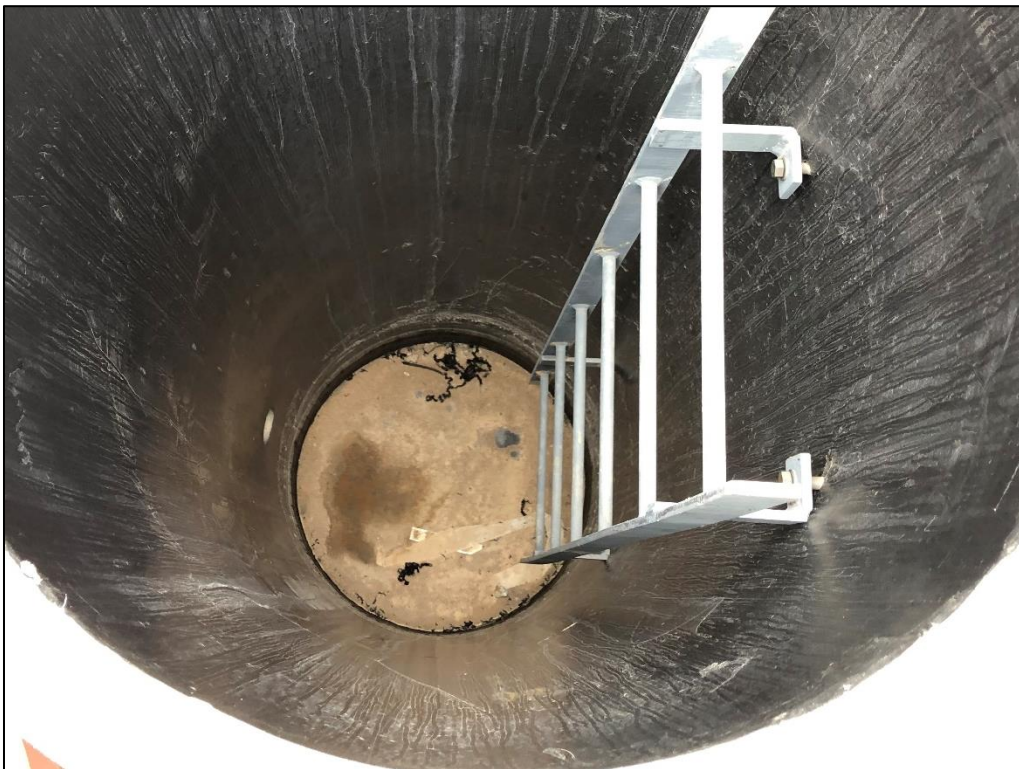
**Photo 8.** View looking inside LDS sump SG-LDS-2, showing sump dry during inspection.

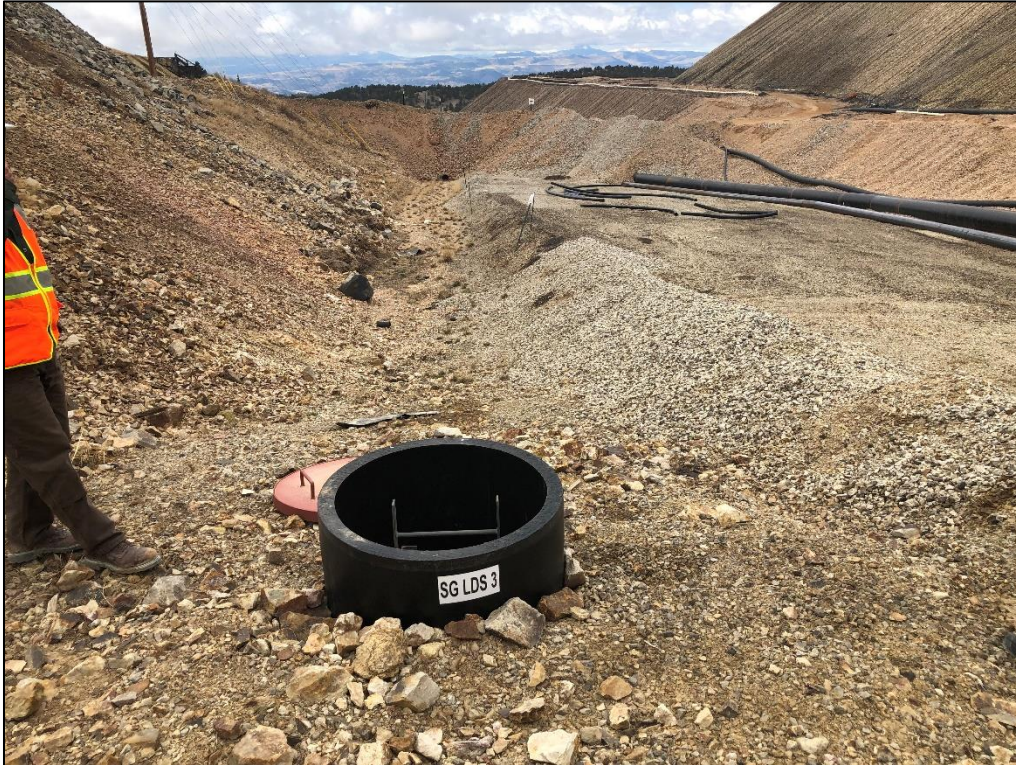
**Photo 9.** View looking southwest, showing location of LDS sump SG-LDS-3 at eastern edge of SGVLF.

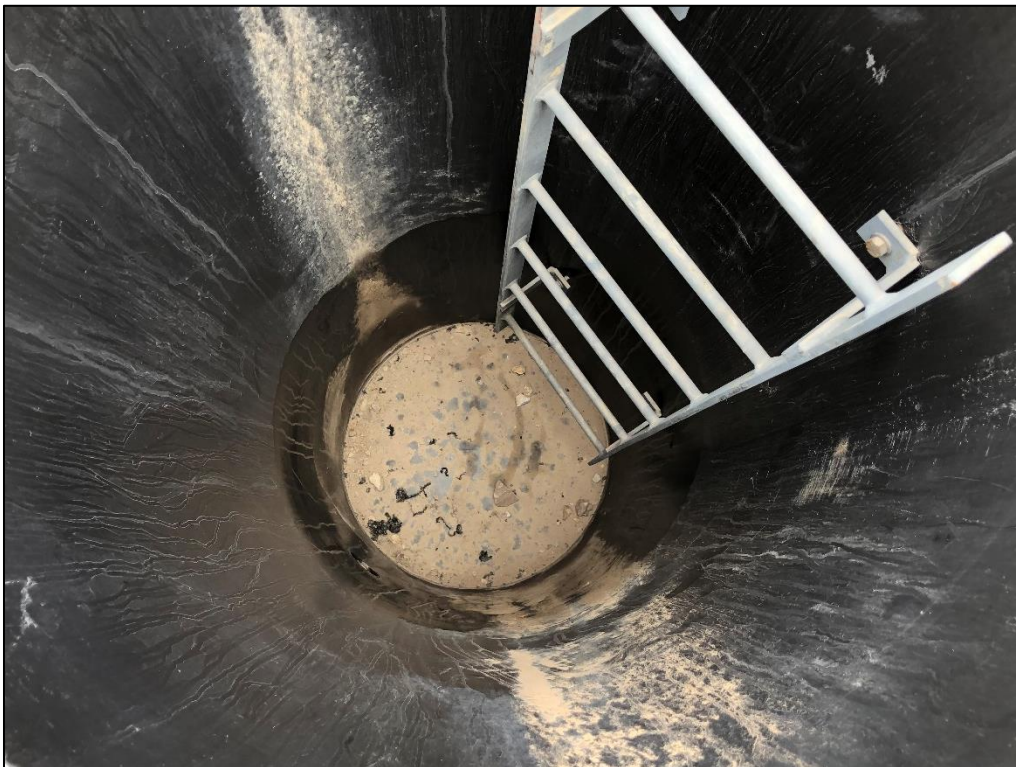
**Photo 10.** View looking inside LDS sump SG-LDS-3, showing sump dry during inspection.

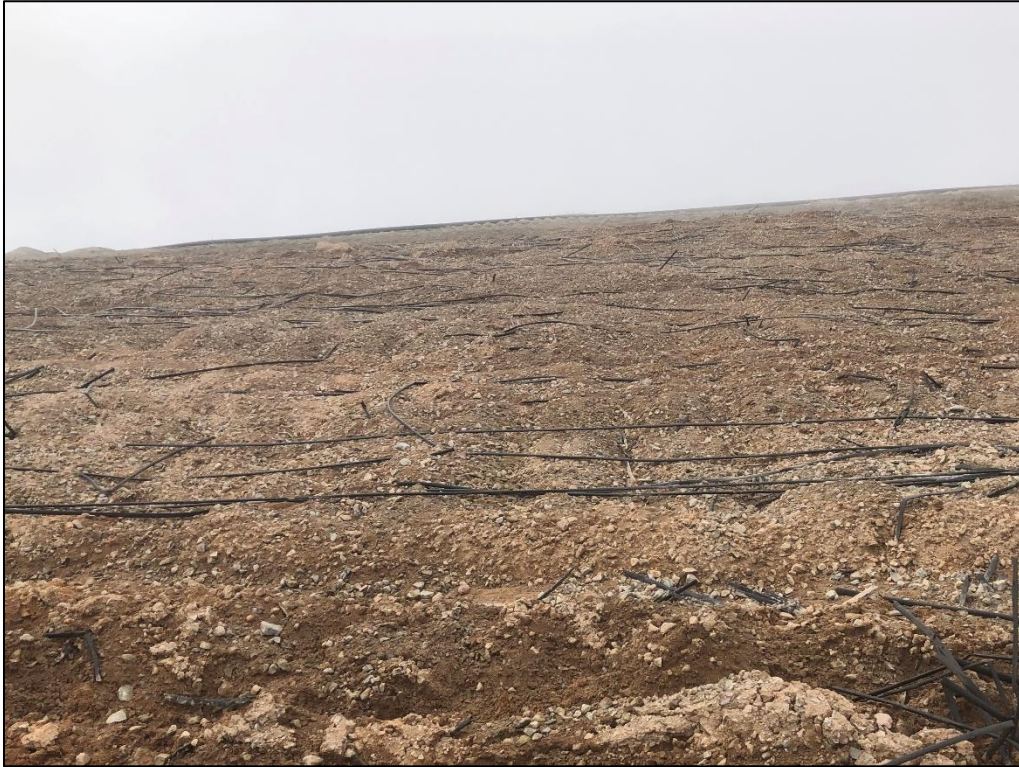
**Photo 11.** View looking across leaching surface of AGVLF. No solution ponding greater than 3 feet x 3 feet in size was observed.

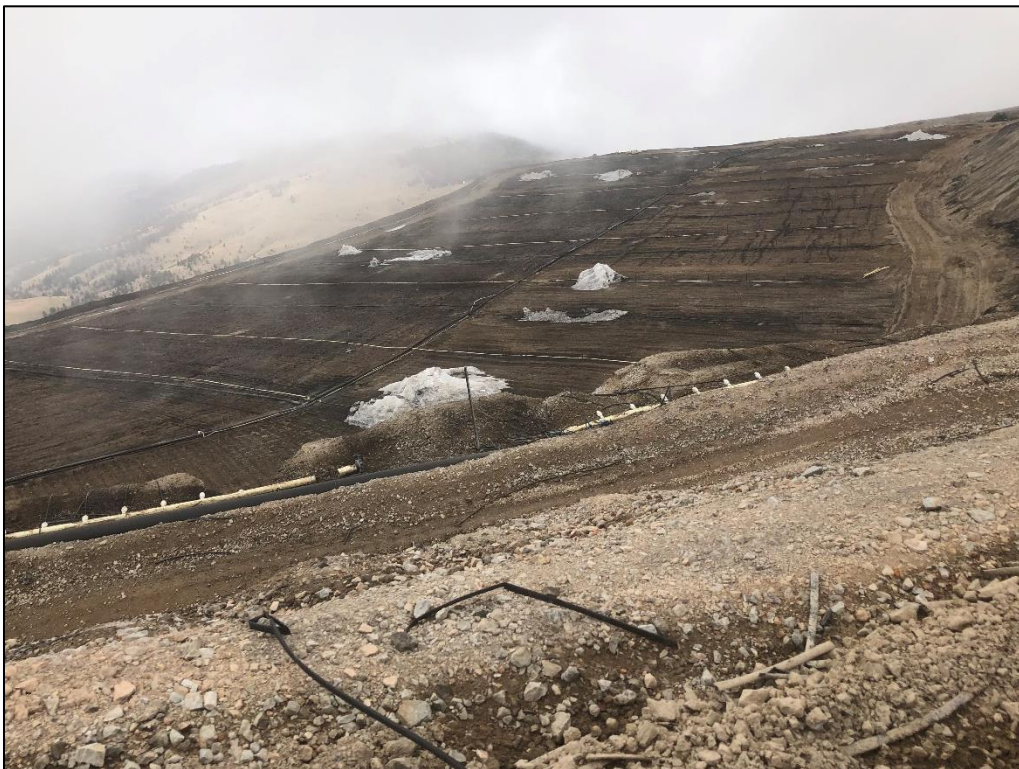
**Photo 12.** View looking across leaching surface of AGVLF at the 10,400 foot elevation. No solution ponding greater than 3 feet x 3 feet in size was observed. Note ice present on leaching surface.

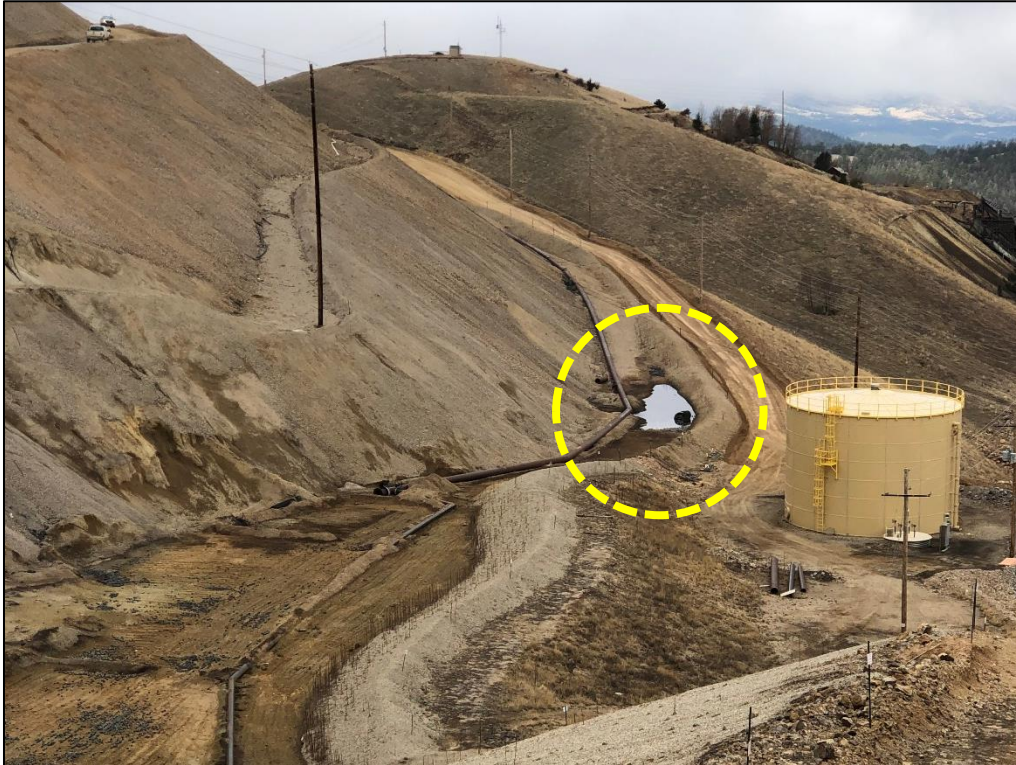
**Photo 13.** View looking southwest from top of HGM platform, showing ponding inside toe berm of AGVLF (circled) which the operator indicated is meteoric water.

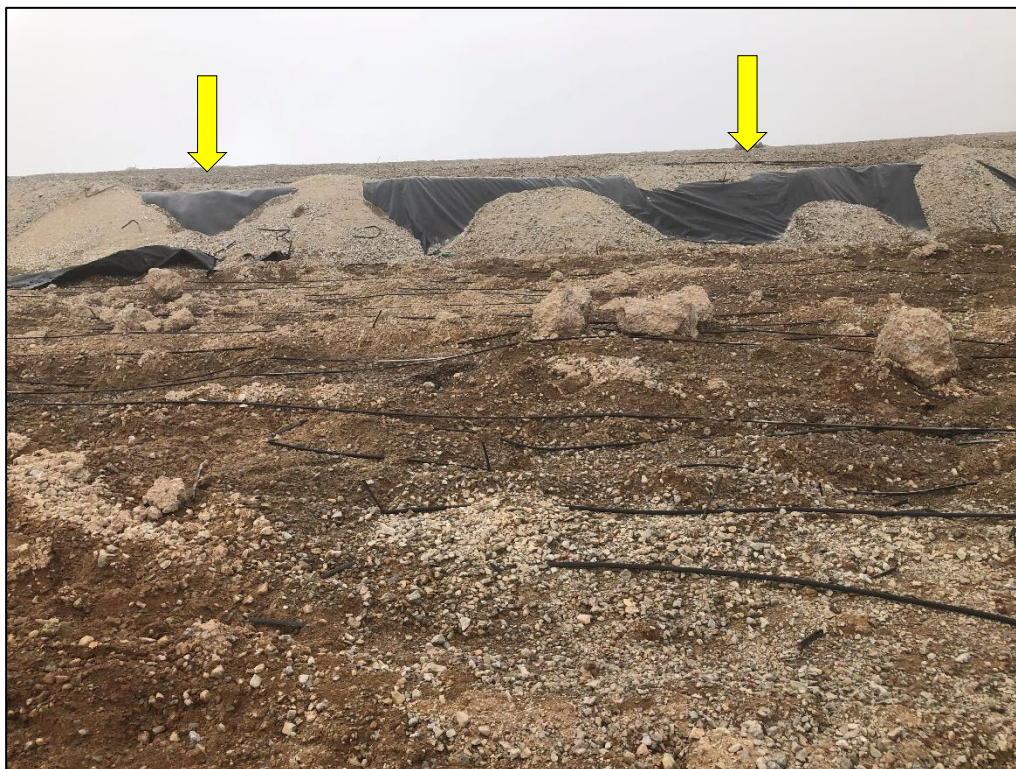
While inspecting the leaching surfaces of AGVLF, the operator pointed out the portion of Phase III proposed for conducting a leach cell study in Technical Revision No. 113 (TR-113). Approximately 18,000 tons of previously processed (leached) crushed ore has already been placed and distributed over the cell liner in this

area, at a depth of approximately 3 feet. The cell liner was installed in an overlapping fashion, with a 10% grade to direct solution to the north (toward the facility). TR-113 described the study area as being approximately 67,049 sq. ft. in size. The Division issued an adequacy review letter for TR-113 on April 26, 2019.

**Photo 14.** View looking west across top of AGVLF, showing Phase III area (indicated) proposed for use in a leach cell study (in TR-113). Approximately 3 feet of previously processed crushed ore has already been placed on a geomembrane liner in this area.

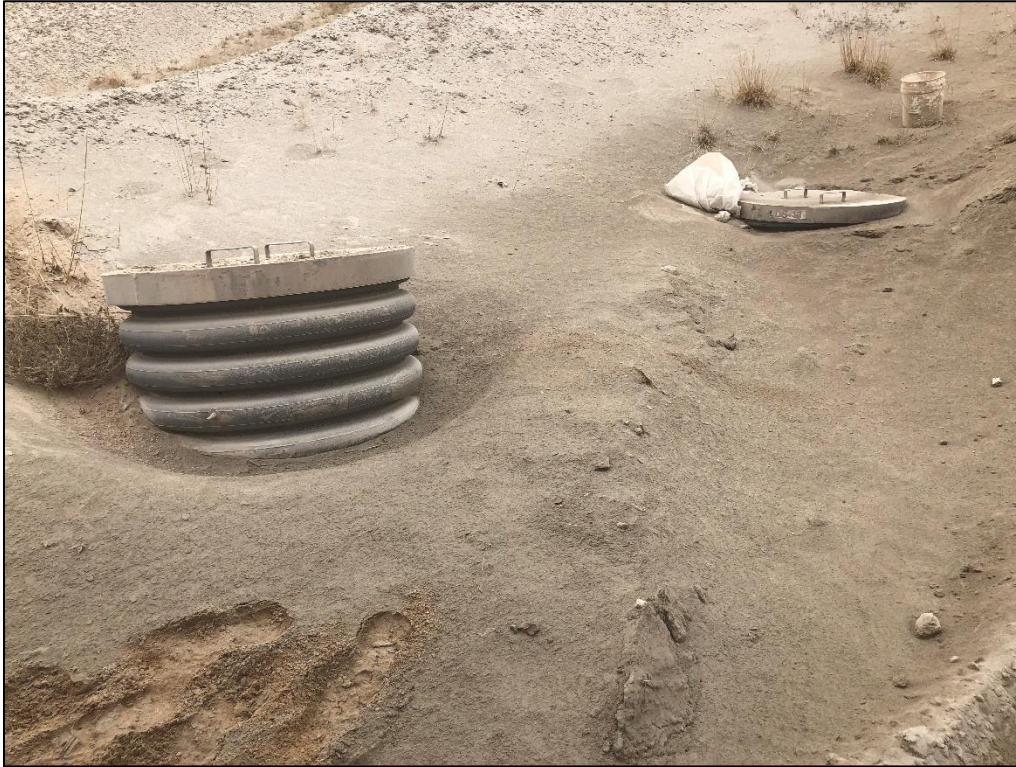
A total of 15 LDS sumps exist in the AGVLF. The Division inspected two of these sumps, including AG-LDS-12 and AG-LDS-13 (located in Phase IV, at the northern edge of the crusher area). The sumps inspected were dry. As mentioned above, the permit requires all LDS sumps to be inspected weekly and any water present in the sumps to be sampled and characterized. The action level for water found in the sumps is pH > 9 and/or (WAD) Cyanide > 0.5 mg/L. The operator stated none of the water samples collected from the sumps thus far has met action level concentrations. All LDS sumps were last inspected by the operation the day before this inspection (on April 22, 2019). Some of the sumps had water and were therefore sampled and the remaining water pumped out. This included the AG-LDS-6 sump which frequently has a few inches of water (observed by the Division during previous inspections). The operator has recently (within the last few weeks) started hanging buckets at the inlets inside the sumps for those which have frequently held water. This has helped the operation to differentiate water entering the sump from the LDS from other water sources (i.e. meteoric). So far, this experiment has shown water present in the sumps to not have come from the inlets, meaning the water is not coming from the LDS. Regardless, the operator continues collecting samples from any water found in the sumps during the weekly inspections, as required by the permit.

**Photo 15.** View looking north, showing location of LDS sumps AG-LDS-12 (foreground) and AG-LDS-13 (background) at northern edge of crusher area in Phase IV of AGVLF.

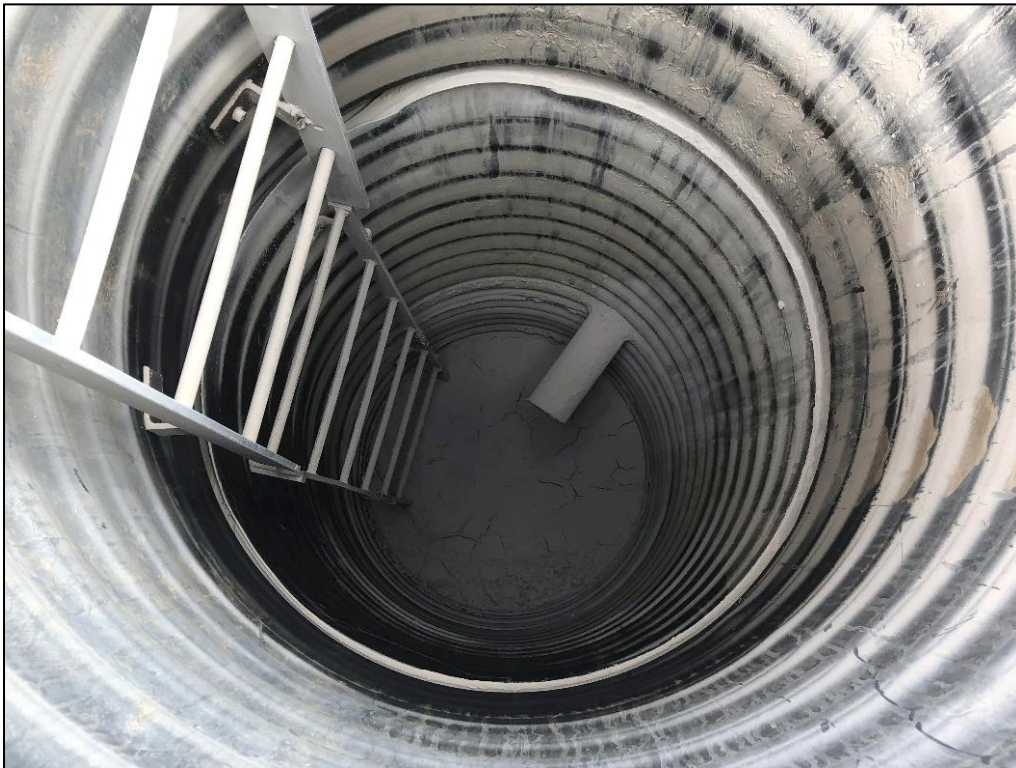
**Photo 16.** View looking inside LDS sump AG-LDS-12, showing sump dry during inspection.

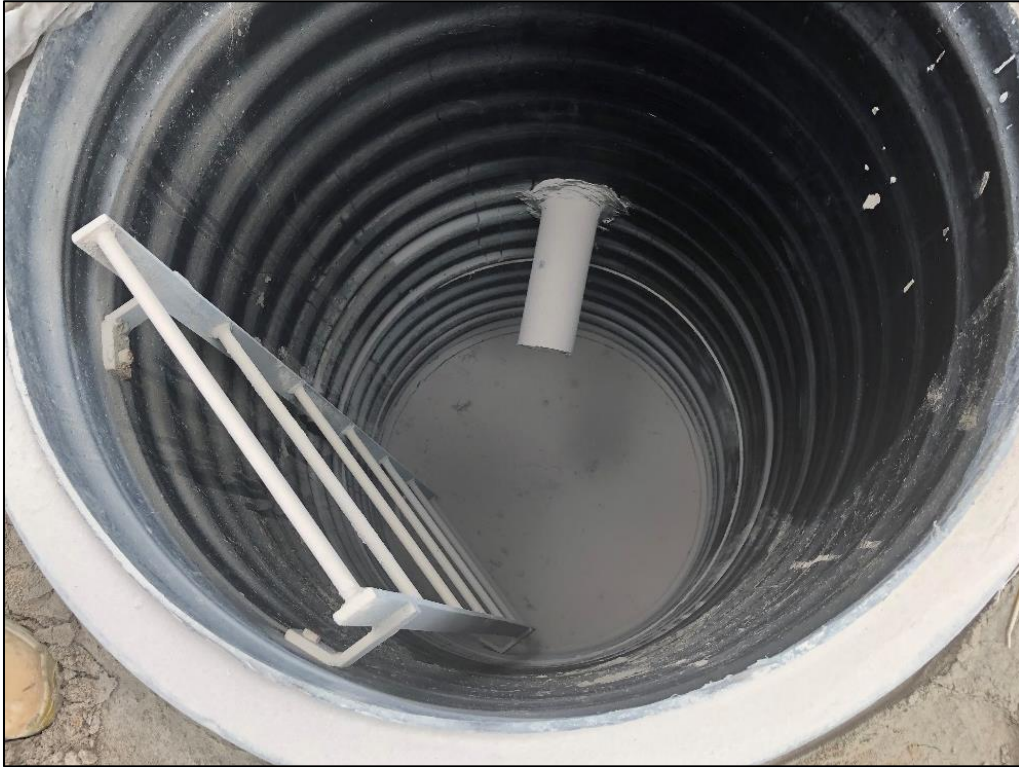
**Photo 17.** View looking inside LDS sump AG-LDS-13, showing sump dry during inspection.

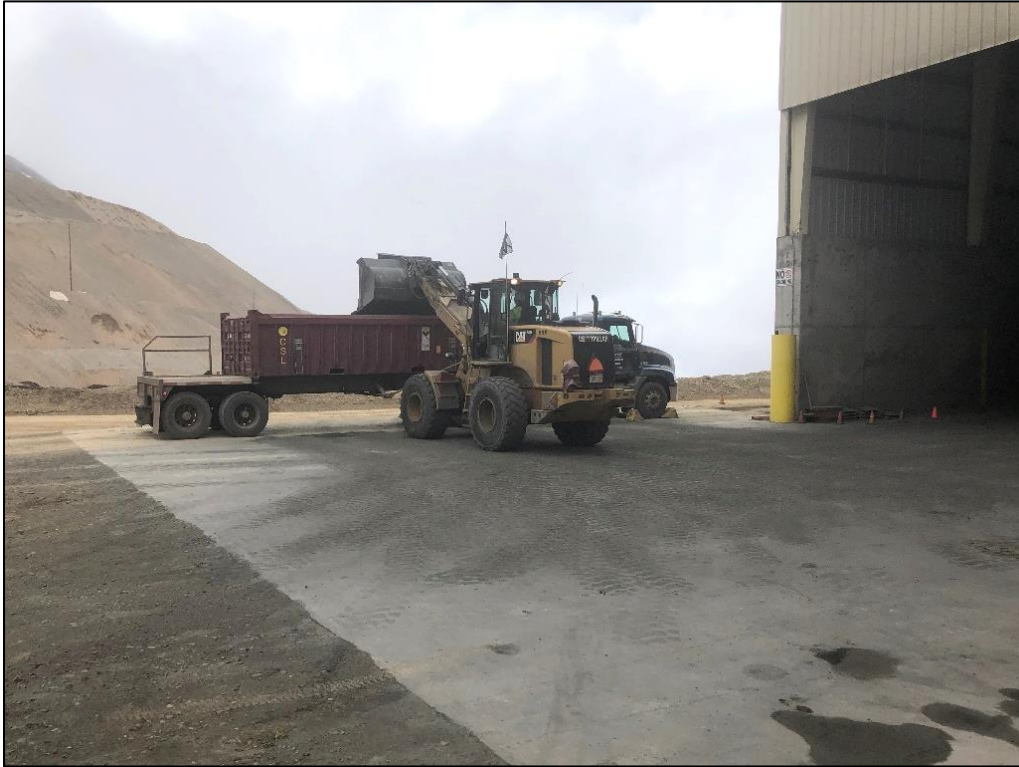
**Photo 19.** View looking south, showing loader loading concentrate from Con Barn into haul truck during inspection.

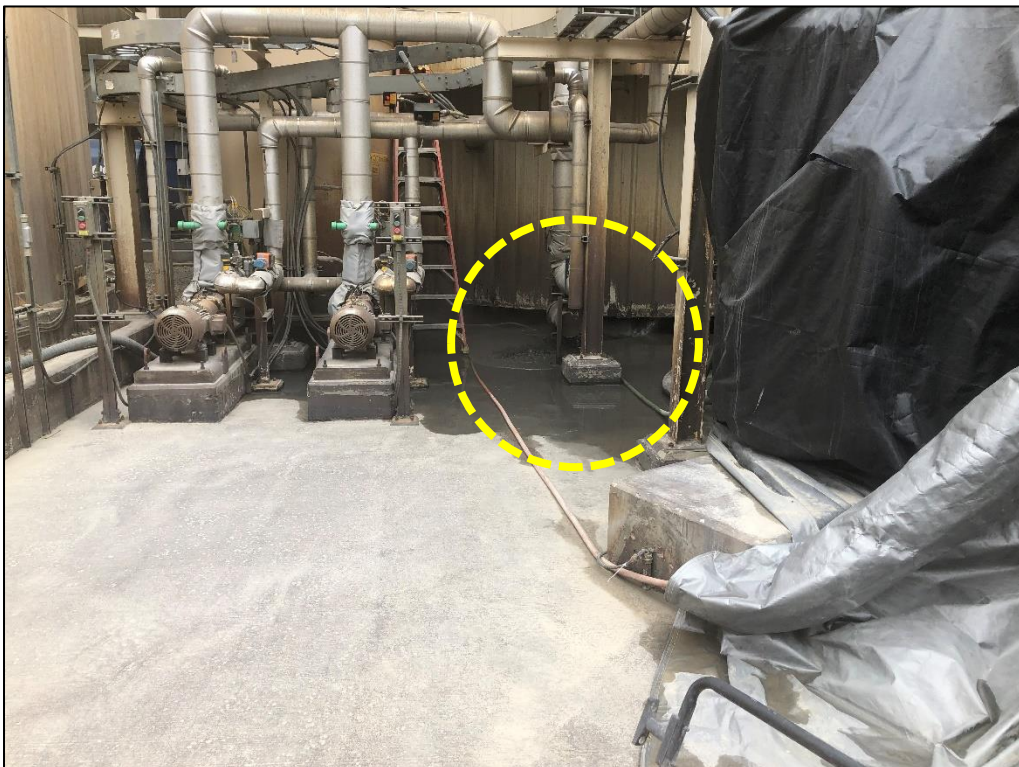
the concentrate storage facility (Con Barn). The Division observed a loader loading a haul truck with concentrate from the Con Barn. During the inspection, the high pH thickener tank located on the eastern side of the building was being drained for cleaning (which occurs annually according to the operator). The fluid from the tank was draining into the high pH thickener secondary containment and into the sump. Water was then being pumped from the sump and discharged into the secondary containment for the processed ore thickener tank, where it flowed to the sump located at the northwest corner of the containment structure. This portion of the structure had approximately 1-2 inches of sludge deposited from the discharge. The tank cleaning process does temporarily utilize a portion of the overall capacity of the secondary containment. However, this occurs over a relatively short period of time (typically during a single day), utilizes a small portion of the containment capacity, and is cleaned out immediately after the process is completed.

**Photo 20.** View looking across secondary containment for high pH thickener, located on east side of HGM. High pH thickener tank was being drained during the inspection for cleaning (drainage area circled).

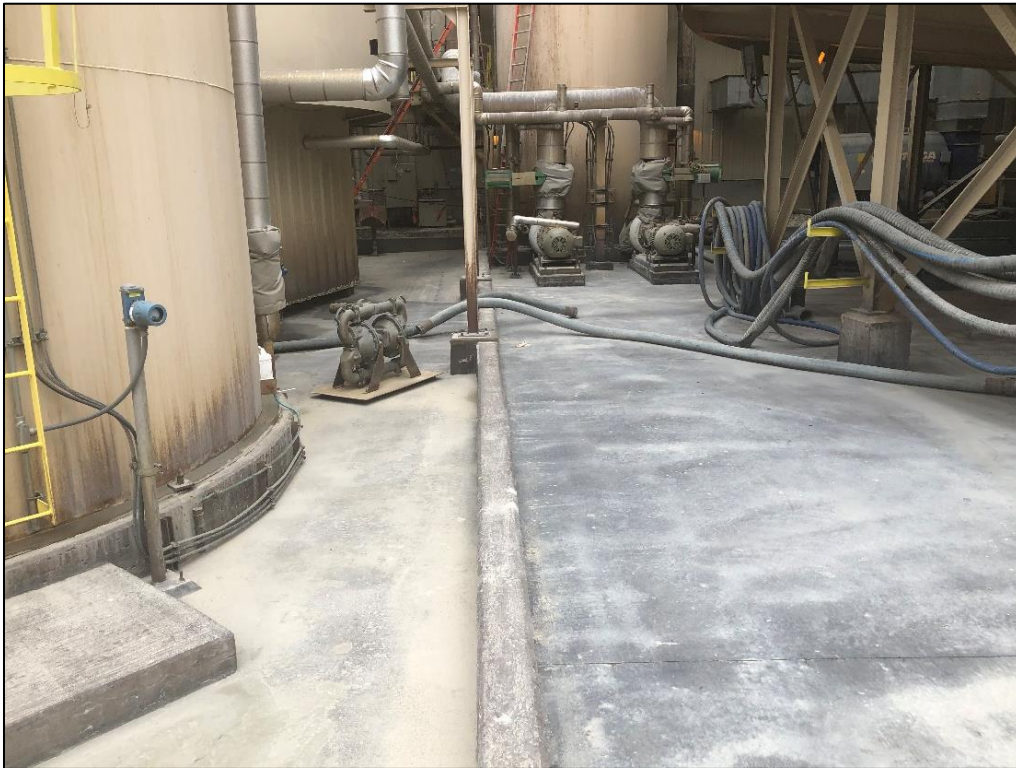
**Photo 21.** View looking across secondary containment for high pH thickener (left) and processed ore thickener (right), located on east side of HGM. Water was being pumped from high pH thickener sump to secondary containment of processed ore thickener during inspection (note hose at center).

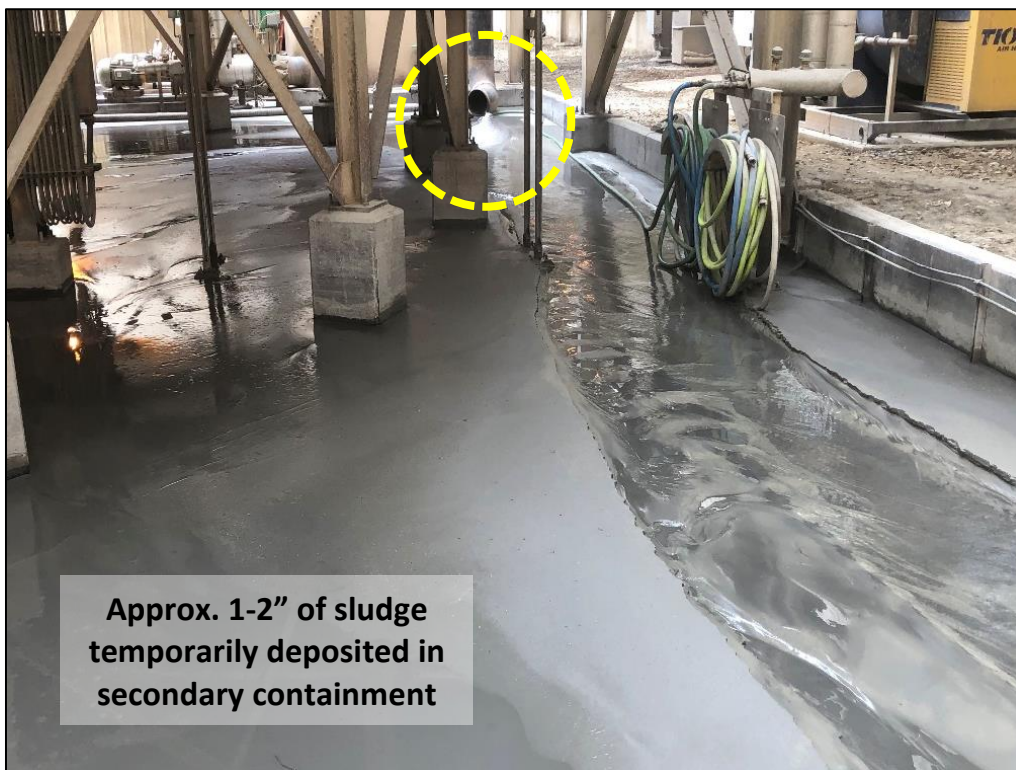
**Photo 22.** View looking across western half of secondary containment for processed ore thickener, located on east side of HGM. Water from high pH thickener sump was being discharged (circled) into this structure during inspection.

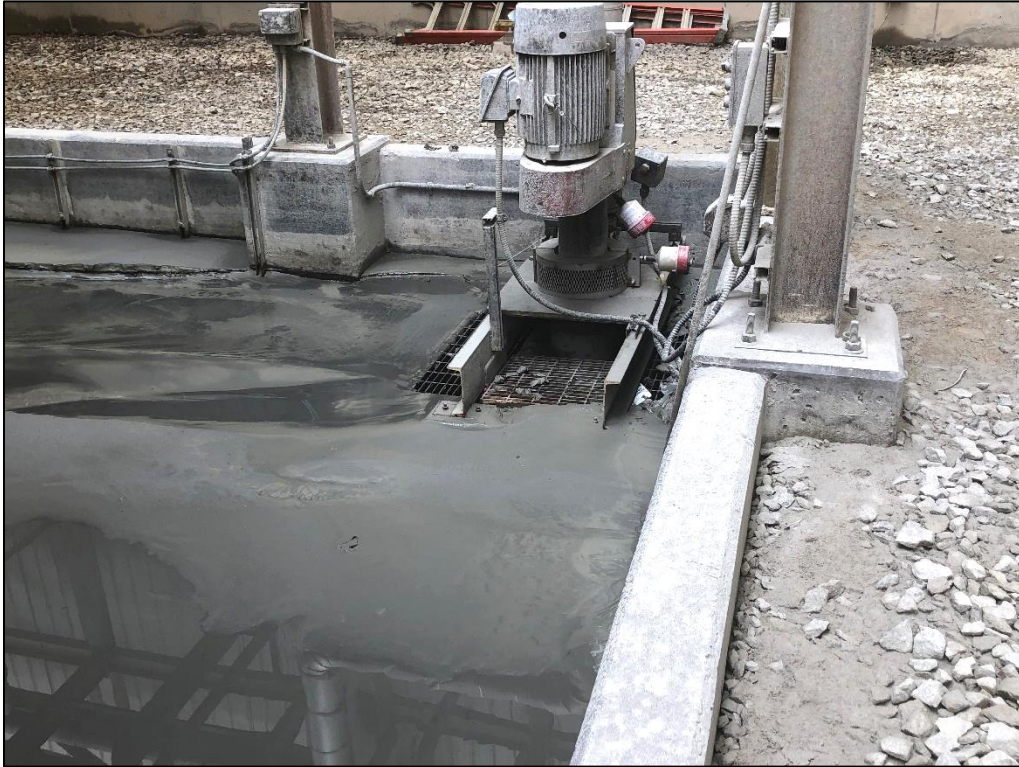
**Photo 23.** View looking across secondary containment for processed ore thickener, located on east side of HGM. High pH thickener discharge was draining into sump (shown) located at northwest corner of this structure.

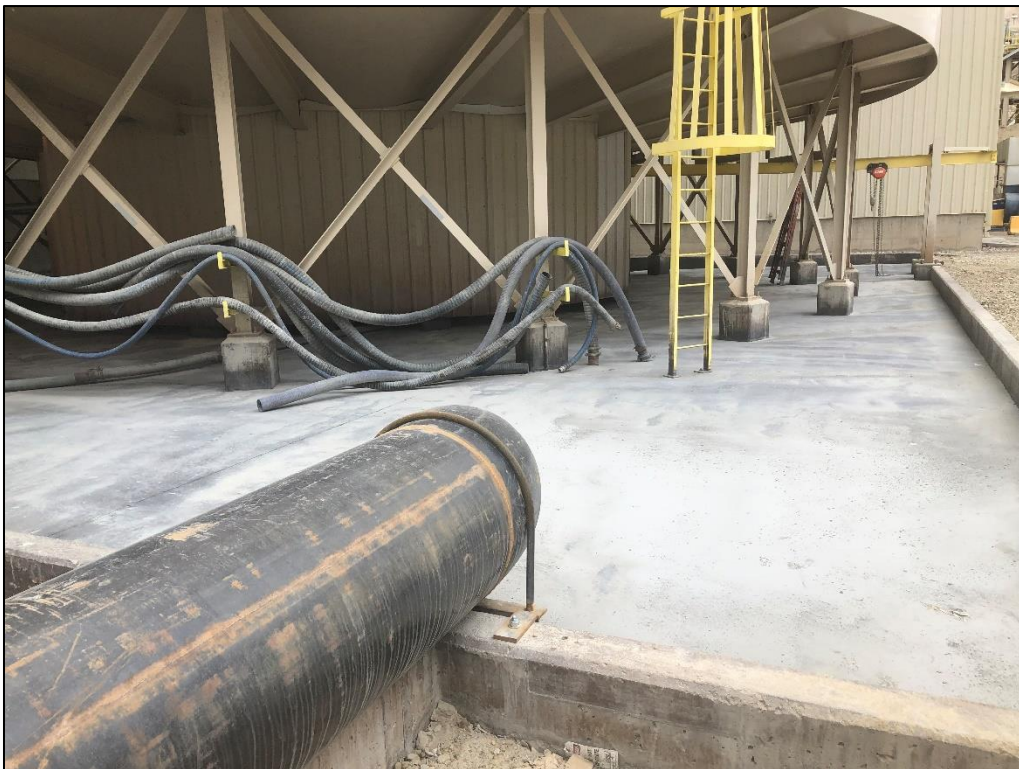
**Photo 24.** View looking across eastern half of secondary containment for processed ore thickener, located on east side of HGM. Note this portion of the structure had no reduction in capacity during the inspection.

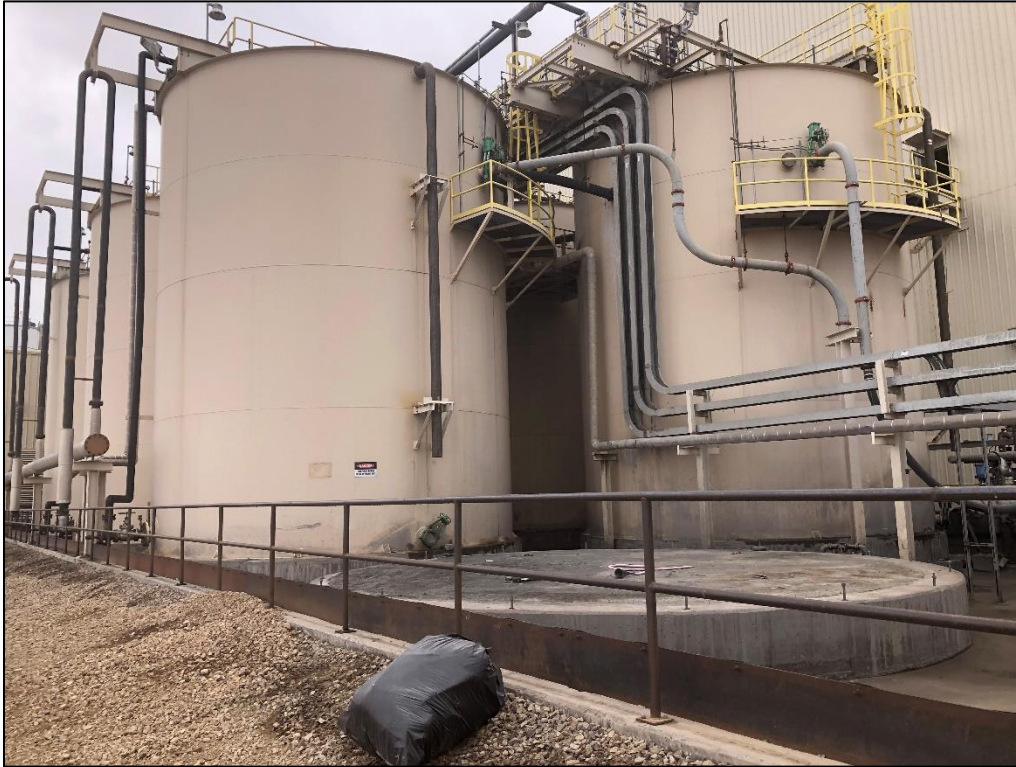
The vat leach circuit on the northwest side of the HGM continued to be offline (since February 2018).

**Photo 27.** View looking across vat leach circuit present on west side of HGM, still offline since February 2018.

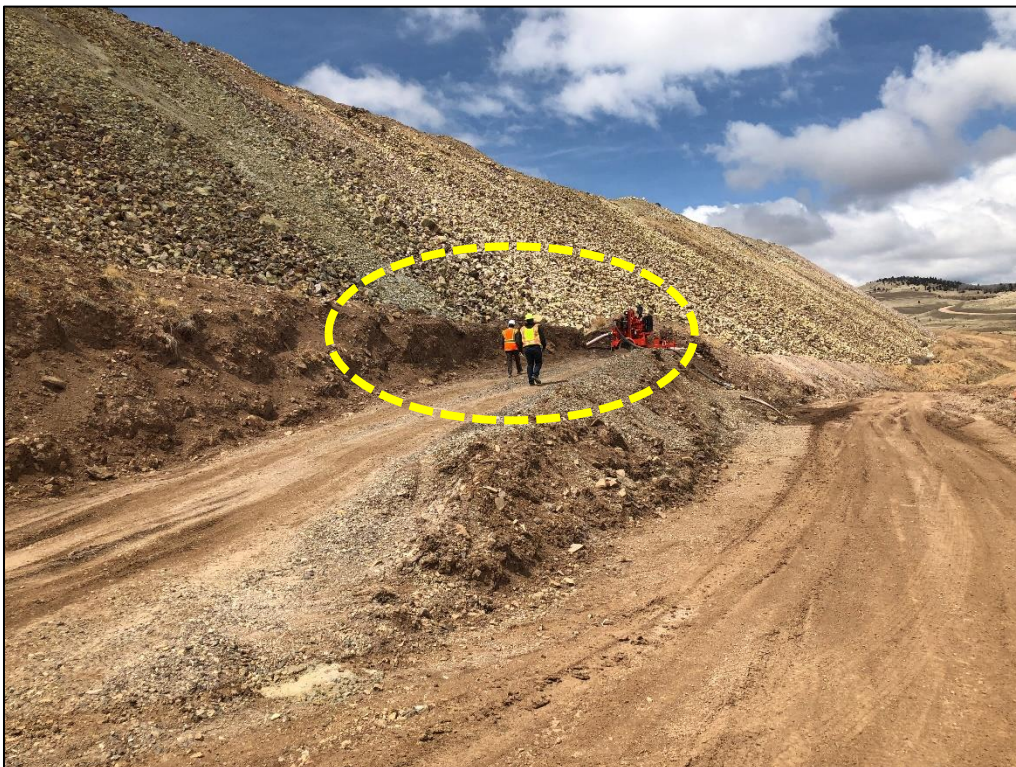
**Photo 28.** View looking northwest, showing location of seep accumulation trench at eastern toe of ECOSA (circled).
