**MINERALS PROGRAM INSPECTION REPORT**  
**PHONE: (303) 866-3567**

| <b>MINE NAME:</b><br>Cresson Project | <b>MINE/PROSPECTING ID#:</b><br>M-1980-244 | <b>MINERAL:</b><br>Gold | <b>COUNTY:</b><br>Teller |
| <b>INSPECTION TYPE:</b><br>Monitoring | <b>INSPECTOR(S):</b><br>Amy Eschberger, Patrick Lennberg | <b>INSP. DATE:</b><br>April 23, 2019 | <b>INSP. TIME:</b><br>09:45 |

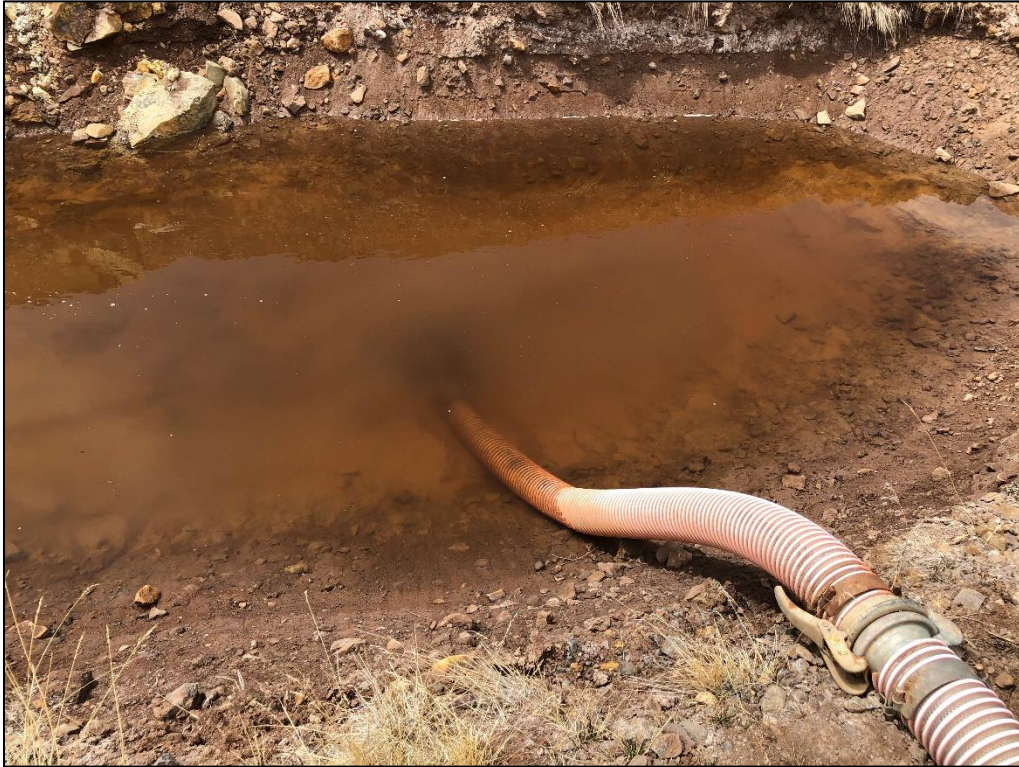
The Division inspected the seep area located at the eastern toe of the ECOSA. The seep accumulation trench was holding water during the inspection. The water was red in color and approximately 2-1/2 feet deep. A trickle of water was observed flowing into the trench (within the toe berm of the ECOSA) from the south/southeast. The operator indicated the length of time between a precipitation event and when the seep expresses from the ECOSA is slowing, and was recently recorded to take approximately 12 hours (more than double the rate observed by the operator last summer). The operator has a plan for monitoring the accumulation of water from the seep, and as needed, transporting the water from the ECOSA to a lined facility on site (one of the valley leach facilities). The operator representatives present during the inspection were not sure of the current seep flow rate or when the accumulation trench was last pumped. The operator did mention plans to install a staff gauge in the trench so the water level can be more easily estimated and tracked.

The operator provided water quality data for the ECOSA seep to the Division on July 20, 2017. This data shows the seep water to have a very low pH (3.45), very high TDS (17,700 mg/L), and elevated concentrations of Aluminum (961 mg/L), Arsenic (0.027 mg/L), Cadmium (2.55 mg/L), Copper (0.407 mg/L), Iron (2.48 mg/L), Manganese (565 mg/L), Nickel (3.46 mg/L), Selenium (0.068 mg/L), Zinc (80.1 mg/L), and Sulfate (11,900 mg/L). Because the majority of the ECOSA (including the portion with the identified seep) is located on top of the diatreme, the operator believes the seep water infiltrates the ground to the diatreme. If the impacted ECOSA seep water were to migrate downgradient, the Division would expect to see evidence of impacted shallow groundwater at the new monitoring well that was installed in Grassy Valley in May of 2018 (GVMW-25). The operator started reporting monitoring data for this well in the 4<sup>th</sup> Quarter 2018 report. The data presented thus far does not indicate impacts from the ECOSA seep. The operator has indicated they are working on a long-term (final closure) mitigation plan for the ECOSA seep which will be presented in a permit revision.

**Photo 29.** View of seep accumulation trench at eastern toe of ECOSA, showing approximately 2-1/2 feet of water present in trench during inspection.

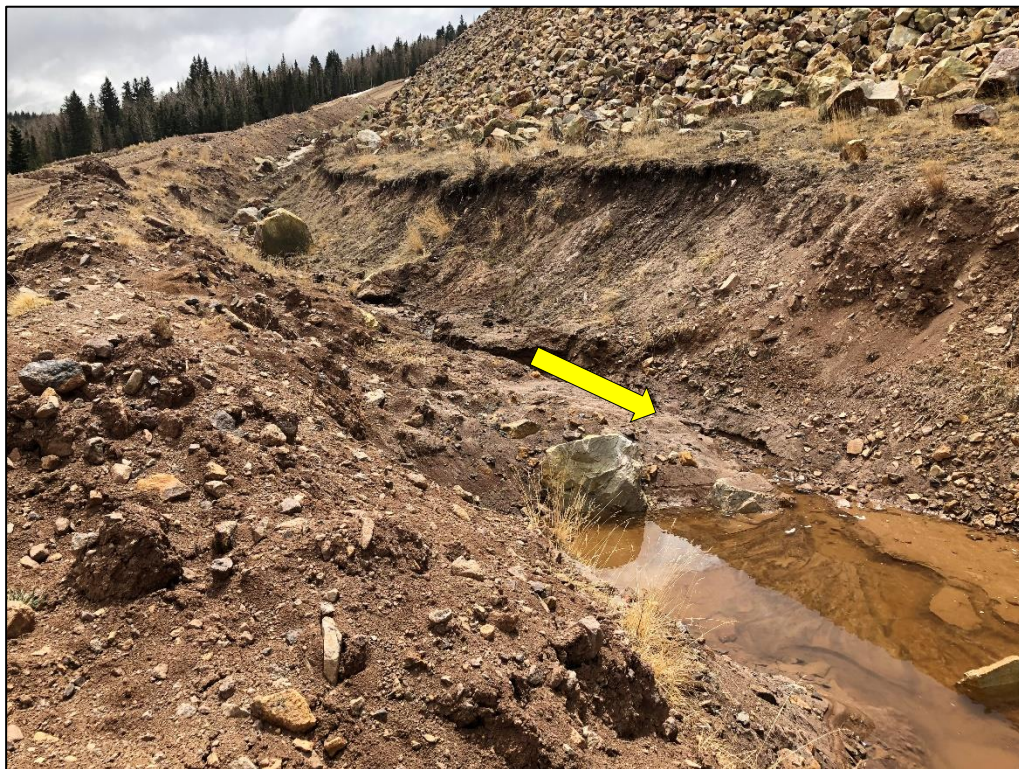
**Photo 30.** View looking southeast from seep accumulation trench at eastern toe of ECOSA. A trickle of water was flowing into the trench during the inspection (flow direction indicated).
