## TECHNICAL MEMORANDUM

**TO:** Mark A. Steen (Colorado Milling Company LLC)  
**FROM:** Christoph Goss PhD, P.E.  
**DATE:** May 15, 2019  
**RE:** Times Mine Bulkhead Evaluation  
D&A Job No. 0788.001.00

This technical memorandum is in response to a request by Colorado Milling Company, LLC to evaluate the Times Mine Bulkhead at the Gold Hill Mill site.

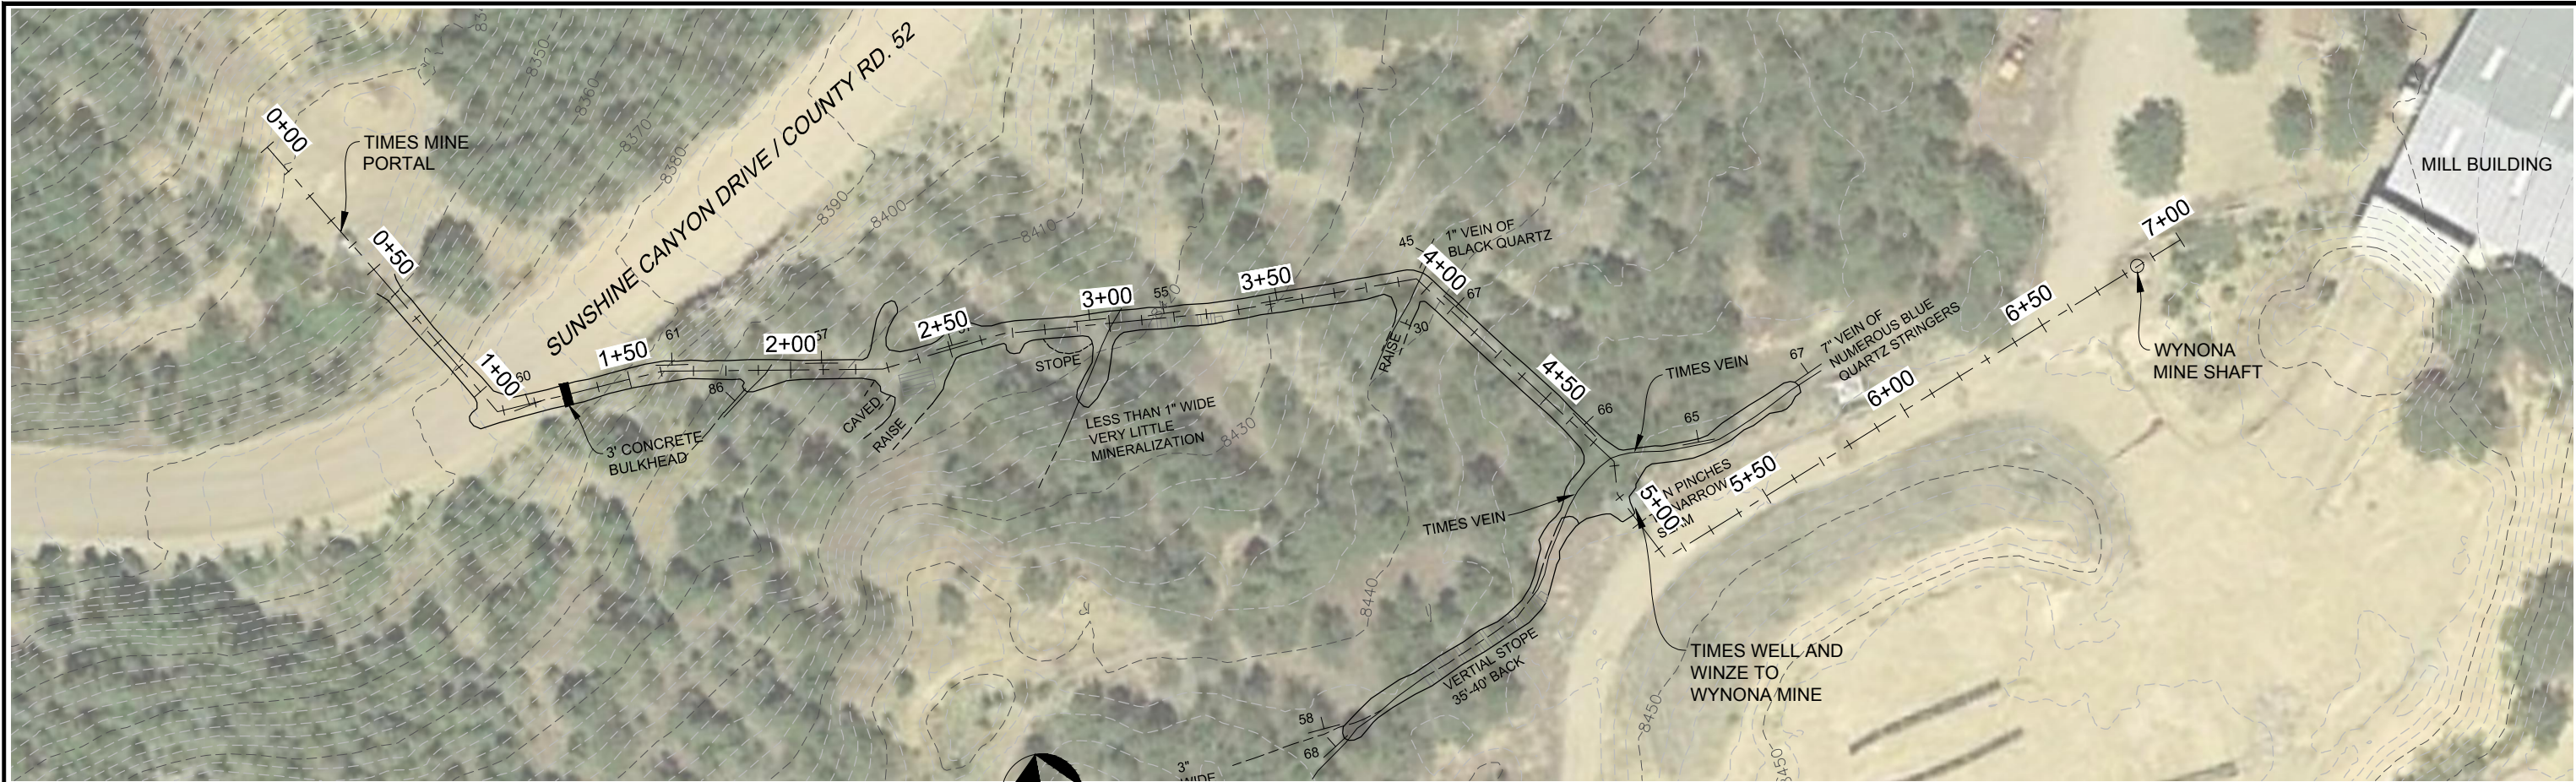
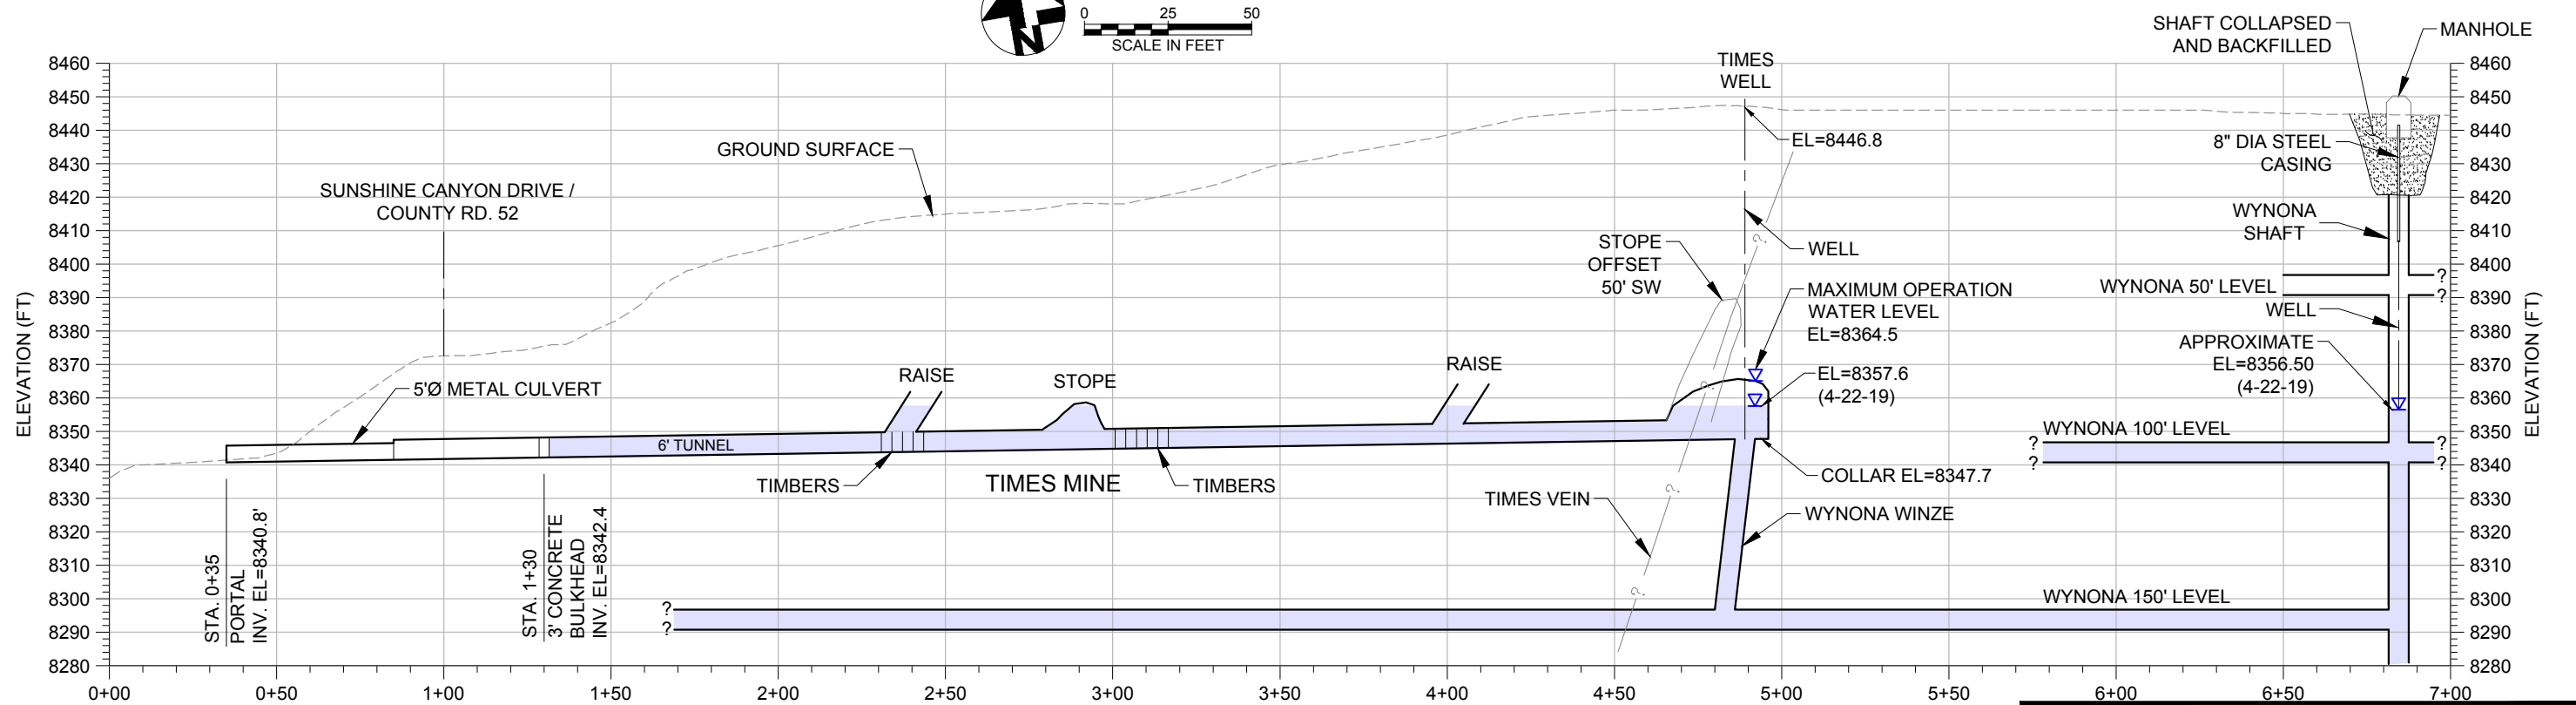
**PLAN AND PROFILE**

Using site measurements, public data, and documentation from CMC and Mountain Surveying LLC, D&A developed a plan and profile of the site to better understand and explain the project. This is shown in **Figure 3**. Key elevations are summarized on the table below. Note that the difference in the water elevations at the Times Well and Wynona Shaft are mostly due to field measurement limitations. The elevations do appear to reflect the same mine pool.

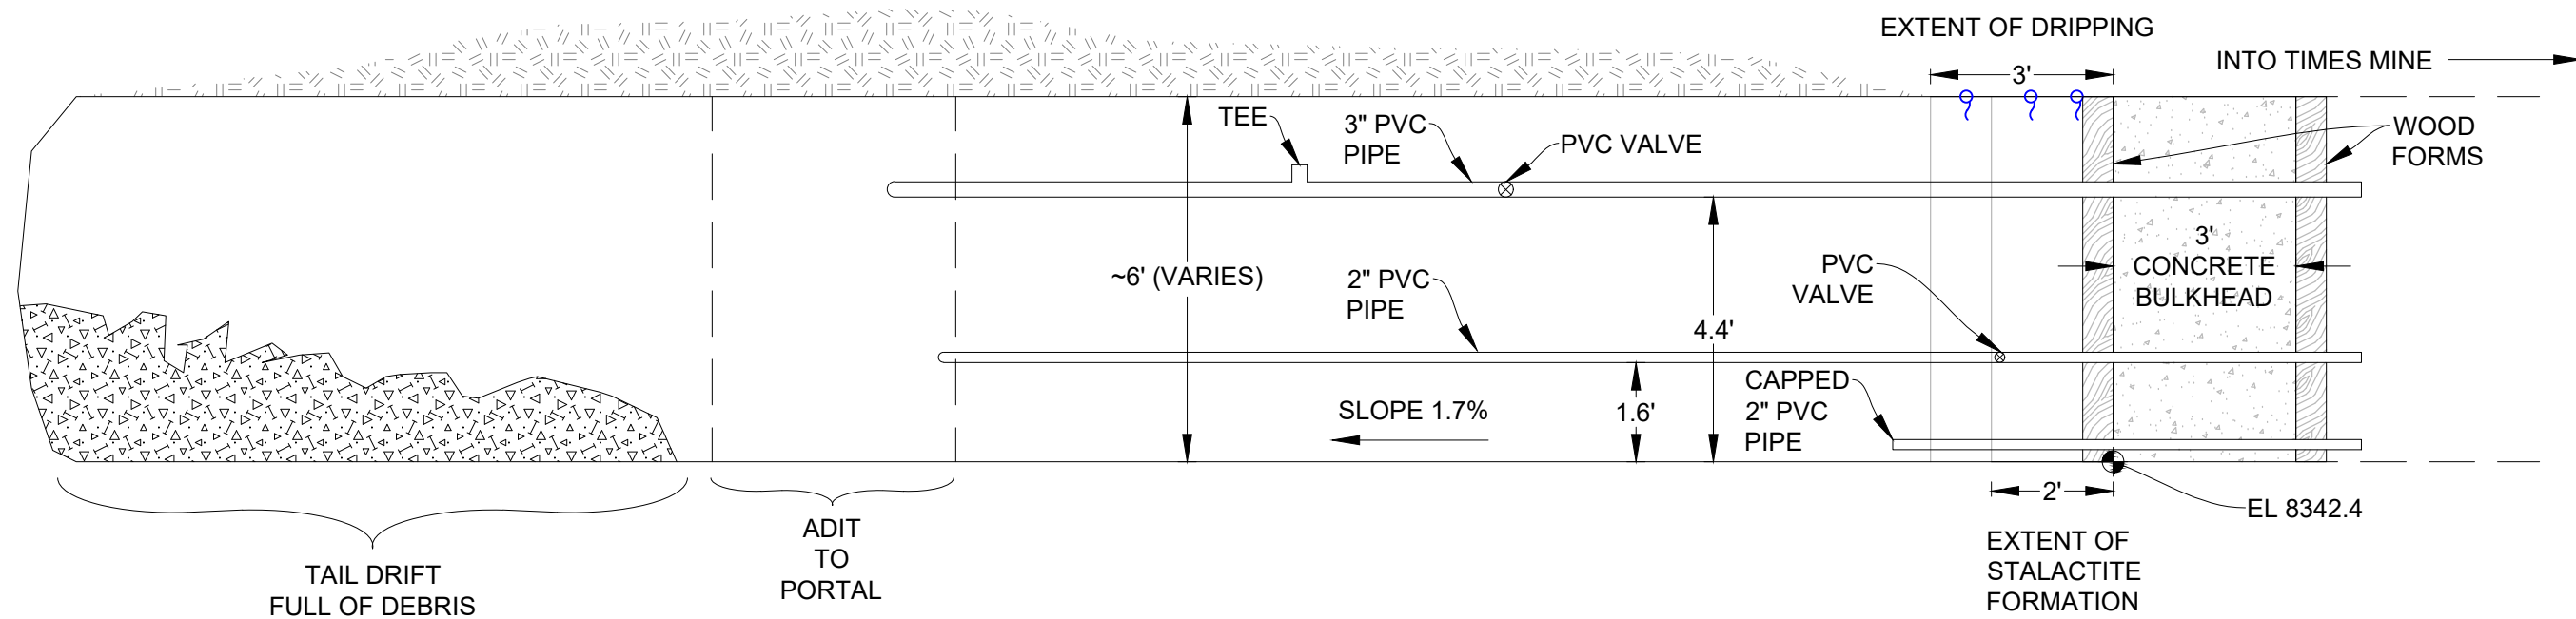
| TIMES MINE BULKHEAD EVALUATION | |
|---|---|
| PROFILE AT BULKHEAD | |

D&A entered the Times Mine to document the adit and bulkhead condition. The first 50 feet of adit consisted of a relatively new 5-foot diameter corrugated metal culvert pipe. Past the pipe, the rock of the adit was somewhat blocky with the main joints dipping moderately to steeply west. Nominal adit dimensions were 6-foot high by 5-foot wide. Ground support consisted of one timber set and several timber props. After 30 feet, the adit intersected a vein striking west and dipping steeply to the north. The vein and alteration halo ranged from 1 to 3 feet wide. The altered rock was soft while the surrounding rock was fractured but generally hard and competent. No ground support was in place. Conditions were dry. Two new PVC pipes ran the length of the adit and entered the bulkhead. Both had closed valves. **Figure 4** shows a profile of this drift.

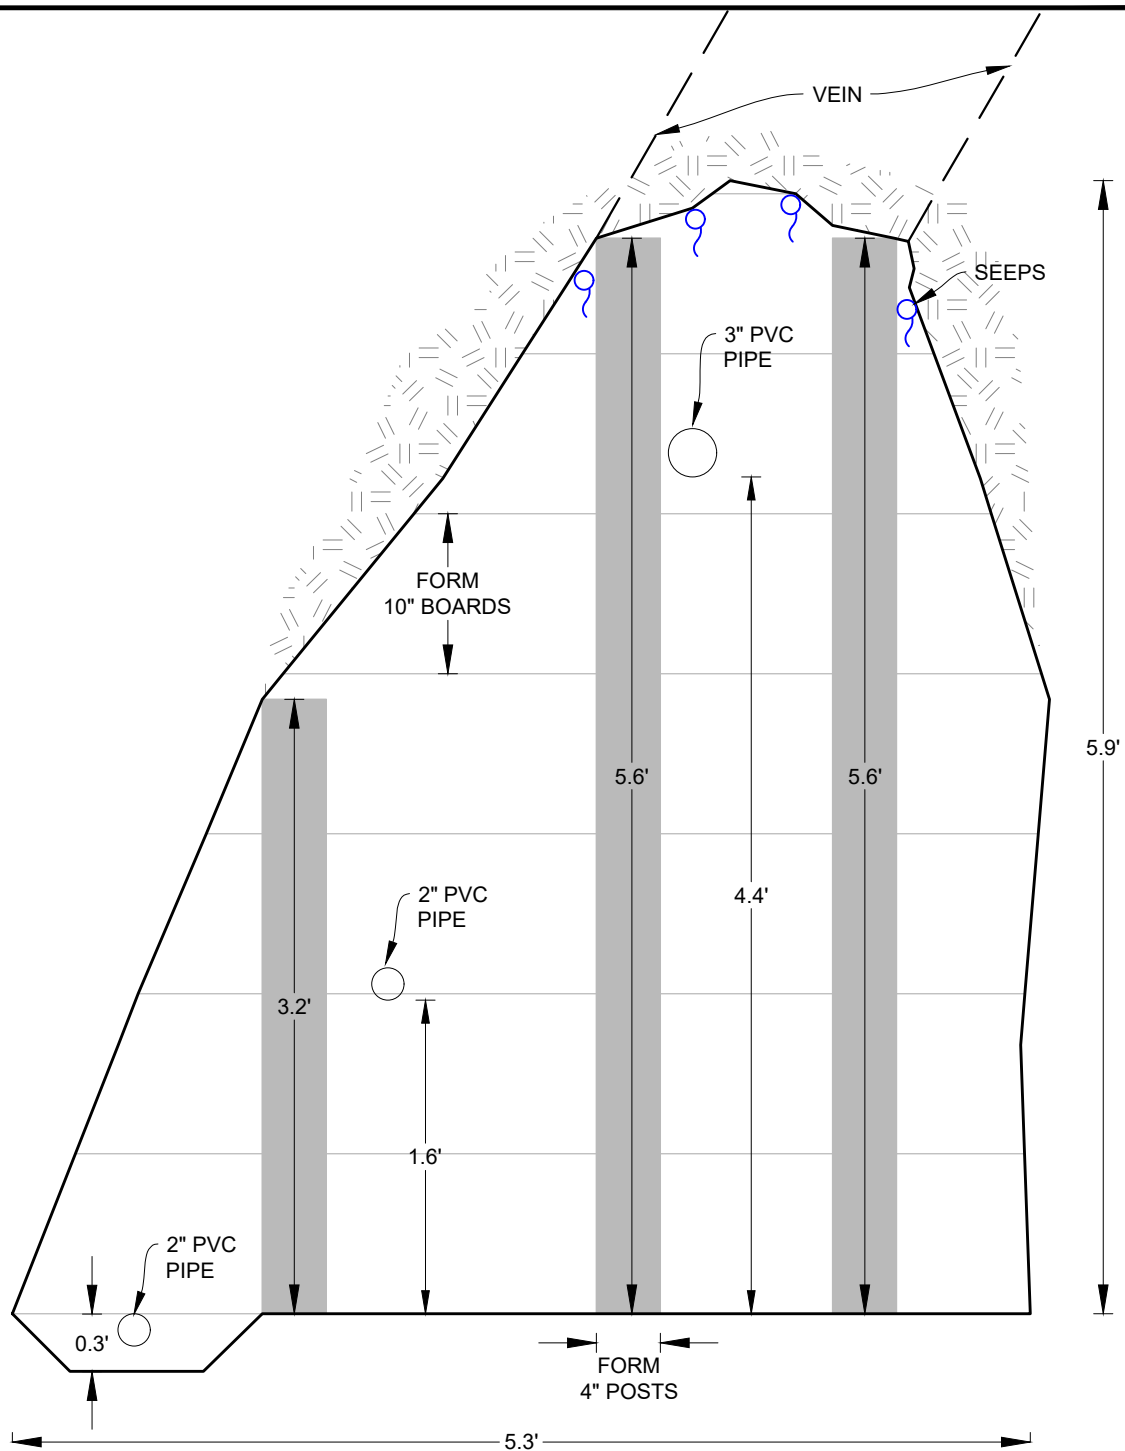
#### **BULKHEAD AIR SIDE FACE CROSS SECTION**

The bulkhead was installed in this drift, approximately 20 feet from the adit intersection. Visible were the wooden concrete forms from the bulkhead placement. The forms were covered in iron precipitant. The bulkhead concrete was not visible. Seepage was noticeable along the back and upper edges of the contact between the bulkhead and the rock. The seepage consisted of a wet sheen with no concentrated flows. No flow was visible on the invert. No concentrated flow was observed at the pipe penetrations. Seepage and iron precipitant extended two and three feet past the bulkhead in the back, along the vein. See attached photos and **Figure 5** for additional detail.

1. PIPES ARE ONE 3" SCHEDULE 40 PVC RATED TO 260 PSI, AND TWO 2" SCHEDULE 40 RATED TO 280 PSI.
2. WOOD FORM FROM BULKHEAD INSTALLATION STILL IN PLACE.

- Install a stainless-steel fluid filled pressure gauge (0-50 psi range) on the bulkhead pipes. It should be installed on a tee between two valves and include a sampling/air bleed port.

- While the PVC pipes and valves are not susceptible to corrosion, they are brittle and can crack. Consider sleeving the pipes with stainless steel and replacing the PVC valves with stainless steel. This should be done when there is no water behind the bulkhead.

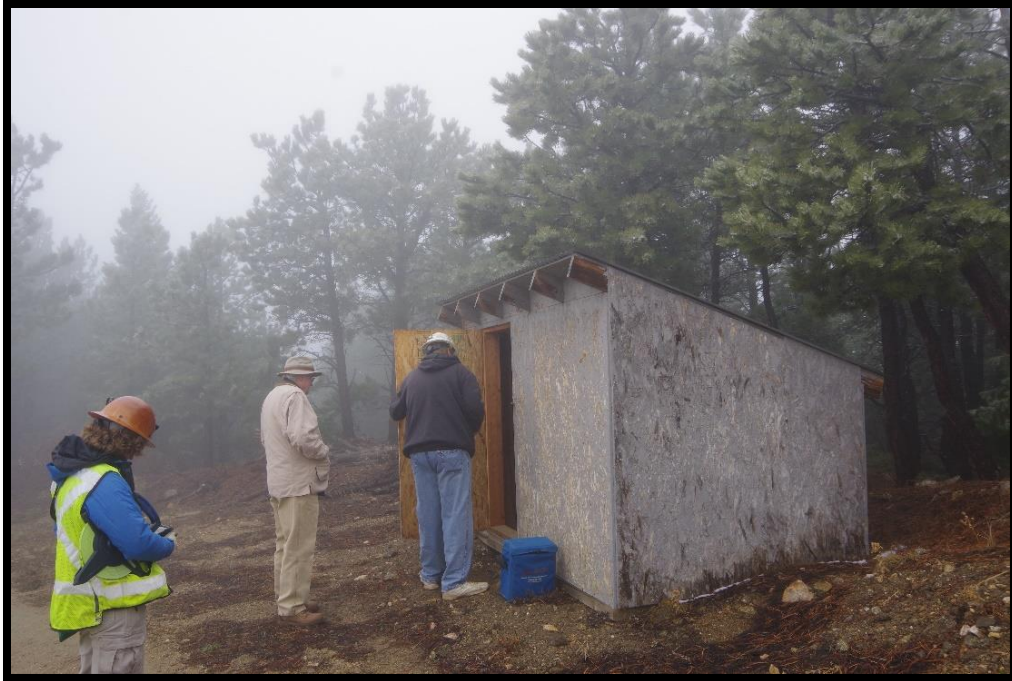
**Photo 1: Shed around the Times Mine Well**

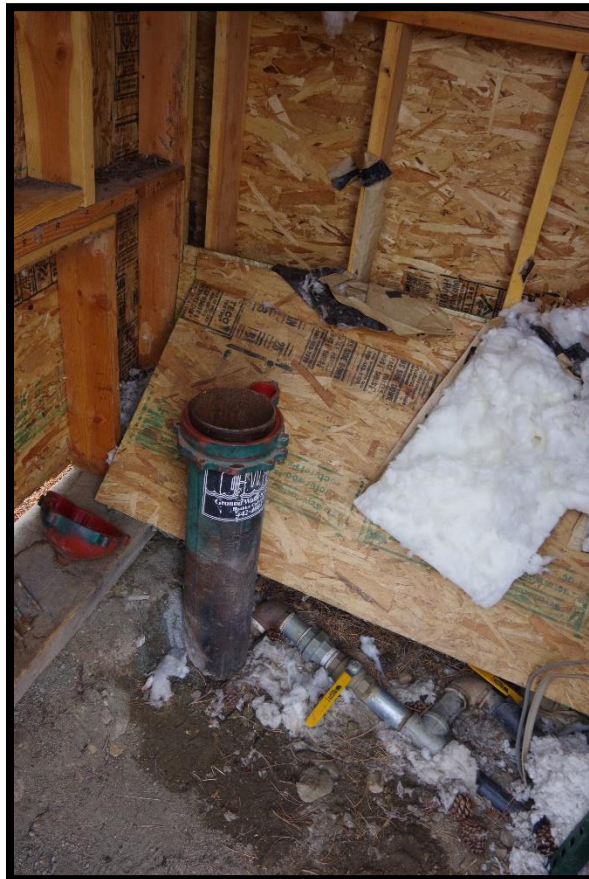
**Photo 2: Times Mine Well head**

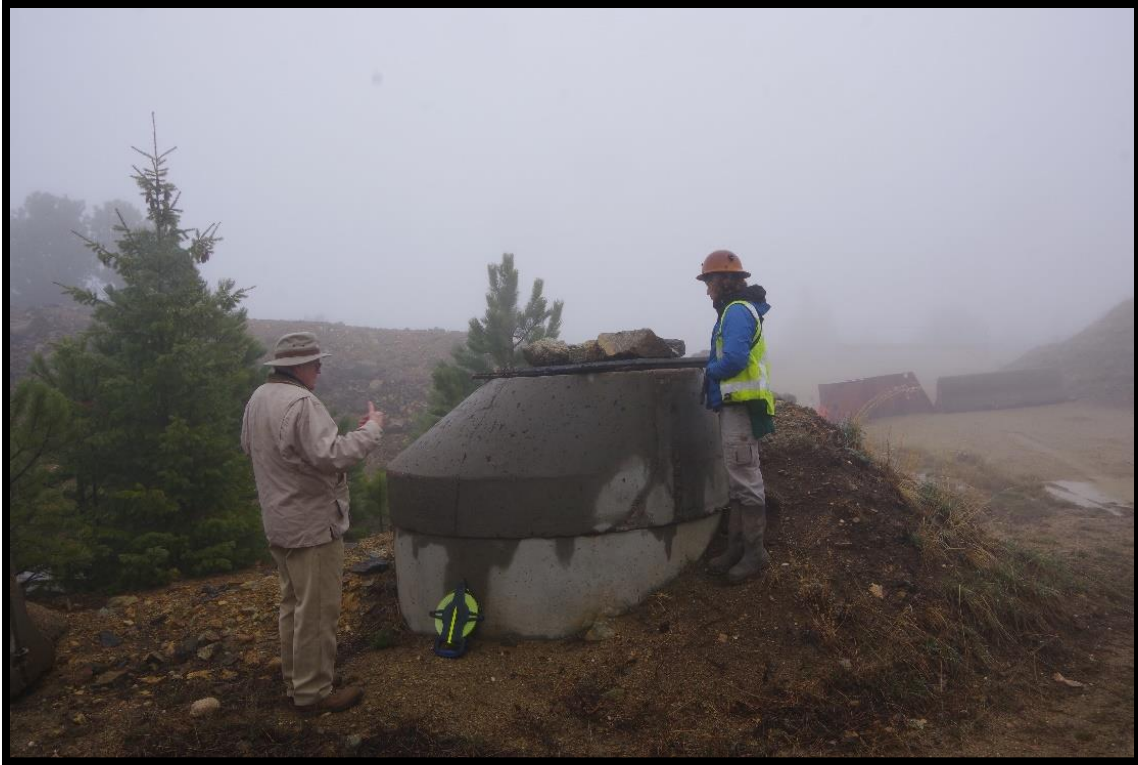
**Photo 3: Concrete manhole around the Wynona mine shaft (collapsed and backfilled)**

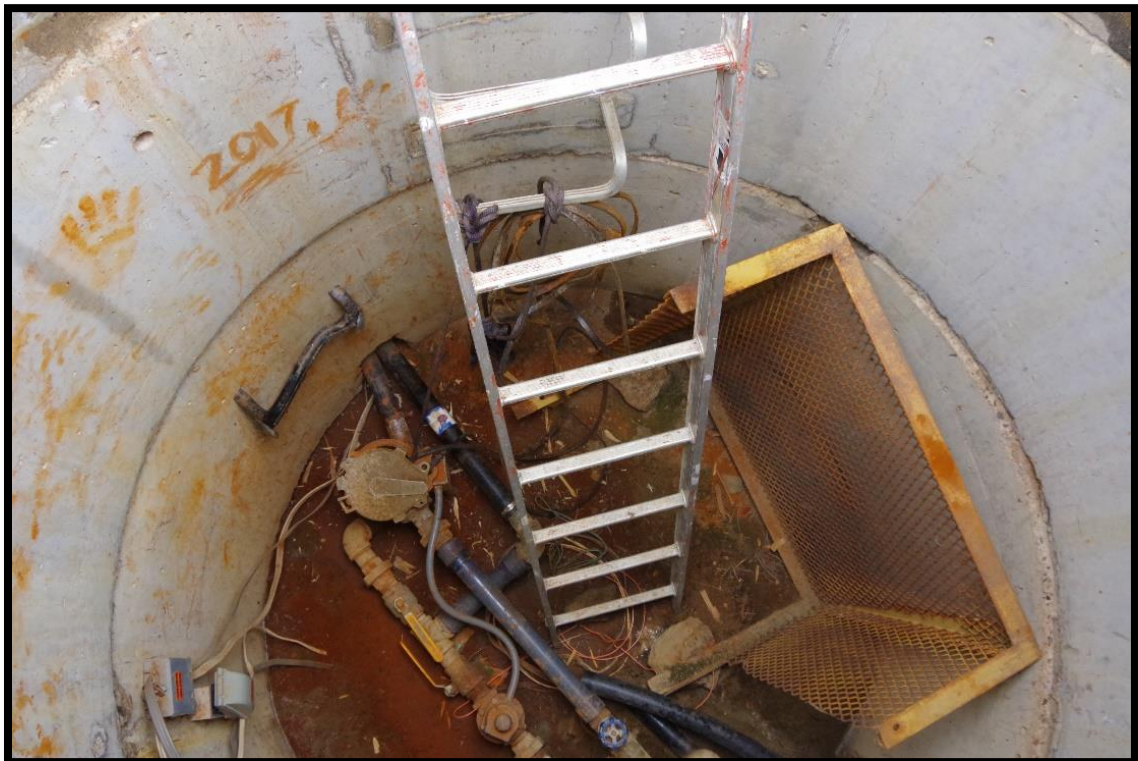
**Photo 4: Inside Wynona Mine Shaft manhole; Well casing into shaft at upper left**

- Remove the stuck pump from the Wynona Shaft and survey the top of casing to allow regular and accurate water level readings.
- Develop a plan to draw down the water in the mine.

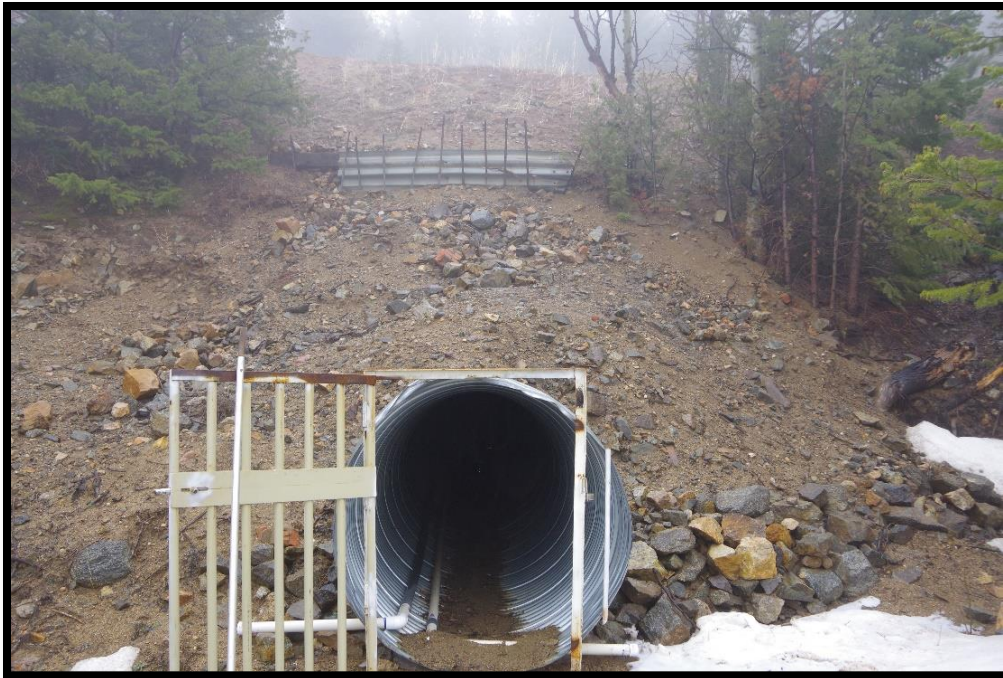
**Photo 5: Portal entrance into the Times Mine; County Road 52 above**

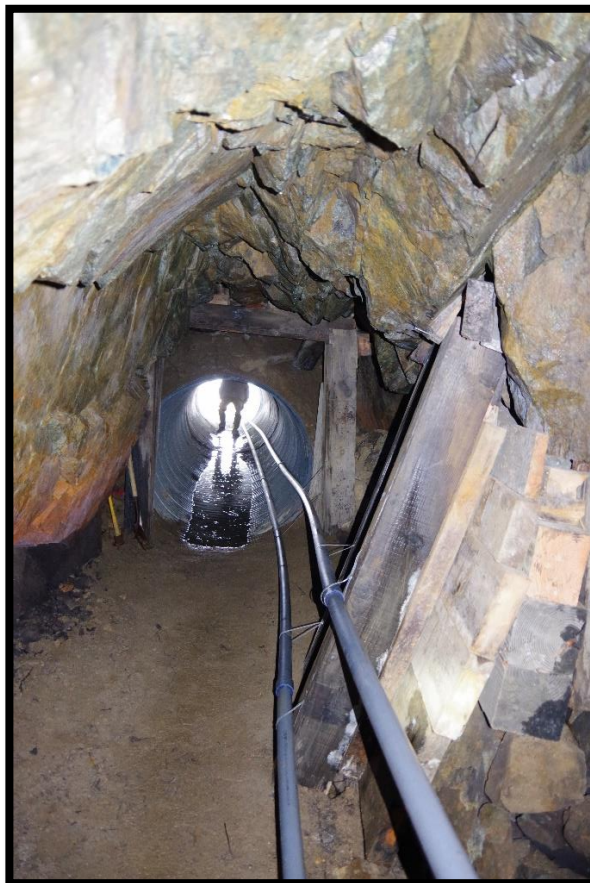
**Photo 6: Piping from portal into adit as seen from drift**

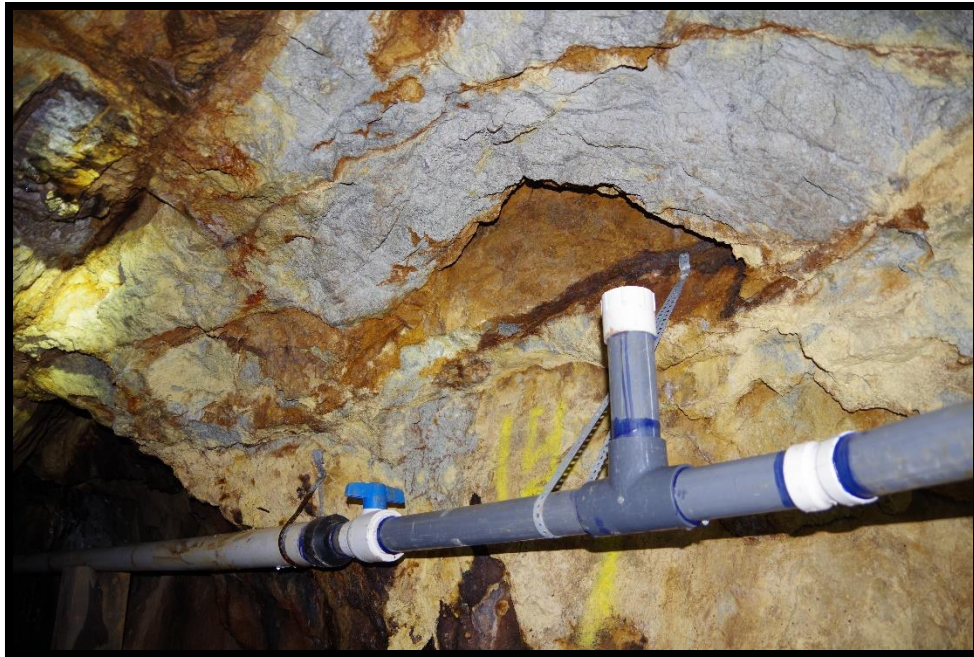
**Photo 7: Upper pipe in Times Mine drift along vein; Note closed valve and Tee**

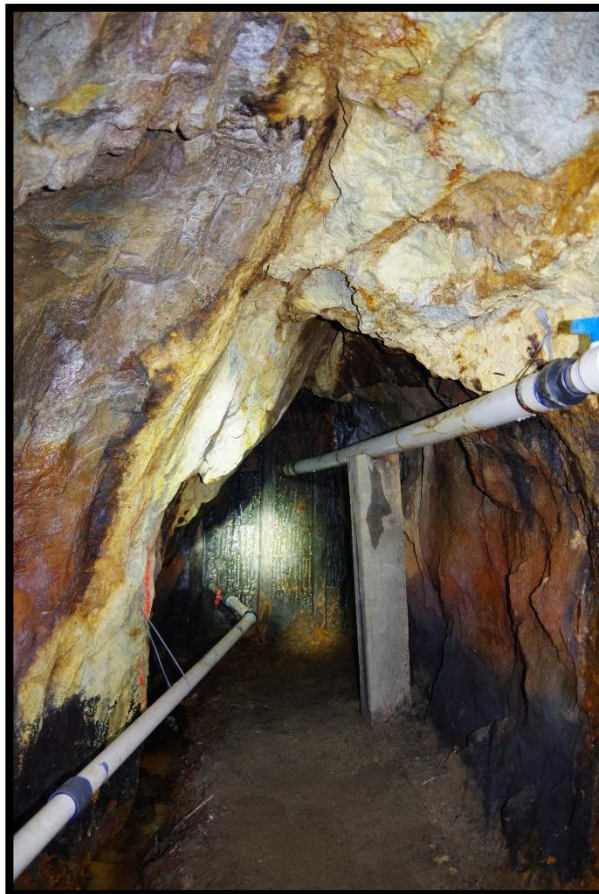
**Photo 8: Piping in drift and into bulkhead; Note off-white alteration zone**

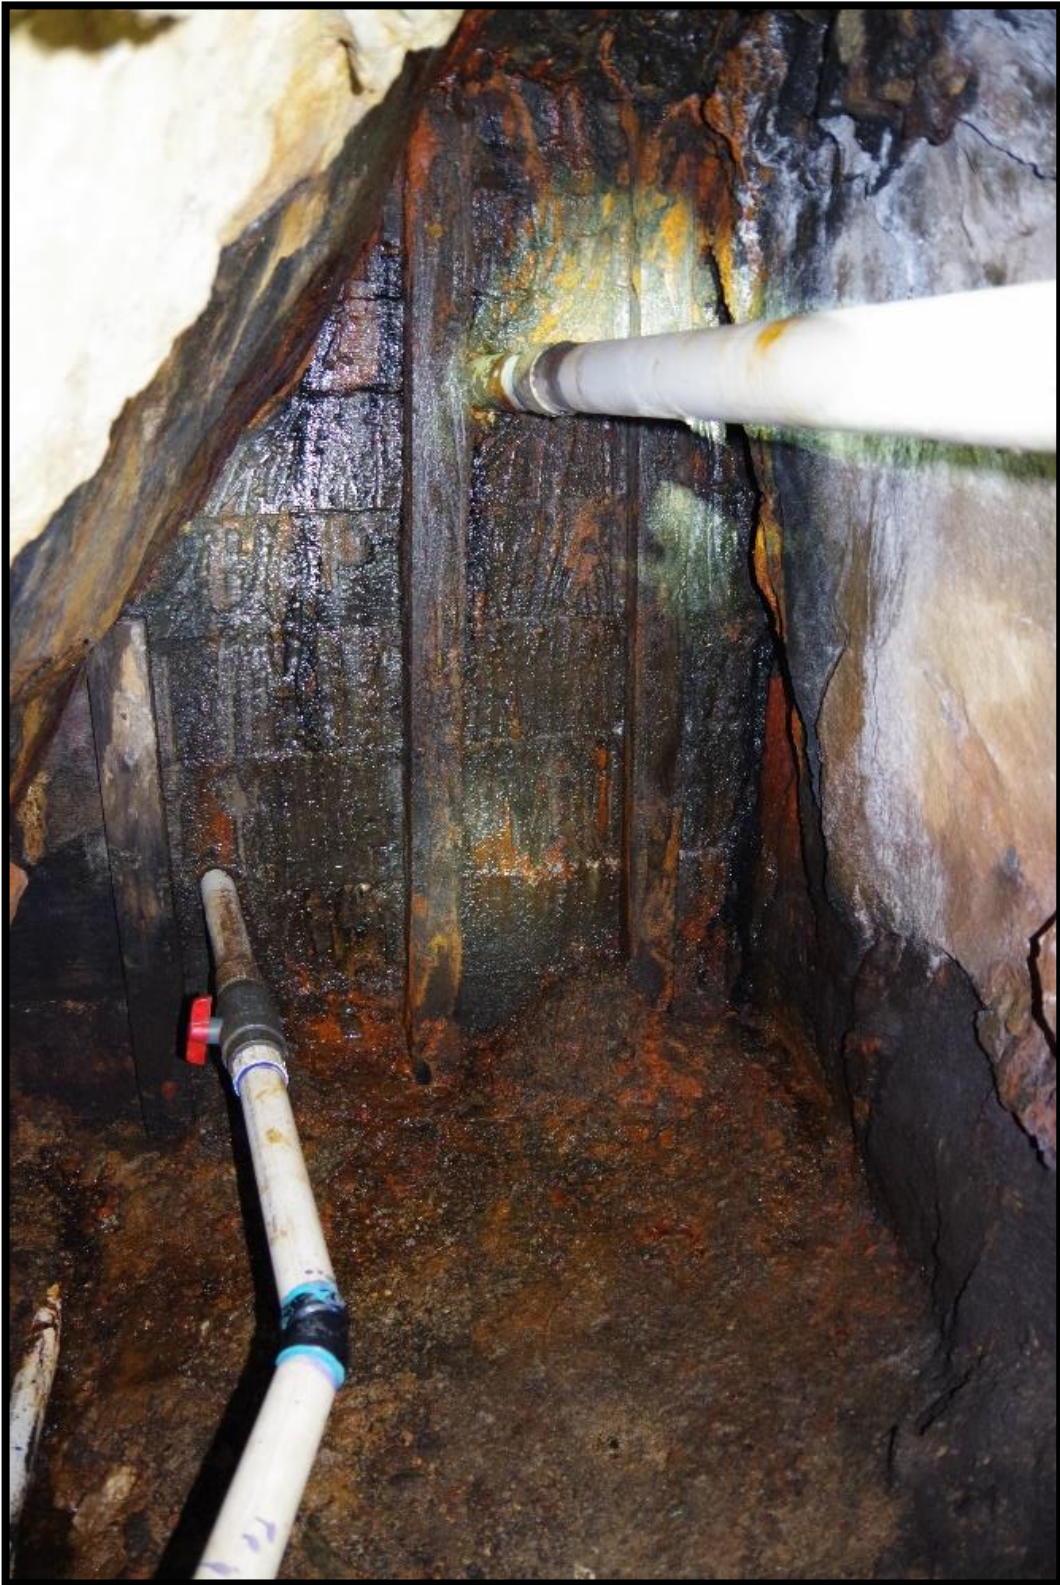
- Total flow past the bulkhead is negligible. No concentrated flows were observed.
- The bulkhead appears to be performing adequately. There are no visible signs of distress.

**Photo 9: Bulkhead overview; Note wood forms remain in place and altered rock removed**

- While we generally recommend removing the bulkhead forms to better observe and assess the condition of the concrete, we do not suggest doing that on this site due to the high risk of damaging the PVC pipes.

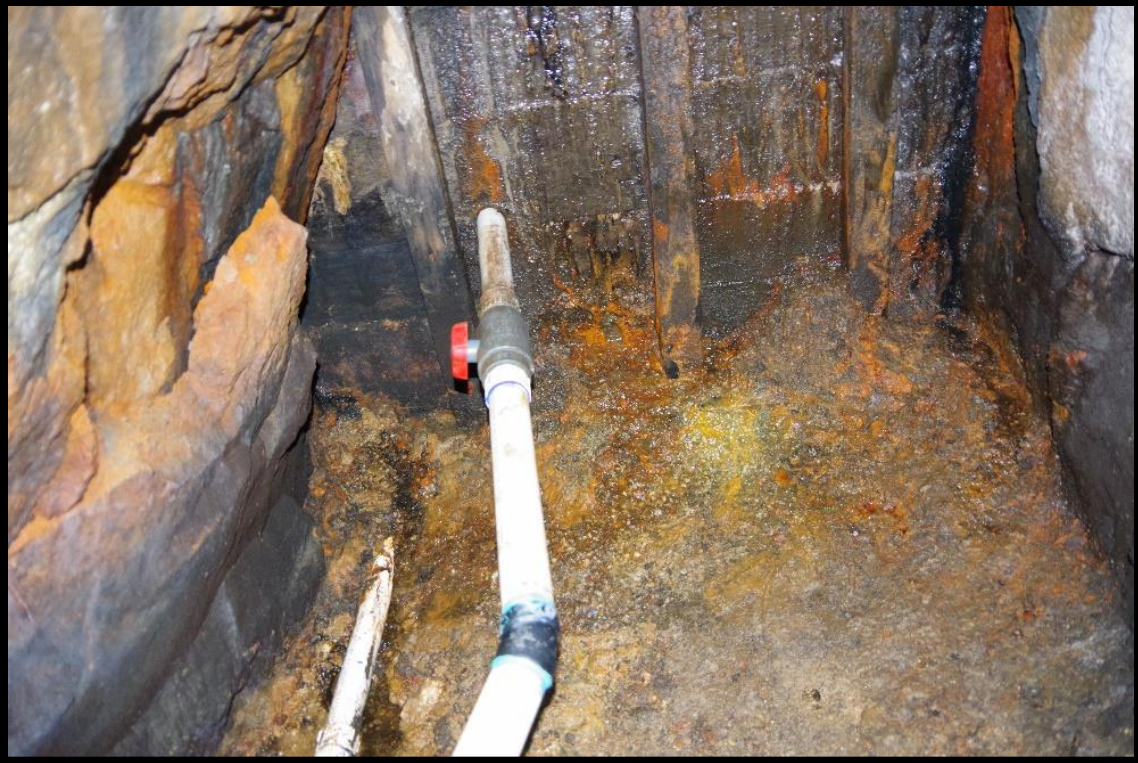
**Photo 10: Lower piping in bulkhead; Note closed valve and precipitant on floor**

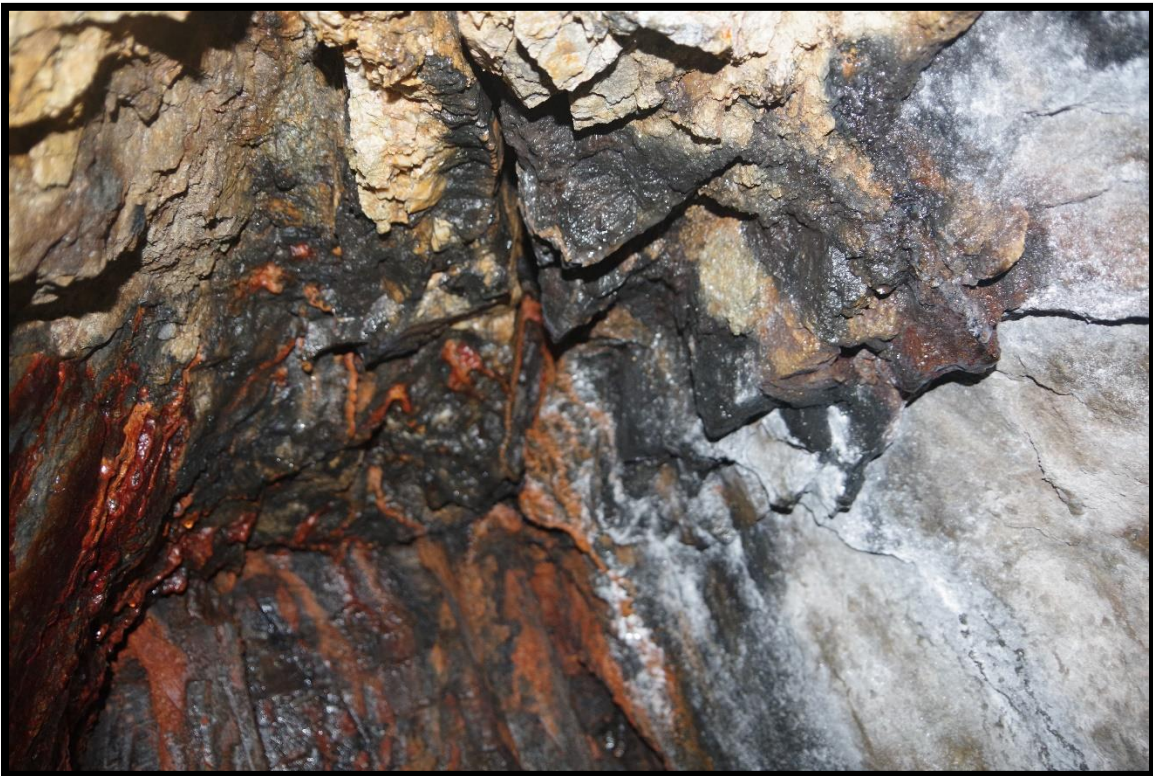
- Minor seepage is visible along the contact between the bulkhead and the rock. The seepage continues 3 feet past the air side face.
- The presence of oxidized iron precipitate on the bulkhead face, rock interface and vein suggest mine pool water is seeping around the bulkhead. This is typical.

**Photo 11: Seepage and precipitant at top of bulkhead**

- Under the maximum proposed operational conditions, the bulkhead area should be observed and conditions documented on a regular basis with a particular focus on any increases in seepage or the development of any concentrated areas of flow. Should a significant flow or seepage increase be observed, the mine pool would need to be lowered rapidly.

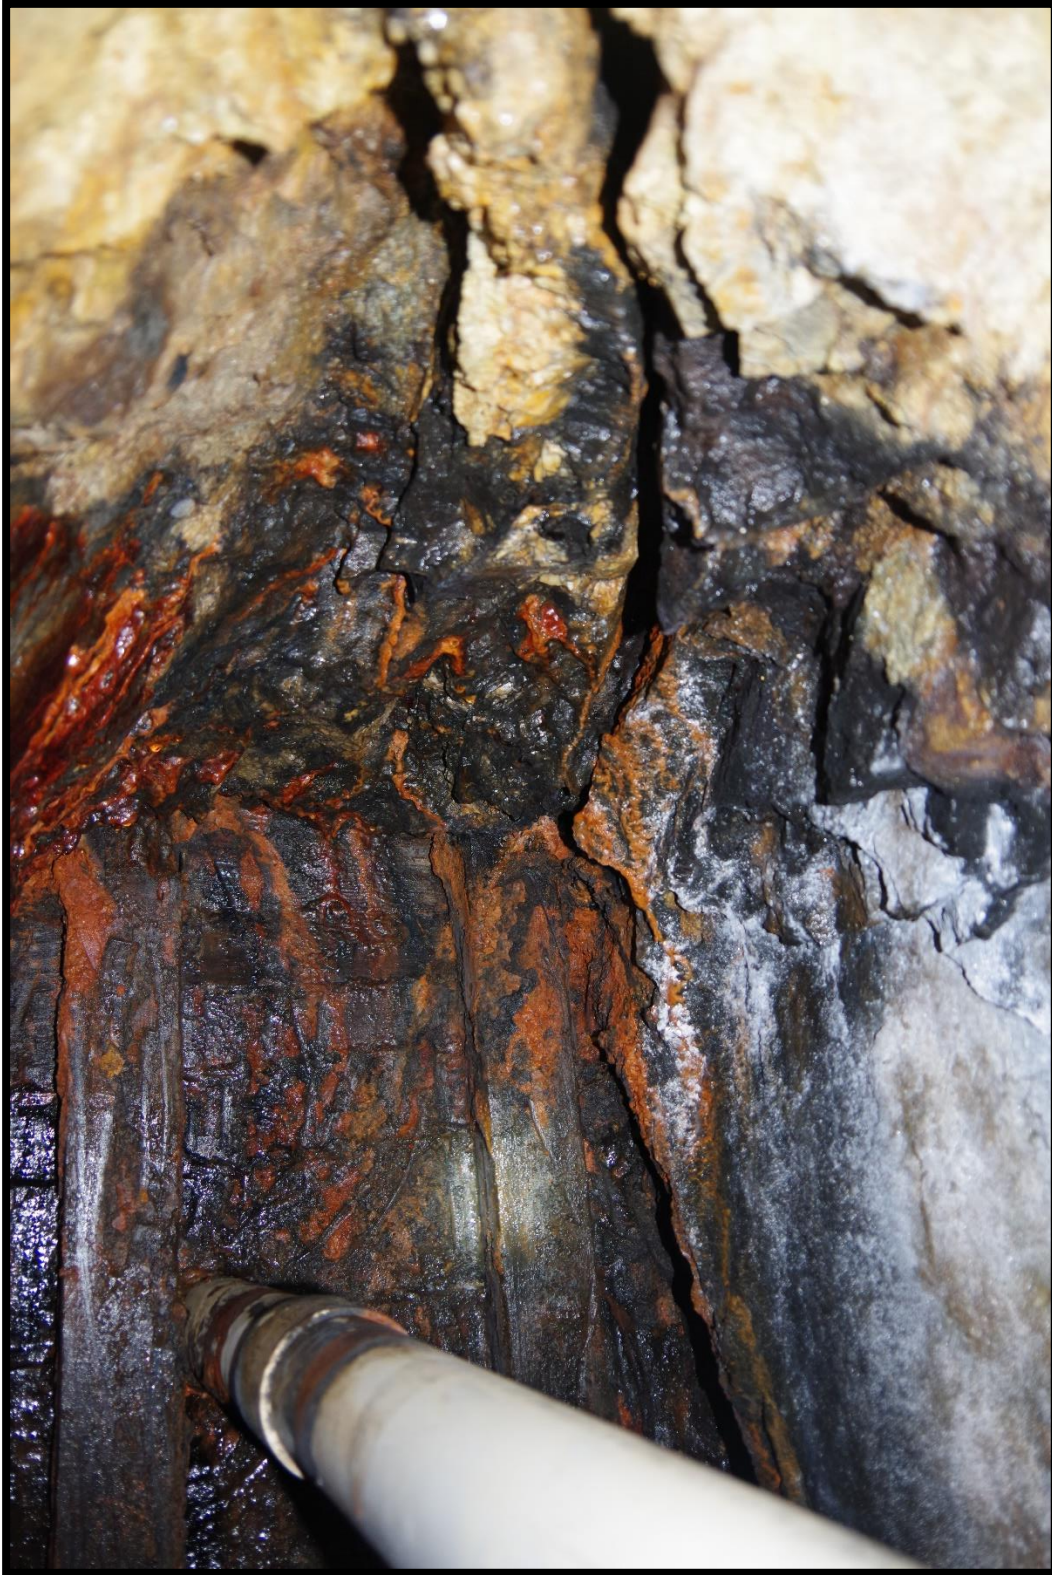
The limitation of the West Driefontein Mine seepage experiment and calculations is that they only consider leakage through the bulkhead, concrete-rock contact, and immediate rock mass. They do not consider seepage or piping through joints or shears parallel to the tunnel, across the plug. The Times Mine Bulkhead is located on a vein that was not pressure grouted. Under high head, this is the most likely seepage path.

Photo 12: Upper bulkhead piping and extent of dripping along vein in back

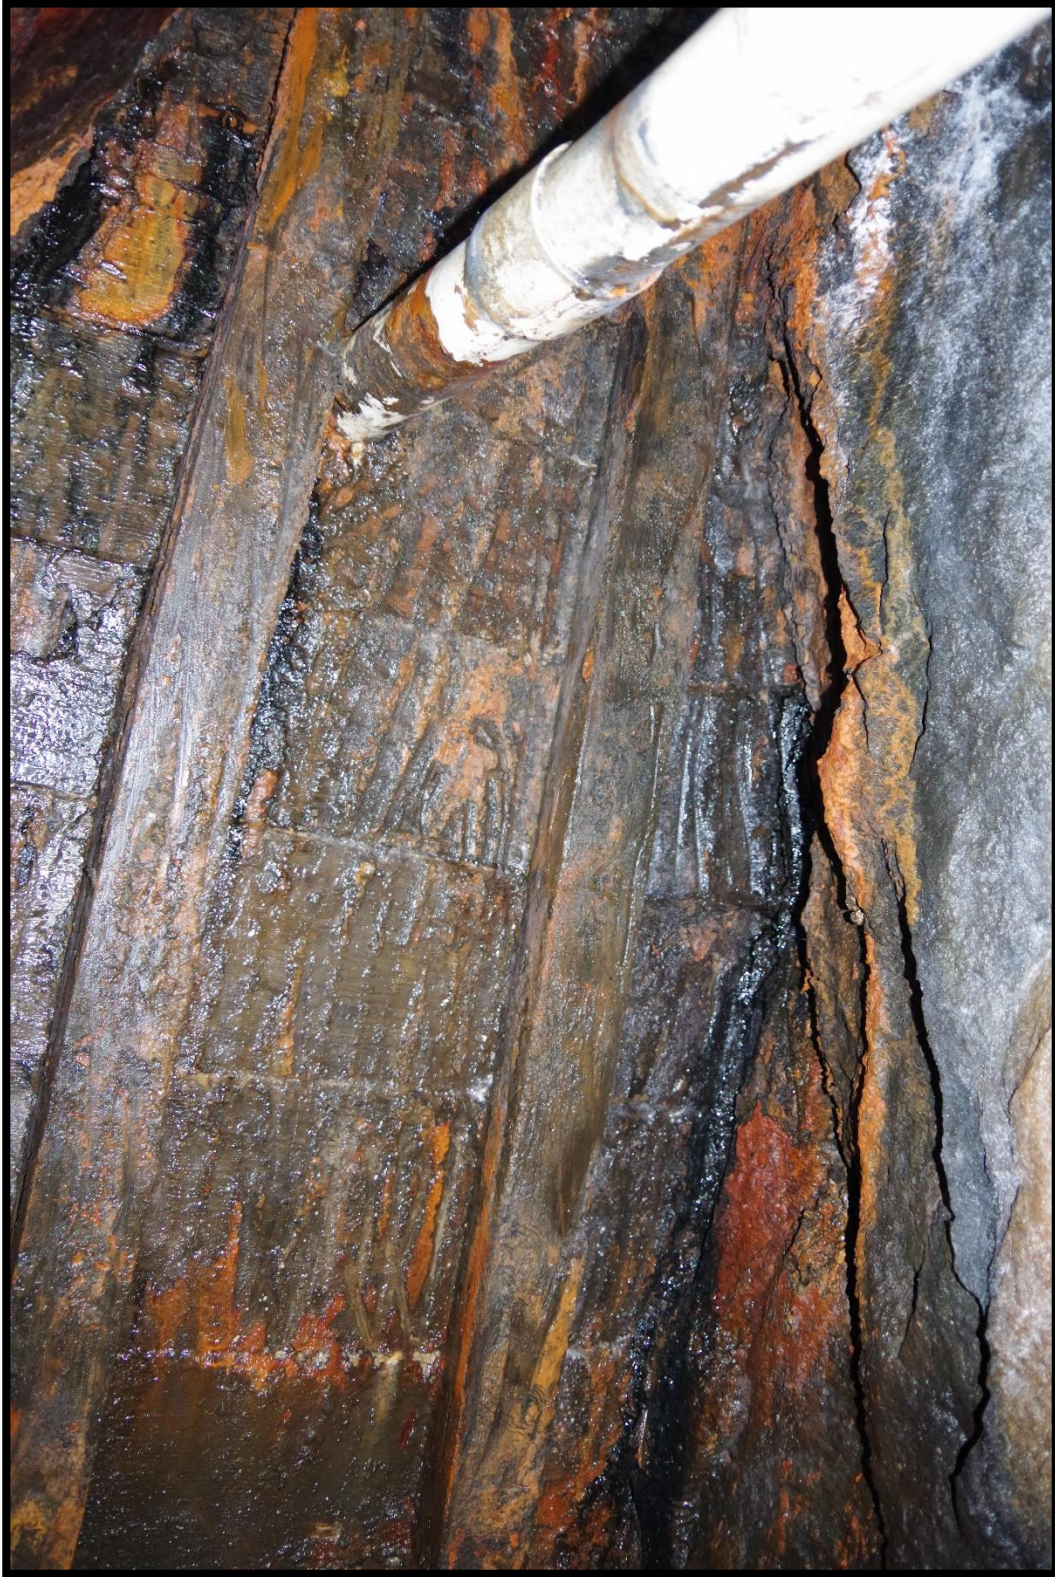
Photo 13: Seepage along right side of bulkhead

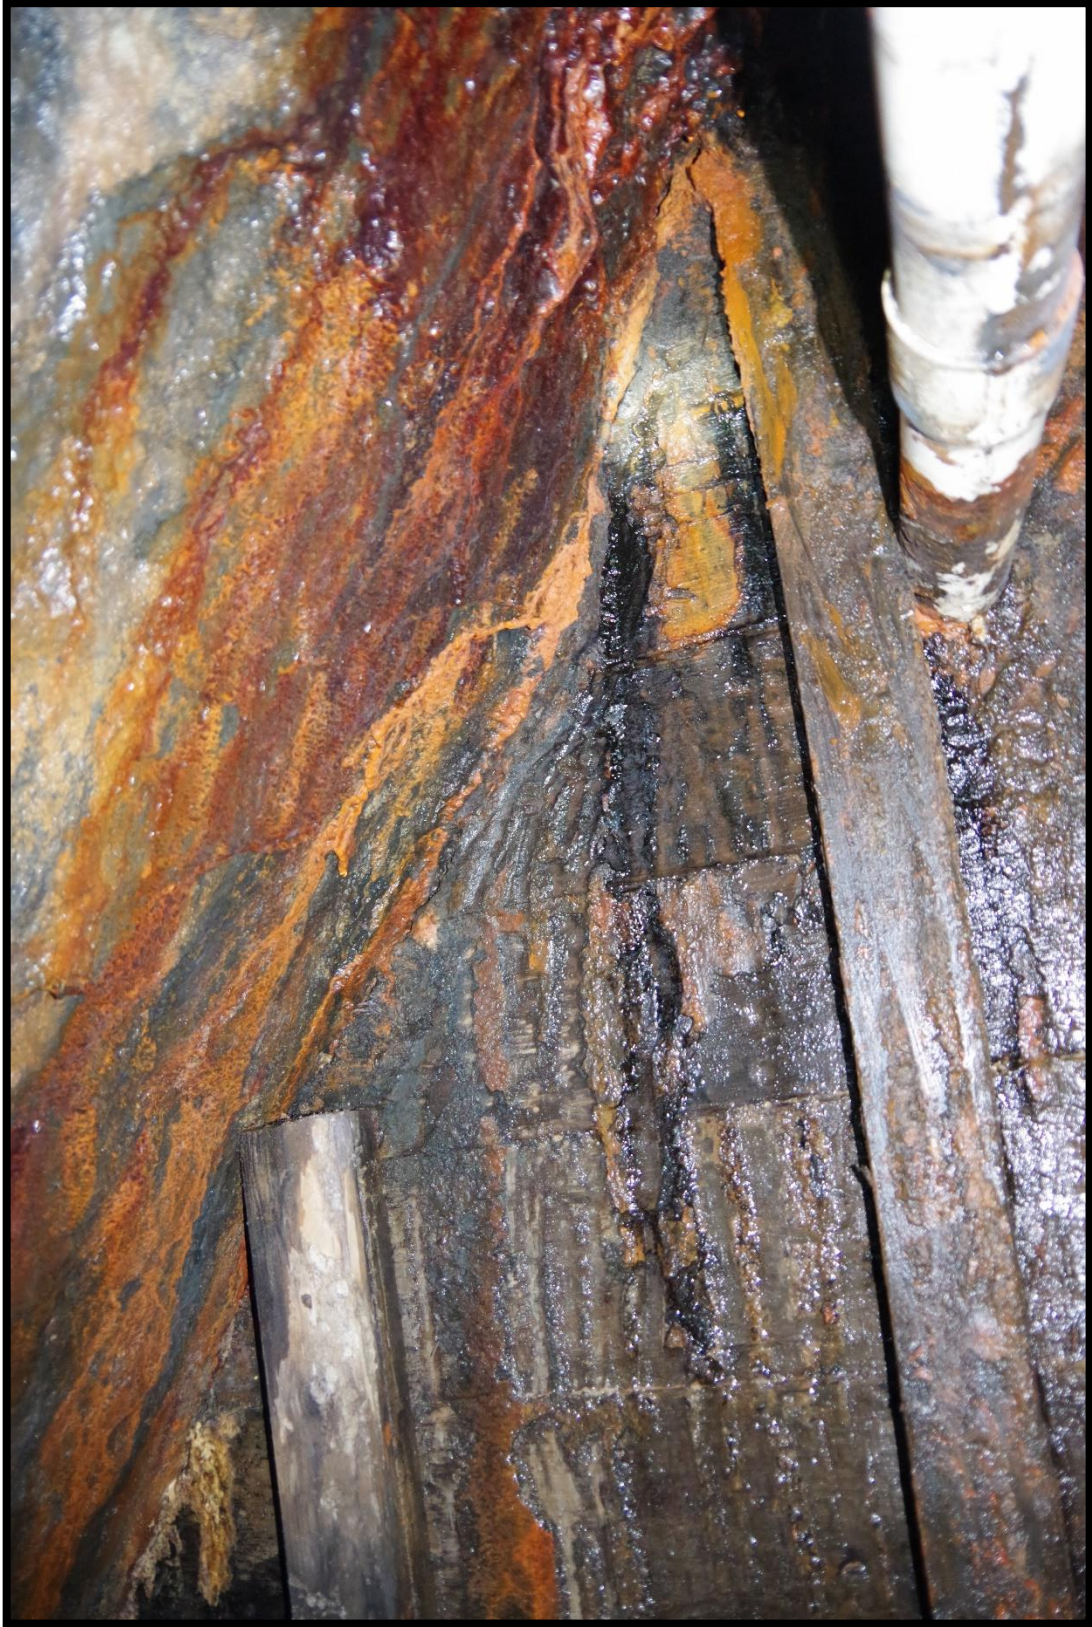
**Photo 14: Seepage along left side of bulkhead**
