MINERALS PROGRAM INSPECTION REPORT
PHONE: (303) 866-3567

MINE NAME: Re-open gravel pit #18 Pipe Springs Ranch L	MINE/PROSPECTING ID#: M-2003-019	MINERAL: Sand and gravel	COUNTY: Baca
INSPECTION TYPE: Monitoring	INSPECTOR(S): Jared L. Ebert	INSP. DATE: May 13, 2019	INSP. TIME: 10:30
OPERATOR: Baca County	OPERATOR REPRESENTATIVE: Kurt Eskew	TYPE OF OPERATION: 112c - Construction Regular Operation	
REASON FOR INSPECTION: Normal I&E Program	BOND CALCULATION TYPE: None	BOND AMOUNT: \$0.00	
DATE OF COMPLAINT: NA	POST INSP. CONTACTS: None	JOINT INSP. AGENCY: None	
WEATHER: Clear	INSPECTOR'S SIGNATURE:

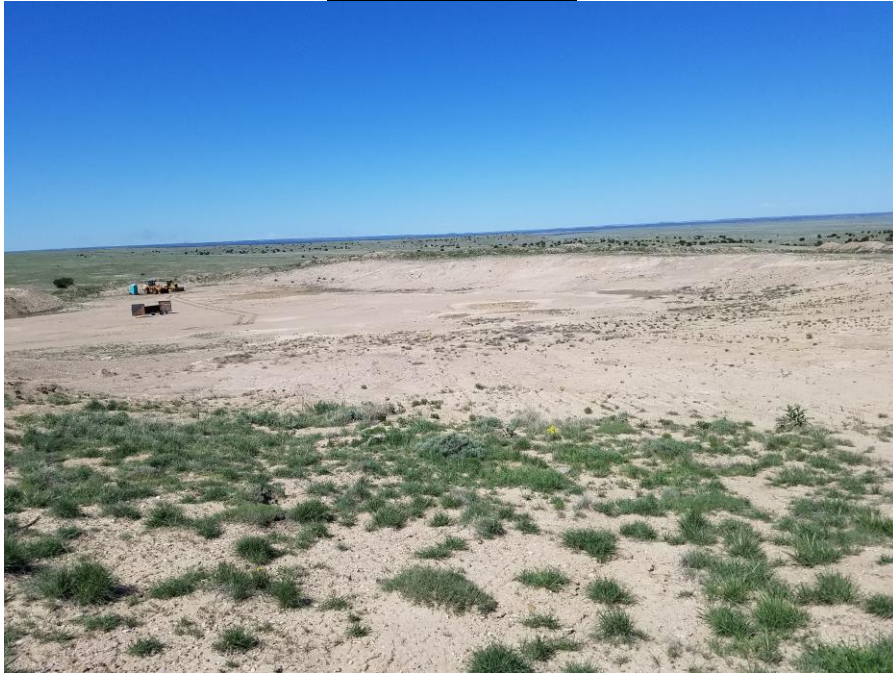
Figure 1. From the northeast corner of the affected land looking southwest.

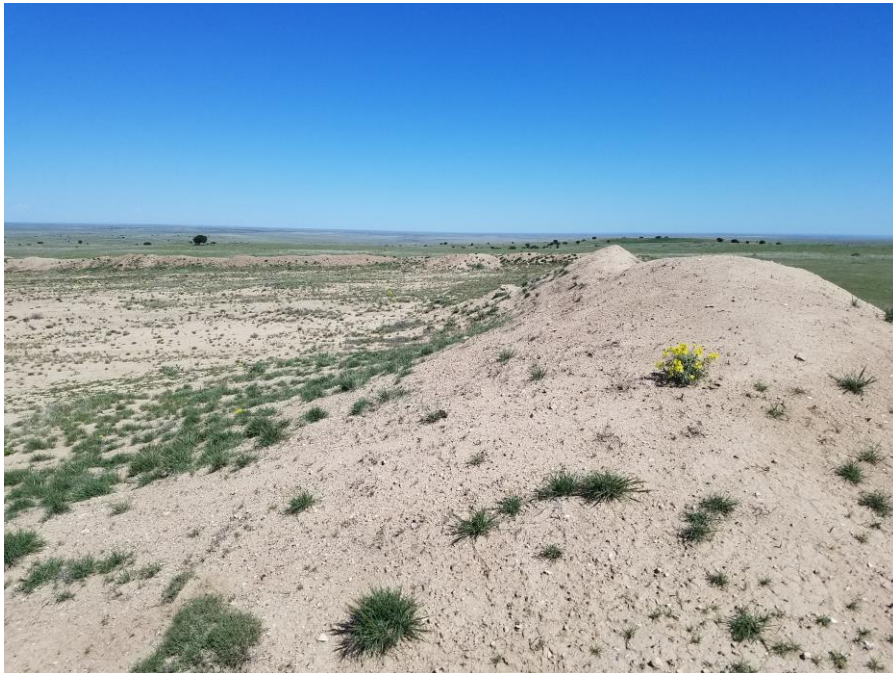
Figure 2. From the northeast corner of the affected land looking west.

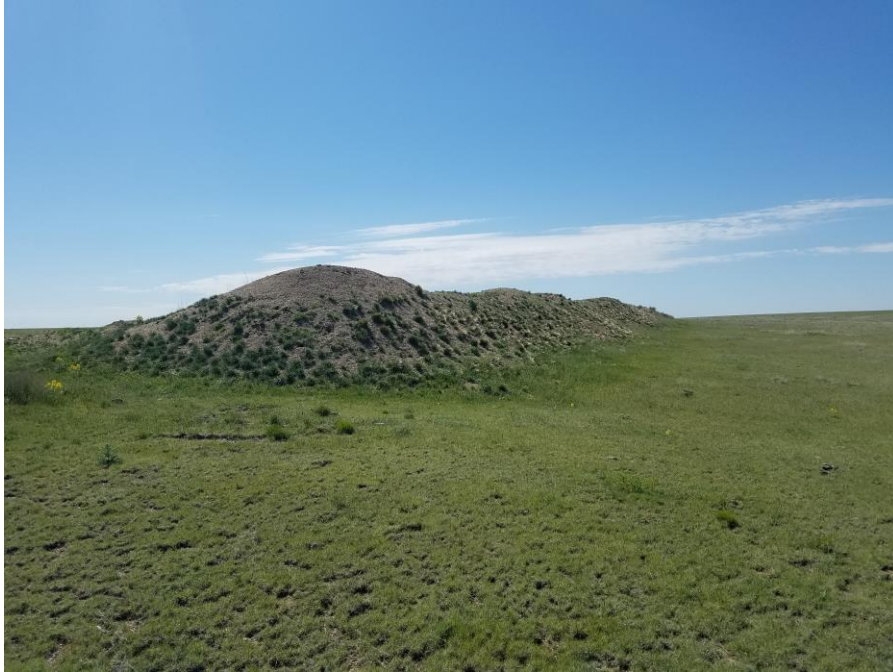
Topsoil is removed in advance of mining and stockpiled adjacent to the pit basin.

Figure 3. Topsoil stockpile adjacent to the pit.
