MINERALS PROGRAM INSPECTION REPORT

MINE NAME: Gunkel Pit No 31	MINE/PROSPECTING ID#: M-1993-088	MINERAL: Gravel	COUNTY: Baca
INSPECTION TYPE: Monitoring	INSPECTOR(S): Jared L. Ebert	INSP. DATE: May 13, 2019	INSP. TIME: 11:09
OPERATOR: Baca County	OPERATOR REPRESENTATIVE: Jason Freiburger and Danny Ausmus	TYPE OF OPERATION: 112c - Construction Regular Operation

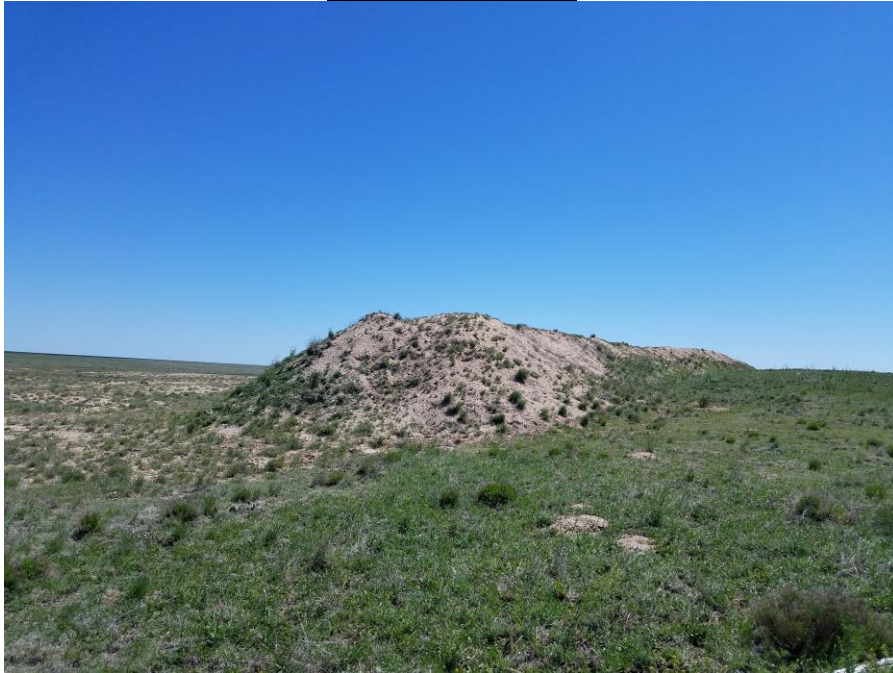
Vegetated topsoil stockpiles are located on the south side of the affected area and on the west side of the affected area. These piles are stable and vegetated.

Figure 1. From the south side of the affected land looking east at a topsoil stockpile.

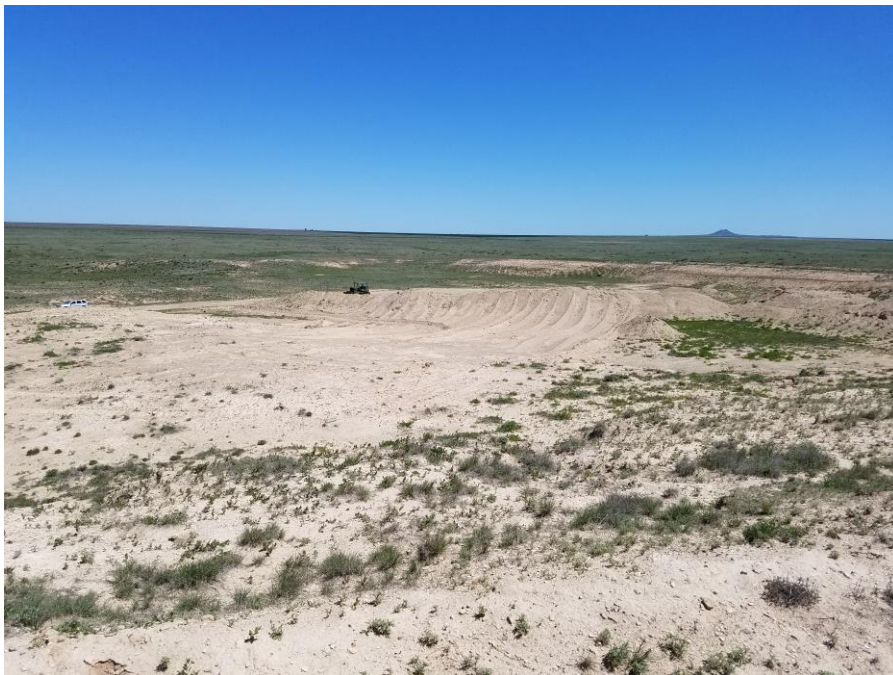
Figure 2. From the southeast corner of the affected land looking northwest.

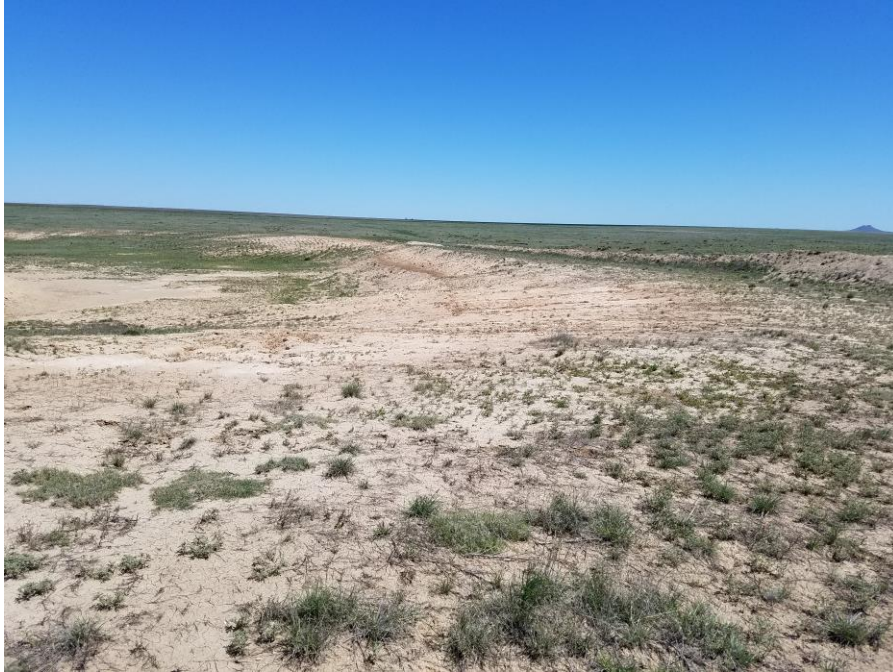
Figure 3. From the southeast corner of the affected land looking north.

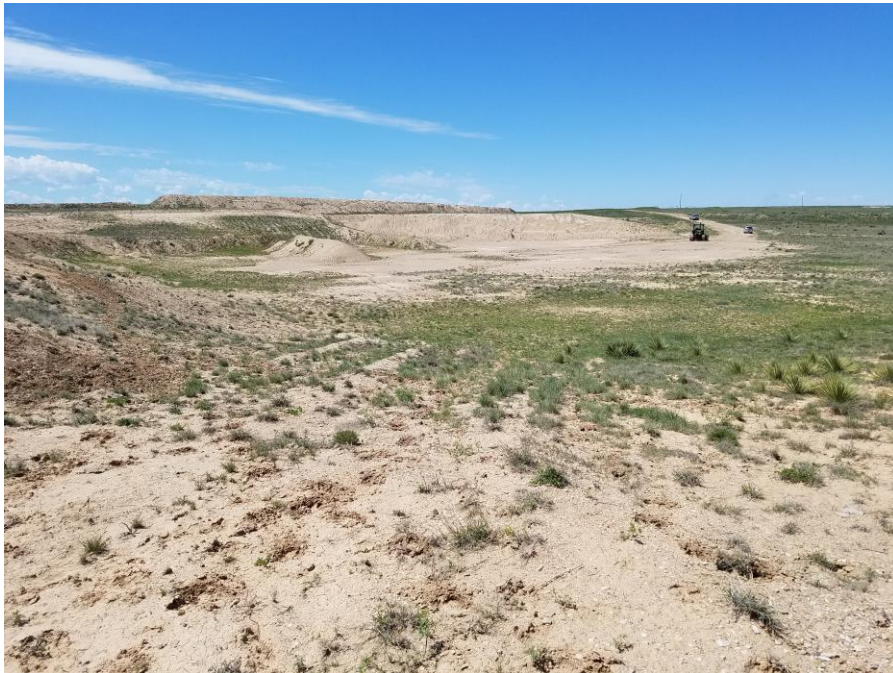
Figure 4. From the northeast corner of the affected land looking southwest.

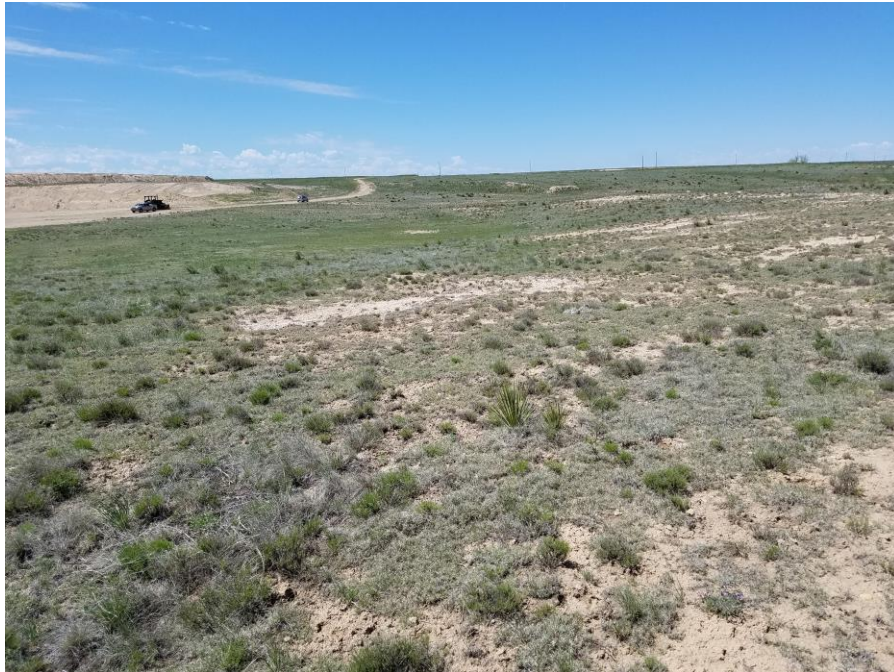
The portions of the affected land that has undergone reclamation has been graded to the required slope. Some vegetation has established in the reclaimed area but it is fairly sparse.

Figure 5. From the northeast corner of the affected land looking west at the reclaimed area.
