MINERALS PROGRAM INSPECTION REPORT
PHONE: (303) 866-3567

MINE NAME: Journey Ventures Pit	MINE/PROSPECTING ID#: M-2008-080	MINERAL: Aggregate	COUNTY: Weld
INSPECTION TYPE: Monitoring	INSPECTOR(S): Peter S. Hays	INSP. DATE: April 9, 2019	INSP. TIME: 10:00
OPERATOR: Journey Ventures, LLC	OPERATOR REPRESENTATIVE: Chris Leone, JC York	TYPE OF OPERATION: 112c - Construction Regular Operation	
REASON FOR INSPECTION: Normal I&E Program	BOND CALCULATION TYPE: Complete Bond	BOND AMOUNT: \$487,550.00	
DATE OF COMPLAINT: NA	POST INSP. CONTACTS: None	JOINT INSP. AGENCY: None	
WEATHER: Clear	INSPECTOR'S SIGNATURE:

Journey Ventures Pit

April 9, 2019 Inspection Map

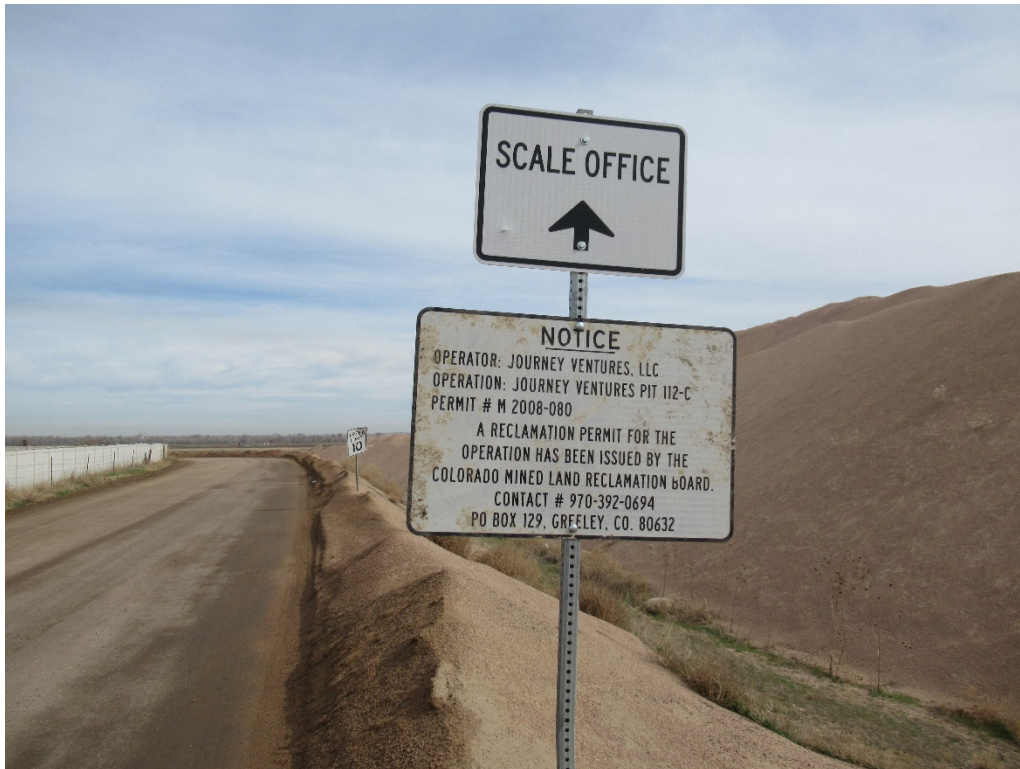
Photographs taken during the inspection and an inspection map created based on the inspection observations are attached. The mine sign and boundary markers were observed as required by Rule 3.1.12.

Journey Ventures mine sign

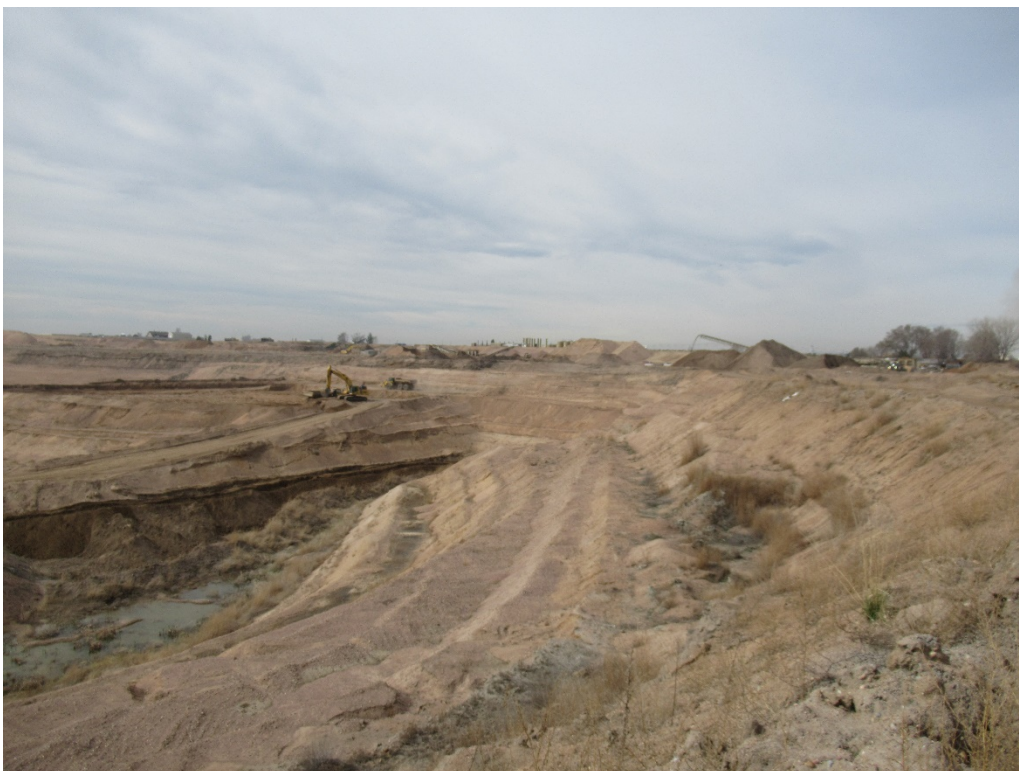
View of Phase 2 excavation from the northeast corner looking west

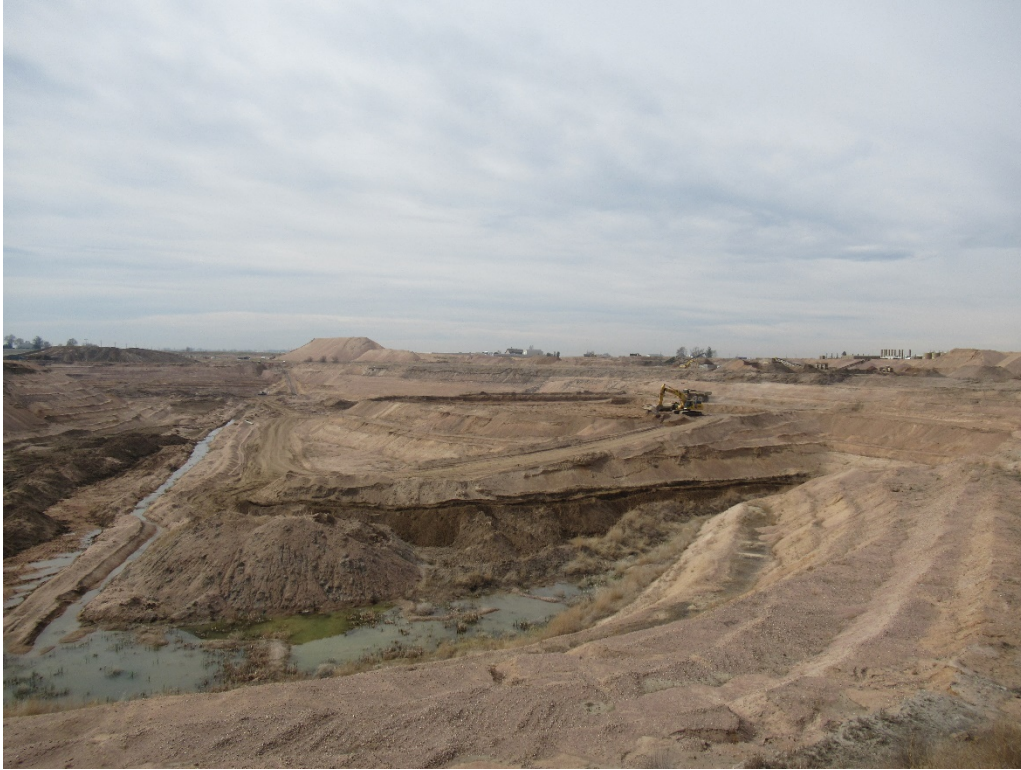
View of Phase 2 excavation from the northeast corner looking southwest

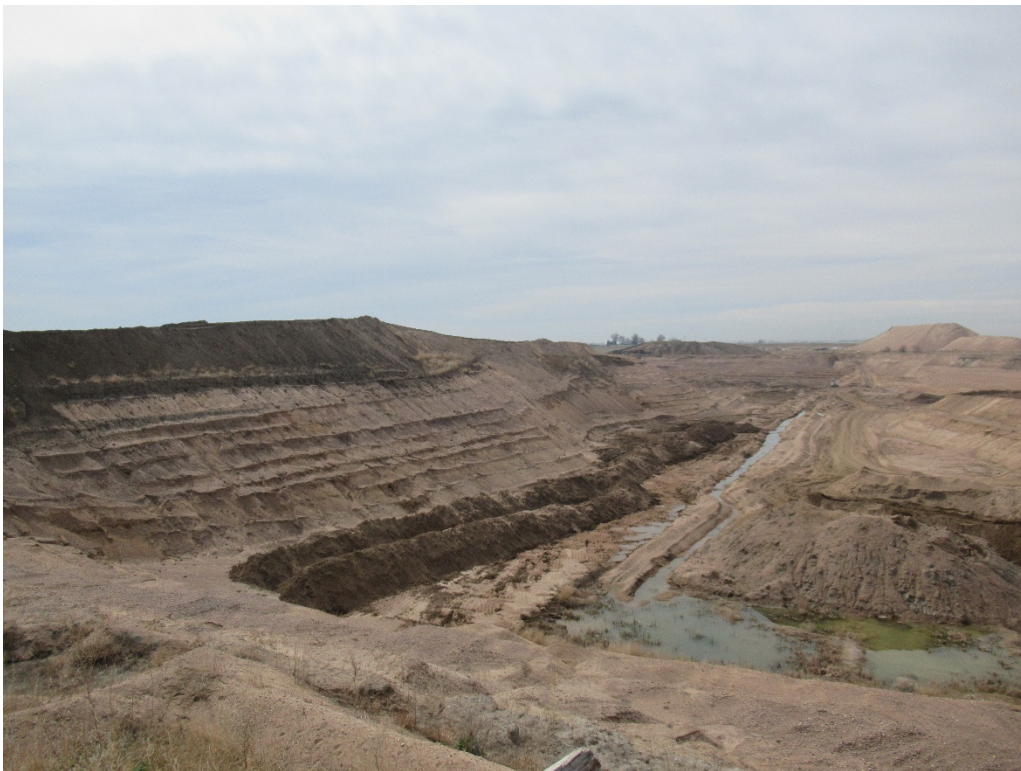
View of Phase 2 excavation from the northeast corner looking south

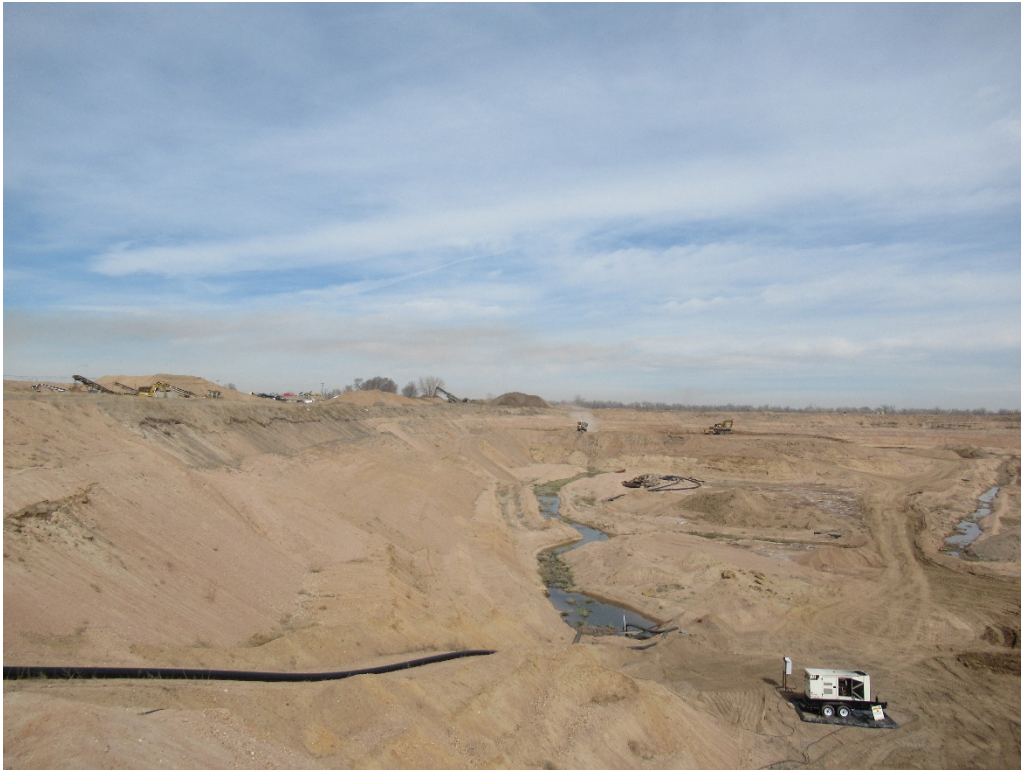
View of Phase 2 excavation from the south side looking northwest

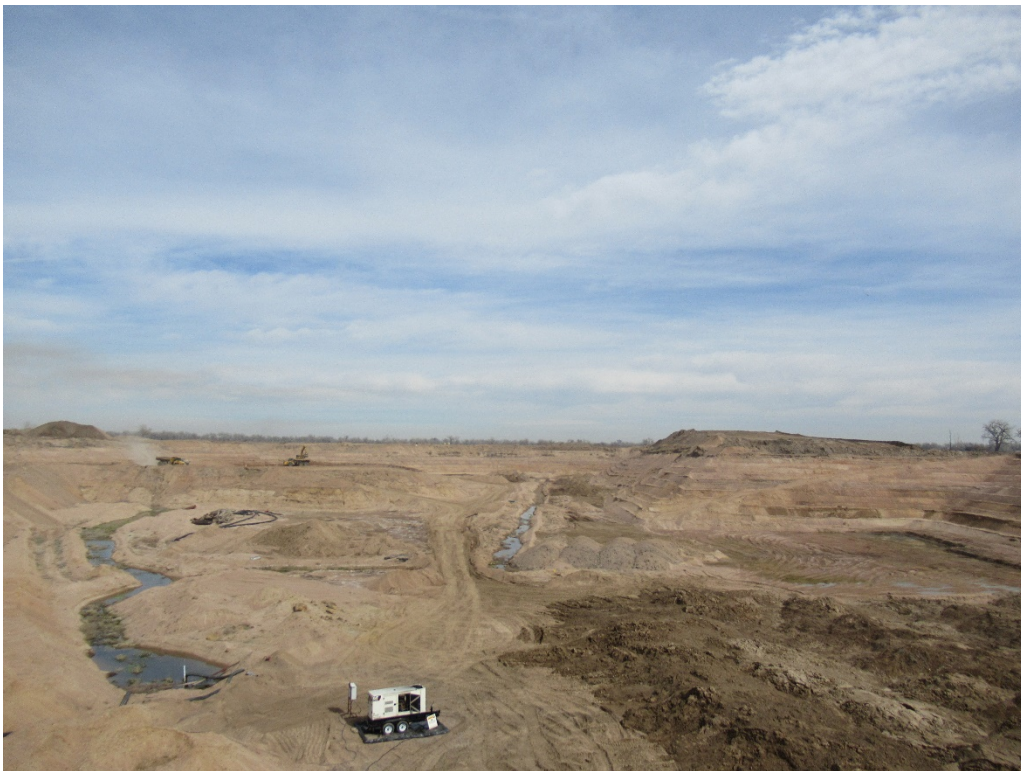
View of Phase 2 excavation from the south side looking northeast

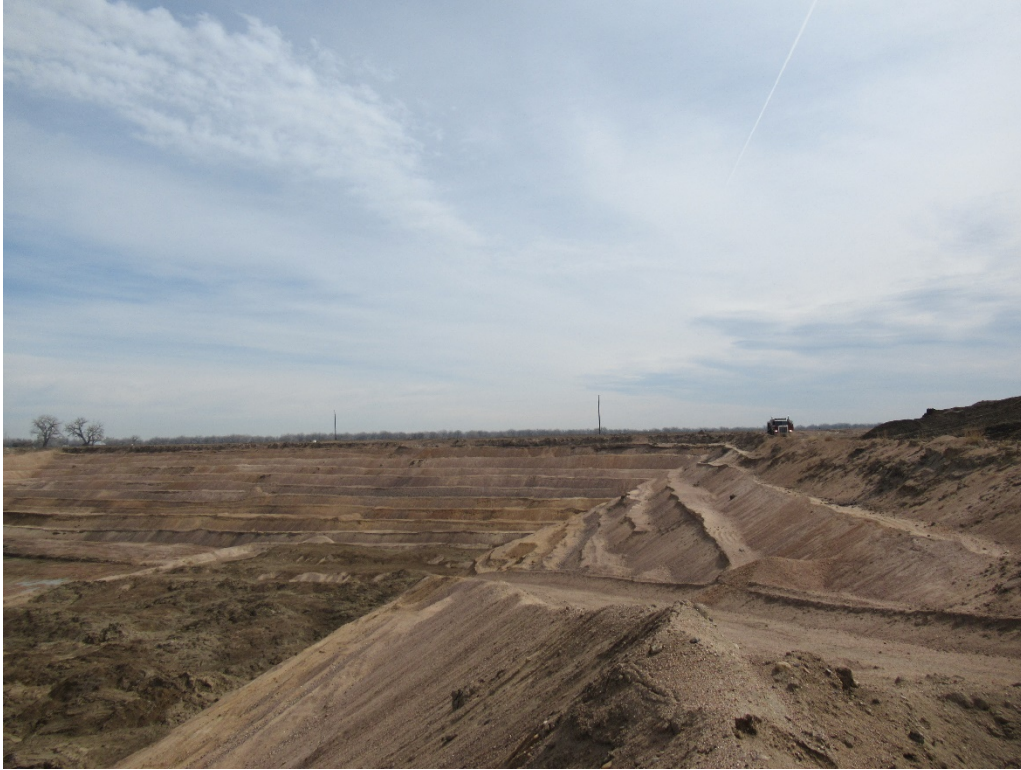
View of Phase 2 excavation from the southwest corner looking east
