MINERALS PROGRAM INSPECTION REPORT
PHONE: (303) 866-3567

MINE NAME: Gravel Pit No 7	MINE/PROSPECTING ID#: M-1977-484	MINERAL: Sand and gravel	COUNTY: Baca
INSPECTION TYPE: Monitoring	INSPECTOR(S): Jared L. Ebert	INSP. DATE: May 13, 2019	INSP. TIME: 12:22
OPERATOR: Baca County	OPERATOR REPRESENTATIVE: Kurt Eskew	TYPE OF OPERATION: 112c - Construction Regular Operation	
REASON FOR INSPECTION: Normal I&E Program	BOND CALCULATION TYPE: None	BOND AMOUNT: \$0.00	
DATE OF COMPLAINT: NA	POST INSP. CONTACTS: None	JOINT INSP. AGENCY: None	
WEATHER: Clear	INSPECTOR'S SIGNATURE:

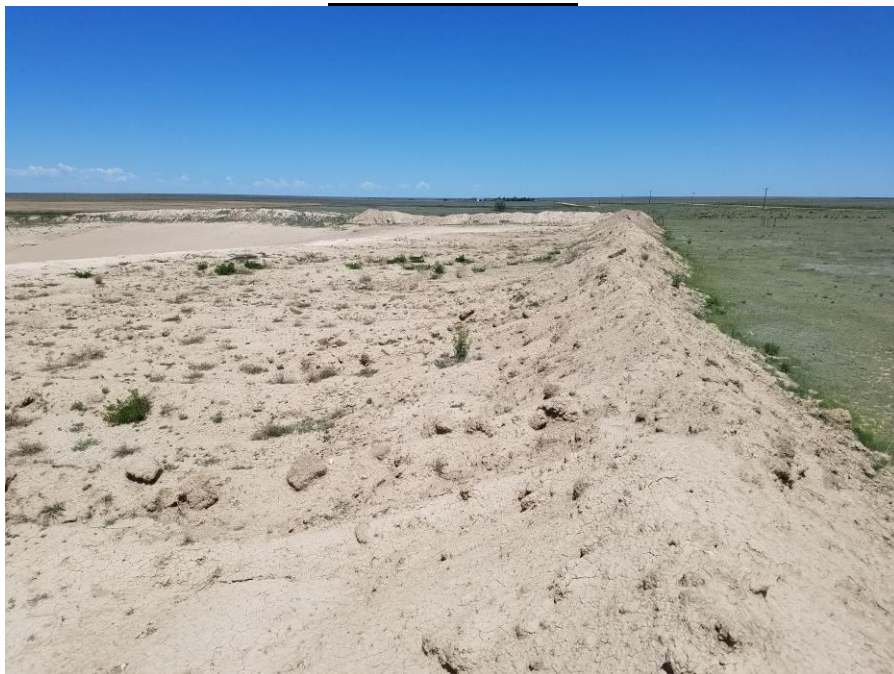
Figure 1. From the southeast corner of the affected land looking north.

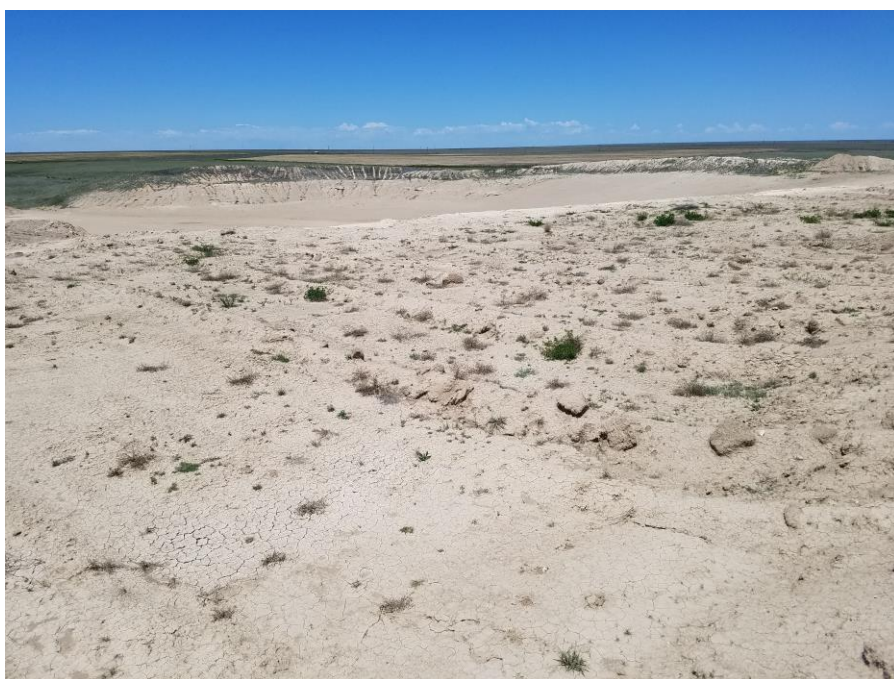
Figure 2. From the southeast corner of the affected land looking northwest.

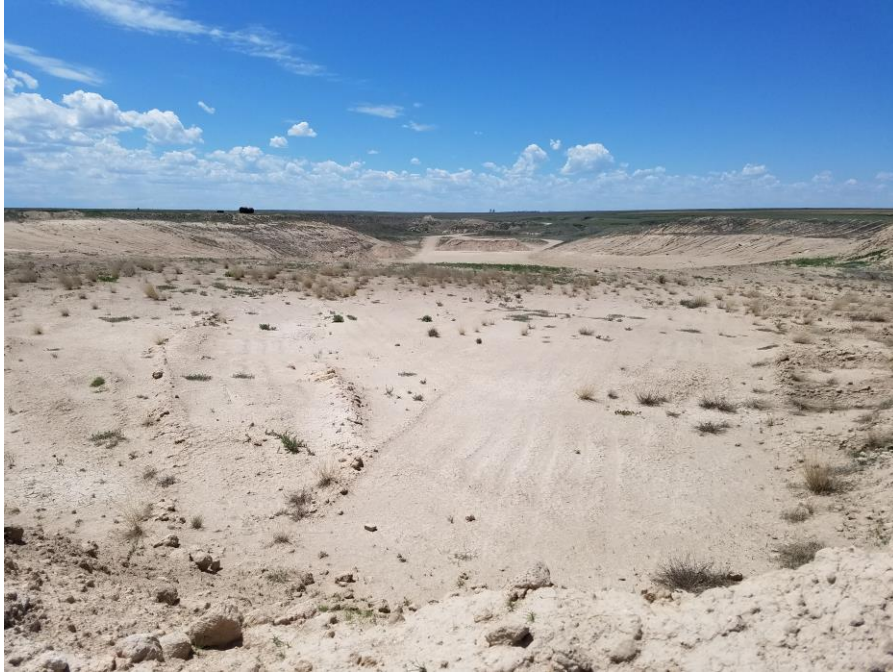
Figure 3. From the east side of the affected area looking west.

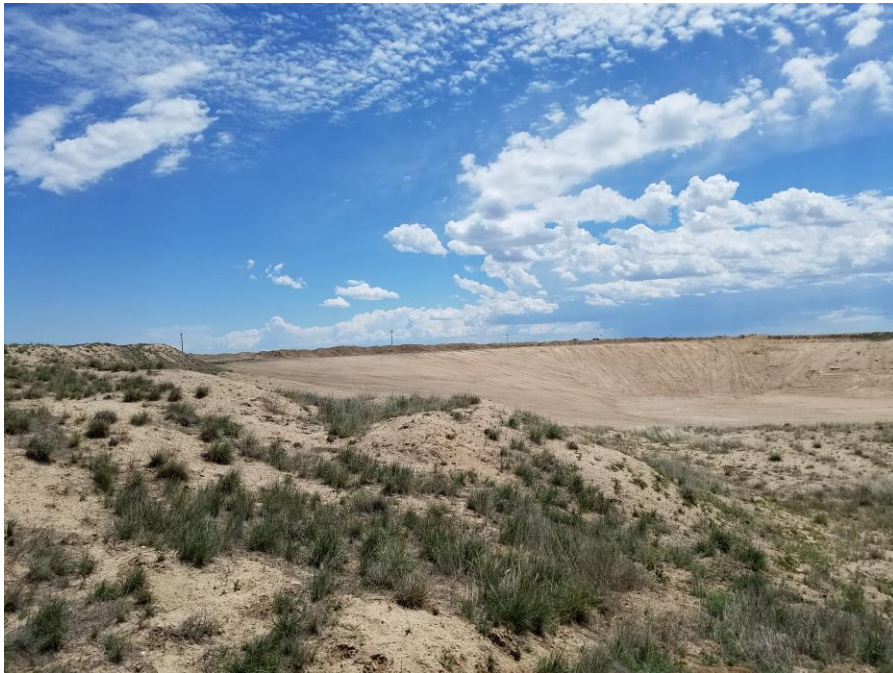
Figure 4. From the north central side of the affected land looking southeast.

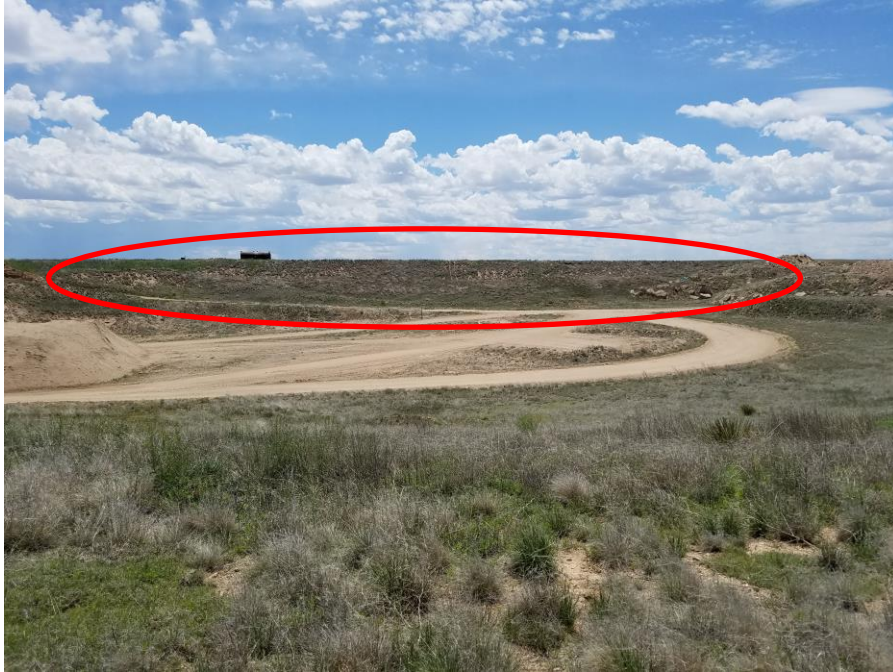
A looped access road comes in from the south and curves east down into the pit. The slope below the access road is graded to a 2.5H:1V angle or less and is eroding in places. According to the last annual report map, this slope below the access road was designated as "reclaimed". However, this slope is not graded in accordance with the approved reclamation plan and is partially eroding. The sediment from the erosion is contained within the pit. This issue was discussed with Mr. Eskew, the Division would not be able to release this area given its current condition, and the County will need to conduct additional grading and revegetation work for this area to be reclaimed in accordance with the approved reclamation plan.

As discussed above, some erosion was noted on the slope below the southern access road. The sediment from this erosion is contained within the pit basin.

Figure 5. From the northwest portion of the affected area looking south. "Reclaimed" slope below access road highlighted.

As discussed above, a portion of the affected area below the access road that was designated in the last annual reclamation report map as "reclaimed" has not been reclaimed in accordance with the approved plan. As the pit is still active and the site is not in final reclamation, this issue is not considered a problem at this time but Baca County will need to conduct additional reclamation of this area in accordance with the approved plan.

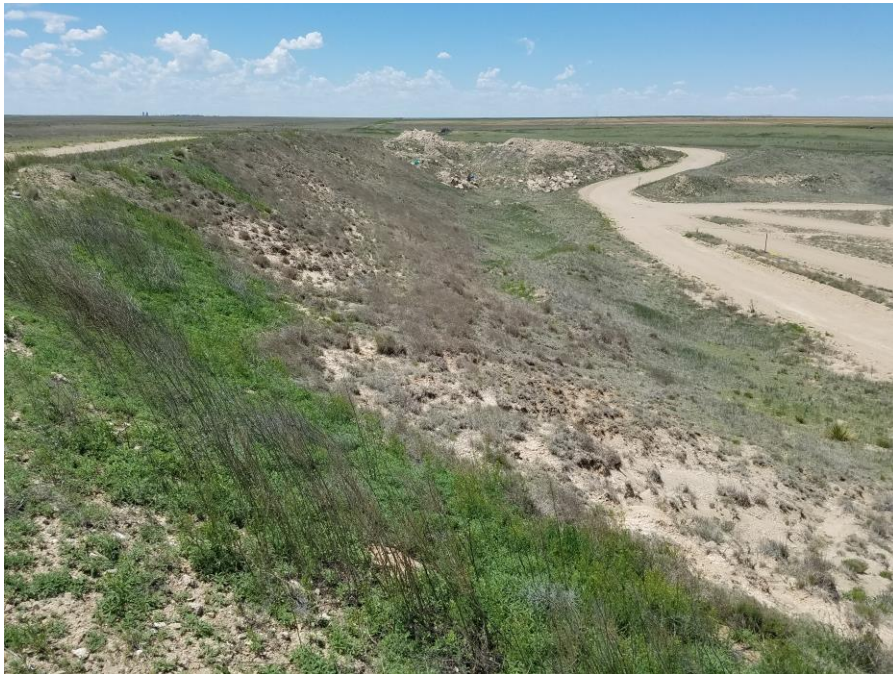
Figure 6. From the south central end of the affected land looking west at "Reclaimed" slope below the access road.
