MINERALS PROGRAM INSPECTION REPORT
PHONE: (303) 866-3567

MINE NAME: McVey Pit	MINE/PROSPECTING ID#: M-1978-225	MINERAL: Sand and gravel	COUNTY: Baca
INSPECTION TYPE: Monitoring	INSPECTOR(S): Jared L. Ebert	INSP. DATE: May 13, 2019	INSP. TIME: 13:32
OPERATOR: Baca County	OPERATOR REPRESENTATIVE: Kurt Eskew	TYPE OF OPERATION: 112c - Construction Regular Operation	
REASON FOR INSPECTION: Normal I&E Program	BOND CALCULATION TYPE: None	BOND AMOUNT: \$0.00	
DATE OF COMPLAINT: NA	POST INSP. CONTACTS: None	JOINT INSP. AGENCY: None	
WEATHER: Clear	INSPECTOR'S SIGNATURE:

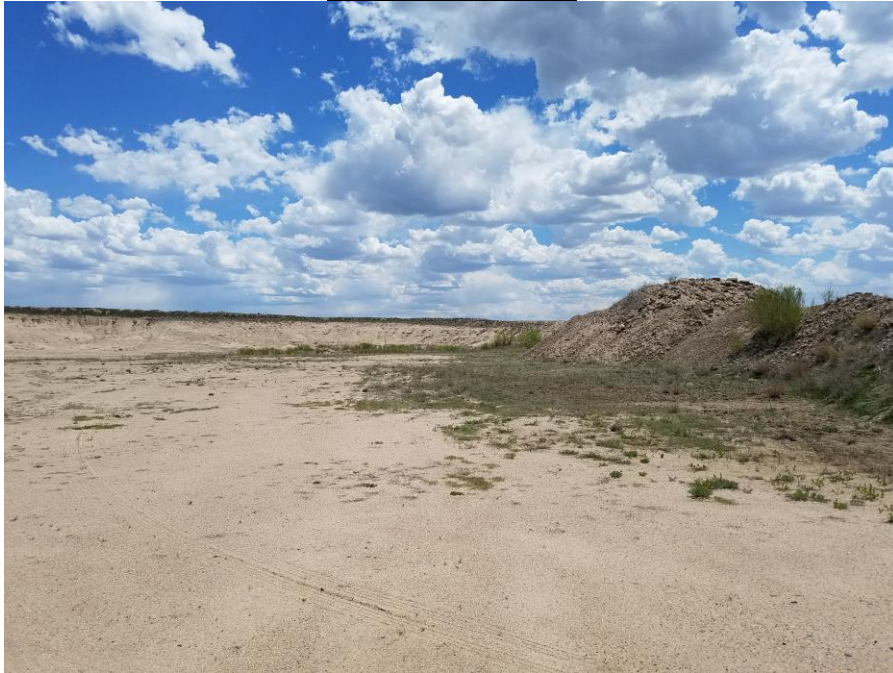
Figure 1. From the central portion of the affected area looking south.

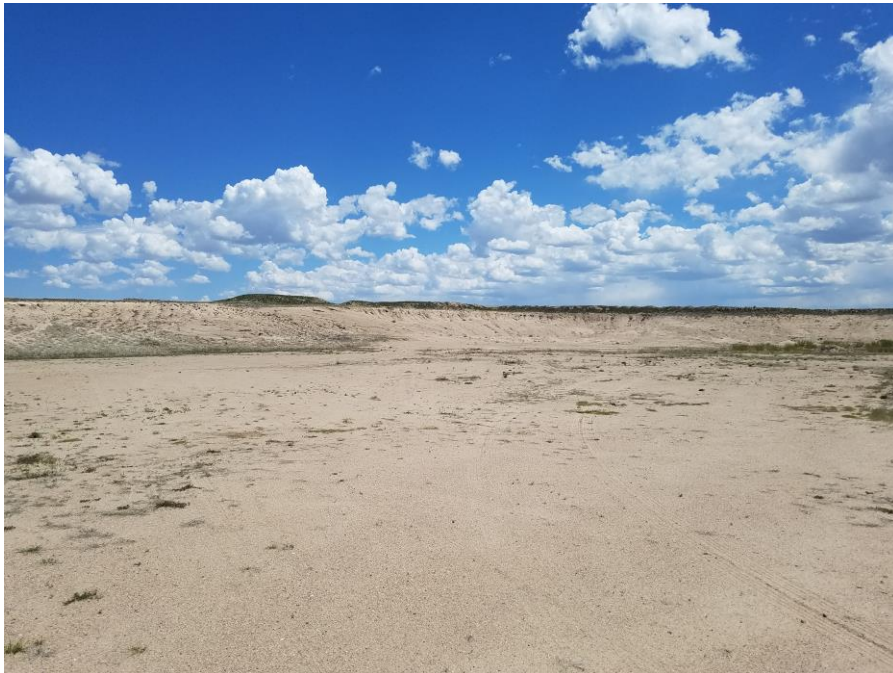
Figure 2. From the central portion of the affected area looking southeast.

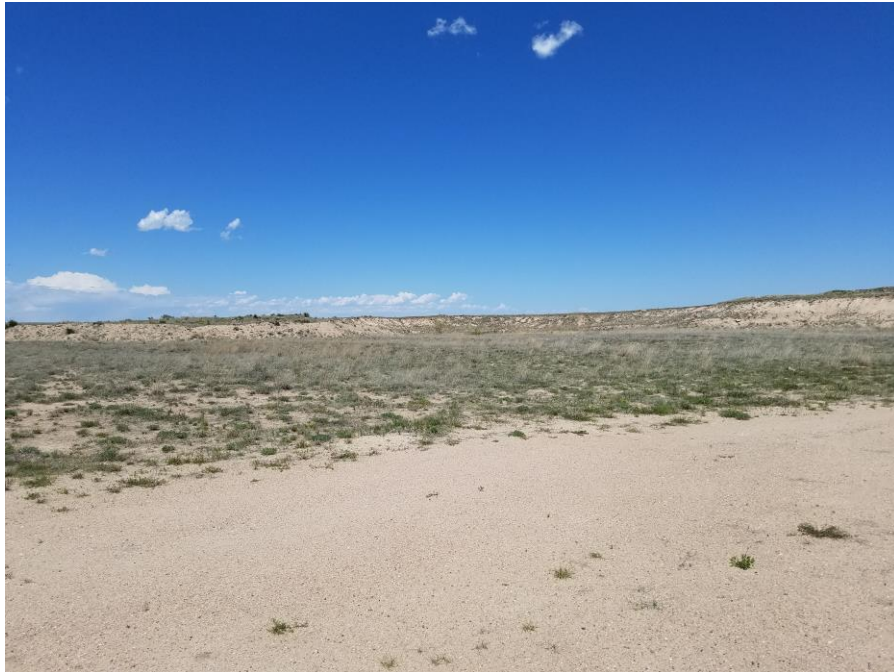
Figure 3. From the central portion of the affected area looking northeast.

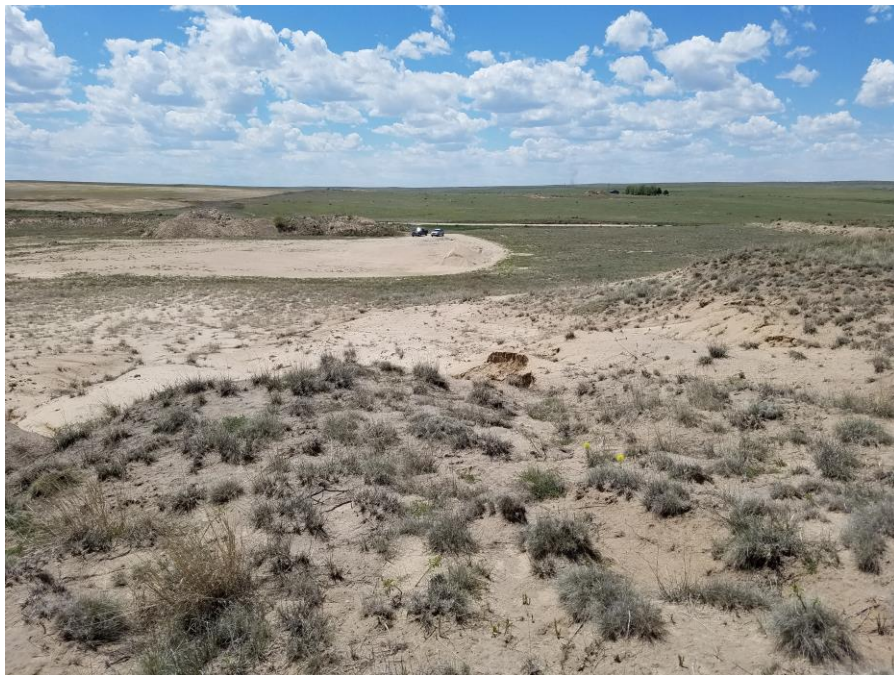
Figure 4. From the northeast portion of the affected area looking west.

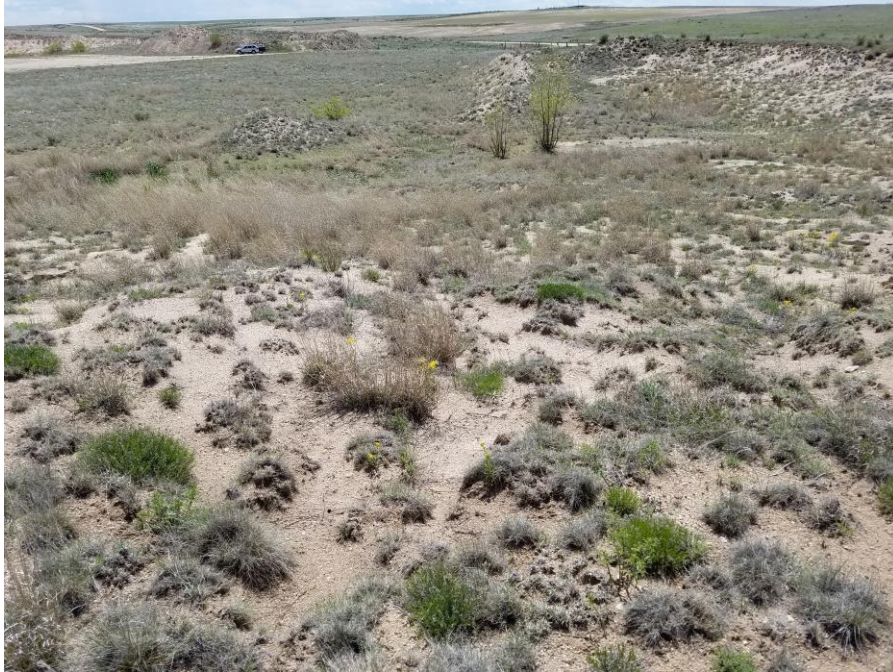
Figure 5. From the north east portion of the affected area looking southwest.
