MINERALS PROGRAM INSPECTION REPORT
PHONE: (303) 866-3567

MINE NAME: Gravel Pit No 8	MINE/PROSPECTING ID#: M-1977-485	MINERAL: Sand and gravel	COUNTY: Baca
INSPECTION TYPE: Monitoring	INSPECTOR(S): Jared L. Ebert	INSP. DATE: May 13, 2019	INSP. TIME: 14:30
OPERATOR: Baca County	OPERATOR REPRESENTATIVE: Gerald Gerber	TYPE OF OPERATION: 112c - Construction Regular Operation	
REASON FOR INSPECTION: Normal I&E Program	BOND CALCULATION TYPE: None	BOND AMOUNT: No Bond Held	
DATE OF COMPLAINT: NA	POST INSP. CONTACTS: None	JOINT INSP. AGENCY: None	
WEATHER: Clear	INSPECTOR'S SIGNATURE:

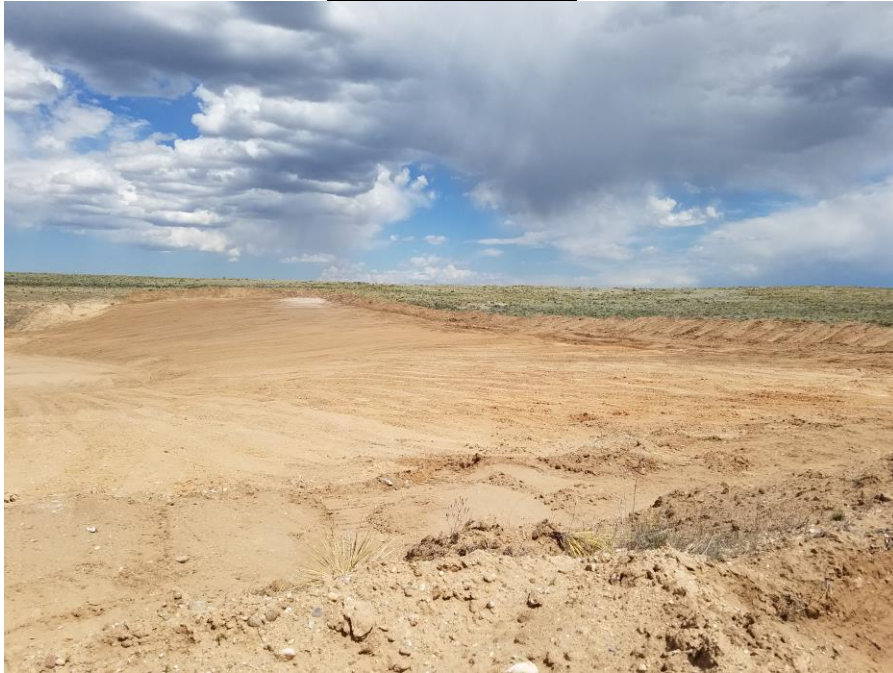
Figure 1. From the southwest corner of the affected land looking east.

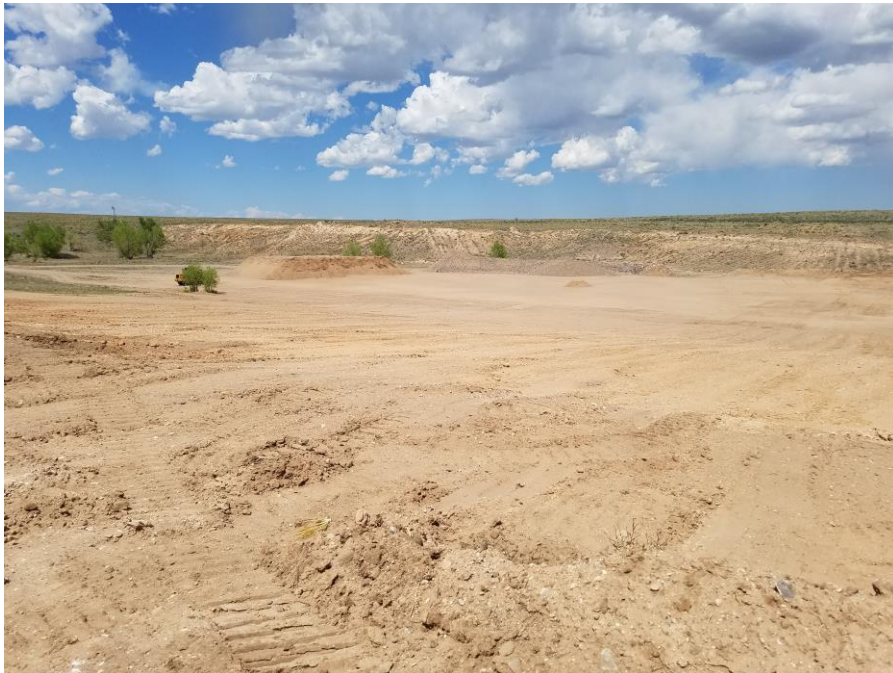
Figure 2. From the southwest corner of the affected land looking northeast.

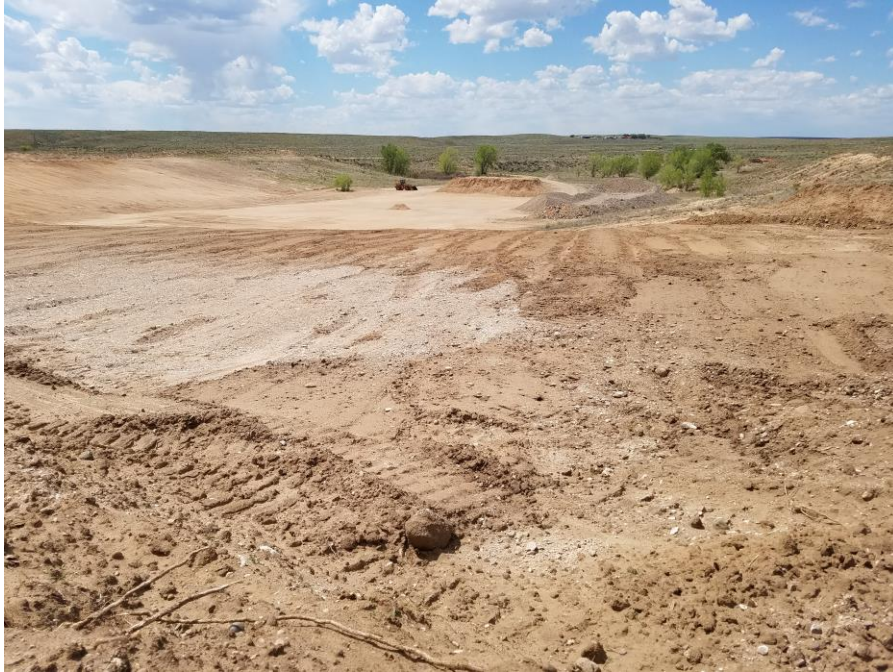
Figure 3. From the southeast corner of the affected land looking northwest.

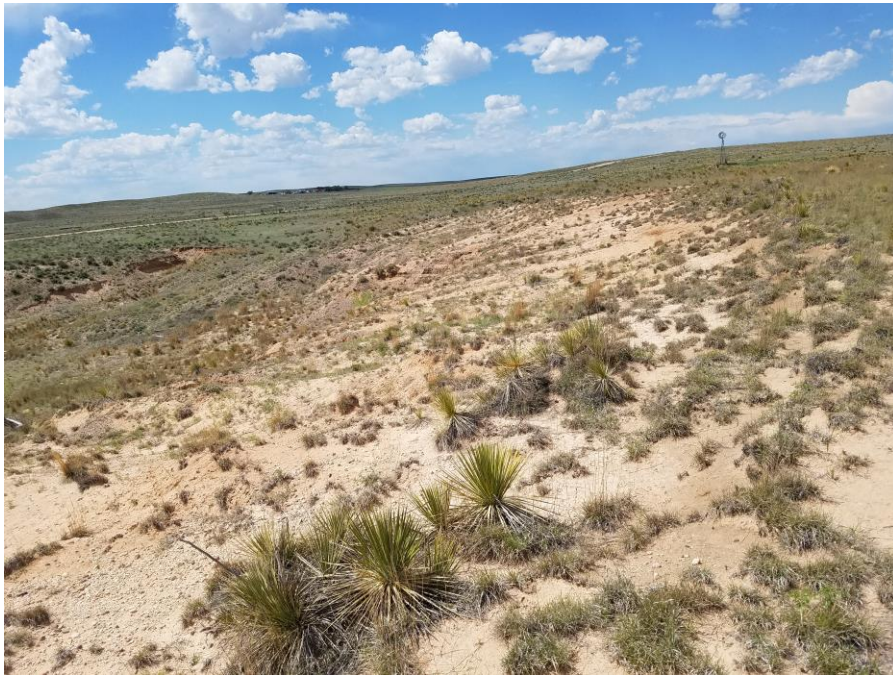
About 22 acres of land has been affected at this site, however a portion of the northern part of the affected area was excavated prior to the enactment of the law and is not designated to be affected by the current mining operation. Of the total affected area, the Division believes about 5 acres of land can be considered pre-law as it appears this area has not been recently affected by the current mining operation.

Figure 4. From the northeast portion of the affected land looking west-northwest at the pre-law affected land.

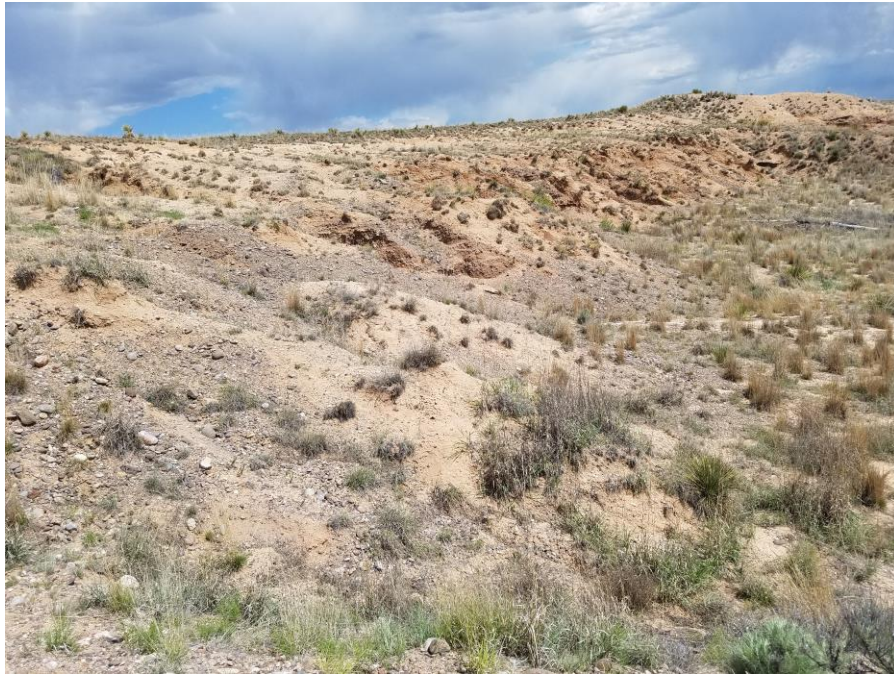
Figure 5. Pre-law affected land from the north central portion of the affected land looking east.
