PERMIT INFORMATION

Permit Number: C-1981-028 Mine Name: Keenesburg Strip Mine Operator: Coors Energy Company Operator Address: Mr. Danny Kipp 1801 California Street Suite 4600 Denver, CO 80202	County: Weld Operation Type: Surface Permit Status: Active Ownership: Private
	Operator Representative Present: Danny Kipp
Operator Representative Signature: (Field Issuance Only)

INSPECTION INFORMATION

Inspection Start Date: April 30, 2019 Inspection Start Time: 08:00 Inspection End Date: April 30, 2019 Inspection End Time: 09:00		Inspection Type: Coal Partial Inspection Inspection Reason: Normal I&E Program Weather: Cloudy	
Joint Inspection Agency: None		Joint Inspection Contacts: 	
Post Inspection Agency: None		Post Inspection Contacts: 	
Inspector(s): Robert D. Zuber, P.E.	Inspector's Signature:

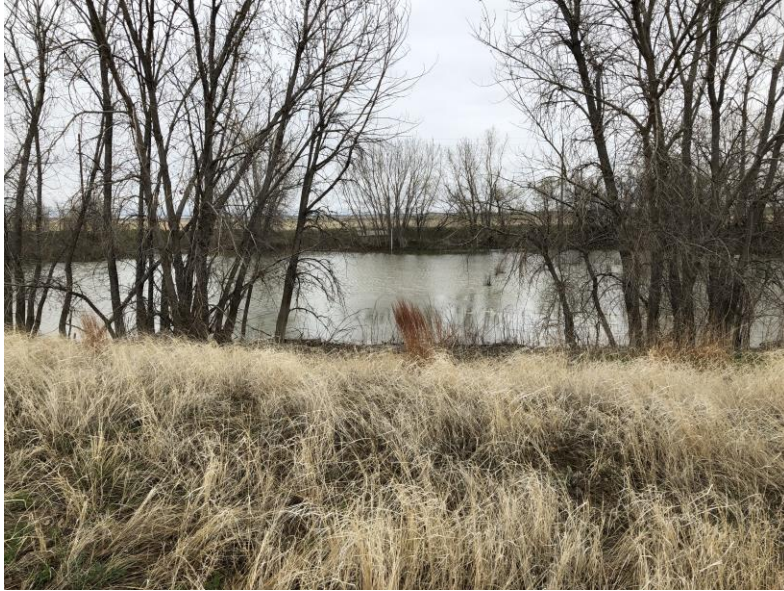
Sediment Pond #2

Water was observed in the two ponds. Neither pond was discharging during the inspection, and the water levels were well below the spillways. No problems were observed with the two ponds.

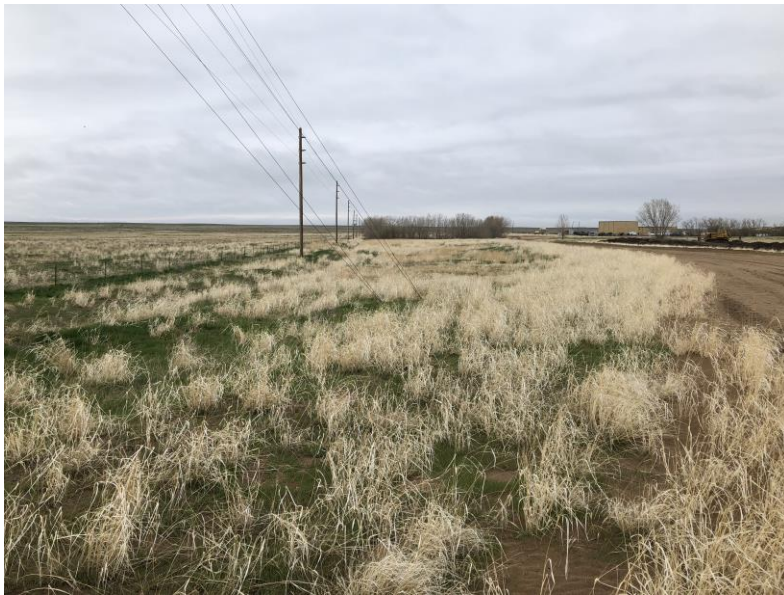
The perimeter ditch along the north side of the mine appeared to be functioning well.

Looking east at north side of site. Sediment Pond is where trees are in middle of photo.

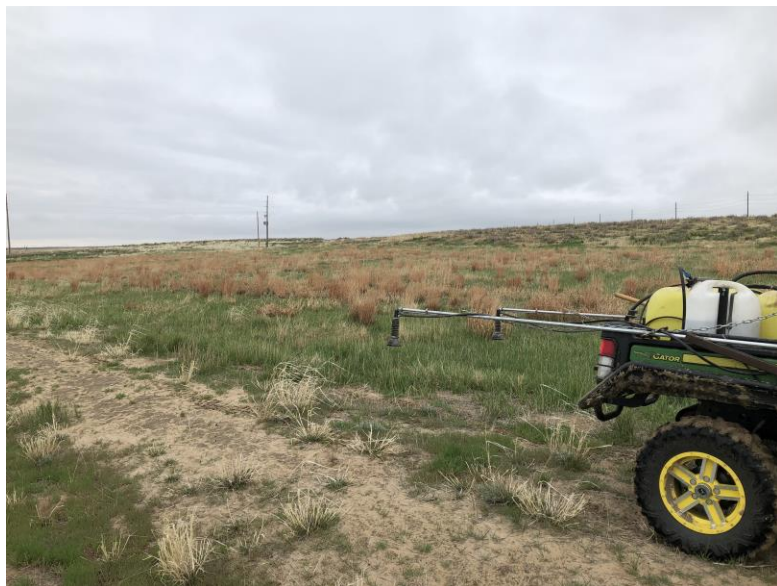
The undisturbed areas near the northwest corner of the permit area did not appear to have been disturbed by CEC or other parties.

Northwest corner of site, looking south

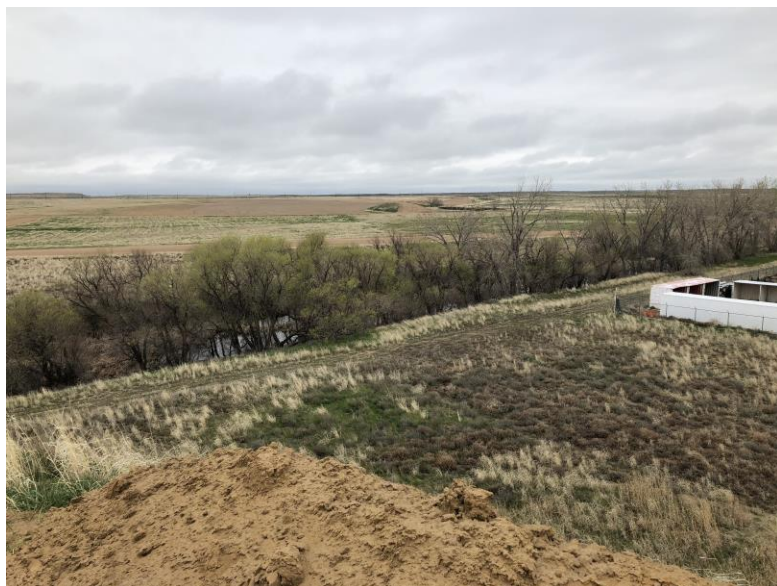
Reclamation of the spoil area and B Pit is not complete, but no large piles or puddles were seen. The grading of this area appears to be in line with the general plan of a slight grade to the northeast.

Dugout pond (below trees) and former spoil area in background
