**MINERALS PROGRAM INSPECTION REPORT**  
**PHONE: (303) 866-3567**

<b>MINE NAME:</b> Lusk Pit #36	<b>MINE/PROSPECTING ID#:</b> M-2009-002	<b>MINERAL:</b> Sand and gravel	<b>COUNTY:</b> Baca
<b>INSPECTION TYPE:</b> Monitoring	<b>INSPECTOR(S):</b> Jared L. Ebert	<b>INSP. DATE:</b> May 13, 2019	<b>INSP. TIME:</b> 16:40
<b>OPERATOR:</b> Baca County	<b>OPERATOR REPRESENTATIVE:</b> Tom Billings and Norm Shaw	<b>TYPE OF OPERATION:</b> 112c - Construction Regular Operation	
<b>REASON FOR INSPECTION:</b> Normal I&E Program	<b>BOND CALCULATION TYPE:</b> None	<b>BOND AMOUNT:</b> \$0.00	
<b>DATE OF COMPLAINT:</b> NA	<b>POST INSP. CONTACTS:</b> None	<b>JOINT INSP. AGENCY:</b> None	
<b>WEATHER:</b> Clear	<b>INSPECTOR'S SIGNATURE:</b>

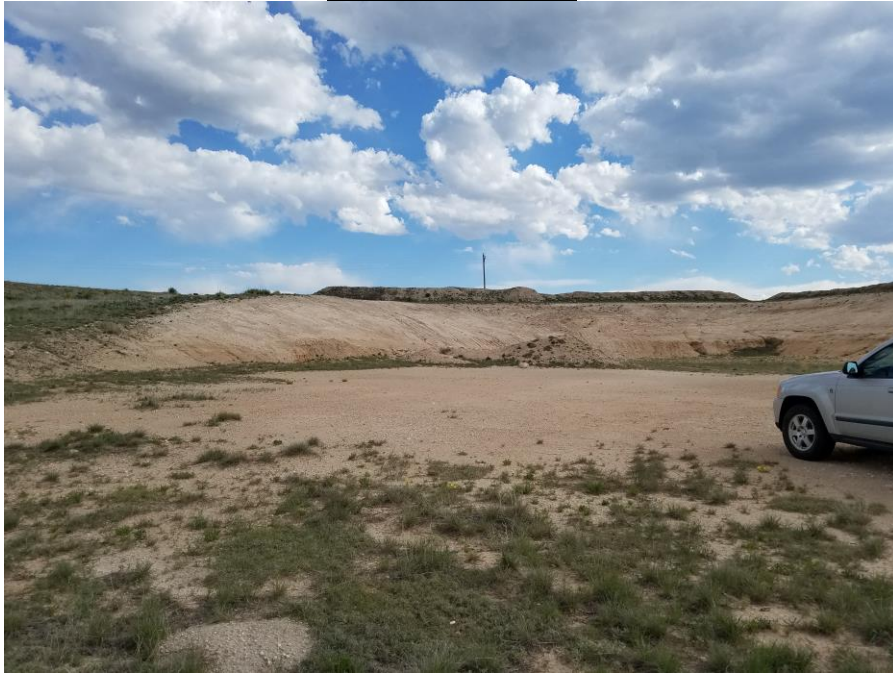
**Figure 1.** From the north side of the affected land looking south.

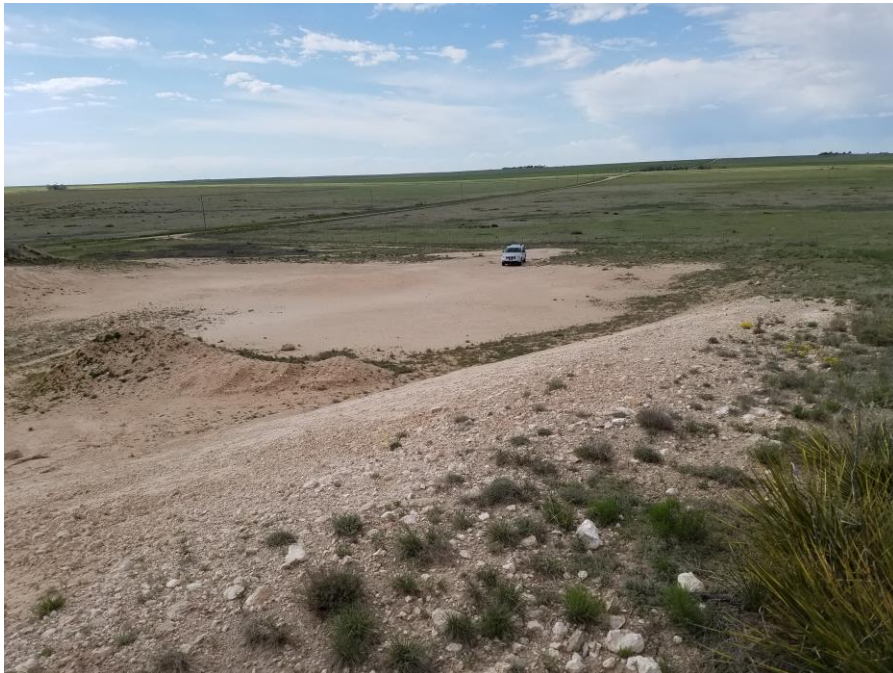
**Figure 2.** From the southeast corner of the affected land looking northwest.

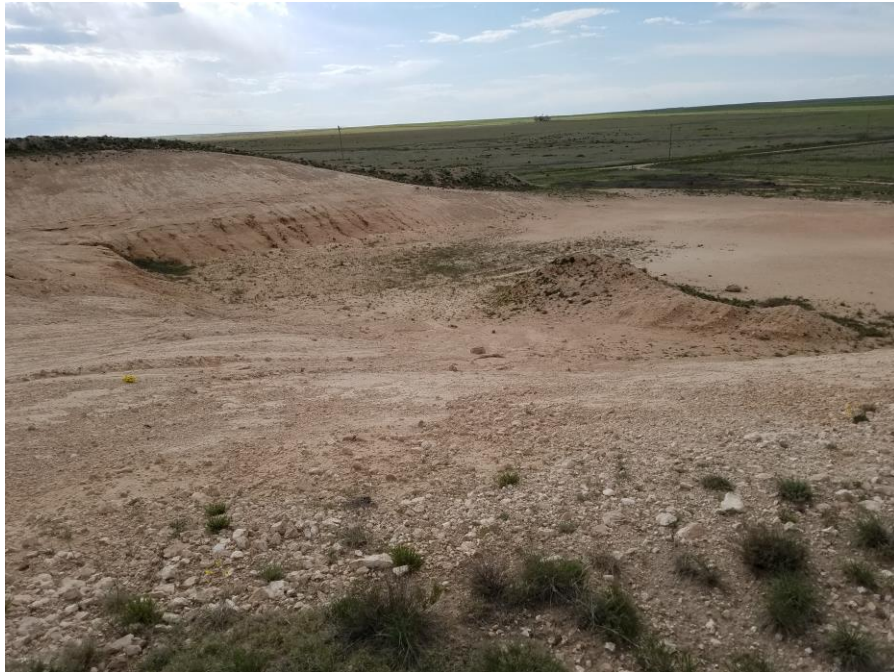
Figure 3. From the southeast corner of the affected land looking west.

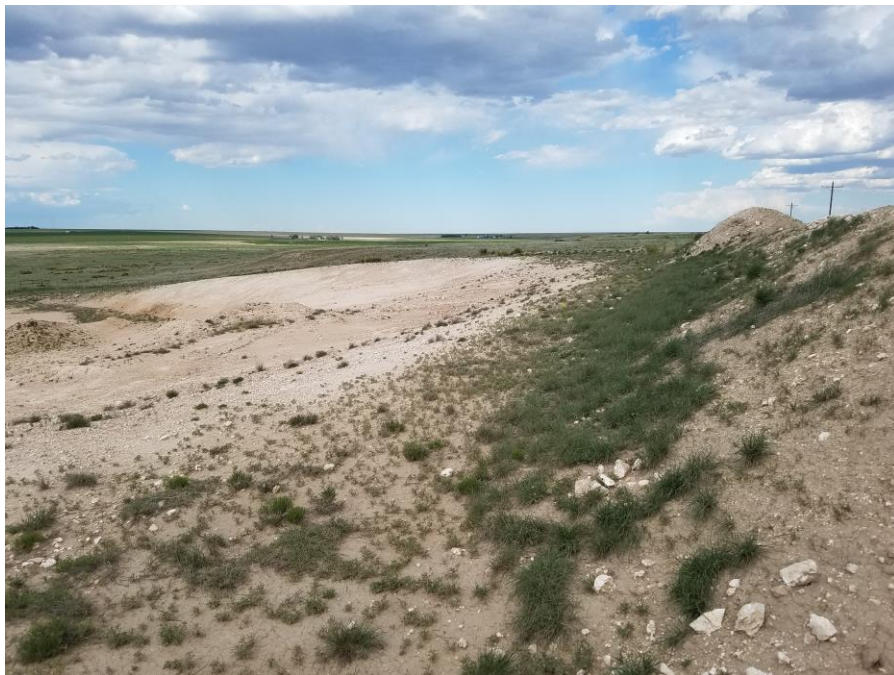
Figure 4. From the southwest corner of the affected land looking east.
