MINERALS PROGRAM INSPECTION REPORT
PHONE: (303) 866-3567

MINE NAME: Harmony Gardens Site	MINE/PROSPECTING ID#: M-2017-021	MINERAL: Sand and gravel	COUNTY: Weld
INSPECTION TYPE: Monitoring	INSPECTOR(S): Peter S. Hays	INSP. DATE: May 6, 2019	INSP. TIME: 12:00
OPERATOR: Connell Resources, Inc.	OPERATOR REPRESENTATIVE: Kevin Anderson	TYPE OF OPERATION: 110c - Construction Limited Impact	
REASON FOR INSPECTION: Normal I&E Program	BOND CALCULATION TYPE: Partial Bond	BOND AMOUNT: \$51,335.00	
DATE OF COMPLAINT: NA	POST INSP. CONTACTS: None	JOINT INSP. AGENCY: None	
WEATHER: Clear	INSPECTOR'S SIGNATURE:

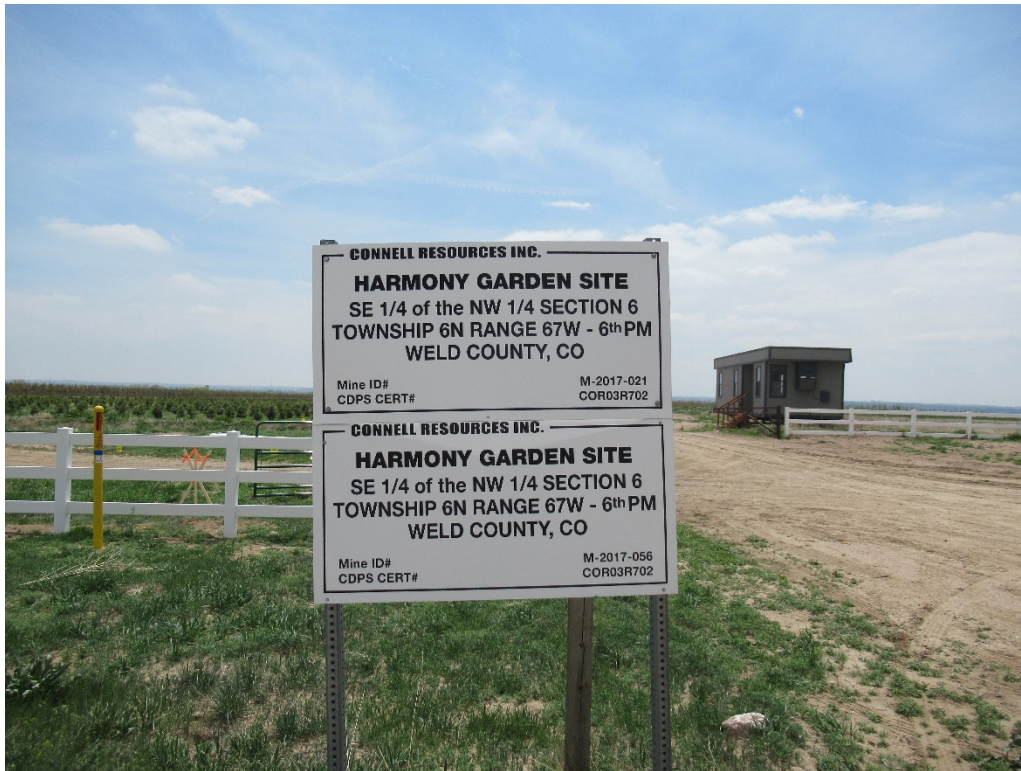
The required mine sign was observed and the boundaries of the affected land were delineated as required by Rule 3.1.12. The Division currently holds a financial warranty in the amount of \$51,335.00, which is adequate to complete reclamation at the site. Photographs taken during the inspection are attached.

Harmony Gardens Site mine sign

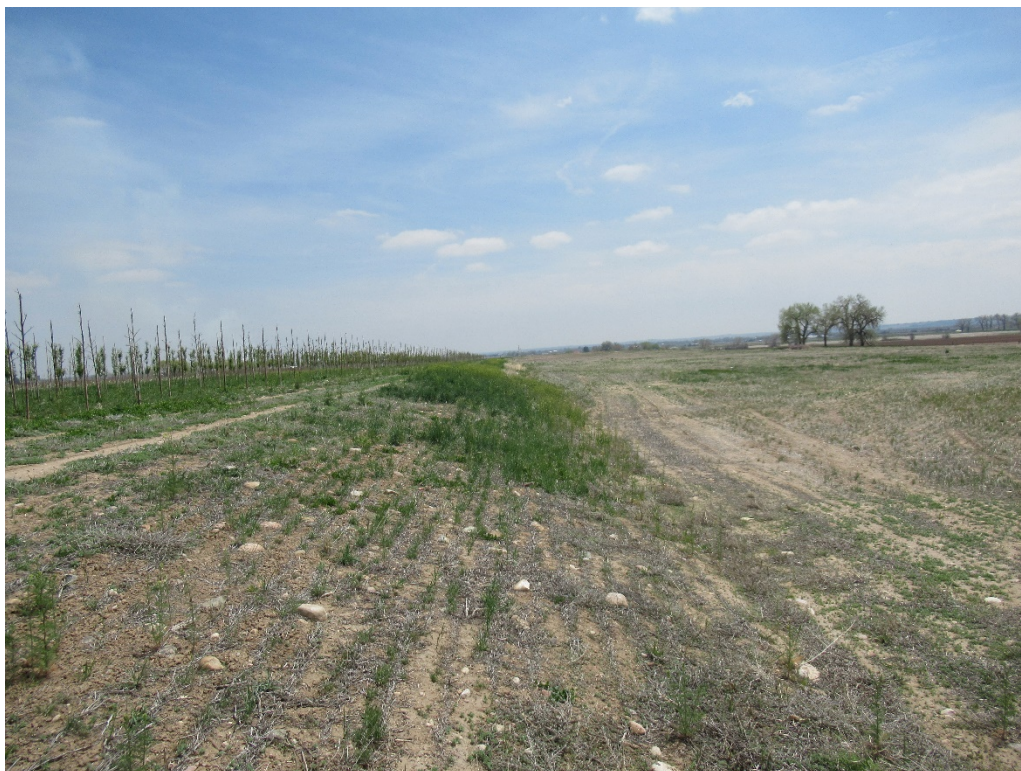
View of the East Mining Area from the northwest corner looking east

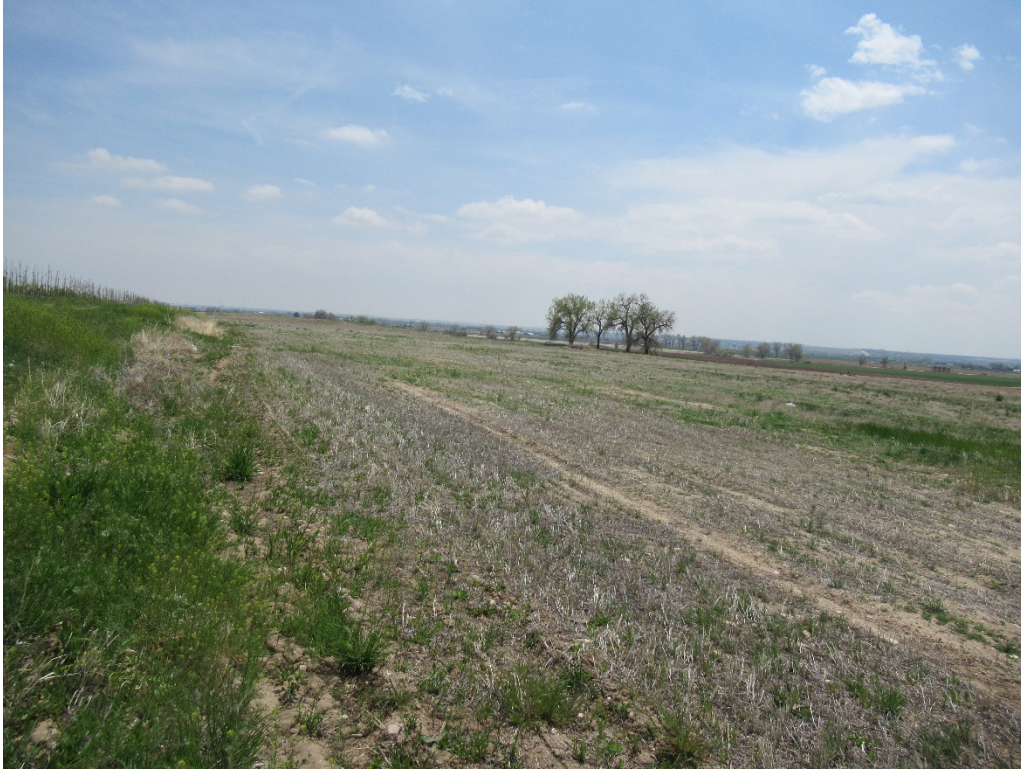
View of the East Mining Area from the northwest corner looking southeast

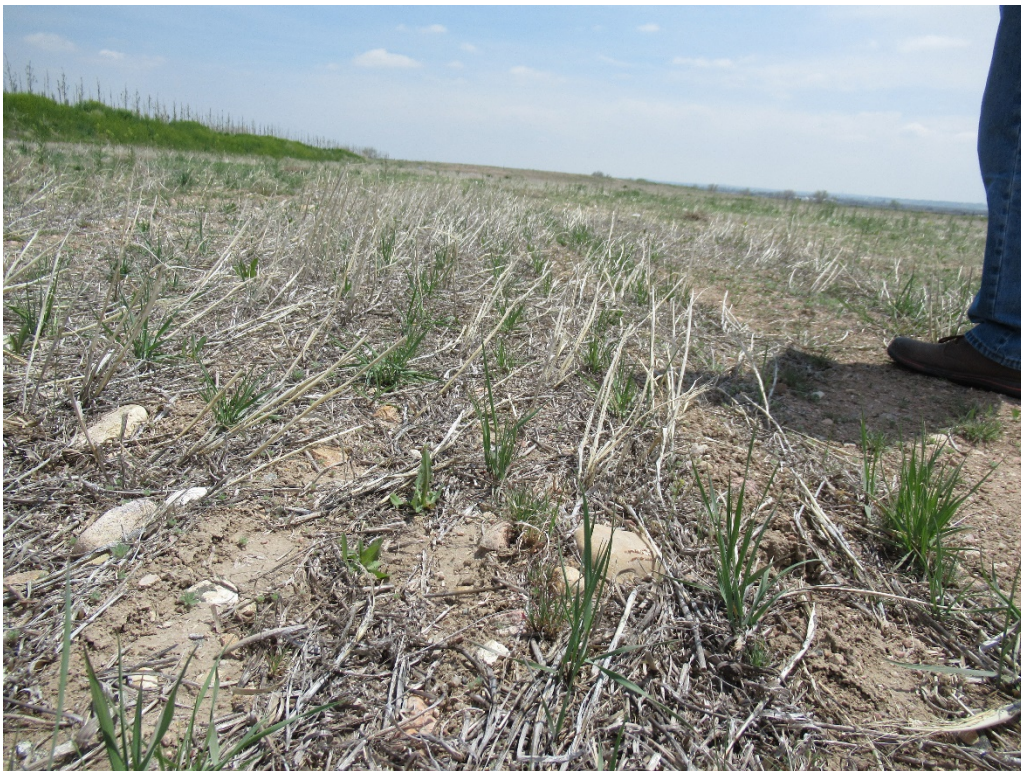
View of the East Mining Area pit floor vegetation

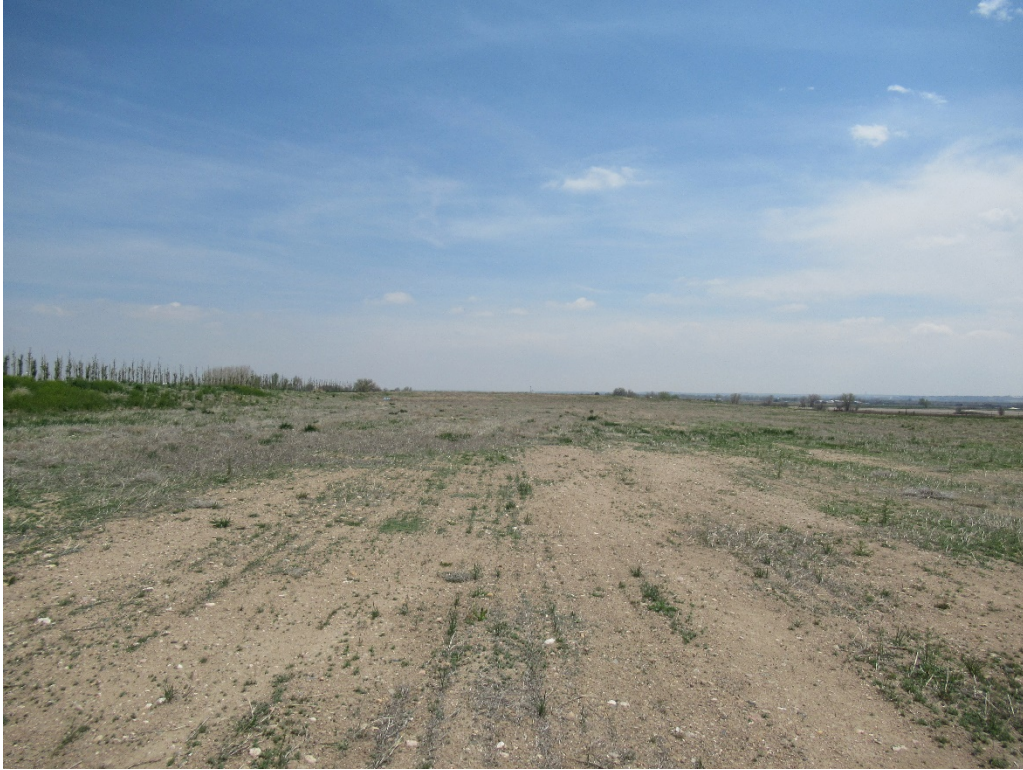
View of the East Mining Area pit floor from the middle of the area looking east

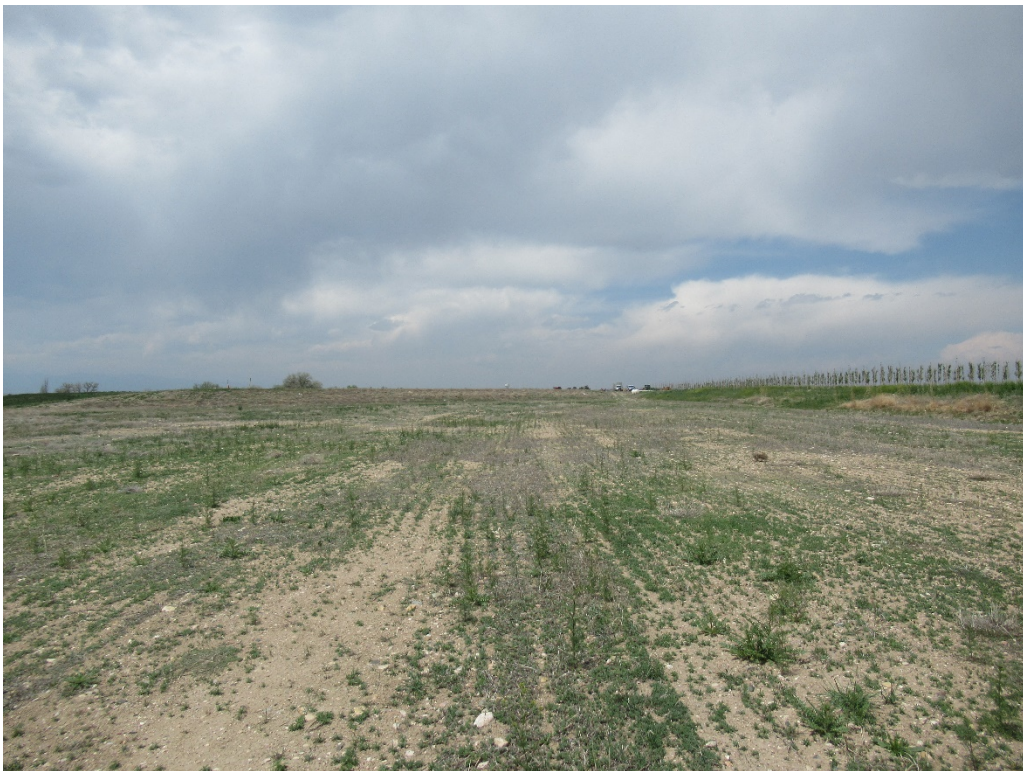
View of the East Mining Area pit floor from the middle of the area looking west

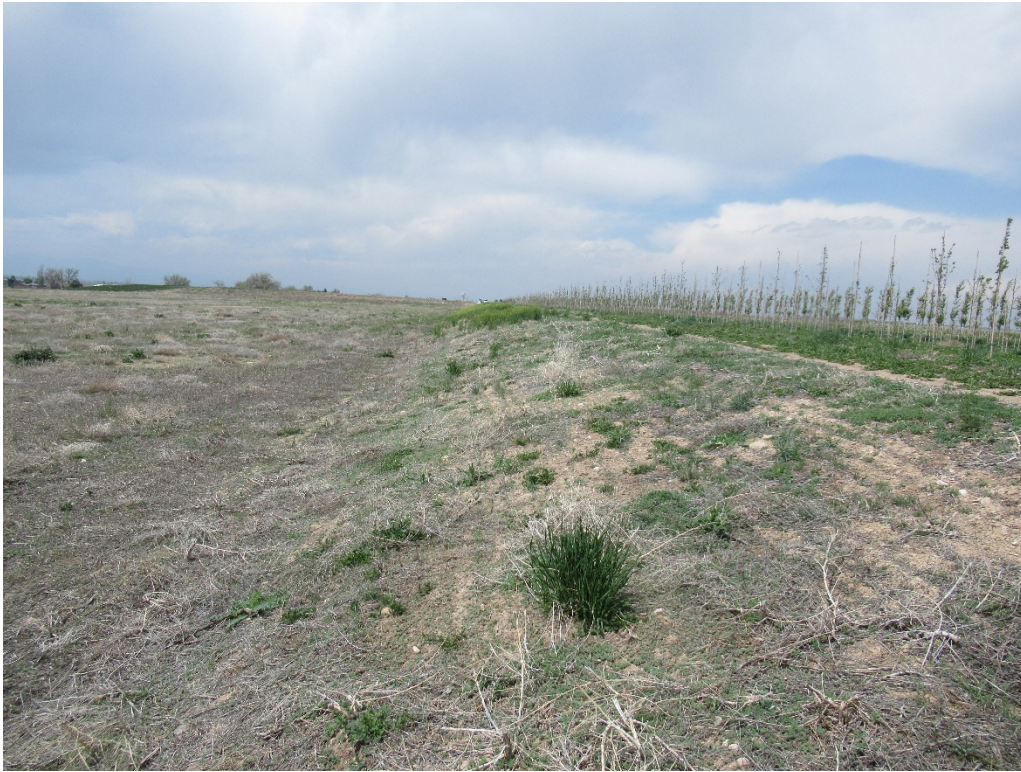
View of the East Mining Area from the northwest corner looking east

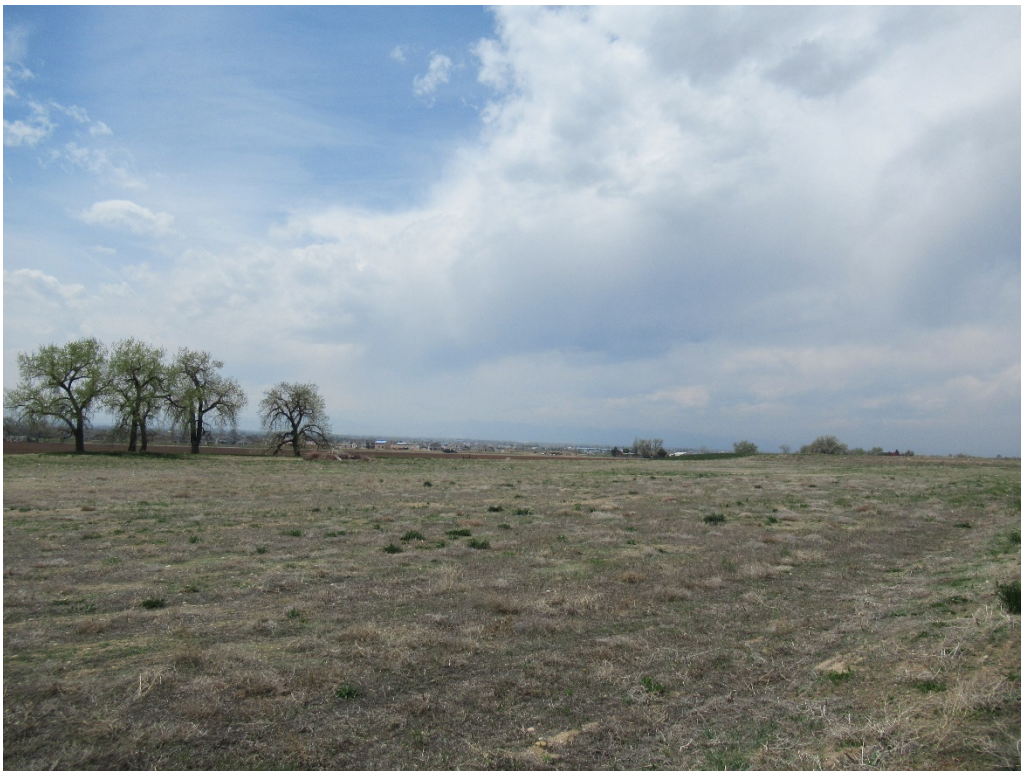
View of the East Mining Area from the northwest corner looking southeast

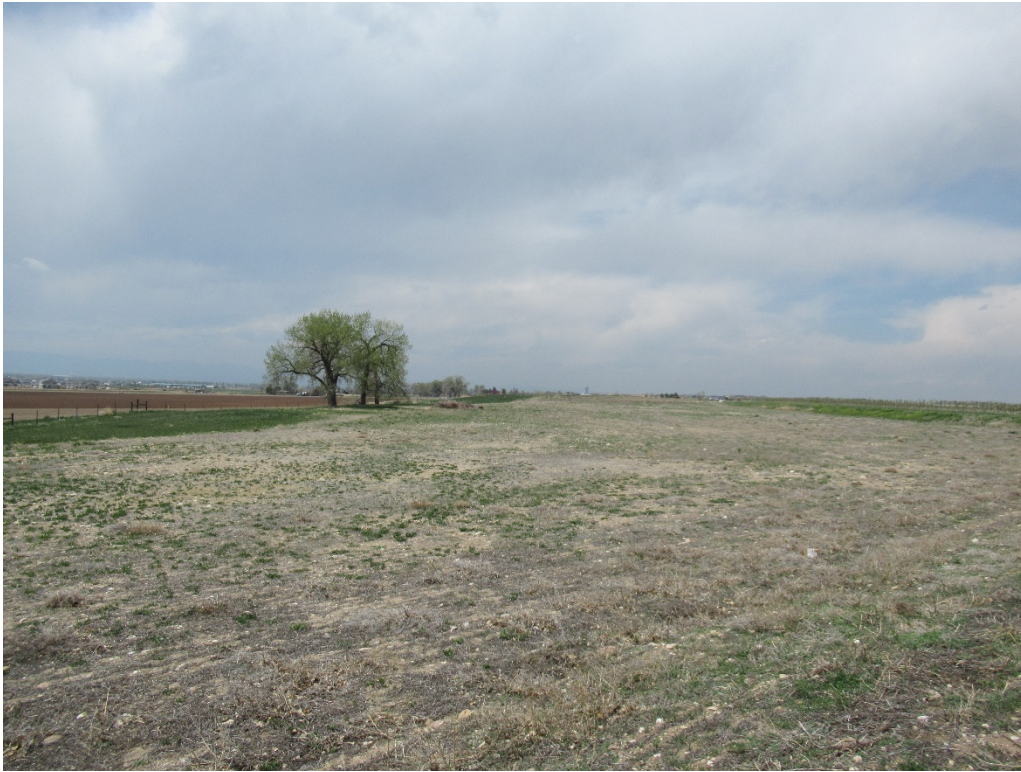
View of the East Mining Area from the southwest corner looking east

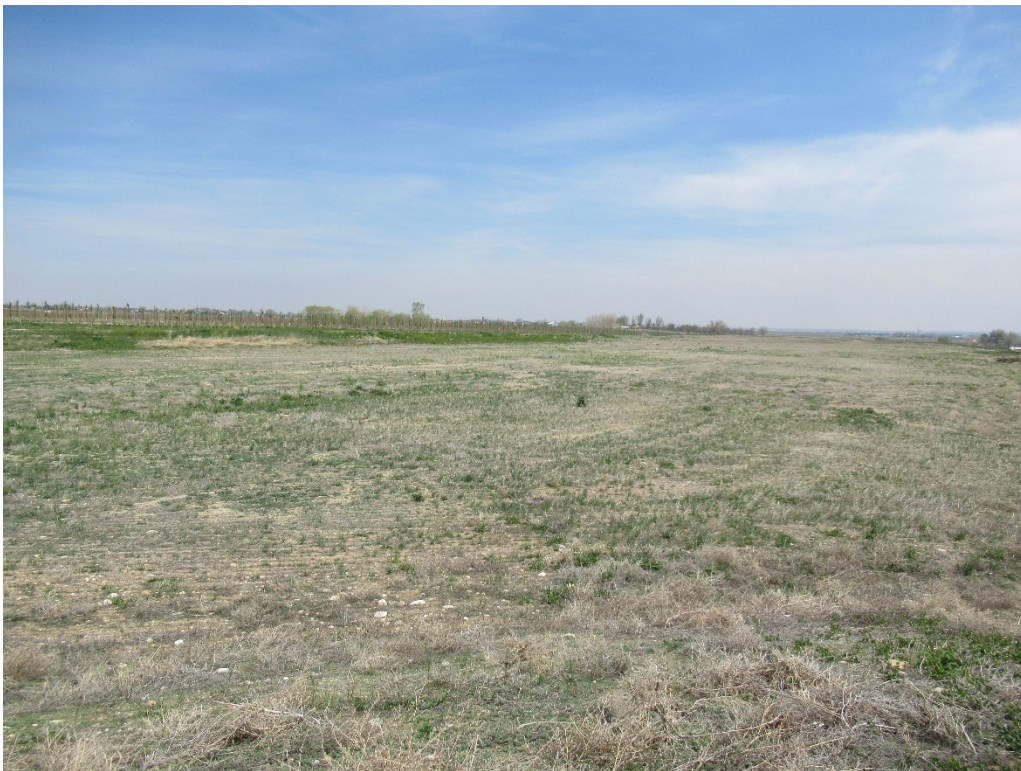
View of the East Mining Area from the southwest corner looking northeast

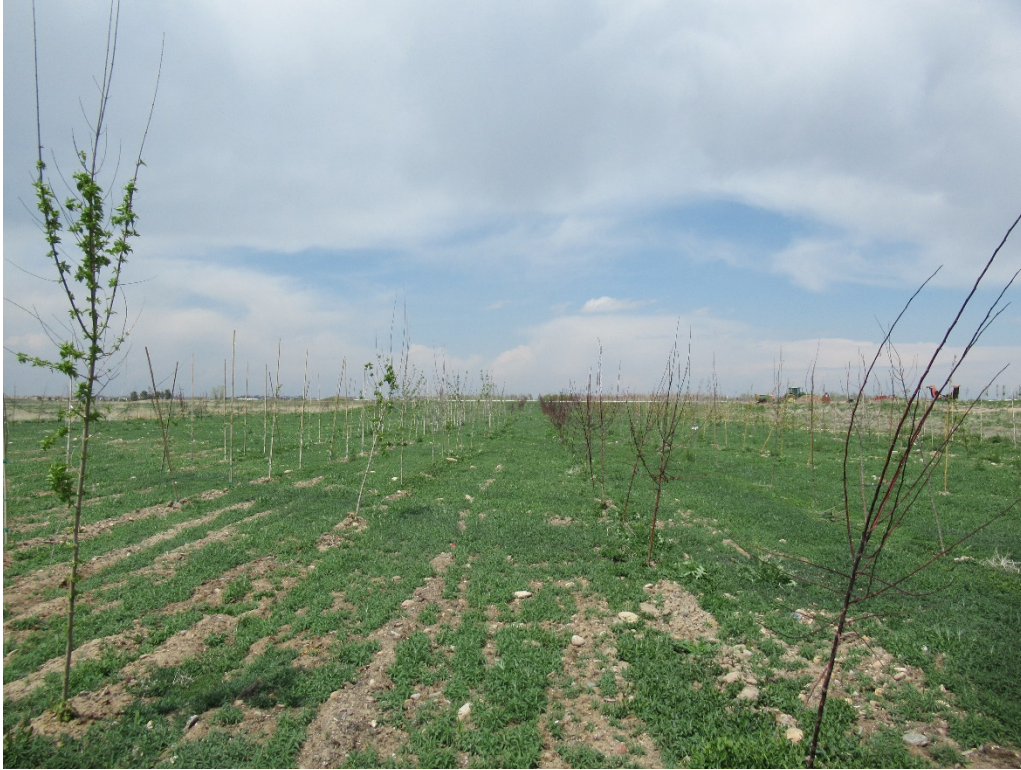
View of the West Mining Area from the south side looking north

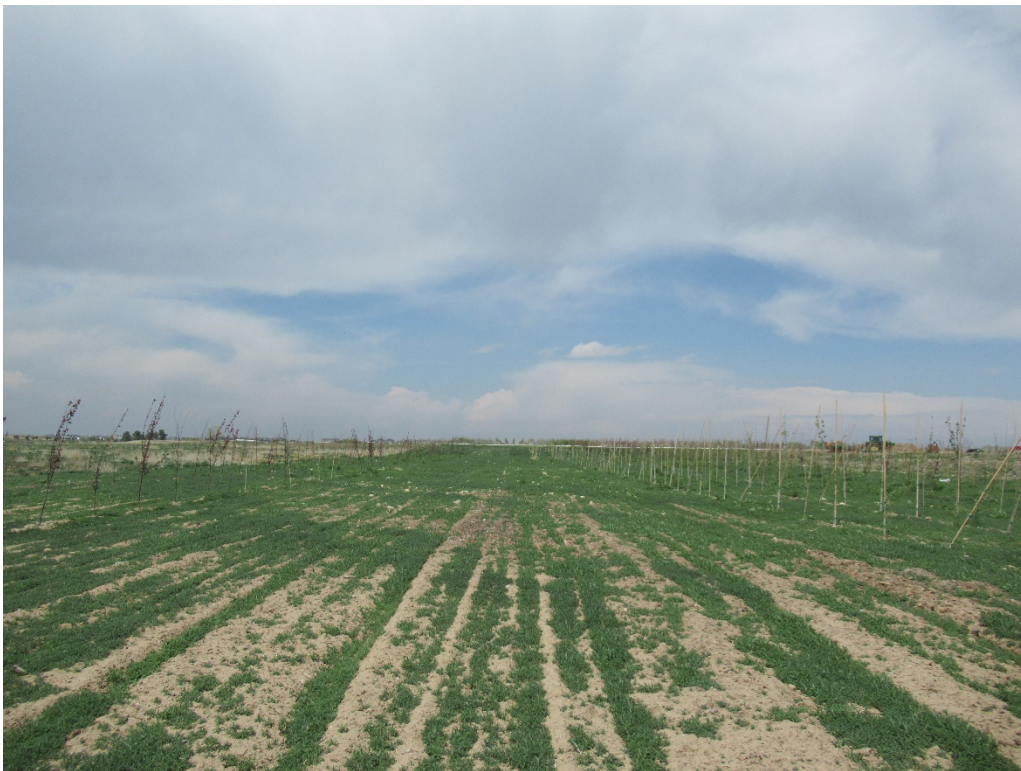
View of the West Mining Area from the south side looking north
