MINERALS PROGRAM INSPECTION REPORT

MINE NAME: Big R Pit	MINE/PROSPECTING ID#: M-1988-052	MINERAL: Sand and gravel	COUNTY: Elbert
INSPECTION TYPE: Surety-Related Inspection	INSPECTOR(S): Patrick Lennberg	INSP. DATE: May 15, 2019	INSP. TIME: 08:00
OPERATOR: Colorado farms llc	OPERATOR REPRESENTATIVE: Bronco Mocevic	TYPE OF OPERATION: 110c - Construction Limited Impact

REASON FOR INSPECTION: Surety Related	BOND CALCULATION TYPE: Complete Bond	BOND AMOUNT: \$18,642.00
DATE OF COMPLAINT: NA	POST INSP. CONTACTS: None	JOINT INSP. AGENCY: None
WEATHER: Clear	INSPECTOR'S SIGNATURE:

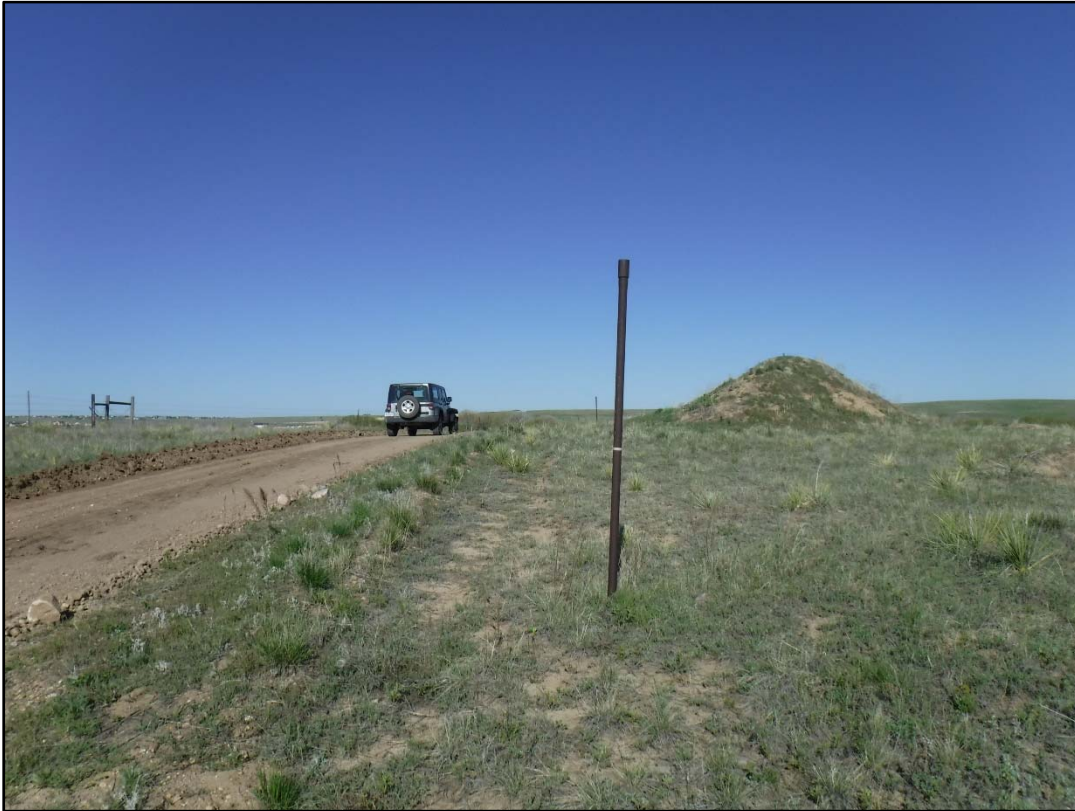
The Division was able to locate all permit boundary markers. All current mining is within the permit boundary but, again, the southern highwall is extremely close to the permit boundary.

Photo 1: Permit Boundary markers

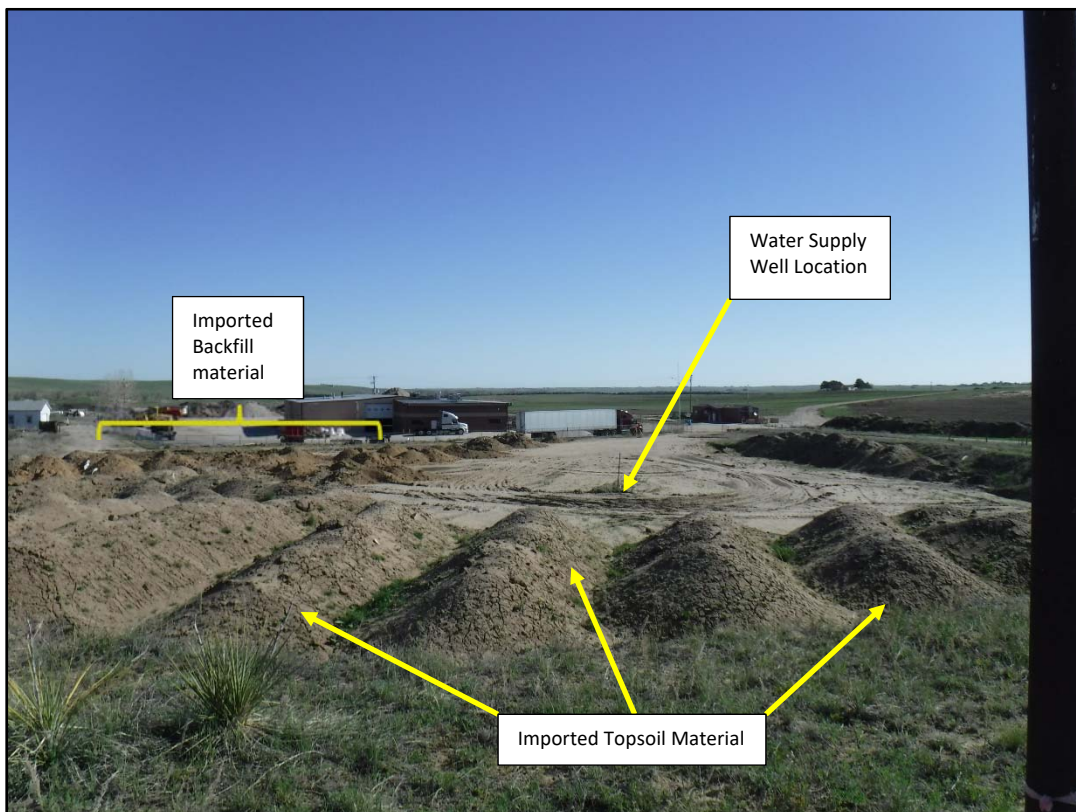
During the inspection the Operator pointed out a water supply well that is located immediately adjacent to the permit boundary to the east where the main pit access road is located. The water supply well is owned by Weld County and they require that the area surrounding the well be flat and open enough for trucks to maneuver and potentially fill from the well.

Photo 2: Southeast end of permit area at mine entrance

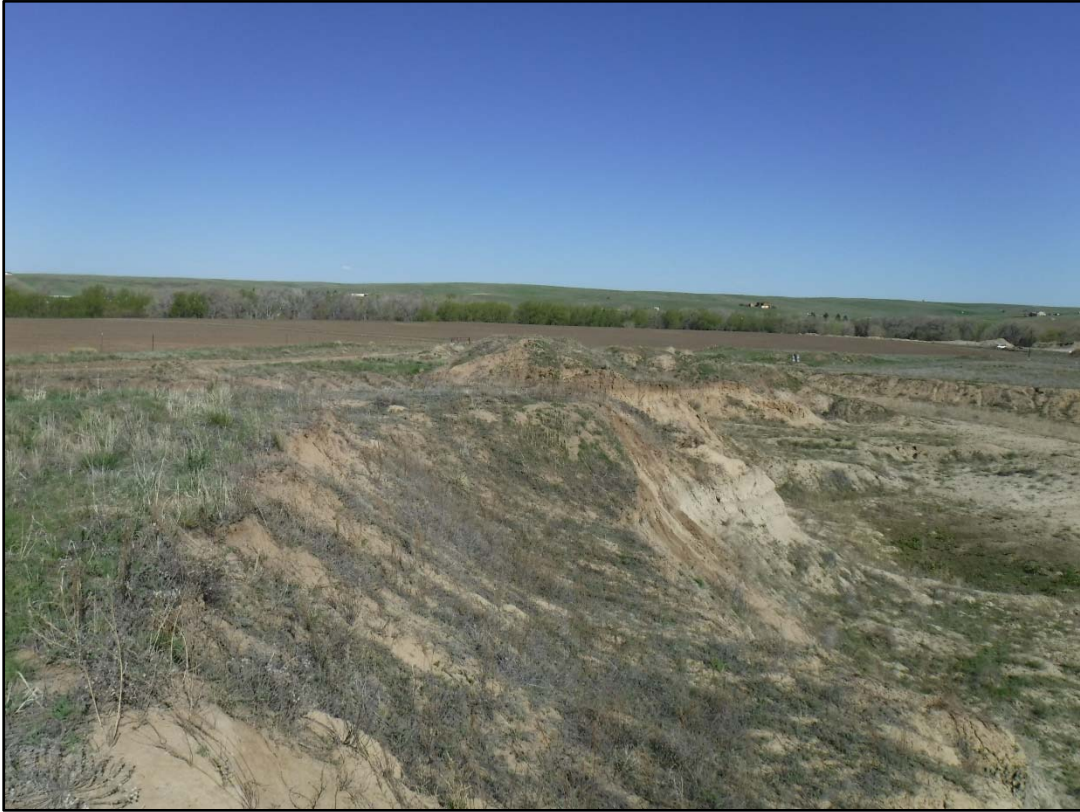
Photo 3: Southern highwall, looking west

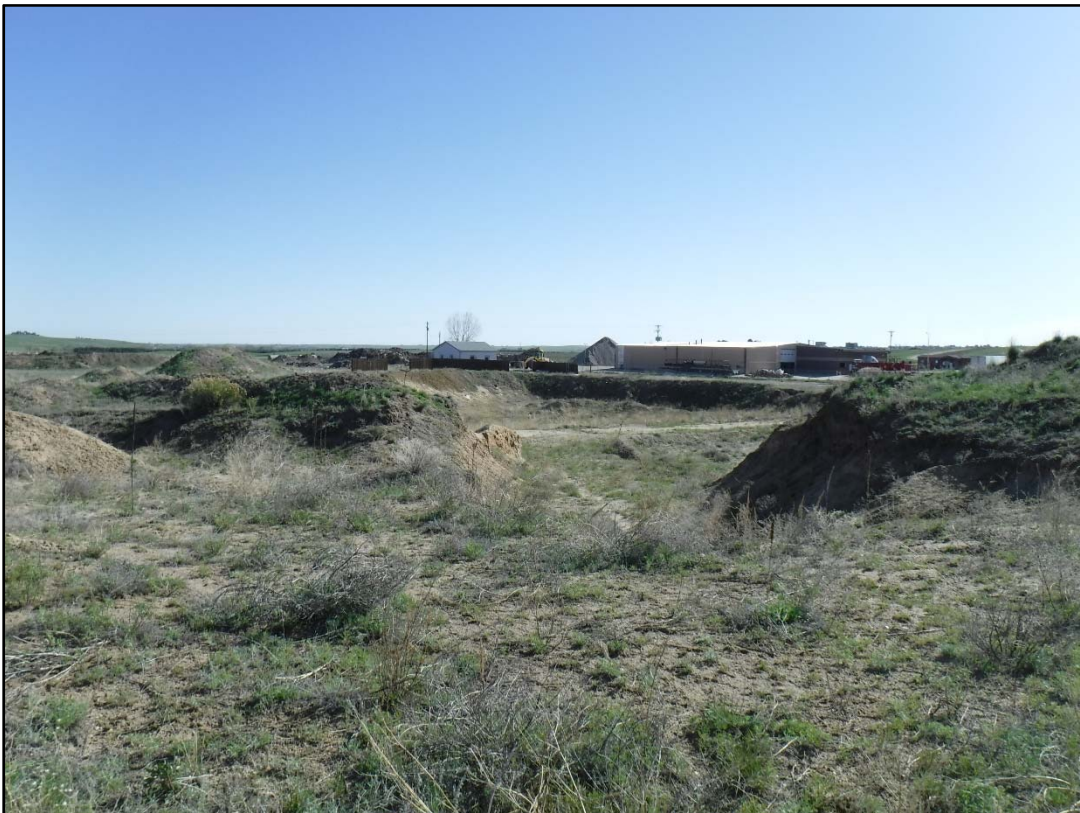
The south pit (3.7 acres) contains a mining area with 1H:1V highwall slopes of 10 to 15 feet in height. It was noted in a 2017 and verified during this inspection there are two erosion features in the southwest highwall that are approaching the permit boundary. Several loads of topsoil were brought into the permit area during the construction of greenhouses elsewhere on the property. Additional fill material was also brought into the permit boundary during the greenhouse construction. Currently, the importing of fill material is not an approved aspect of the site Reclamation Plan and is being cited as a problem in this report. The Operator is required by Rule 3.1.5(9) to notice the Division of any proposed backfill activity not covered in the Reclamation Plan.

Photo 4: Former mining and erosion features approaching permit boundary

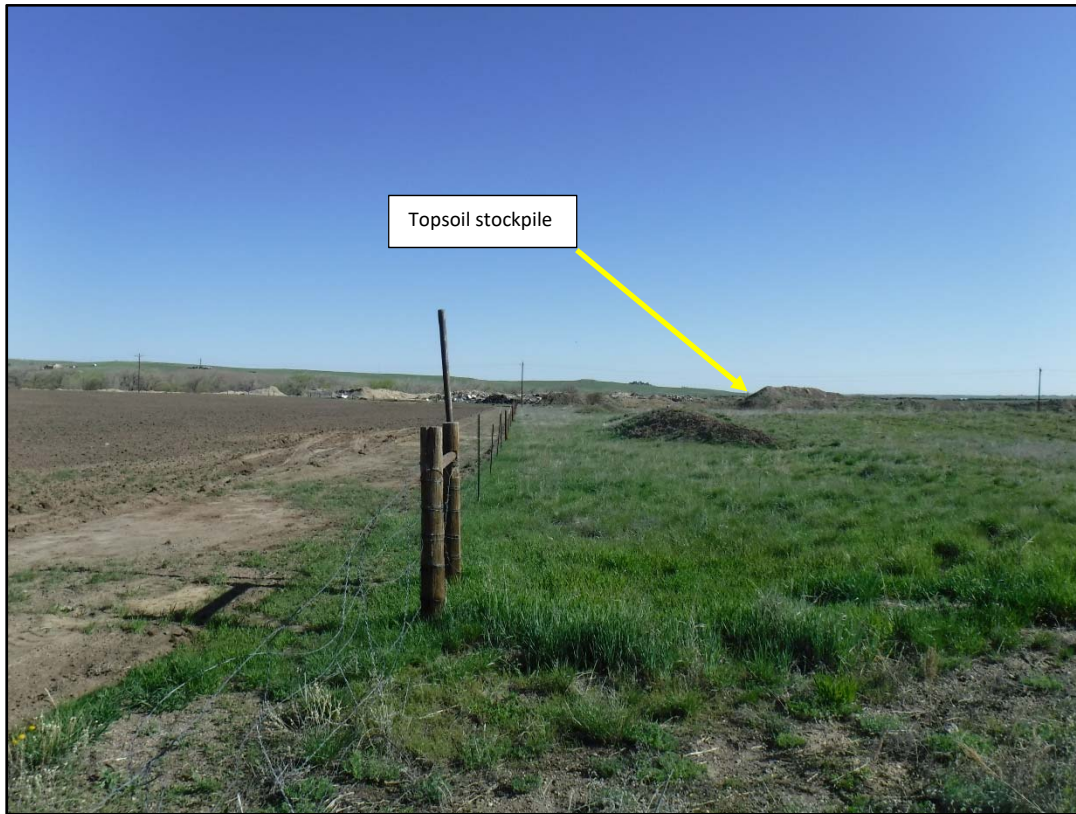
Photo 5: Looking from the southwest corner north towards the northwest permit corner

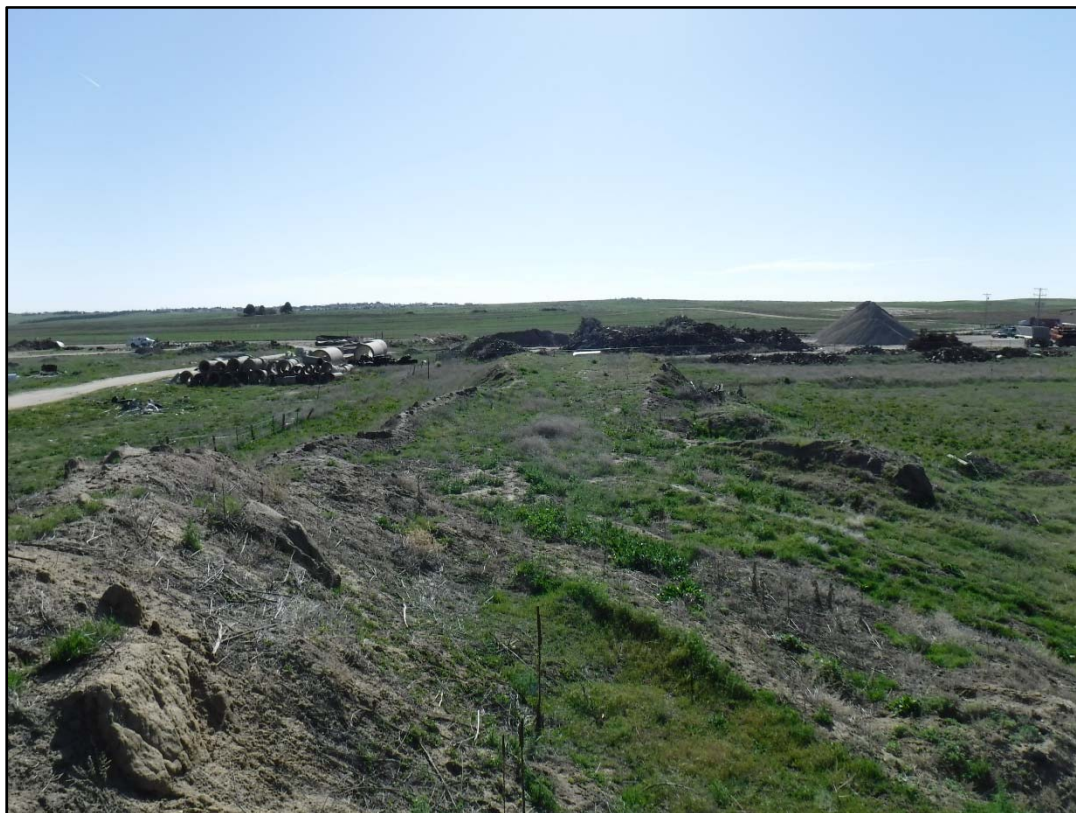
Photo 6: Looking east along the northern topsoil stockpile

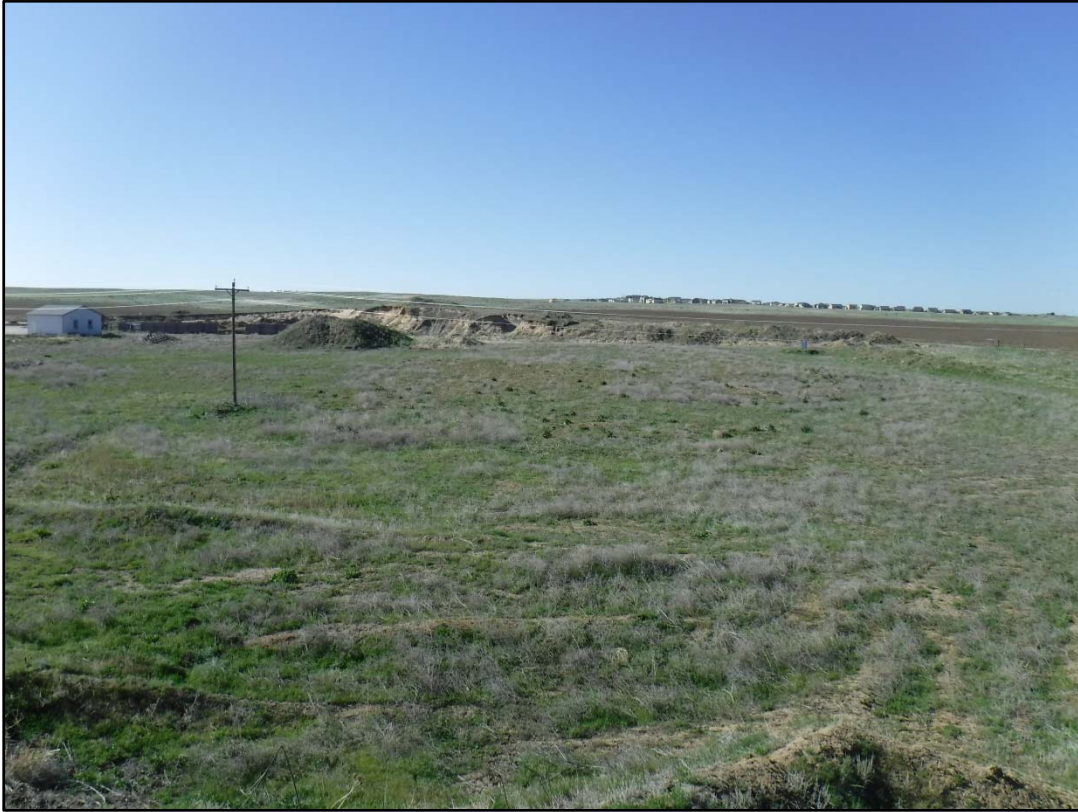
Photo 7: Looking south from the northern stockpile towards the southern pit area

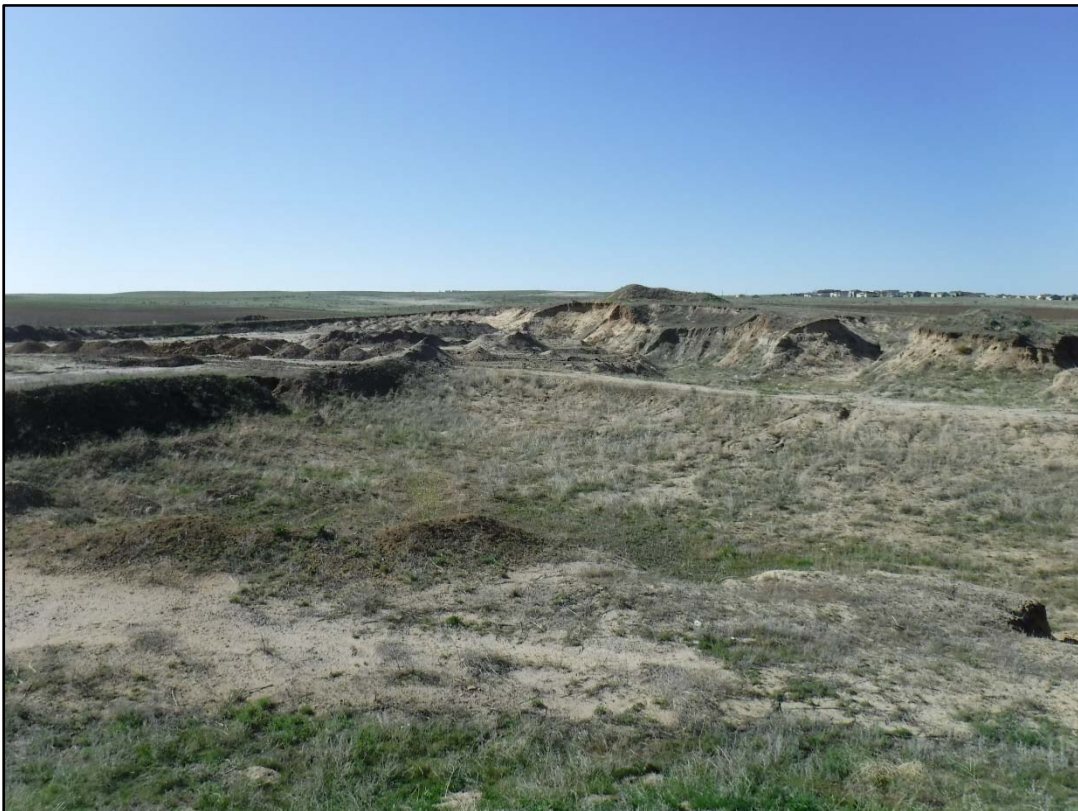
Photo 8: Southern highwall

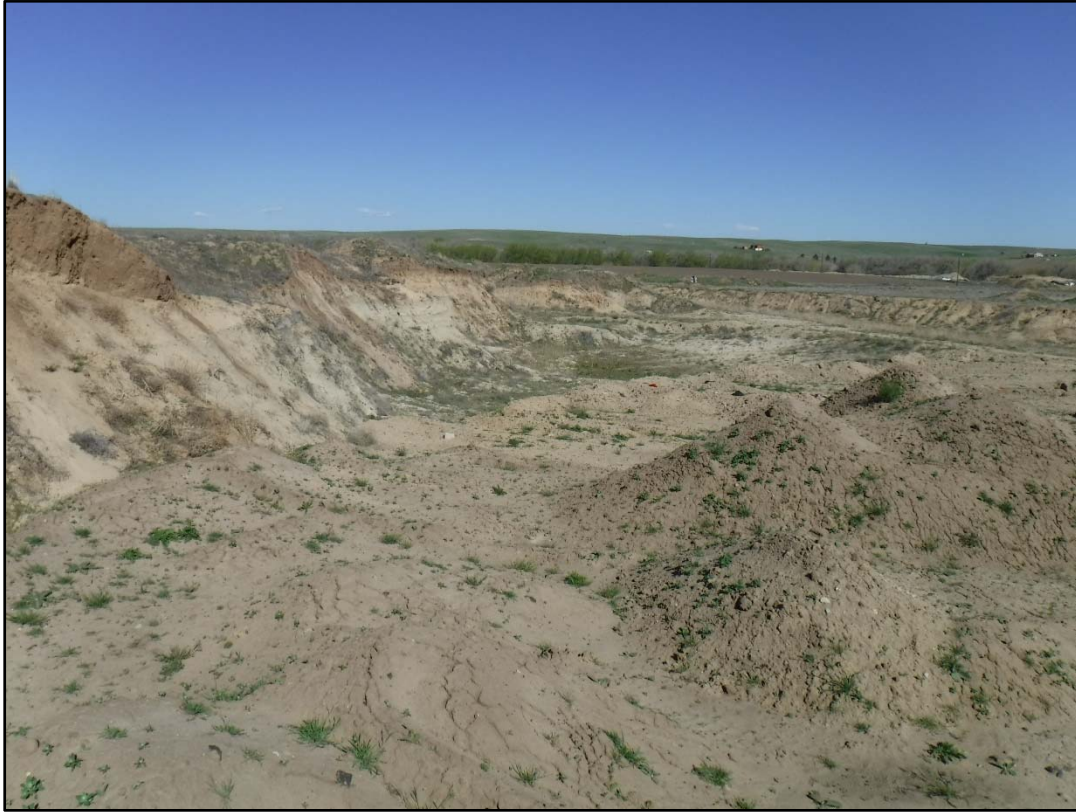
Photo 9: Southern highwall looking west
