MINERALS PROGRAM INSPECTION REPORT**PHONE: (303) 866-3567**

MINE NAME: West Pit	MINE/PROSPECTING ID#: M-1983-130	MINERAL: Sand and gravel	COUNTY: Elbert
INSPECTION TYPE: Surety Release Inspection	INSPECTOR(S): Patrick Lennberg	INSP. DATE: May 15, 2019	INSP. TIME: 10:30
OPERATOR: Elbert County	OPERATOR REPRESENTATIVE: Ralph Lewis	TYPE OF OPERATION: 110c - Construction Limited Impact

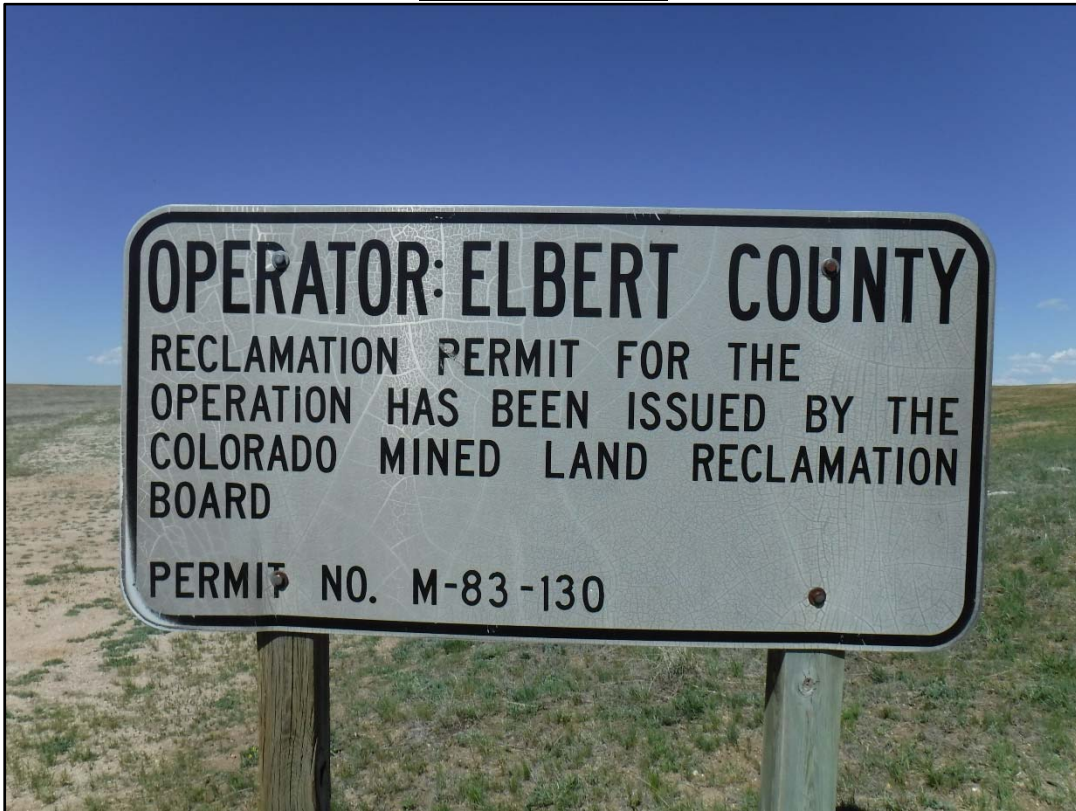
Photo 1: Mine sign at entrance off of County Road 39

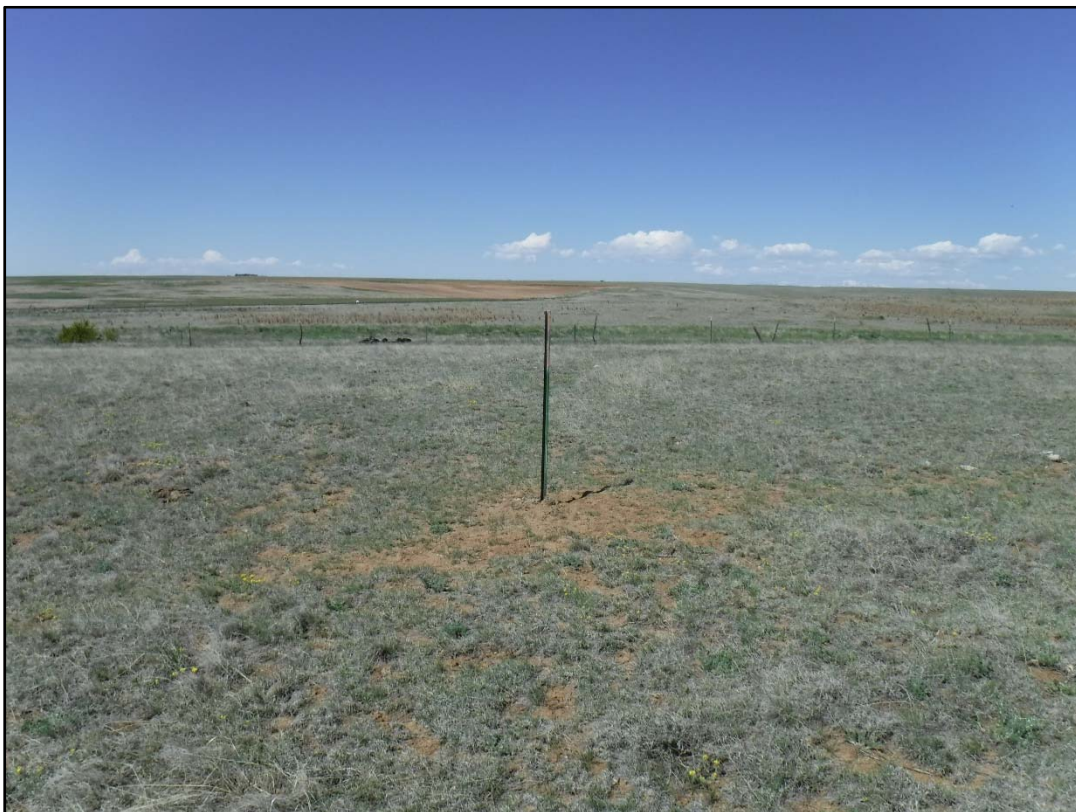
The Division was able to GPS all permit boundary markers. All areas affected by mining is well within the permit boundaries.

Photo 2: Typical permit boundary marker

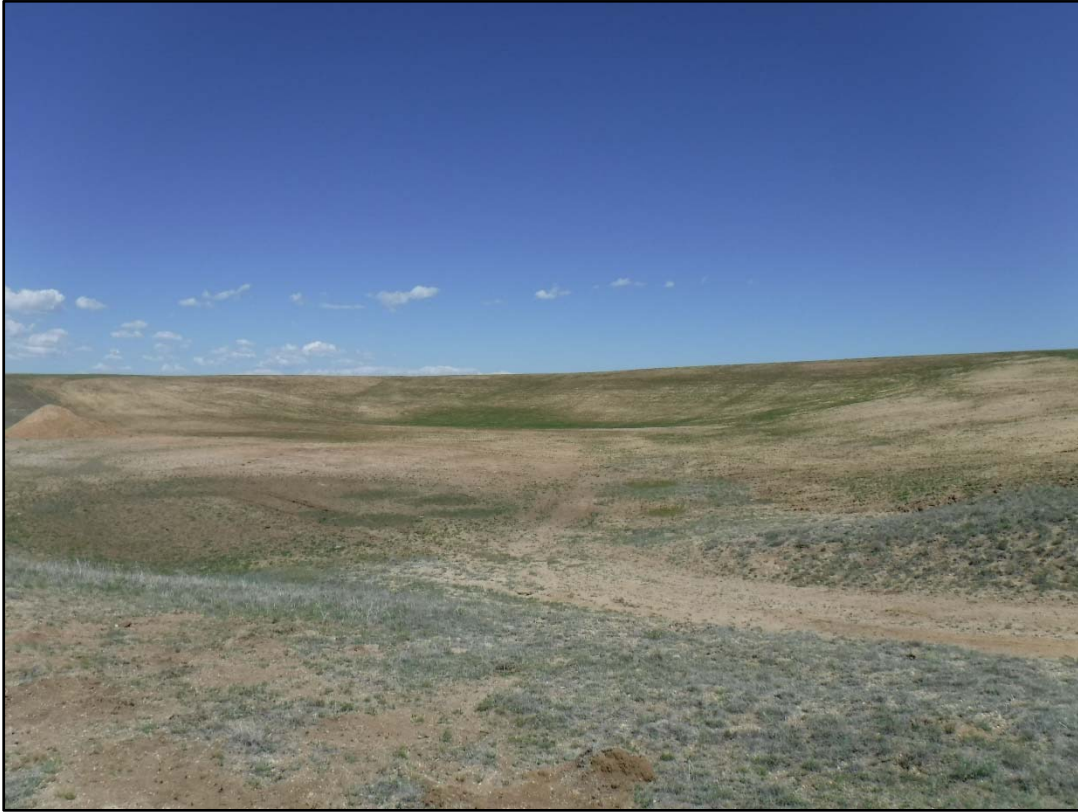
The Operator seeded and hydro-mulched the disturbed area late last year. The seeded plants are growing well and the area is filling in nicely. However, it is too soon to determine if the vegetation meets the requirements of Rule 3.1.10(1) which in part states "...establish a diverse, effective, and long-lasting vegetative cover that is capable of self-regeneration...without continued dependence on irrigation, soil amendments or fertilizer, and is at least equal in extent of cover to the natural vegetation of the surrounding area". Based on observations made during this inspection the request for release will not be approved. The Division recommends at least another two full growing seasons before the Operator seeks another release request.

Photo 3: Mine area that was seeded and hydro-mulched at the end of last year, looking north

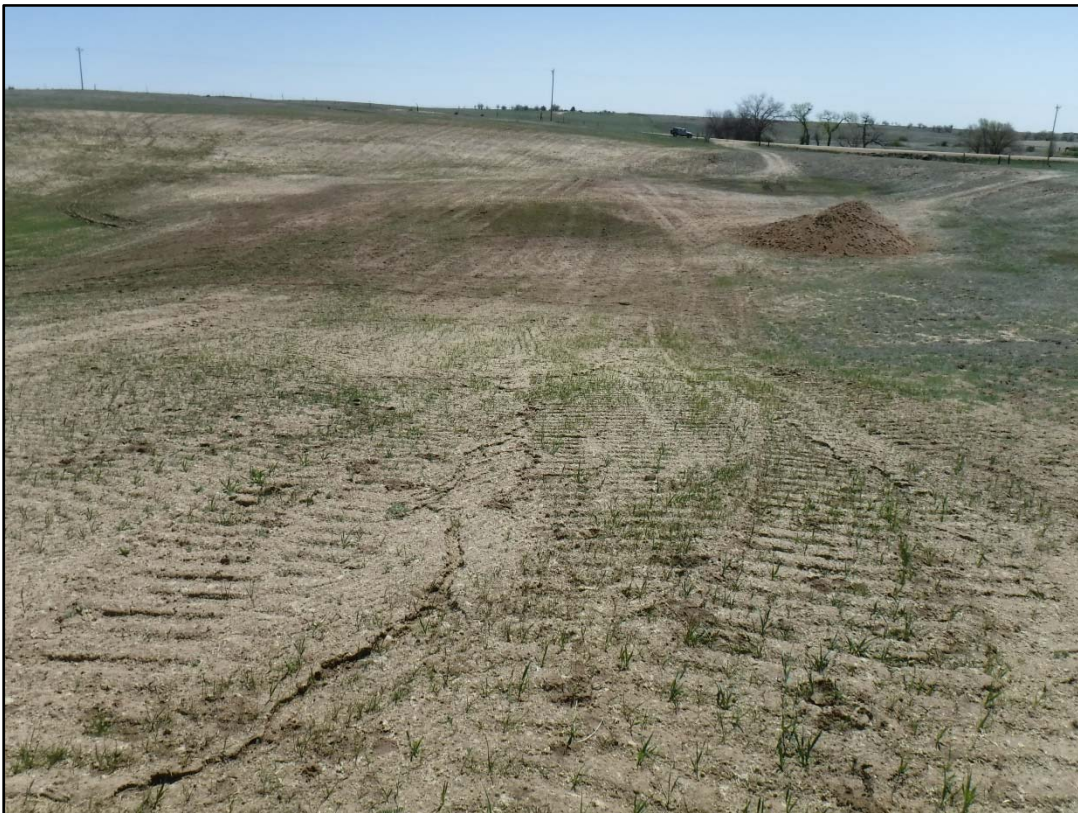
Photo 4: Looking south down the revegetated slope

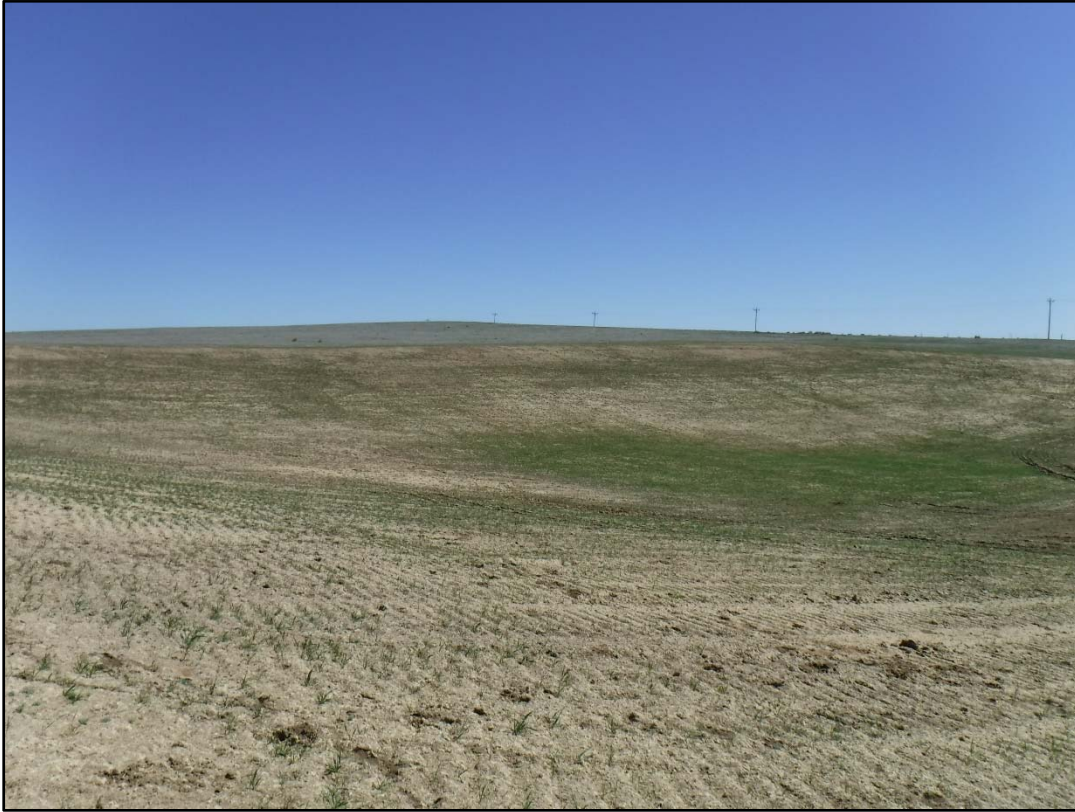
Photo 5: Looking east at the revegetated slope

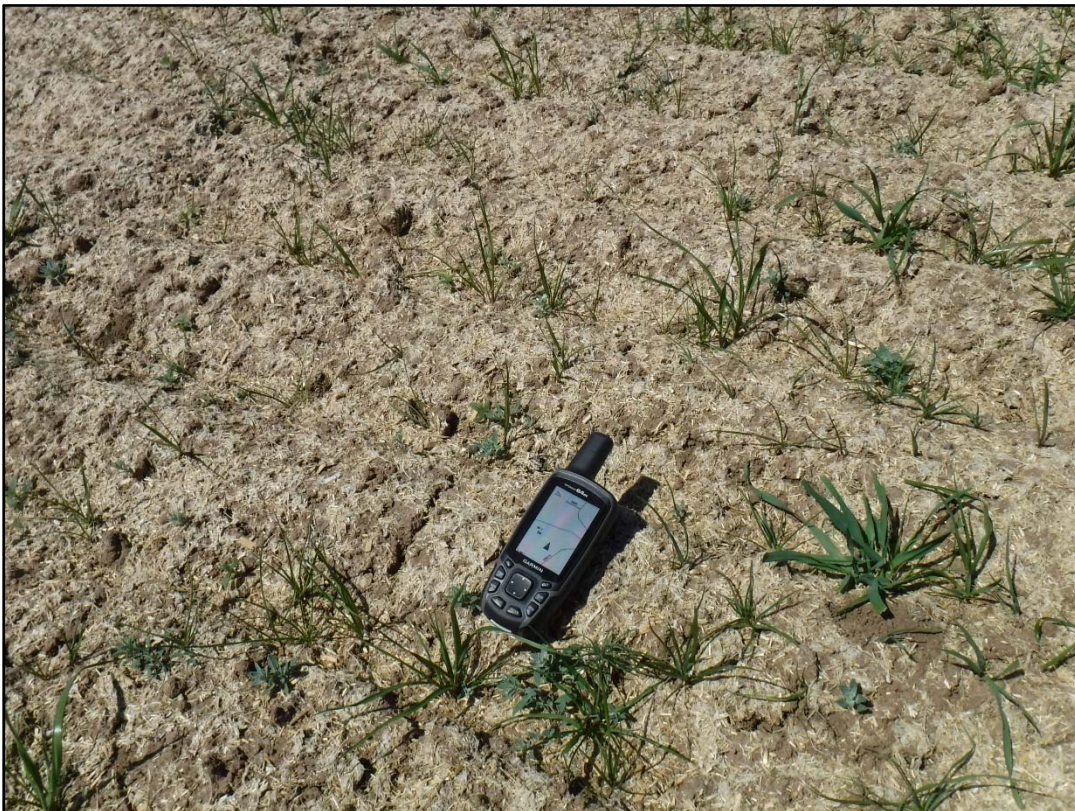
Photo 6: Typical growth of recently planted vegetation

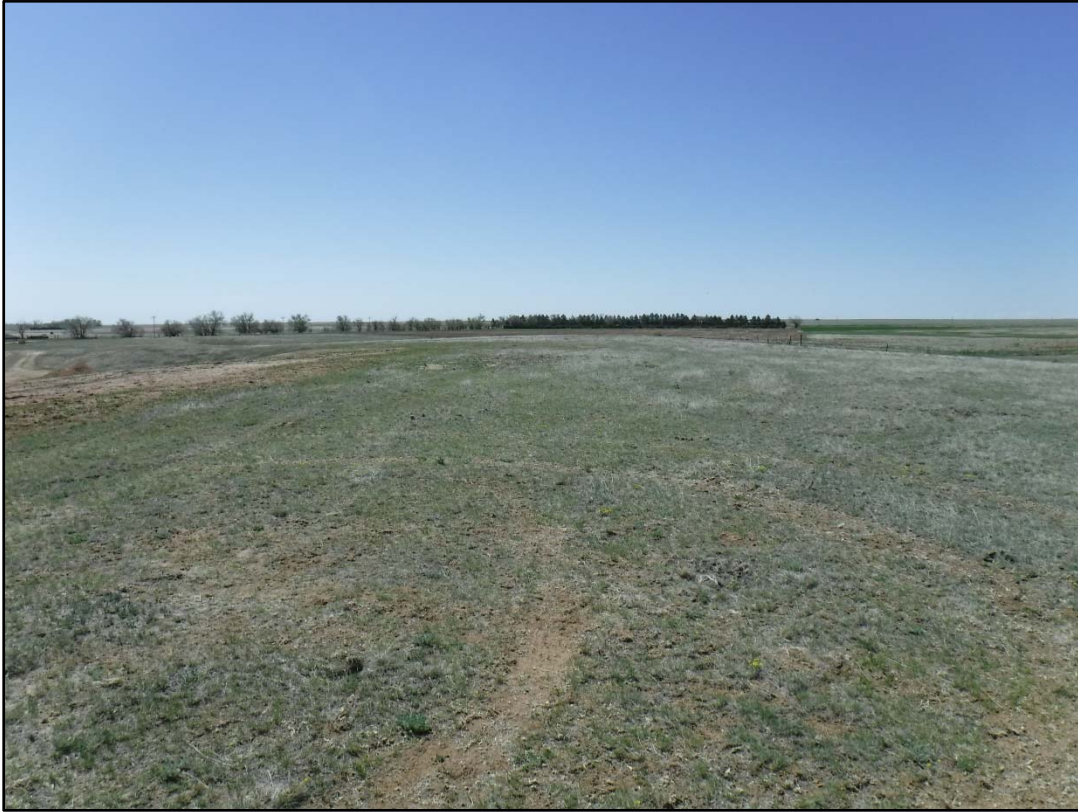
Photo 7: Typical native vegetation growth outside of mine area

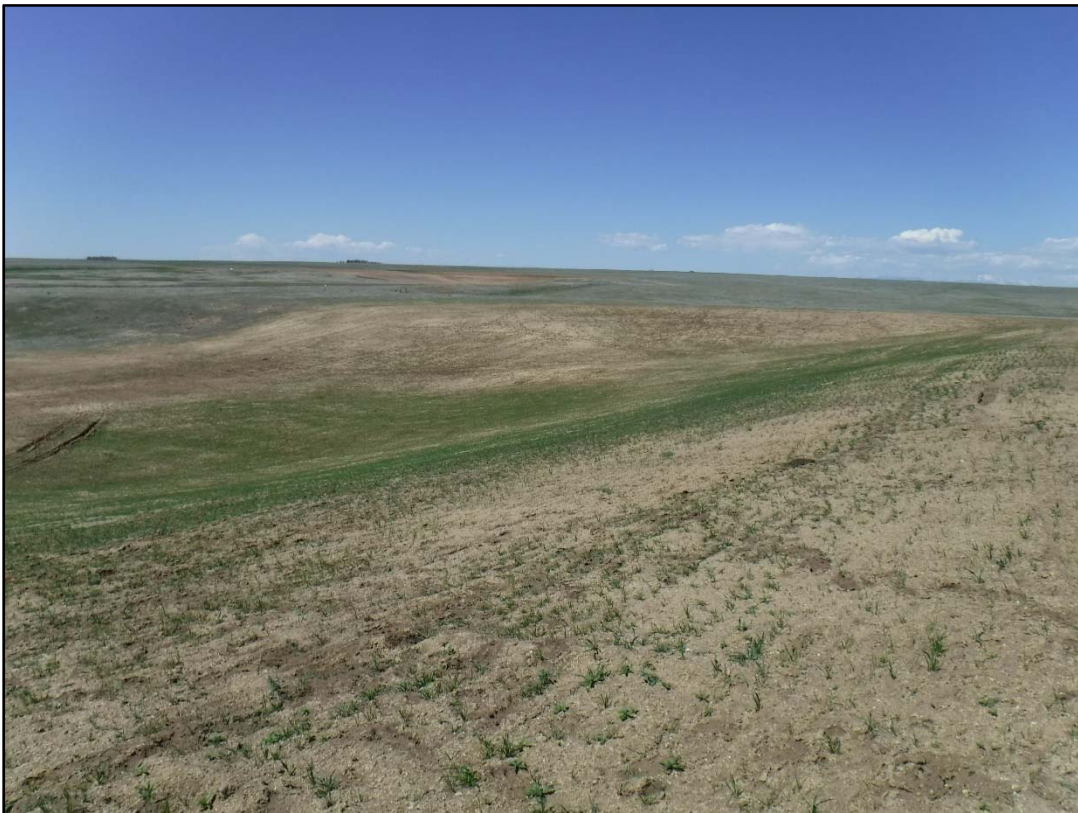
Photo 8: Looking west across the revegetated area.
