MINERALS PROGRAM INSPECTION REPORT
PHONE: (303) 866-3567

MINE NAME: Orchard Grove Industrial Pit	MINE/PROSPECTING ID#: M-1990-094	MINERAL: Gravel	COUNTY: Mesa
INSPECTION TYPE: Surety-Related Inspection	INSPECTOR(S): Amy C. Yeldell	INSP. DATE: April 9, 2019	INSP. TIME: 10:00
OPERATOR: Kilgore Companies LLC dba Elam Constructi	OPERATOR REPRESENTATIVE: Jim Doody	TYPE OF OPERATION: 112c - Construction Regular Operation	
REASON FOR INSPECTION: Surety Related	BOND CALCULATION TYPE: Partial Bond	BOND AMOUNT: \$52,600.00	
DATE OF COMPLAINT: NA	POST INSP. CONTACTS: None	JOINT INSP. AGENCY: None	
WEATHER: Clear	INSPECTOR'S SIGNATURE:

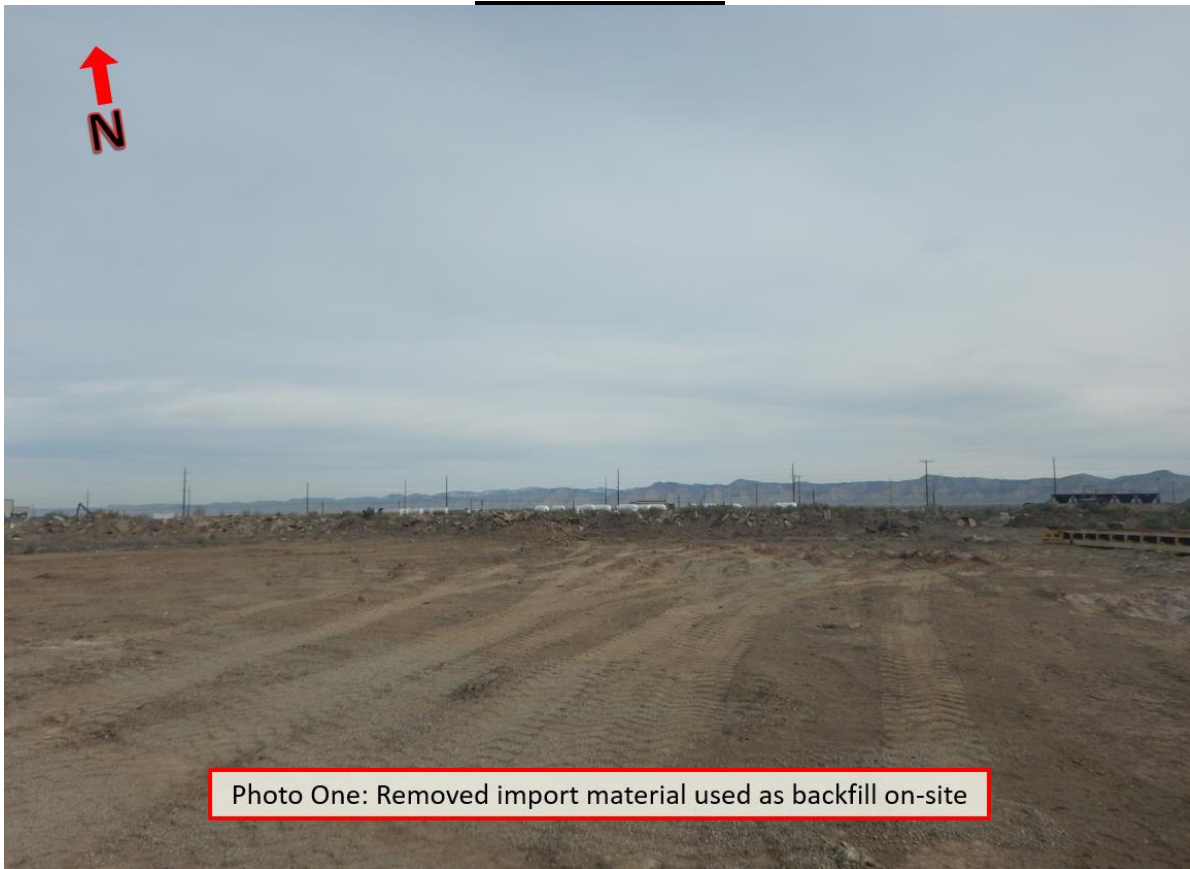
The operator has made significant changes since the last inspection. A large area of previously stockpile imported material was placed as backfill within the pit. The cleaned up imported material is in the northeast corner of the permit (photo one). The Division estimates that the operator is under the 10,000 CY maximum for on-site storage of imported backfill material.

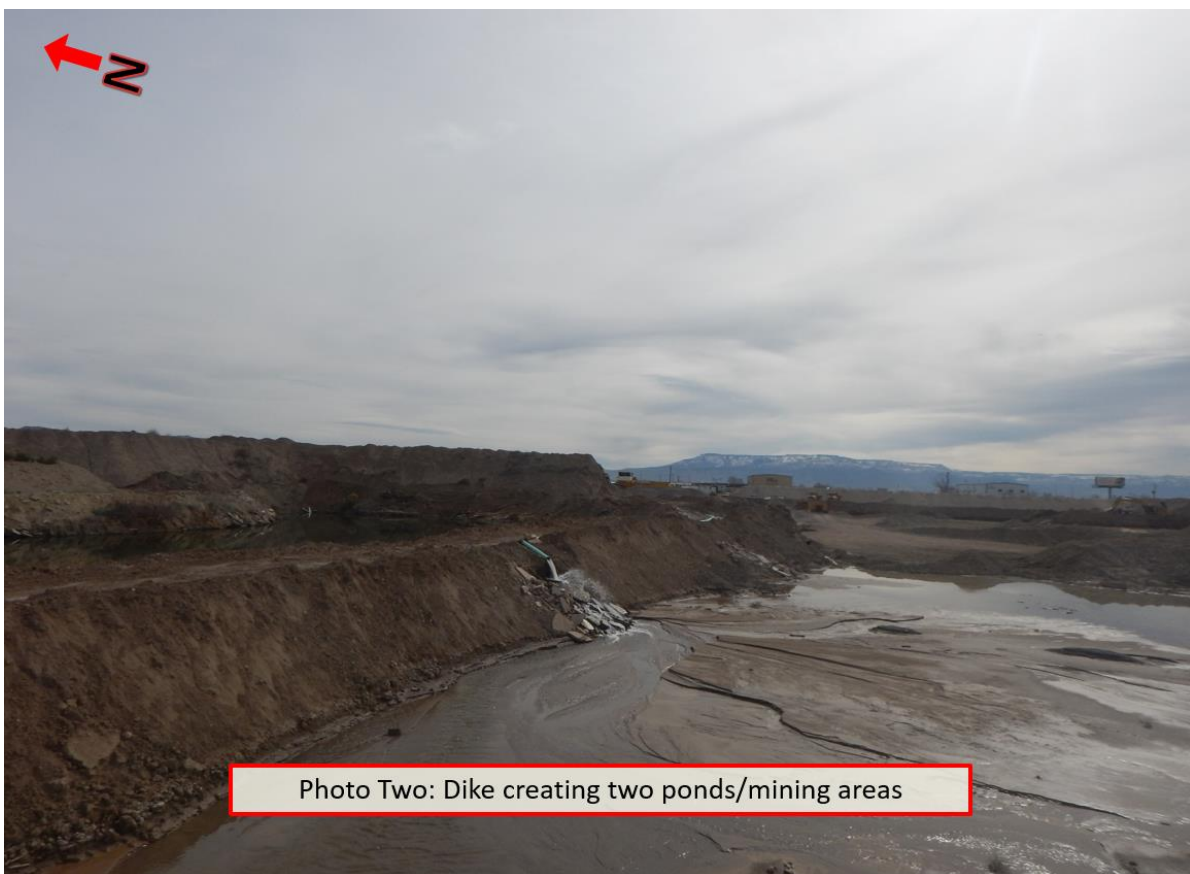
Two ponds have been created by the use of a dike (photo two). The older northern pond area remains fully inundated and is estimated to be 2.5 surface acres (photo three). The dike runs east/west parallel with the old Parkerson scale house. The south pit has been dewatered and is currently being expanded to the east (photo four). The fully excavated pit area is estimated to be approximately 25 feet deep with near vertical highwalls. The expanded area has been excavated to a depth of approximately 15 feet and is approximately 300 ft x 300 ft (photo five).

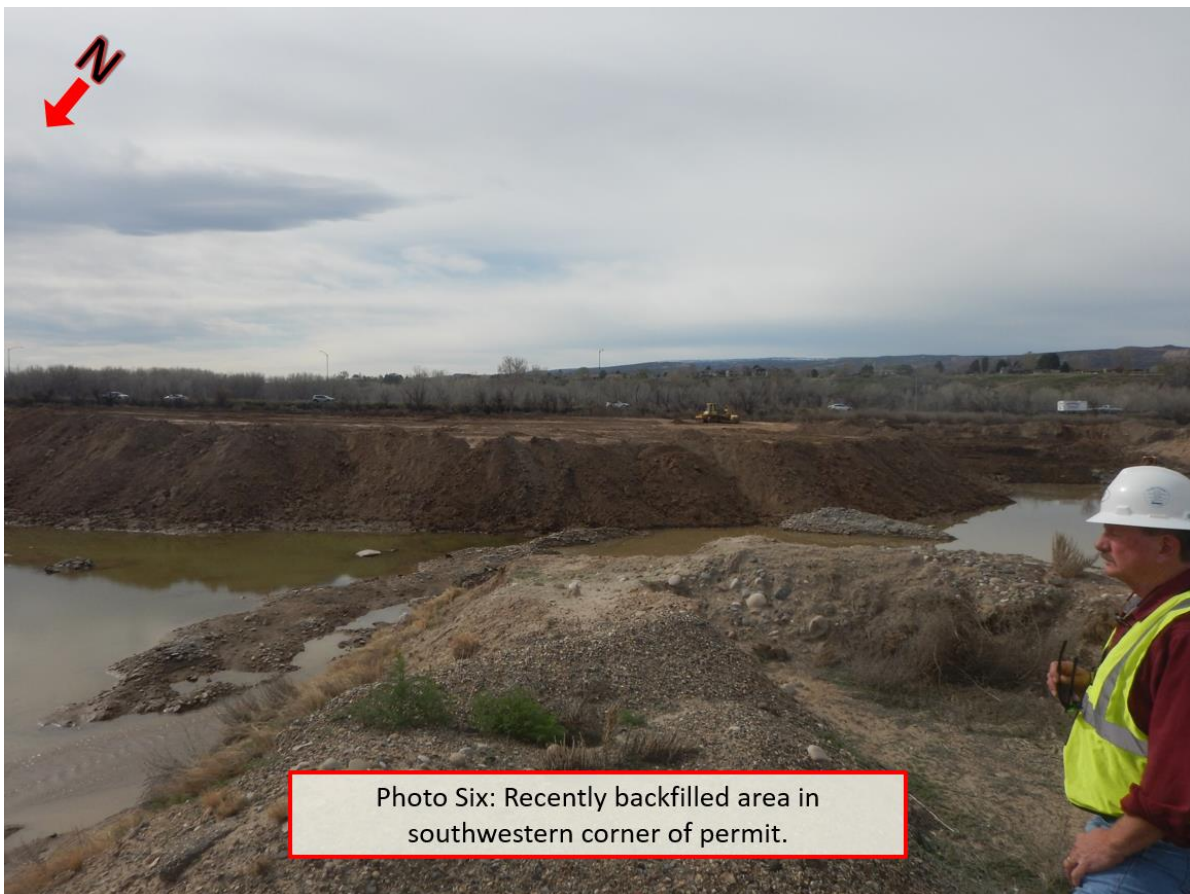
Backfill material was placed in the southwest corner of the permit in the dewatered pit area (photo six). The backfilled area is estimated to be 400 ft wide by 200 ft deep and at grade. A small portion (50' X 150') in the southwestern most corner still requires 10 additional feet of backfill and is currently being used to house the dewatering equipment (photo seven).
