MINERALS PROGRAM INSPECTION REPORT
PHONE: (303) 866-3567

MINE NAME: White Sand & Gravel Pit #1	MINE/PROSPECTING ID#: M-2010-062	MINERAL: Borrow material for gravel and sand	COUNTY: Baca
INSPECTION TYPE: Monitoring	INSPECTOR(S): Jared L. Ebert	INSP. DATE: May 14, 2019	INSP. TIME: 08:00
OPERATOR: White Sand & Gravel, LLC	OPERATOR REPRESENTATIVE: Gerald White	TYPE OF OPERATION: 112c - Construction Regular Operation	
REASON FOR INSPECTION: Normal I&E Program	BOND CALCULATION TYPE: Complete Bond	BOND AMOUNT: \$17,646.00	
DATE OF COMPLAINT: NA	POST INSP. CONTACTS: None	JOINT INSP. AGENCY: None	
WEATHER: Clear	INSPECTOR'S SIGNATURE:

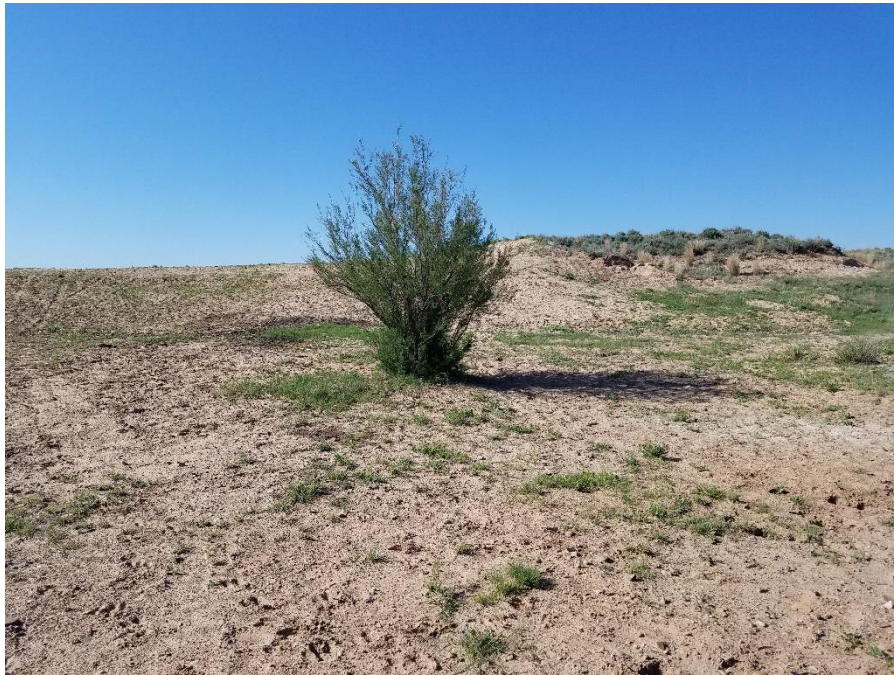
Figure 1. From the northern portion of the affected land looking southwest.

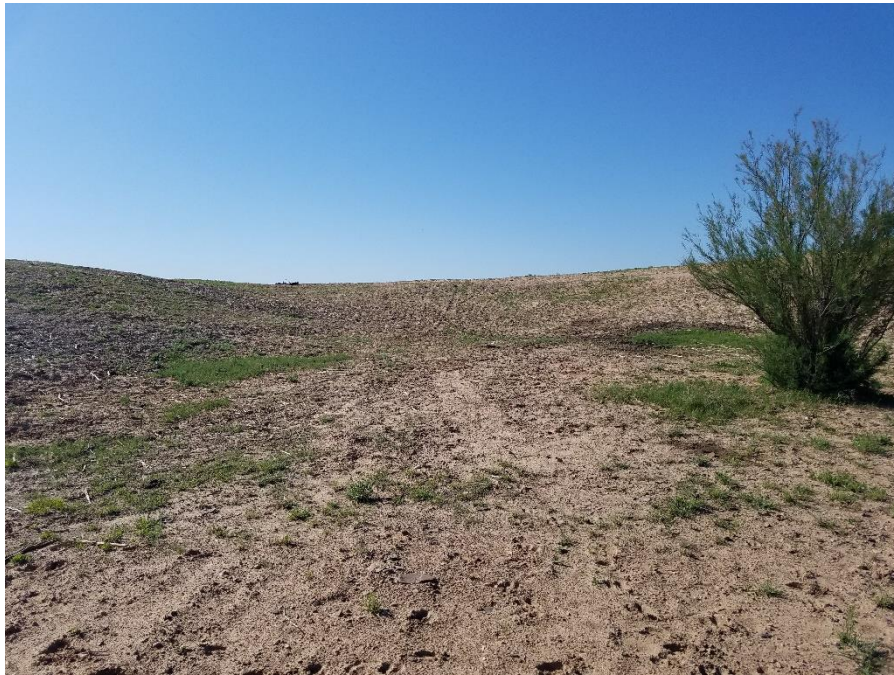
About 2.7 acres of land is affected within the Phase 1 portion of the proposed mining area. The land has been sold and the Operator does not intend to conduct additional mining at the site and has reclaimed the former pit excavation. It appears the excavation occurred within the southern embankment of a small branch or meander of the Cimarron River. The excavation had a north/northwest aspect. The operator has graded the excavation to a gentle 4H:1V slope.

Figure 2. From the northern portion of the affected land looking south at graded excavation area.

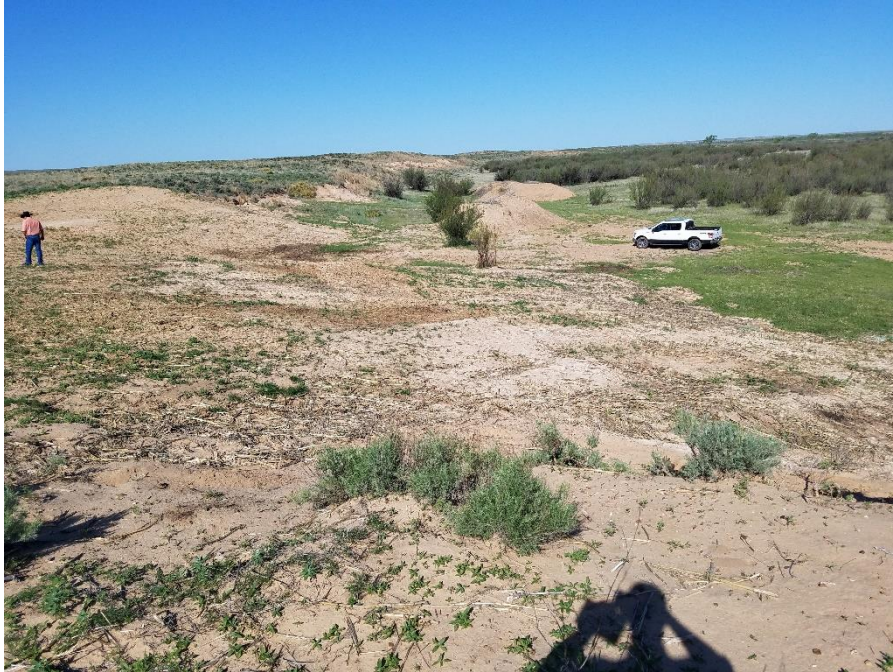
Figure 3. From the eastern portion of the affected land looking west.

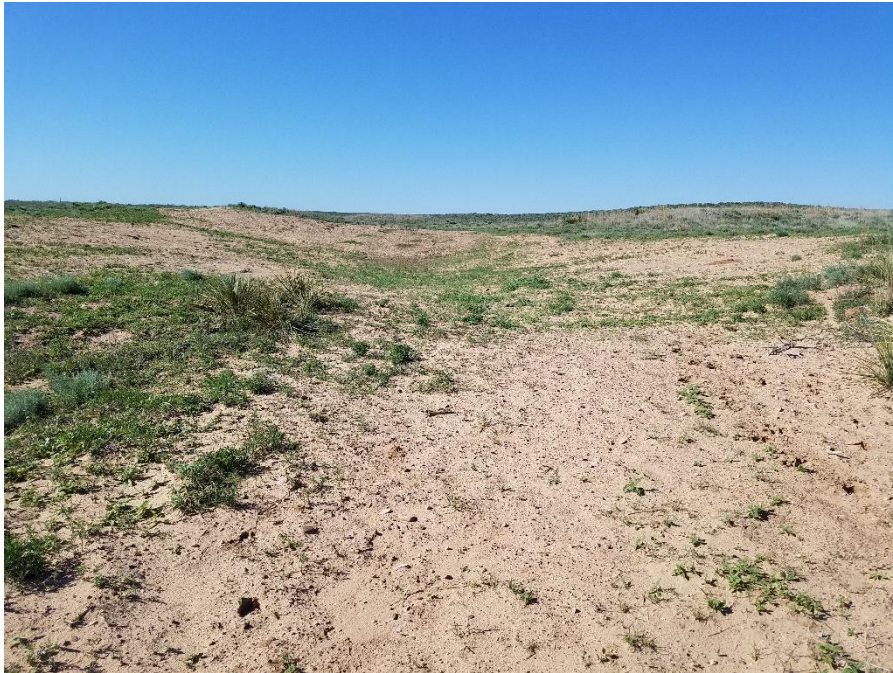
Another small excavated area was located south of the primary excavation. This area has been regraded to blend in with the surrounding un-affected land and appears stable.

Figure 4. Small excavation south of the main excavation. From the north side looking south.
