MINERALS PROGRAM INSPECTION REPORT
PHONE: (303) 866-3567

MINE NAME: Walsh Pit No. 2	MINE/PROSPECTING ID#: M-1977-479	MINERAL: Sand and gravel	COUNTY: Baca
INSPECTION TYPE: Monitoring	INSPECTOR(S): Jared L. Ebert	INSP. DATE: May 14, 2019	INSP. TIME: 10:18
OPERATOR: Baca County	OPERATOR REPRESENTATIVE: Jason Freiburger and Danny Ausmus	TYPE OF OPERATION: 112c - Construction Regular Operation	
REASON FOR INSPECTION: Normal I&E Program	BOND CALCULATION TYPE: None	BOND AMOUNT: No Bond Held	
DATE OF COMPLAINT: NA	POST INSP. CONTACTS: None	JOINT INSP. AGENCY: None	
WEATHER: Clear	INSPECTOR'S SIGNATURE:

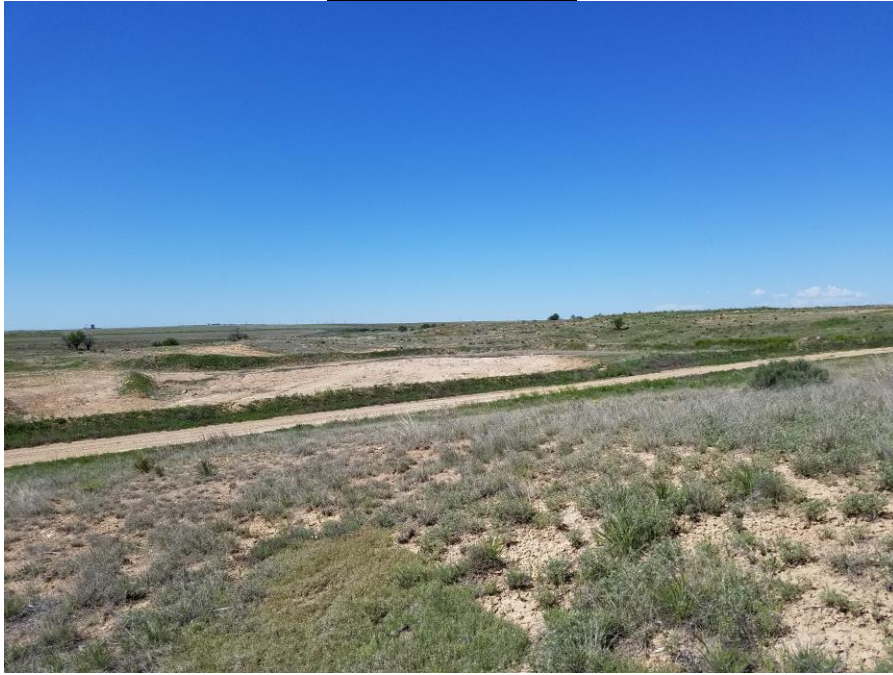
Figure 1. From the north side of the excavation north of Bear Creek looking southwest.

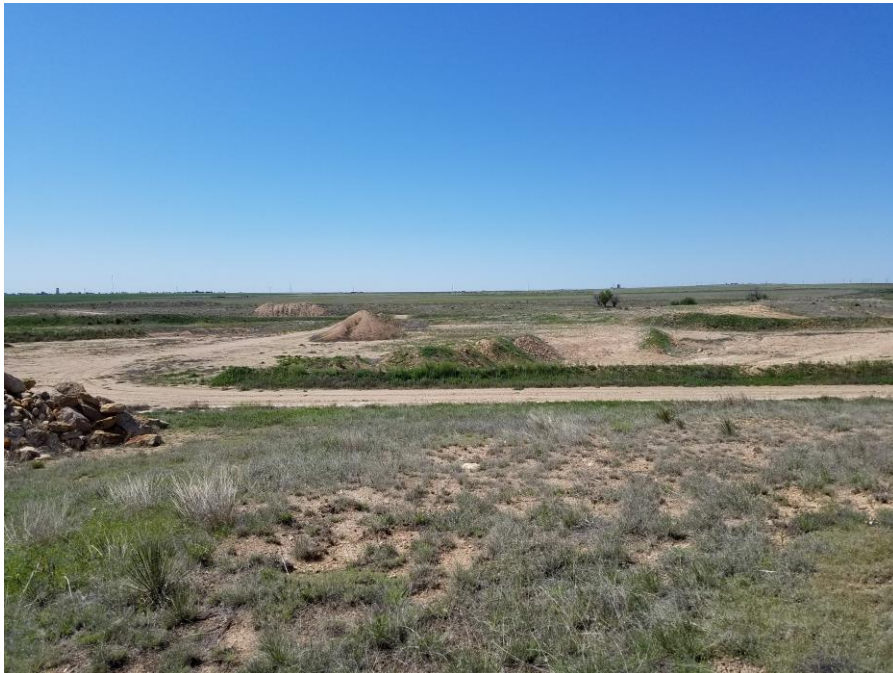
Figure 2. From the north side of the north excavation looking south.

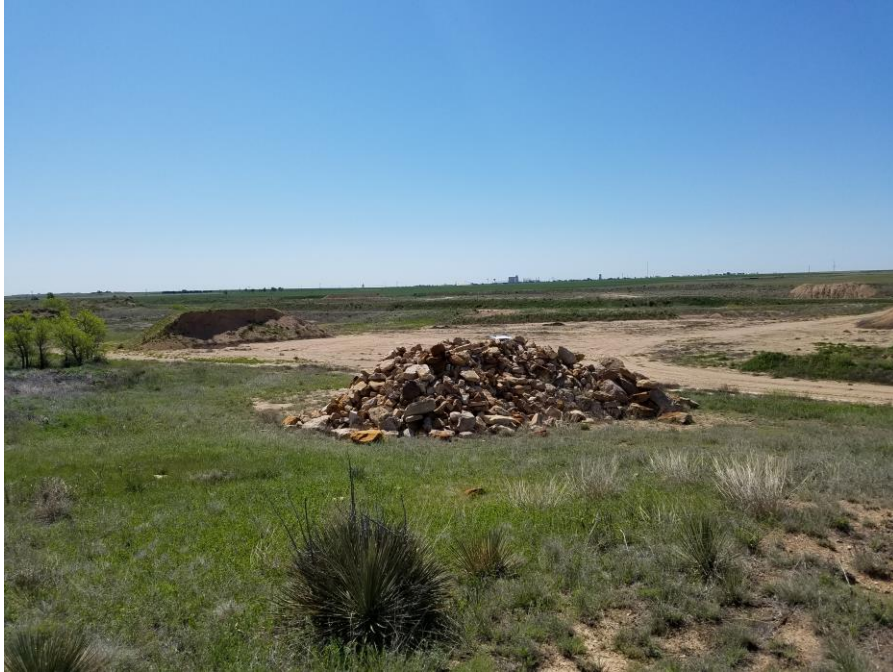
Figure 3. From the north side of the north excavation looking southeast.

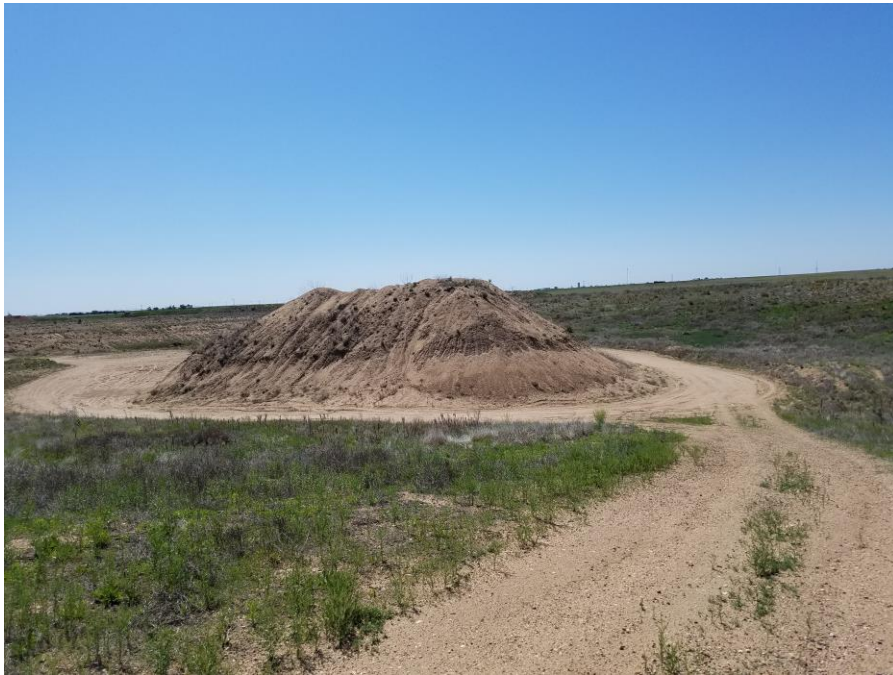
Figure 4. From the north side of the south excavation looking south.

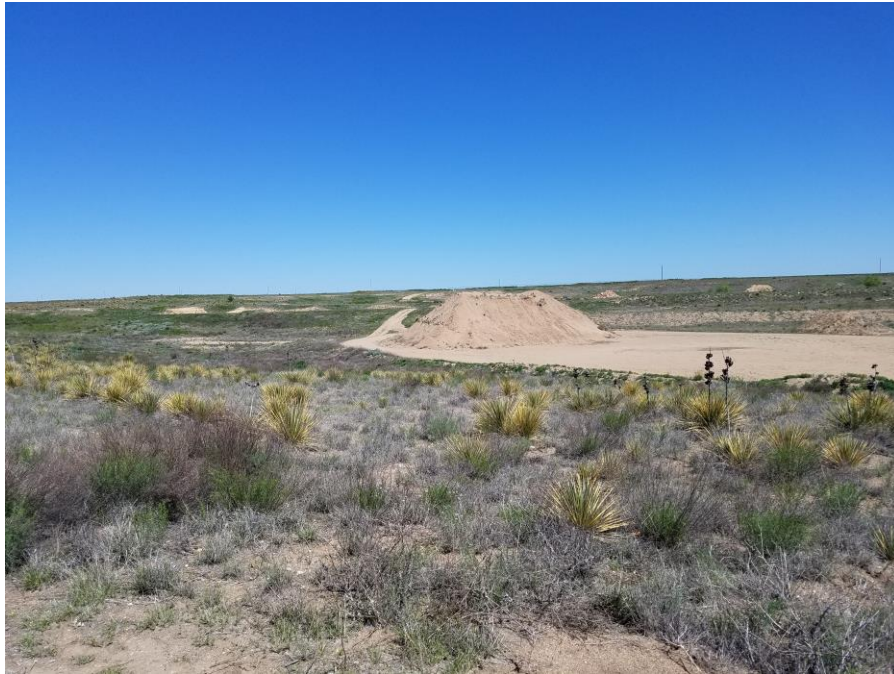
Figure 5. From the south central side of the south excavation looking northwest.

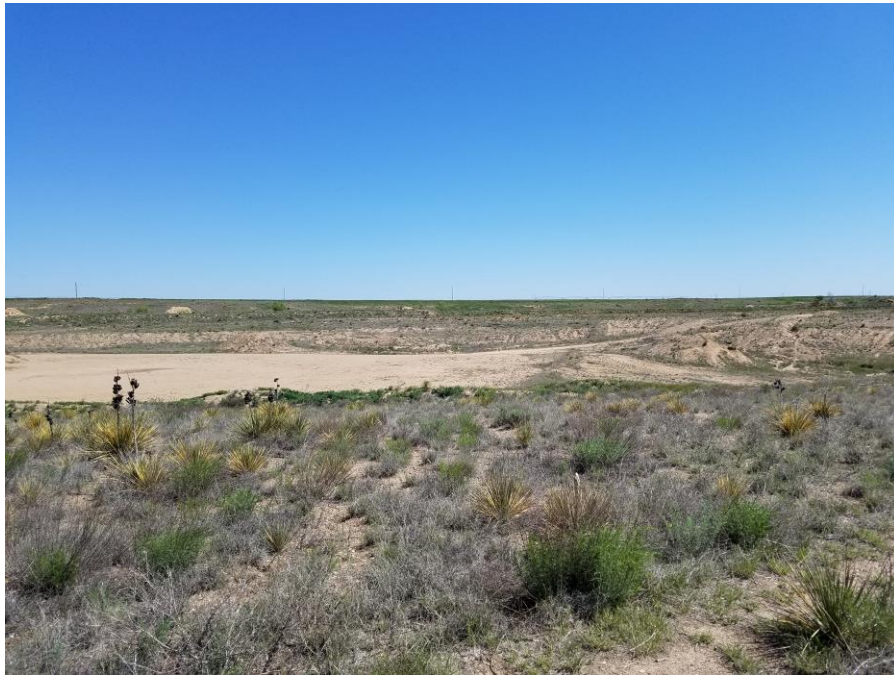
Figure 6. From the south central side of the south excavation looking north.

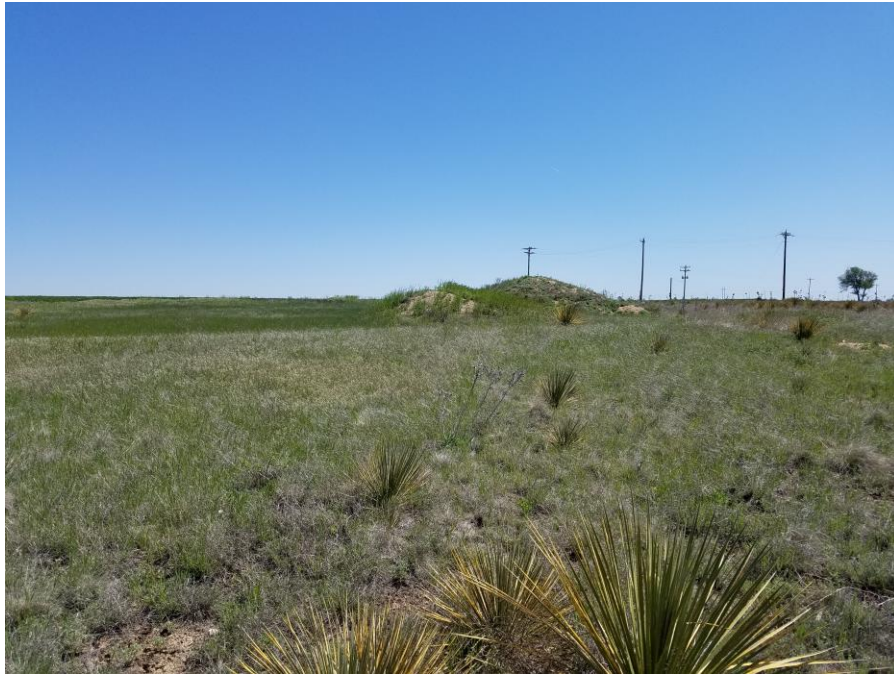
Figure 7. Stockpile of material located in the northeast corner of the affected land.
