MINERALS PROGRAM INSPECTION REPORT
PHONE: (303) 866-3567

MINE NAME: Mundell Estate No. 32	MINE/PROSPECTING ID#: M-1995-019	MINERAL: Gravel	COUNTY: Baca
INSPECTION TYPE: Monitoring	INSPECTOR(S): Jared L. Ebert	INSP. DATE: May 14, 2019	INSP. TIME: 11:30
OPERATOR: Baca County	OPERATOR REPRESENTATIVE: Jason Freiburger and Danny Ausmus	TYPE OF OPERATION: 112c - Construction Regular Operation	
REASON FOR INSPECTION: Normal I&E Program	BOND CALCULATION TYPE: None	BOND AMOUNT: \$0.00	
DATE OF COMPLAINT: NA	POST INSP. CONTACTS: None	JOINT INSP. AGENCY: None	
WEATHER: Clear	INSPECTOR'S SIGNATURE:

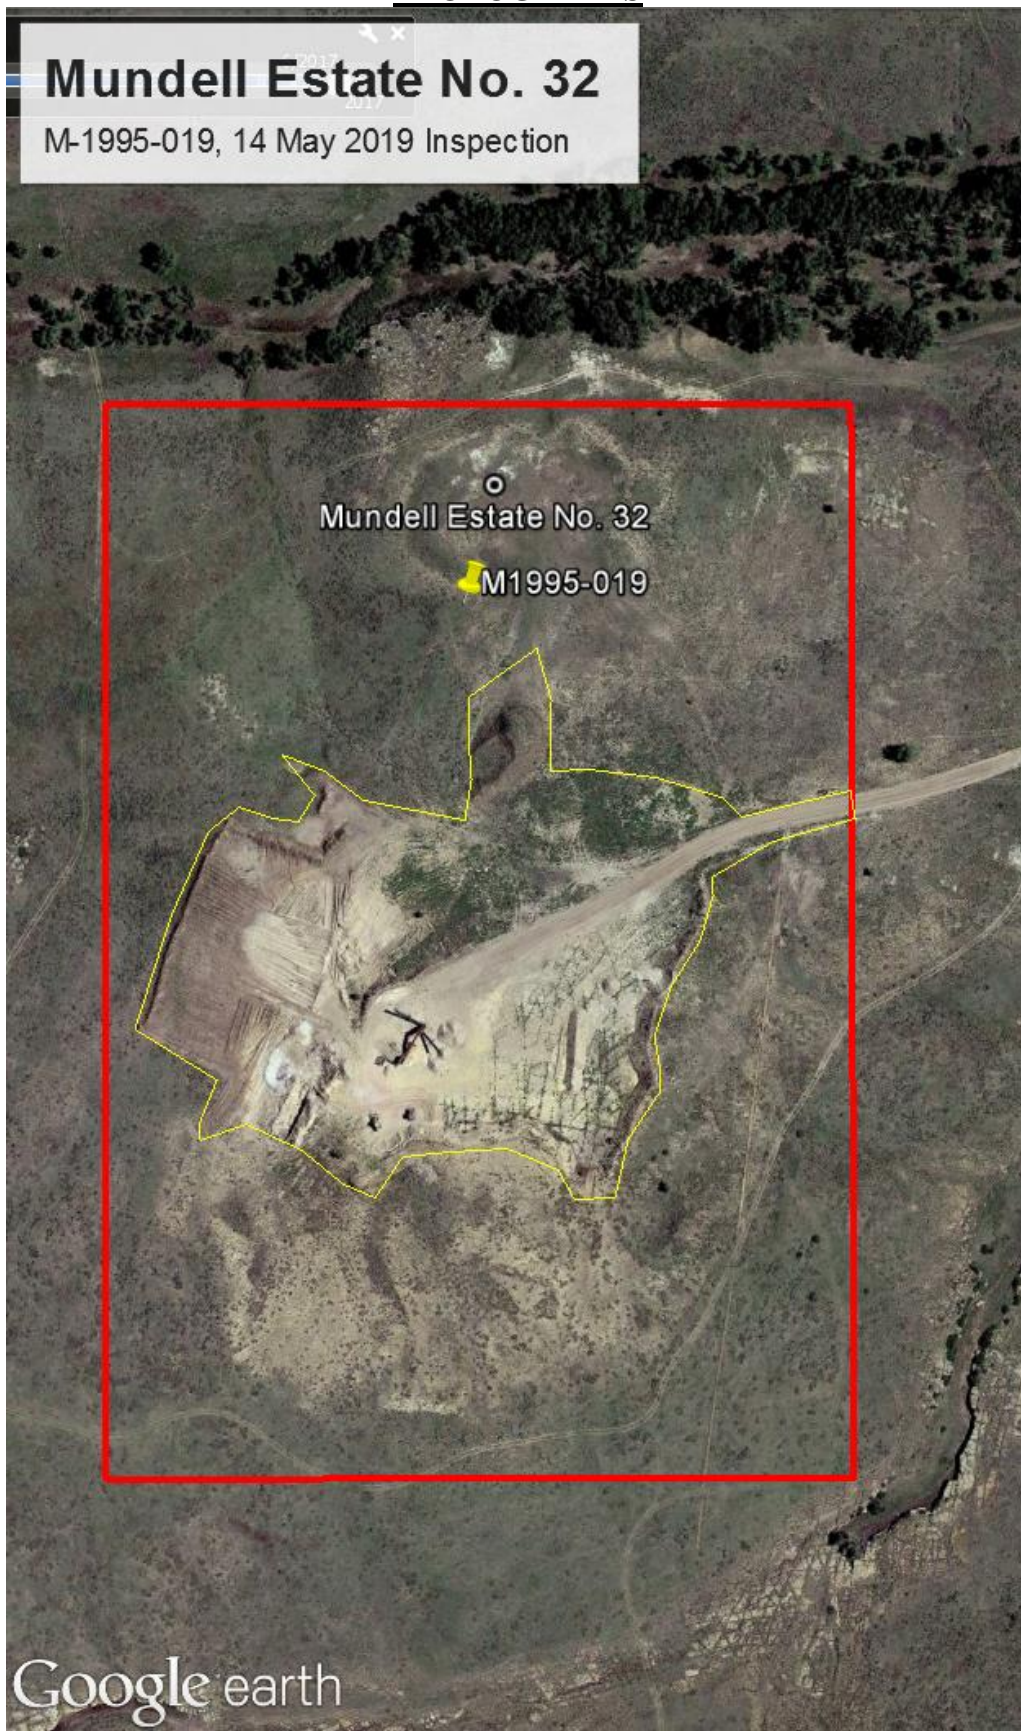
Overall, the operation is in compliance with the approved mine plan. It appears mining has occurred at the site in various locations overtime both north and south of the current pit basin, however much of these areas have been graded to blend in well with the surrounding area and have native vegetation established. The Division estimates about ten acres of land is currently disturbed within the permit boundary.

Figure 1. Yellow line indicates estimate of affected land.

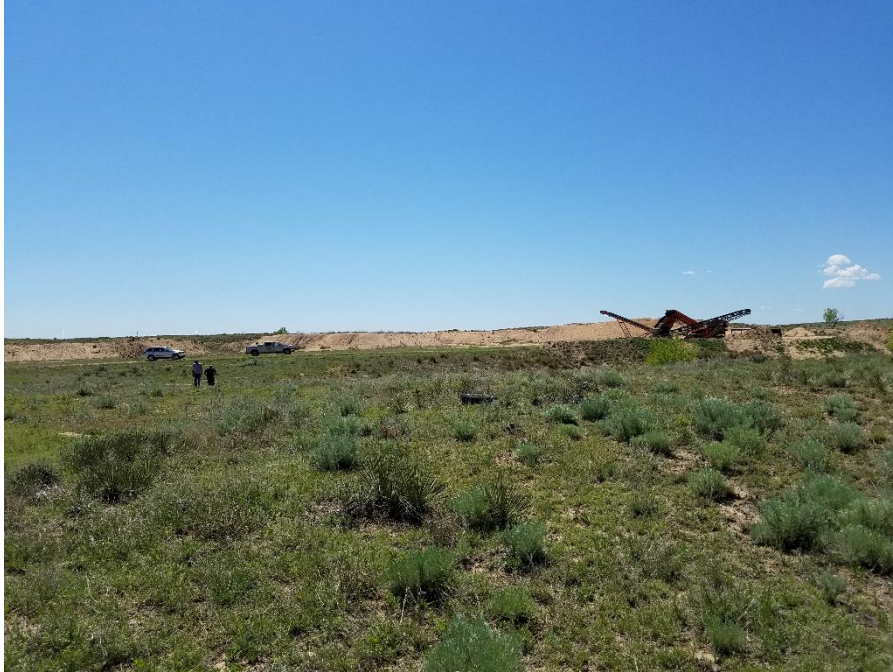
Figure 2. From the northern portion of the affected land looking south.

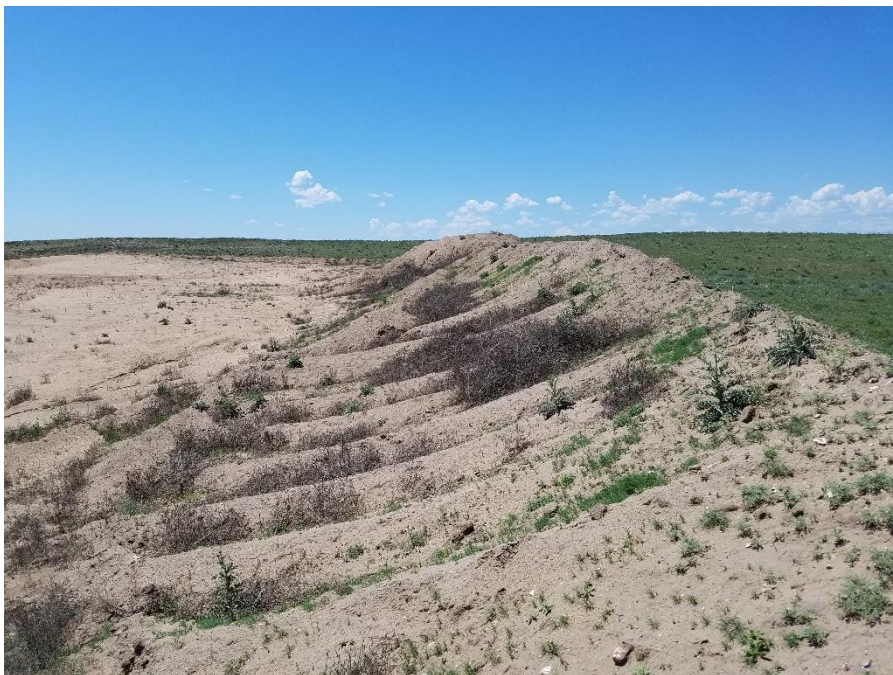
Figure 3. From the northwest end of the affected land looking south.

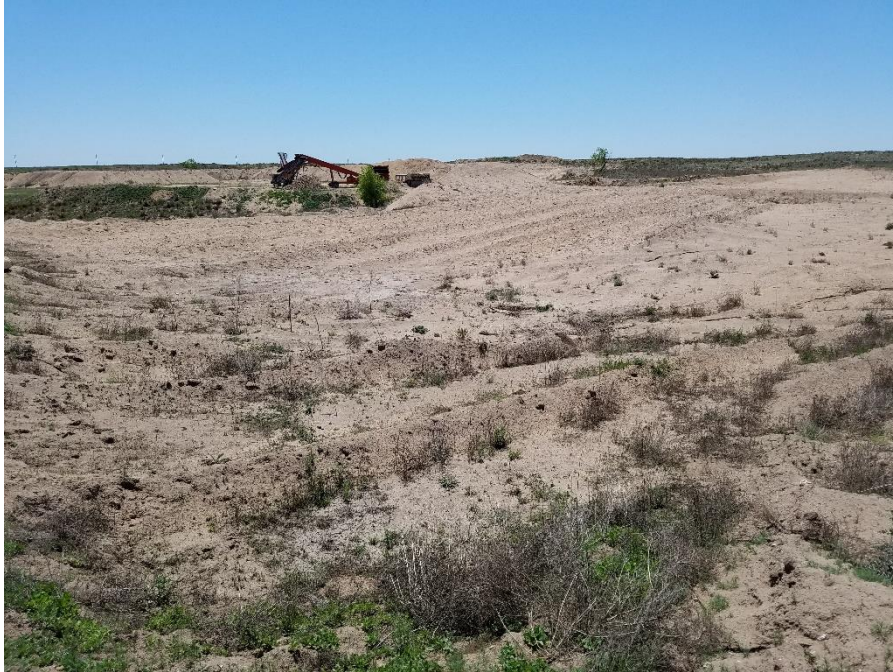
The site consists of a pit basin with an excavation within about a ten acre affected area. The Operator is pushing the mined material at a 4H:1V slope on the west side of the affected area. Steeper pit slopes exist on the southern and eastern boundary of the affected area and were generally noted to be set at the angle of repose.

Figure 4. From the west end of the affected land looking east.

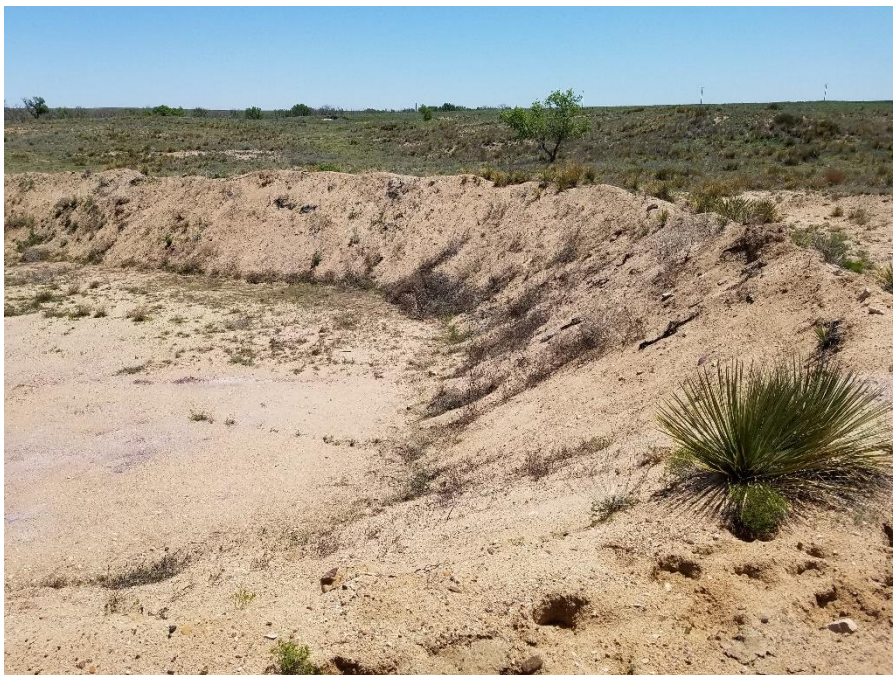
Figure 5. From the south central portion of the affected land looking northeast.

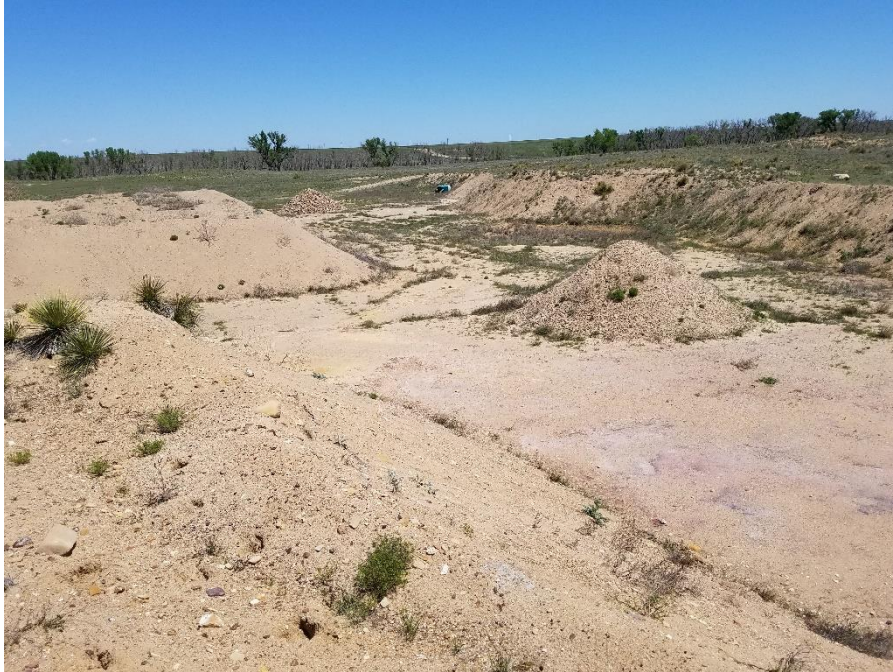
Figure 6. From the south central portion of the affected land looking northeast.

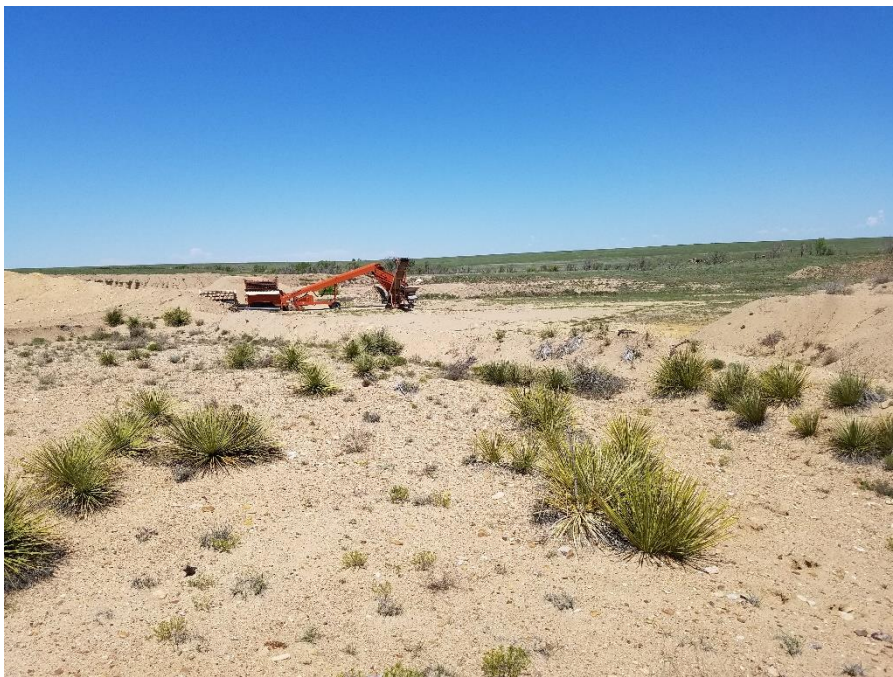
Figure 7. From the south central portion of the affected land looking north.

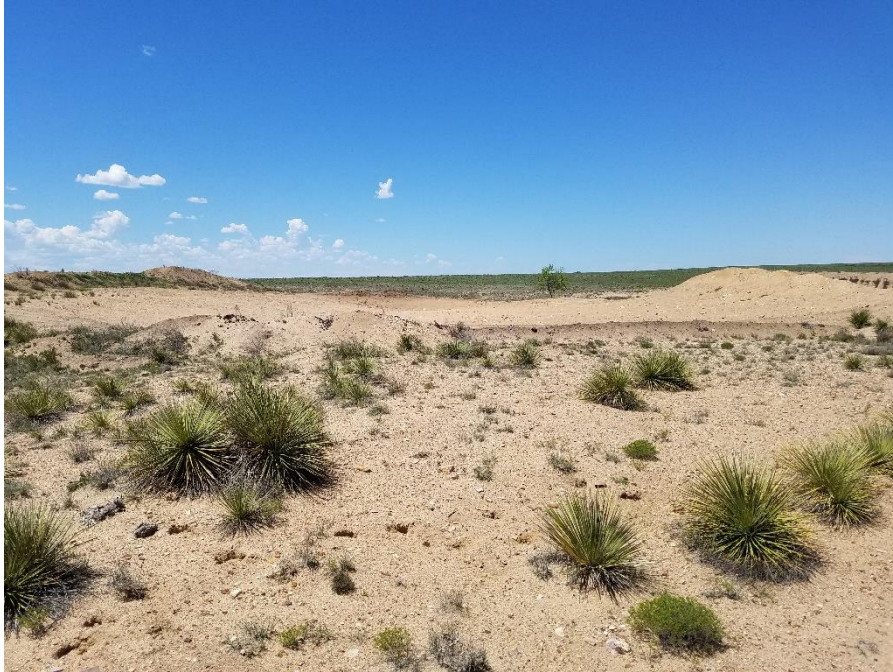
Figure 8. From the south central portion of the affected land looking northwest.
