**MINERALS PROGRAM INSPECTION REPORT****PHONE: (303) 866-3567**

<b>MINE NAME:</b> Mask Ranch Pit #2	<b>MINE/PROSPECTING ID#:</b> M-2018-015	<b>MINERAL:</b> Aggregate and grave	<b>COUNTY:</b> Archuleta
<b>INSPECTION TYPE:</b> Monitoring	<b>INSPECTOR(S):</b> Lucas J. West	<b>INSP. DATE:</b> May 14, 2019	<b>INSP. TIME:</b> 12:55
<b>OPERATOR:</b> Fremont Paving & Redi-Mix, Inc.	<b>OPERATOR REPRESENTATIVE:</b> Jodi Schreiber	<b>TYPE OF OPERATION:</b> 111 - Construction by Government Agency	
<b>REASON FOR INSPECTION:</b> Normal I&E Program	<b>BOND CALCULATION TYPE:</b> Complete Bond	<b>BOND AMOUNT:</b> \$45,000.00	
<b>DATE OF COMPLAINT:</b> NA	<b>POST INSP. CONTACTS:</b> None	<b>JOINT INSP. AGENCY:</b> None	
<b>WEATHER:</b> Clear	<b>INSPECTOR'S SIGNATURE:</b>

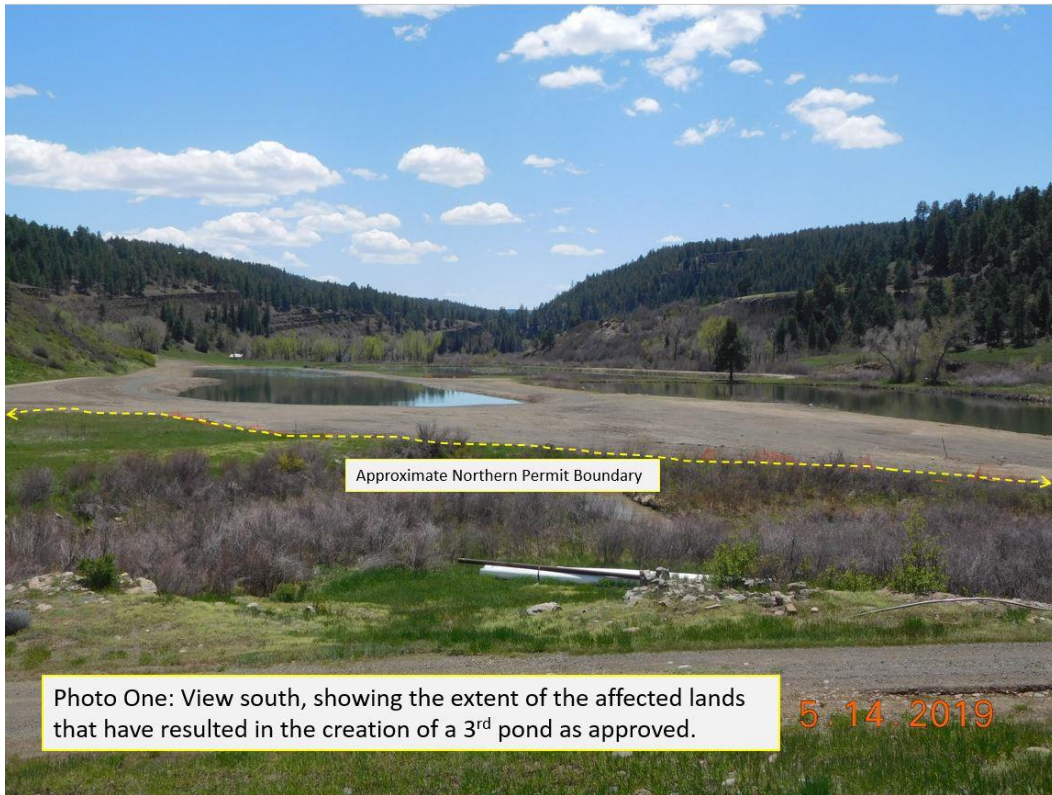
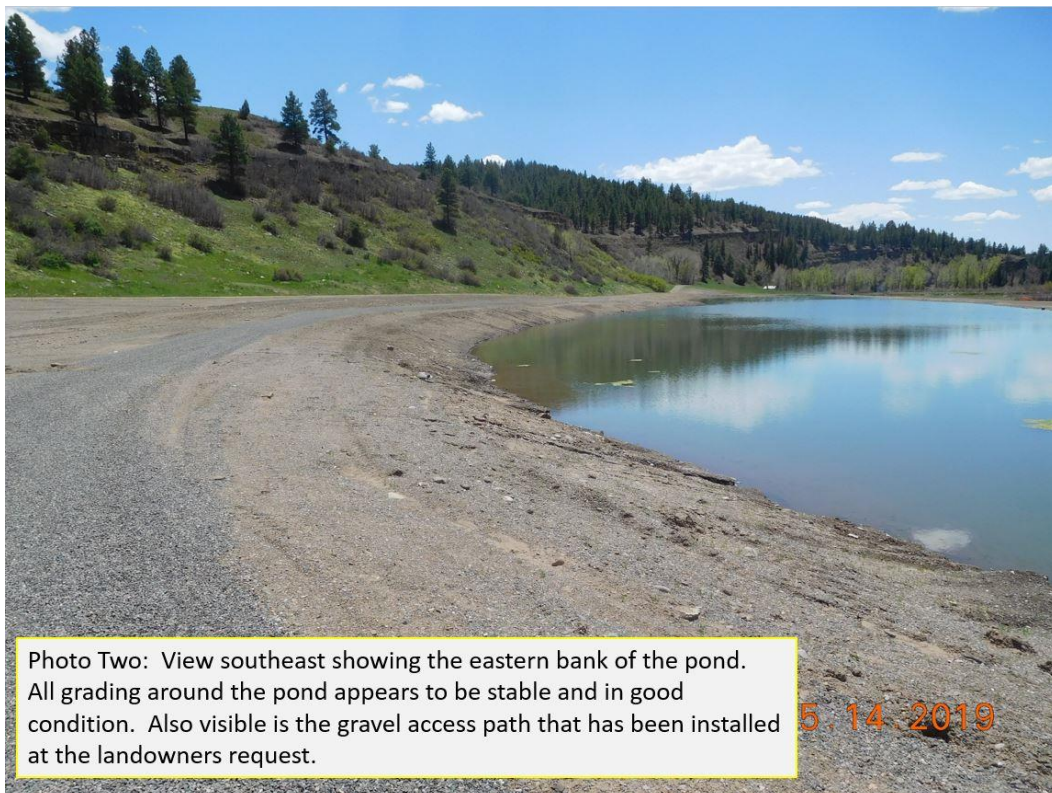
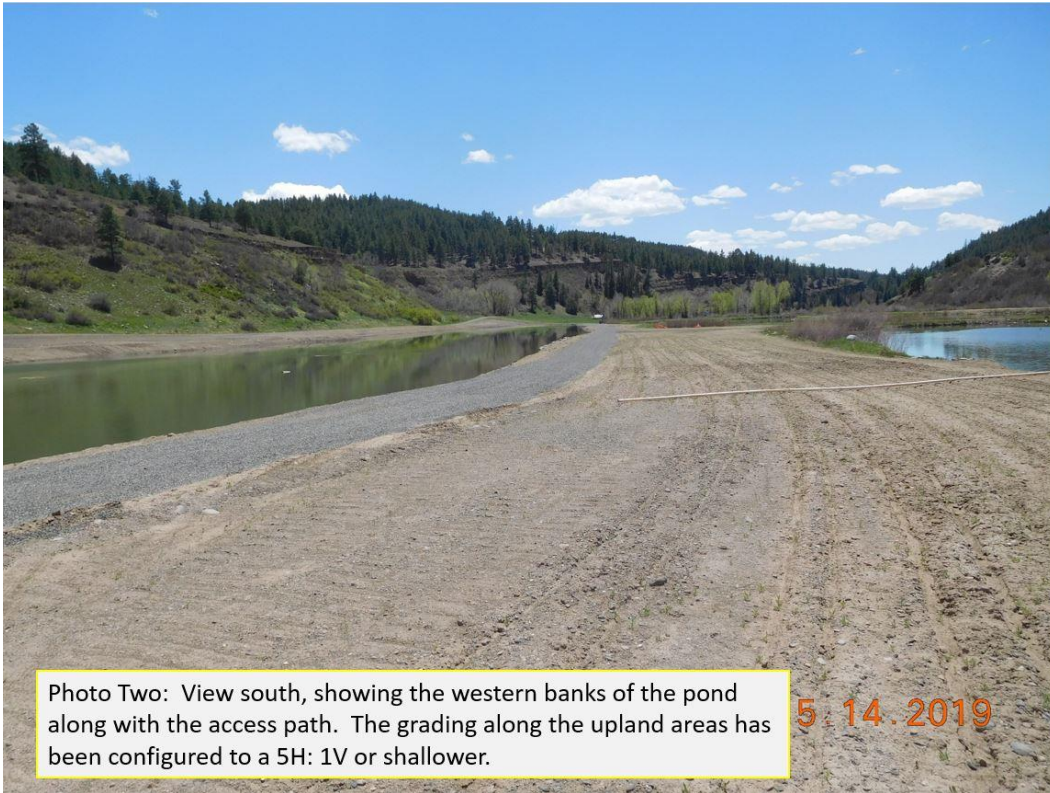
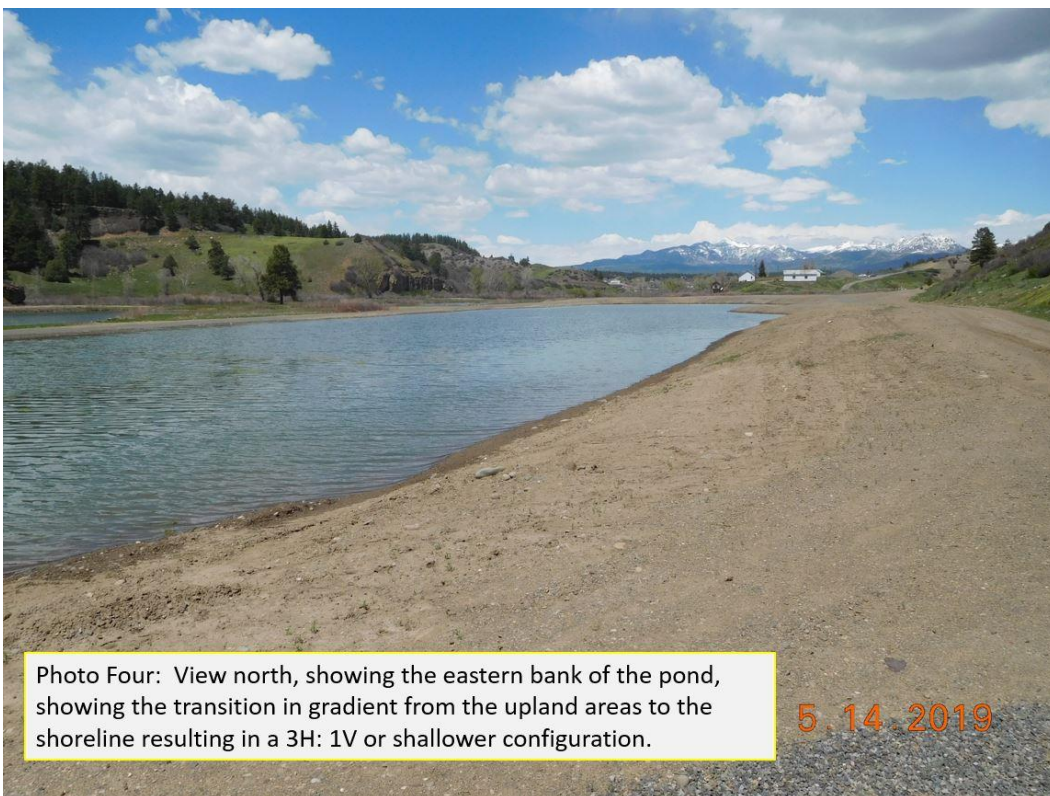
The mining activity has created a 3<sup>rd</sup> pond on site as approved through the original application. All grading of the pond banks and upland areas has been completed and can be seen in Photos One through Four. The grading appears to be stable and in good condition, no signs of significant settling, slumping or erosion were overserved during the inspection. All grading has configured the upland areas to have a gentle grade, approximately a 5H: 1V or shallower. The pond bank slopes have been configured to no steeper than 3H: 1V in accordance with Construction Materials Rule 3.1.5(7). The footprint of the pond consists of a gentle undulating shoreline that will assist in preventing wave erosion as well as be aesthetically pleasing. An access trail has also been left around the perimeter of the pond which can be seen in the photographs, at the request of the landowner.

The overall footprint of the site is in good condition and free from trash and debris. No settling slumping or signs of significant erosion was noted throughout the site. No state listed noxious weeds were observed, and no problems or possible violations exist on site. All responses to this report should be directed to Lucas West at the Colorado Division of Reclamation, Mining and Safety at 1313 Sherman Street, Room 215, Denver, CO 80203, by phone at (970)-243-6368 or by email at [lucas.west@state.co.us](mailto:lucas.west@state.co.us).

The Operator has indicated the tilling, seeding and mulching portion of the reclamation will take place in the coming weeks. The site will be flown with an unmanned aerial vehicle to show the exact area to be revegetated. Revegetation and weed control is the only task that remains to complete final reclamation.
