MINERALS PROGRAM INSPECTION REPORT**PHONE: (303) 866-3567**

MINE NAME: Sharp Pit #2	MINE/PROSPECTING ID#: M-2013-023	MINERAL: Gravel and sand	COUNTY: Bent
INSPECTION TYPE: Monitoring	INSPECTOR(S): Amy Eschberger	INSP. DATE: March 7, 2019	INSP. TIME: 16:45
OPERATOR: Riverside Aggregates, LLC	OPERATOR REPRESENTATIVE: Rudy Torres	TYPE OF OPERATION: 110c - Construction Limited Impact	
REASON FOR INSPECTION: Normal I&E Program	BOND CALCULATION TYPE: Complete Bond	BOND AMOUNT: \$24,800.00	
DATE OF COMPLAINT: NA	POST INSP. CONTACTS: None	JOINT INSP. AGENCY: None	
WEATHER: Clear	INSPECTOR'S SIGNATURE:

M-2013-023 / Sharp Pit #2 / Riverside Aggregates, LLC

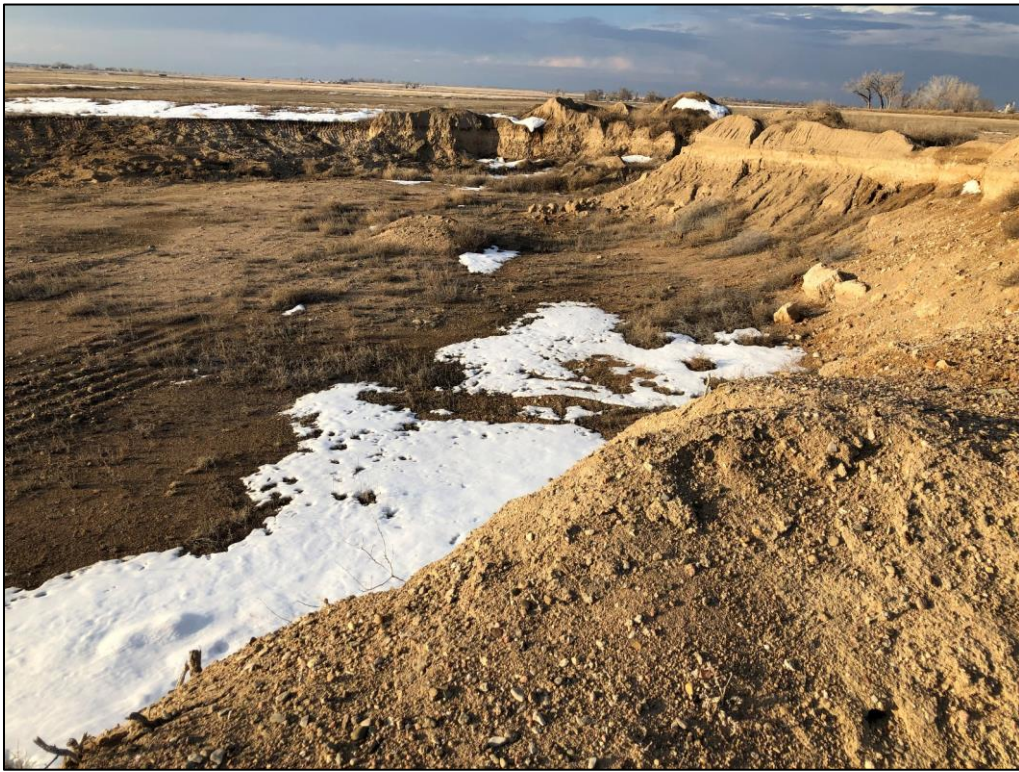
The active pit is currently located in the western half of the permit area. The Division estimates the highwall to be approximately 750 feet in length, which is less than the approved maximum length at any time of 850 feet. The highwall is up to 10 feet in height, with 1H:1V slopes. The pit is being expanded primarily to the east and south. According to Mr. Torres, the operation will not continue expanding the pit westward. The operation has graded an approximately 250 foot section of the western highwall to 4H:1V. Vegetative cover of this area consisted of grasses and annual weeds. Mr. Torres indicated the operation plans to backfill the southwestern section of the highwall in the near future. A few material stockpiles were stored on the pit floor and in the eastern half of the permit area. Salvaged topsoil was stored primarily at the southern edge of the permit area and appeared to be stable.

Photo 1. View looking north across active pit located in western half of permit area. Highwalls were up to 10 feet in height with 1H:1V slopes.

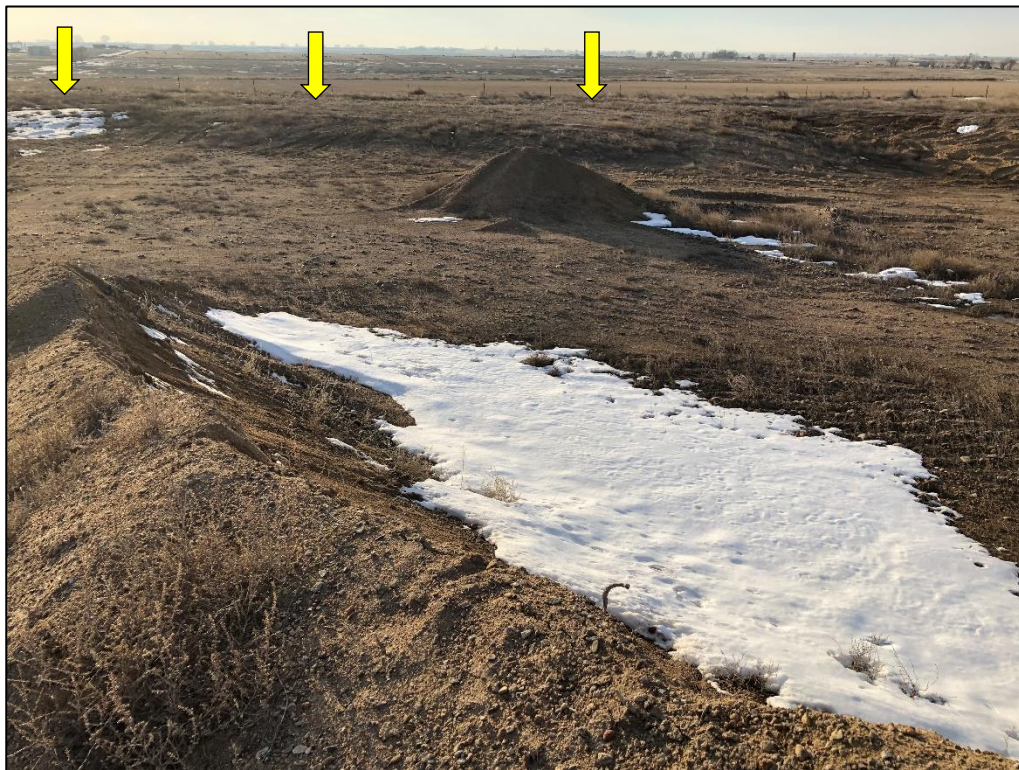
Photo 2. View looking northwest across active pit located in western half of permit area. Note small material stockpile stored on pit floor. Reclaimed section of western highwall visible in background (indicated with arrows).

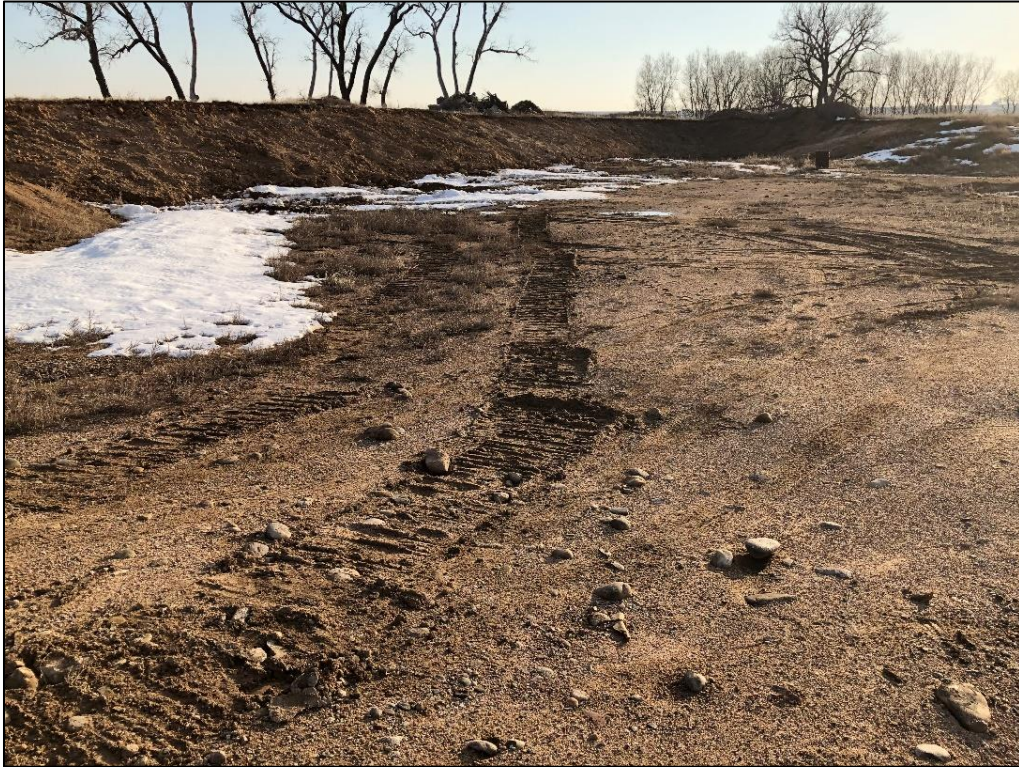
Photo 3. View looking southwest across active pit located in western half of permit area. The operator intends to backfill this section of the highwall in the near future.

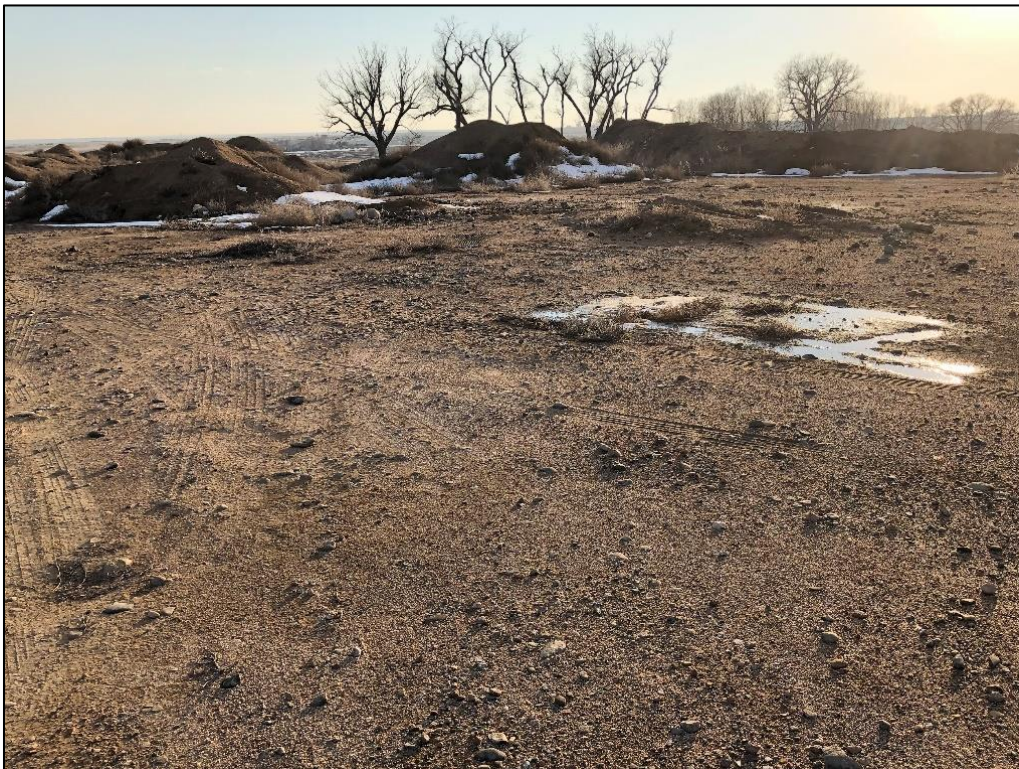
Photo 4. View looking south, showing topsoil stockpiled at southern edge of permit area (in background).

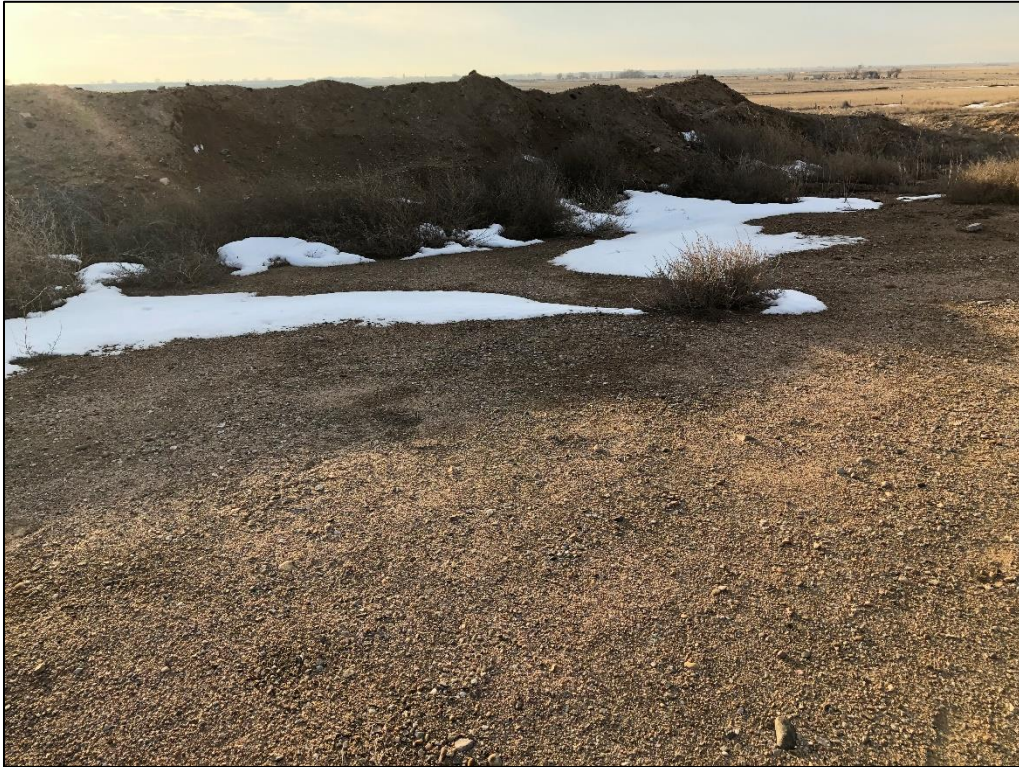
Photo 5. View looking west, showing topsoil stockpiled at eastern edge of pit.

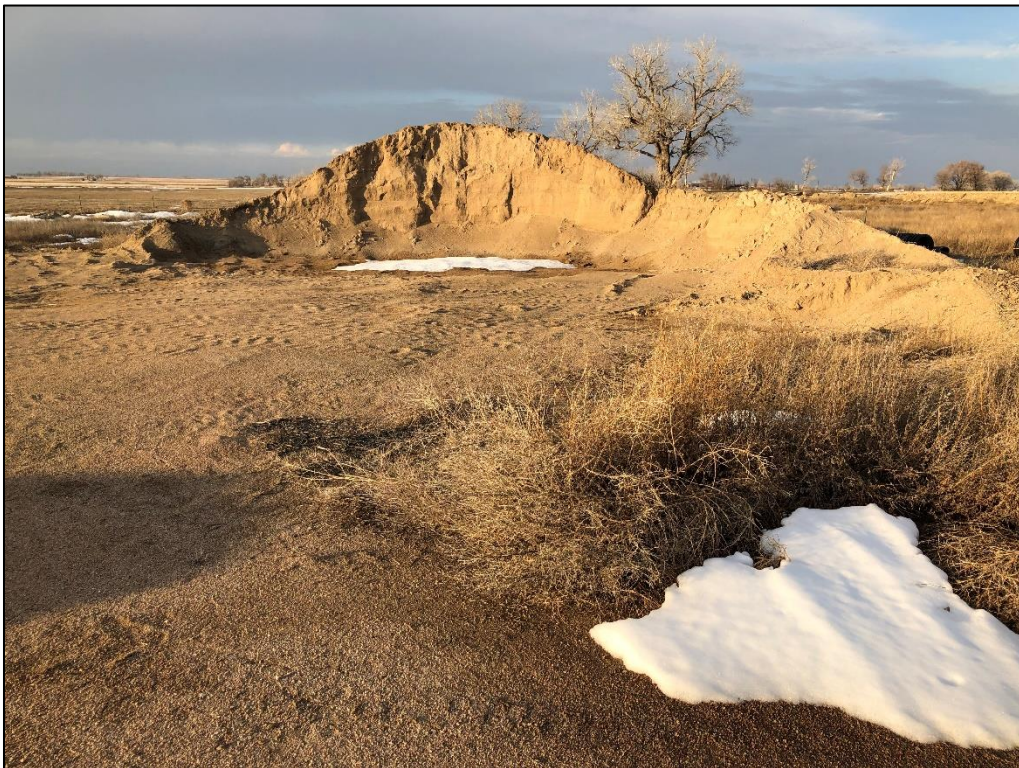
Photo 6. View looking northeast, showing material stockpile stored at eastern edge of permit area.

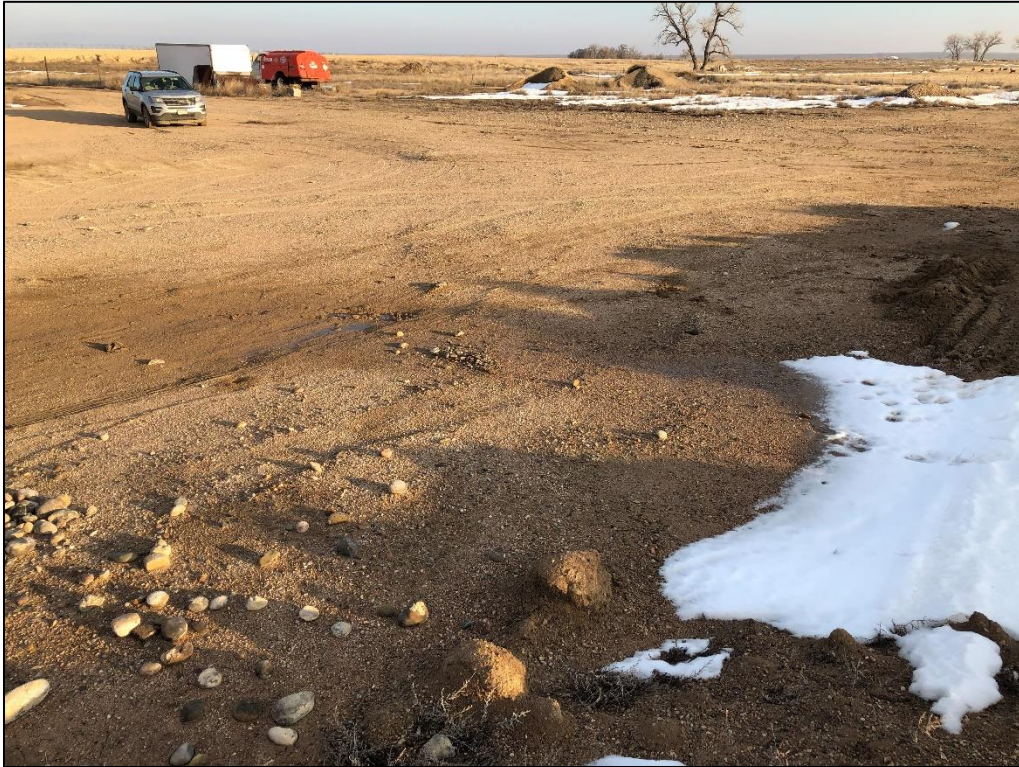
Photo 7. View looking southeast across stockpiling/processing area located in eastern half of permit area.

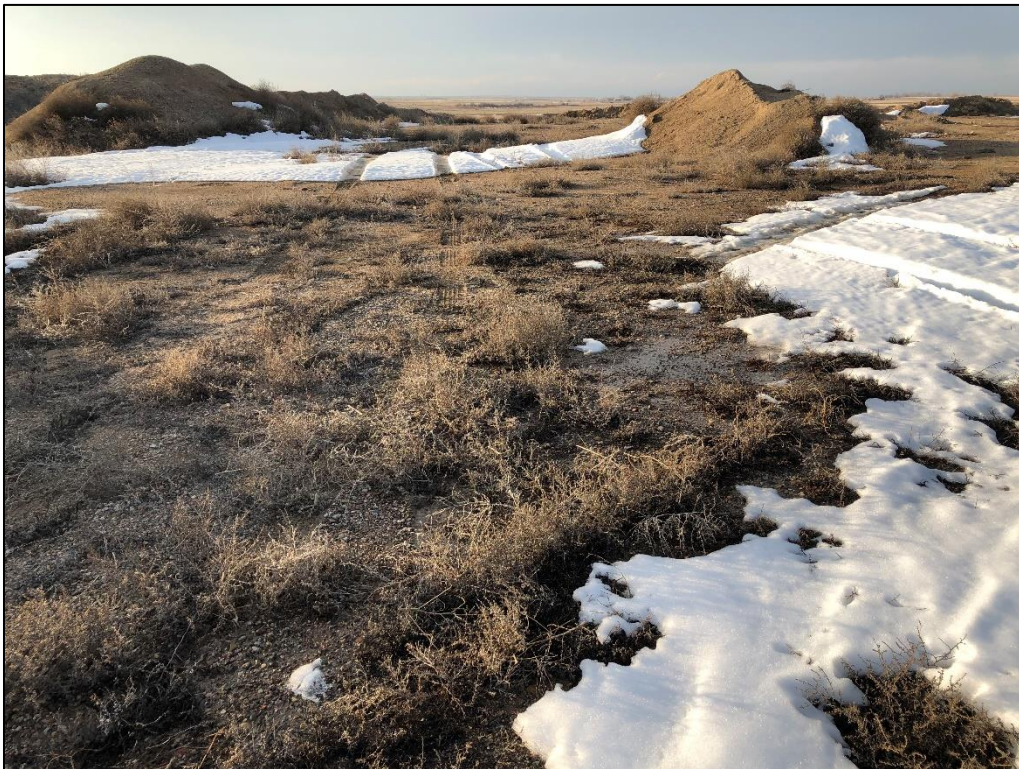
Photo 8. View looking east across southeastern edge of stockpiling/processing area, showing a few material stockpiles scattered across this area.

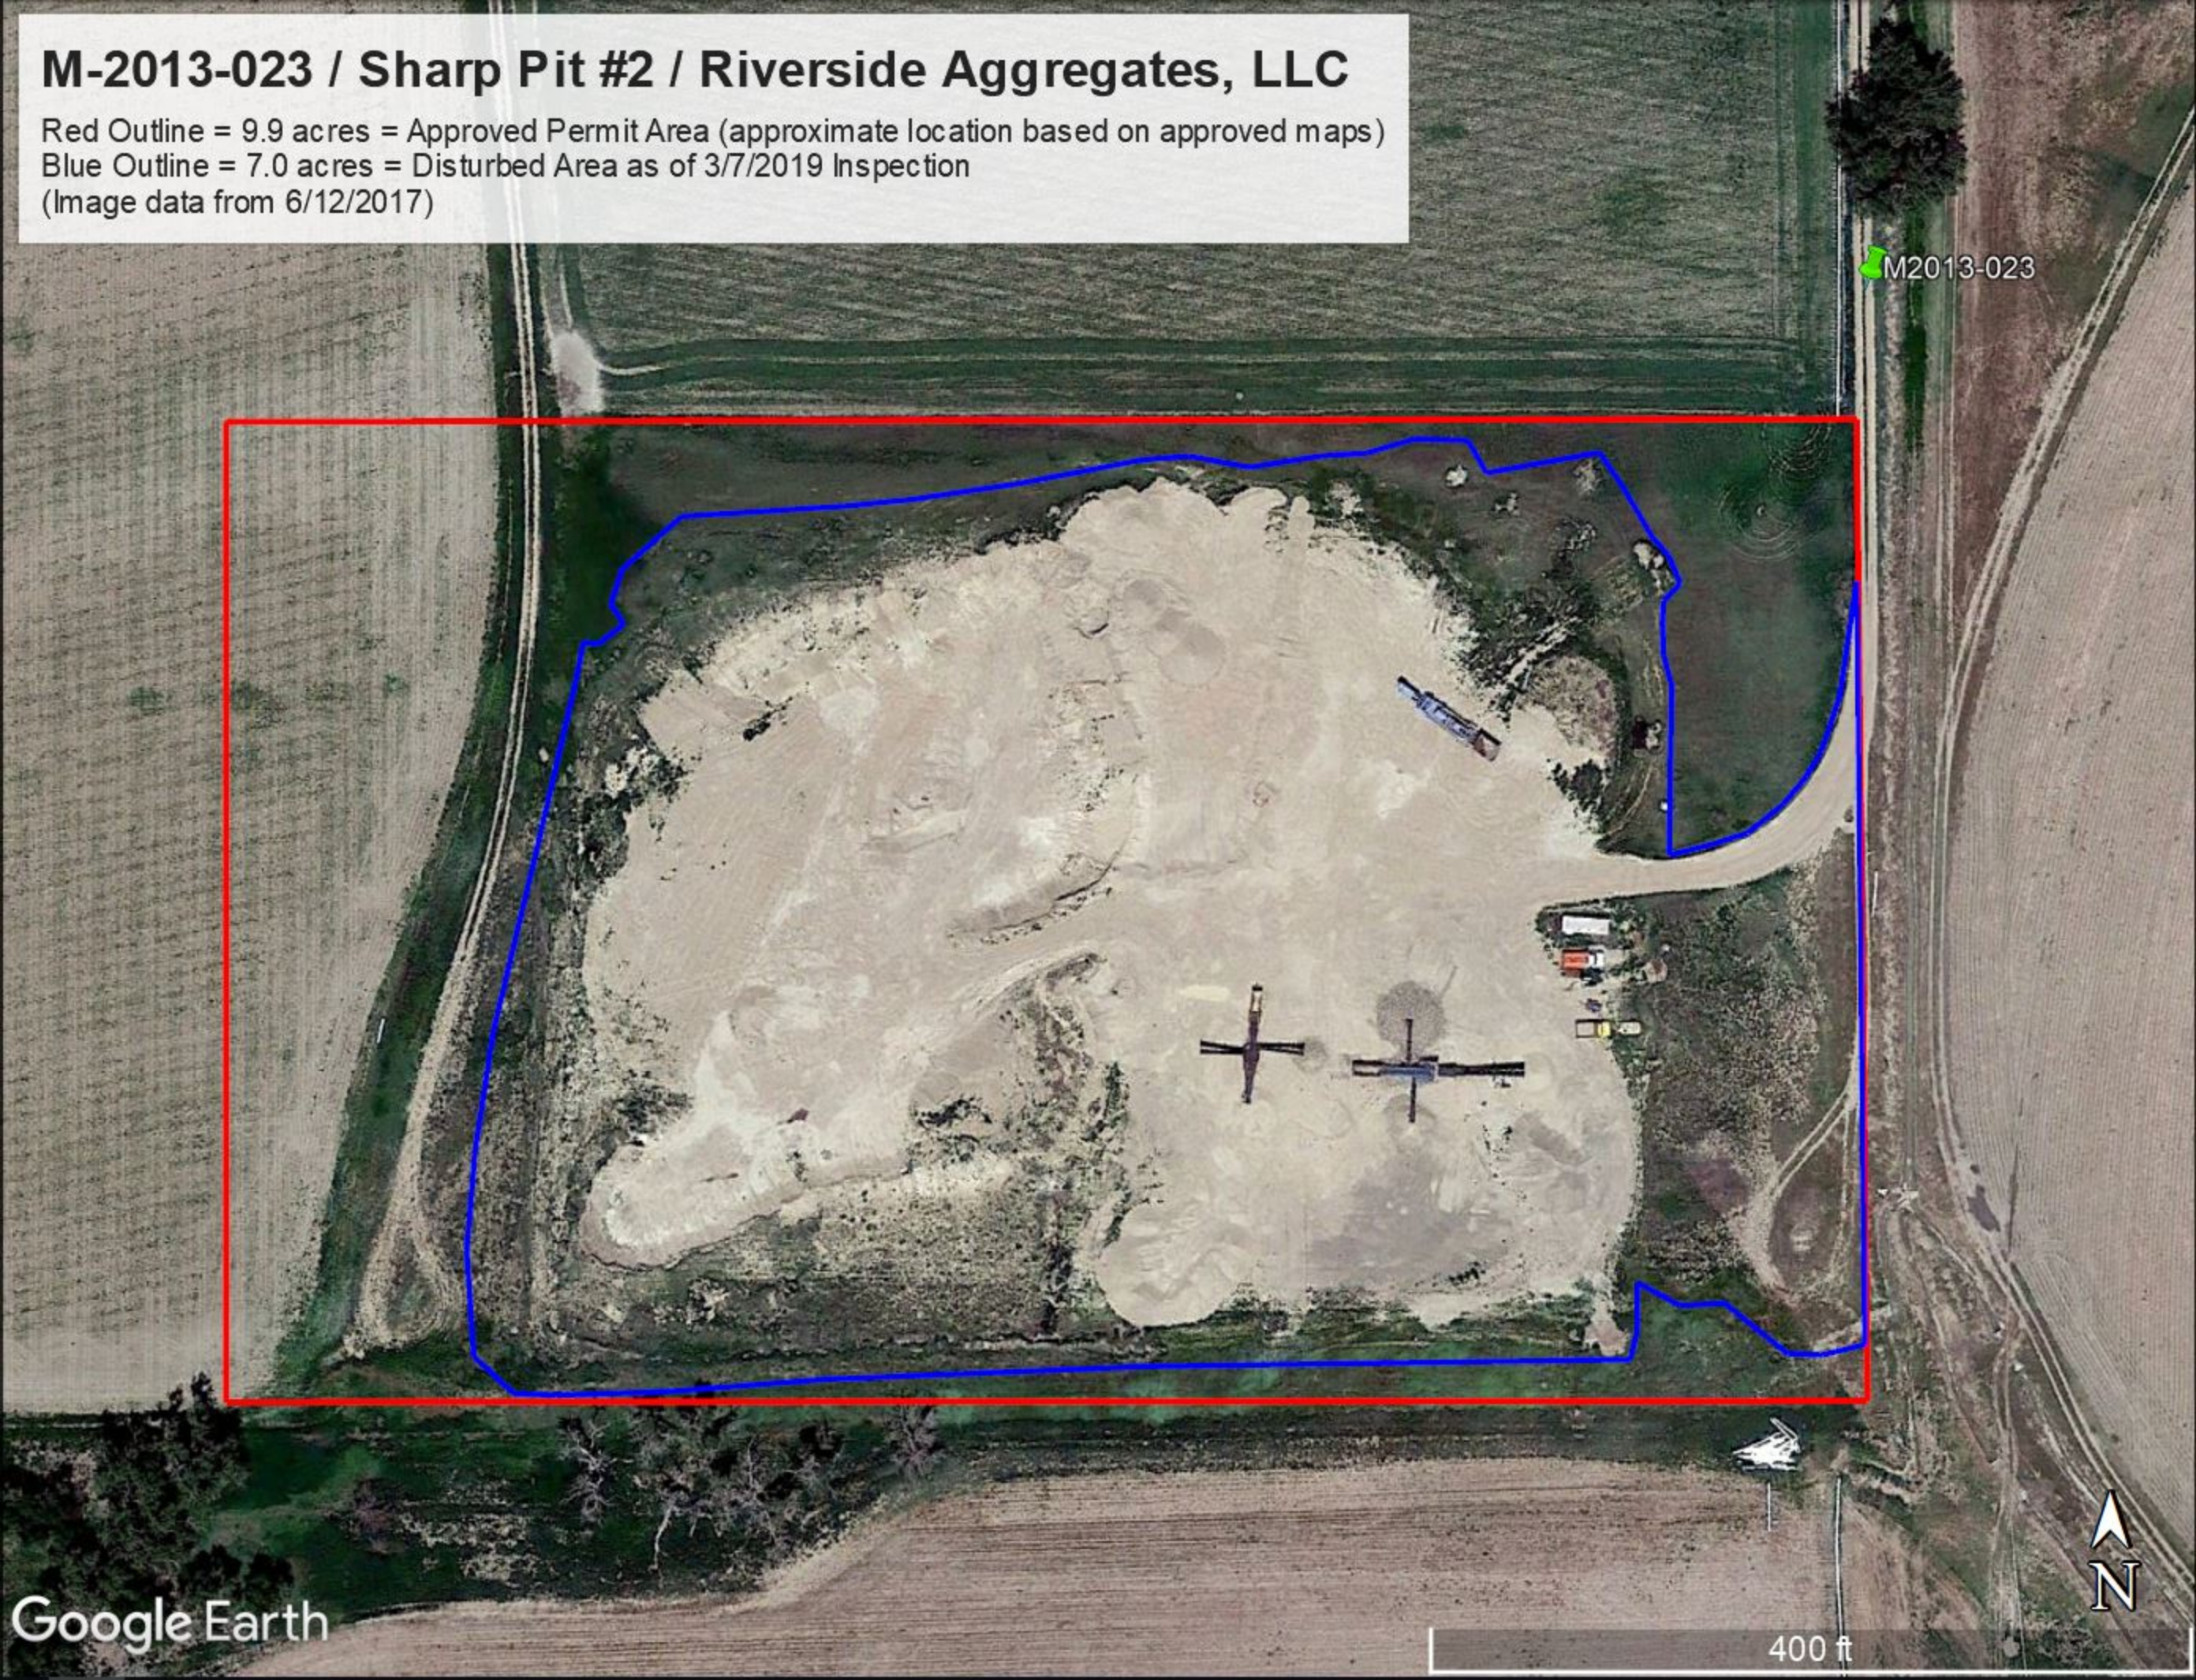
The Division estimates the operation has currently disturbed a total of 7 acres. The Division reassessed the required financial warranty for the site and determined the current financial warranty of \$24,800.00 to be adequate to reclaim the site in accordance with the approved reclamation plan.

Red Outline = 9.9 acres = Approved Permit Area (approximate location based on approved maps)
Blue Outline = 7.0 acres = Disturbed Area as of 3/7/2019 Inspection
(Image data from 6/12/2017)
