# MINERALS PROGRAM INSPECTION REPORT PHONE: (303) 866-3567

MINE/PROSPECTING ID#:	MINERAL:	COUNTY:		
M-2006-073	Sand and gravel	El Paso		
INSPECTOR(S):	INSP. DATE:	INSP. TIME:		
Timothy A. Cazier	May 22, 2019	08:30		
OPERATOR REPRESENTATIVE:	TYPE OF OPERATION:			
Mike Drabing	112c - Construction Regular Operation			
REASON FOR INSPECTION: BOND CALCULATION TYPE: BOND AMOUNT:				
BOND CALCULATION TYPE:	BOND AMOUNT:			
None	\$1,000.00			
POST INSP. CONTACTS:	JOINT INSP. AGENCY:			
None	None			
INSPECTOR'S SIGNATURE:	SIGNATURE DATE:			
Thing all	May 23, 2019			
	M-2006-073 INSPECTOR(S): Timothy A. Cazier OPERATOR REPRESENTATIVE: Mike Drabing  BOND CALCULATION TYPE: None POST INSP. CONTACTS: None	INSPECTOR(S): Timothy A. Cazier  OPERATOR REPRESENTATIVE: Mike Drabing  BOND CALCULATION TYPE: None POST INSP. CONTACTS: None INSPECTOR'S SIGNATURE:  INSP. DATE: May 22, 2019  TYPE OF OPERATOR TYPE OPERATOR T

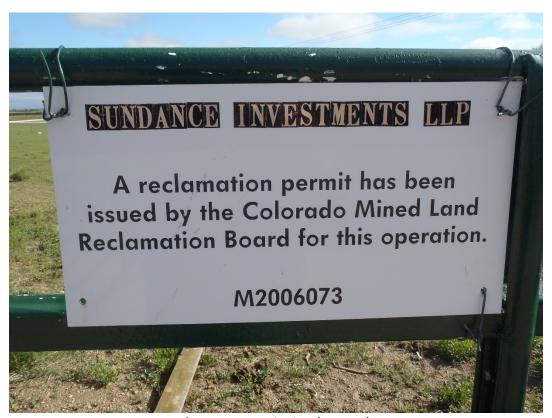
<u>Inspection</u>: The permit sign was displayed as required (see **Photo 1**). The permit boundaries were marked by fences (see **Photo 2**). The entire site was driven. No mining related disturbances were observed. Mr. Drabing stated he'd let the El Paso county permit lapse. This inspector informed him the County permit is required prior to initiating mining.

Photo 1. Permit sign (at gate).

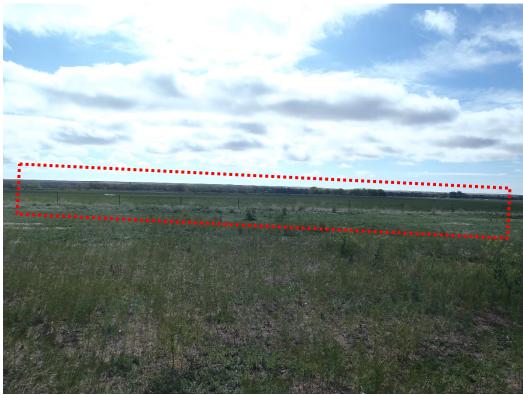
Photo 2. Typical boundary fence.
